Effect of Fusion Boundary Microstructure on Flow-Accelerated Corrosion Cracking

Abstract: Flow-accelerated corrosion (FAC) preferentially attacks the downstream heat-affected zone of the root-pass weld in steam pipe systems. A detailed characterization identifies the fusion boundary as the initiation location for the attack. Alloying elements are found depleted along the weld fusion boundary, and multiple welding thermal cycles and repetitive austenite-to-ferrite phase transformations result in an increased proportion of grains with Goss {110}<001> texture along the fusion boundary. The synergistic effects of chemical segregation and the Schmid factor may contribute to the preferential initiation of FAC cracks along the root weld fusion boundary, making it the weakest link for FAC attack in steam pipe girth welds.

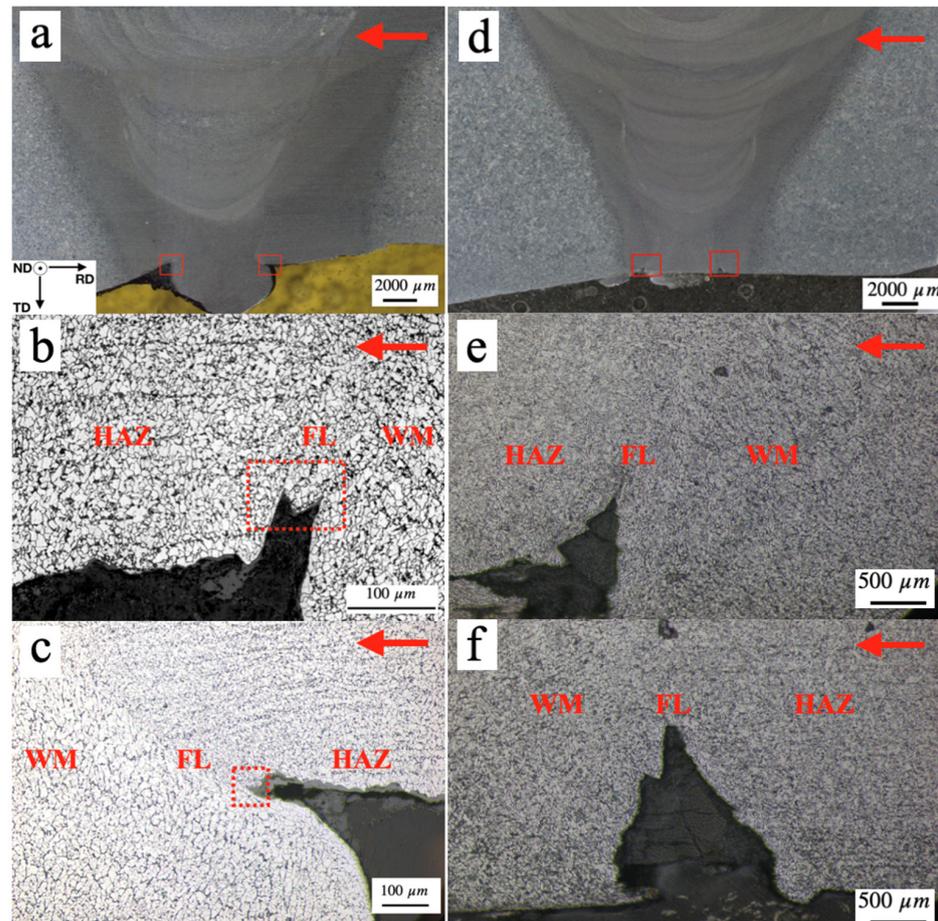
Figure 1 shows the micrographs of the girth welds that contained crack initiations for flow-accelerated corrosion attack. The red arrows point to the direction of steam flow. Subsequent characterization used the following frame of reference for the specimen: following the right-hand rule, the X-axis is in the radial direction (RD), the Y-axis in the thickness direction (TD), and the Z-axis in the normal direction (ND). Under this frame of reference, the microcracks were found to have initiated at both upstream and downstream weld toes and propagated along the Y-axis direction, as indicated by the red rectangles in Figure 1a,d. At a higher magnification, the crack initiations were identified at the weld fusion line (FL), for both the downstream (Figure 1b,e) and the upstream (Figure 1c,f) weld toes. No FAC crack initiations were found in the adjacent heat-affected zone (HAZ) or in the root-pass weld filler metal (WM). It is notable that FAC crack initiations were detected at the fusion line of the root pass at various locations of the steam pipe girth weld. The macrograph shown in Figure 1a was captured from the 12 o'clock location of the girth weld, while the macrograph shown in Figure 1d was captured from the 3 o'clock location of the

girth weld, assuming the observer was looking at the flow direction. It is apparent that the protruding weld reinforcement at the 3 o'clock location has been severely eroded by the flow; it also contains two small crack tips, each located at the weld fusion line of the upstream and downstream weld toes. The 12 o'clock location, in contrast, has the root weld reinforcement intact, although the crack initiations at the weld fusion line can be observed.

Figure 1. (a) Weld joint section from the 12 o'clock location shows crack initiations. The red arrows point to the steam flow direction. (b) Crack initiation point at the fusion line near the downstream toe of the root pass, indicated by the red box on the left in (a). (c) Crack initiation point at the fusion line near the upstream toe of the root-pass weld, indicated by the red box on the right in (a). (d) Weld joint from the 3 o'clock location. (e) Crack initiation point at the fusion line near the downstream toe of the root pass, indicated by the red box on the left in (d). (f) Crack initiation point at the fusion line near the upstream toe of the root-pass weld, indicated by the red box on the right in (d).

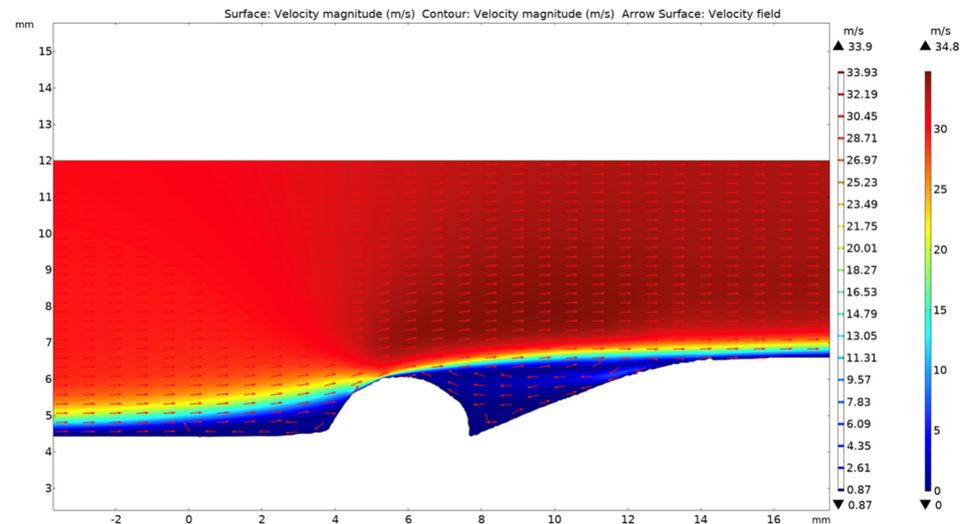
Figure 1a was digitized and converted into 2D finite-element meshes for the CFD simulation in COMSOL Multiphysics. A single-phase water film flow with an assumed velocity of 30 m/s is shown in Figure 2. As the flow passes through the girth weld surface, there are disruptions in the flowing water. The relationship between component surface shear stress (τ) and flow velocity (u) can be explained by the following equation [30], $\tau = \mu \frac{du}{dy}$, where y is distance, μ is the dynamic viscosity of the water, and du/dy is the slope of the flow velocity distribution curve. Near the protruding root weld reinforcement, a sudden alteration in flow velocity results in an increase in the value of du/dy , leading to higher shear stress and more significant mechanical erosion at the location. Near the fusion line at the weld toe, the water is stagnant, resulting in less fluid erosion.

Figure 2. Flow pattern and velocity distribution over the surface of the 12 o'clock weld, computed in Comsol Multiphysics.

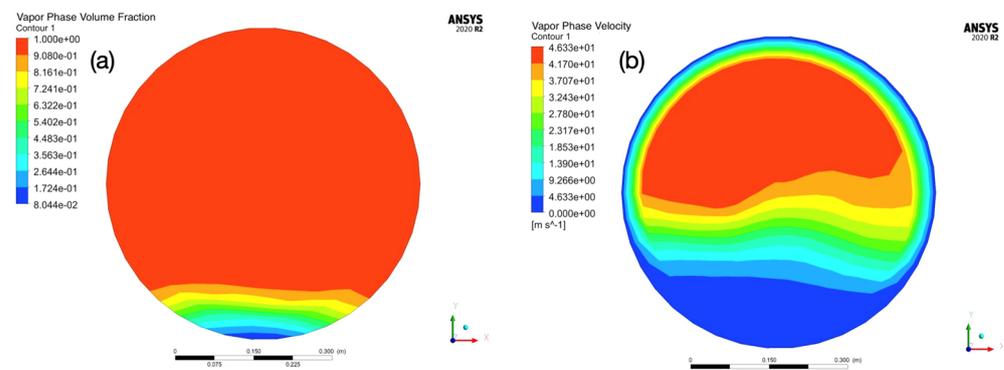
Figure 3 shows the phase and velocity distribution maps of the flowing steam–water mixture. It can be observed that due to heat and pressure loss along the transmission direction, the circulating steam has partly condensed to water. Additionally, influenced by gravity, the condensed water accumulates at the bottom of the pipe, as shown in Figure 3a. Seen in Figure 3b, due to collection of the condensed water, the area of the vapor phase is reduced. Compared to the initial steam velocity at the inlet (30 m/s), the velocity of the vapor phase increases to 46.3 m/s, while the condensed water at the bottom of the pipe is more stagnant, with a velocity of 4.6 m/s. A large velocity difference can generate a shear force at the vapor–liquid interface. If this shear force exceeds the strength of the liquid at the interface, some liquid will be sheared off the liquid layer and be carried along with the rapidly flowing vapor. Some of these sheared droplets may collide with the protruding weld reinforcement. This phenomenon, known as liquid droplet impingement (LDI), rapidly removes the oxide layer on the metal surface, thereby promoting flow-accelerated corrosion.

Figure 3. CFD results simulated using Ansys Fluent software. (a) depicts the cross-sectional phase distribution diagram of the flow, and (b) depicts the cross-sectional flow velocity distribution.

The CFD simulation indicates that water is sparse near the 12 o'clock position of the circumferential weld, while water is more densely distributed close to the bottom (6 o'clock) of the circumferential weld. The steam flow exhibits a cross-sectionally non-uniform distribution within the pipe, contributing to the varying FAC damage morphology observed in different locations along the girth weld. Additionally, the flow over the fusion line (or weld toe) areas is more stagnant, indicating that these regions are less affected by erosion. However, the microstructure of the material, such as the distribution of alloying elements and crystallographic orientations, determines the local mechanical properties that respond to the development of FAC cracks at the weld fusion line.

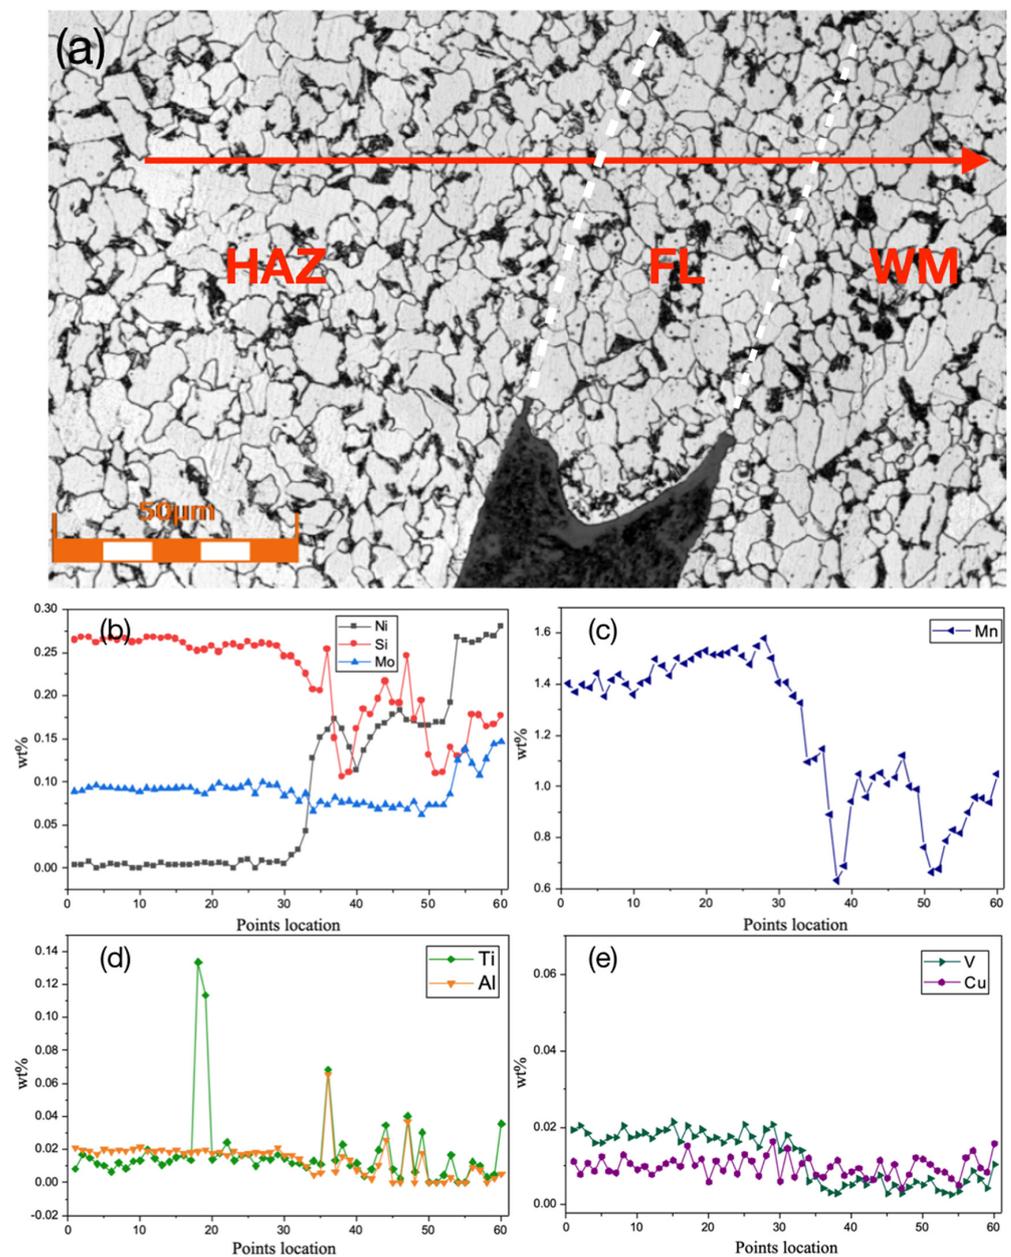
The microstructure and quantitative compositional analysis by EPMA on the downstream crack-tip region are shown in Figure 4a. The fusion boundary or fusion line (FL) is a region several grain sizes wide, sometimes referred to as the partially melted zone. In this region, the peak temperature falls between the solidus and liquidus of the steel. At this magnification, the ferrite grains in the fusion boundary contain some precipitates, as do the weld metal ferrite grains. On the other hand, the ferrite grains in the heat-affected zone do not contain observable precipitates at all. The red arrow indicates the location of the EPMA line scan. Shown in Figure 4b–e, the fusion line region has the average (of the base metal and weld metal) chemical compositions for Ni and Mn, likely due to the dilution by the base metal. There is a depletion of carbide-forming elements (Mo and V) in the fusion line region, although the de-oxidizing elements Ti and Al show several peaks, indicating possible oxide inclusions.

Figure 4. (a) The EPMA line scan along the arrow mark across the FL from the HAZ to the WM. (b) Concentrations of Ni, Si, and Mo, and (c) concentration of Mn. (d) Concentrations of Ti and Al, and (e) concentrations of V and Cu.

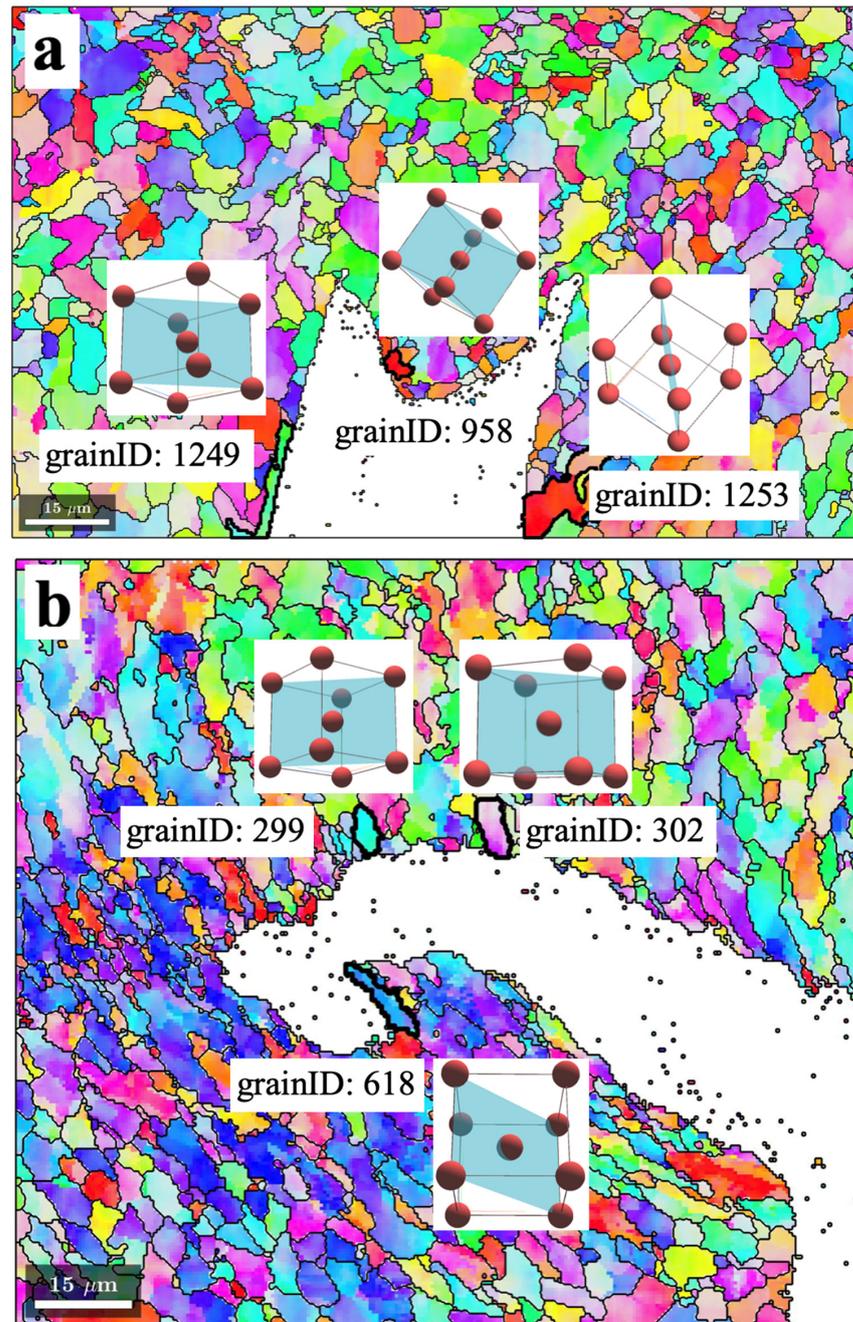
Figure 5 shows the EBSD crystal orientation maps with respect to the Z-axis (specimen normal direction) of downstream and upstream crack-tip areas outlined by the rectangles shown in Figure 1b,c. In the downstream fusion boundary (Figure 5a), three grains along the crack path with ID numbers 958, 1249, and 1253 were randomly selected for spatial crystal visualization. The $\{110\}$ plane family for grains 1249 and 1253 aligned closely with the crack surface. The $\{110\}$ plane family for grain 958 did not align closely with the crack surface. Similarly, in the upstream fusion line area (Figure 5b), three grains (ID numbers 299, 302, and 618) on the crack path were randomly selected and their corresponding crystal unit cells were visualized. The $\{110\}$ crystal planes of grains 299 and 302 were found to align with (i.e., be parallel to) the crack surface.

Figure 5. EBSD crystal orientation mapping with respect to the Z-axis of the (a) downstream weld toe, and (b) the upstream weld toe. Grains outlined by black bold lines were randomly selected for orientation visualization.

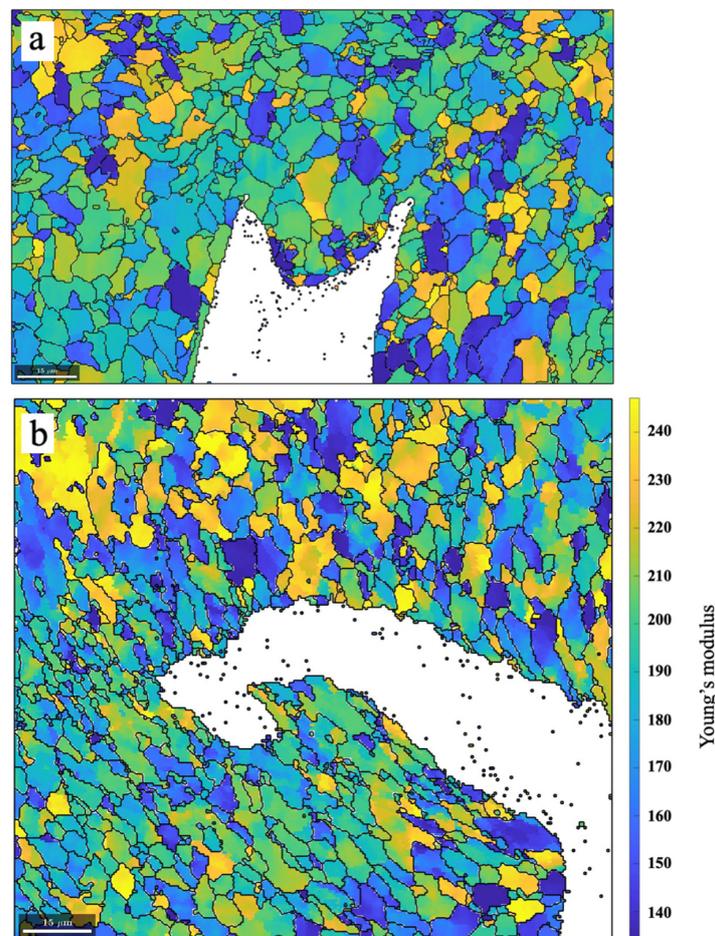
By specifying the direction of external force aligned with the steam pressure direction (e.g., the Y-axis) of the girth weld in MTEX (London, UK) Version 5.11 software, the distribution of Young's modulus values in the upstream and downstream crack-tip areas was obtained (Figure 6). It is evident that the fusion line is weaker than the adjacent base metal and weld metal. The FAC crack initiations appear to preferentially propagate along the weld fusion line with a lower Young's modulus.

Figure 6. The distribution of Young's modulus values in the (a) downstream and (b) upstream crack-tip areas, obtained by specifying the direction of external force aligned with the Y-axis in MTEX software.

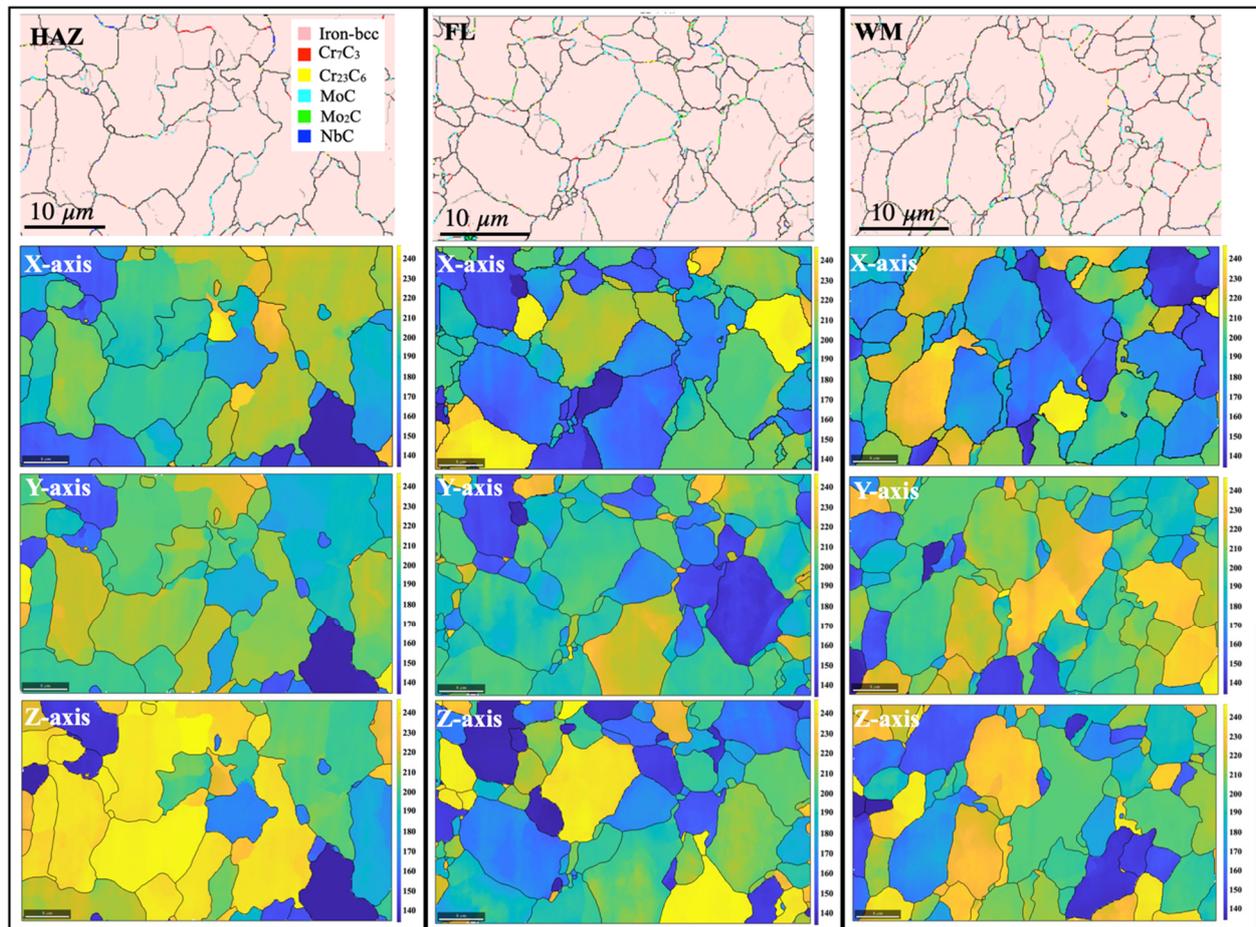
EBSD results measured with a finer step size of $0.15\ \mu\text{m}$ from the heat-affected zone, fusion line, and weld metal adjacent to the downstream crack tip are shown in Figure 7. Precipitate quantities, grain sizes, and fractions of high-angle and low-angle grain boundary types are summarized in Table 2. No significant differences in grain sizes or grain boundary types were observed among the heat-affected zone, fusion line, and weld fusion zone. The volume fractions of precipitates were almost identical, except that the fusion line contained more Mo–carbide.

Figure 7. EBSD phase maps for the heat-affected zone (HAZ), fusion line (FL), and weld metal (WM) overlaid with grain boundaries, and the corresponding Young's modulus maps calculated along the X-, Y-, and Z-axes, respectively. The different colors can be understood by referring to the legends.

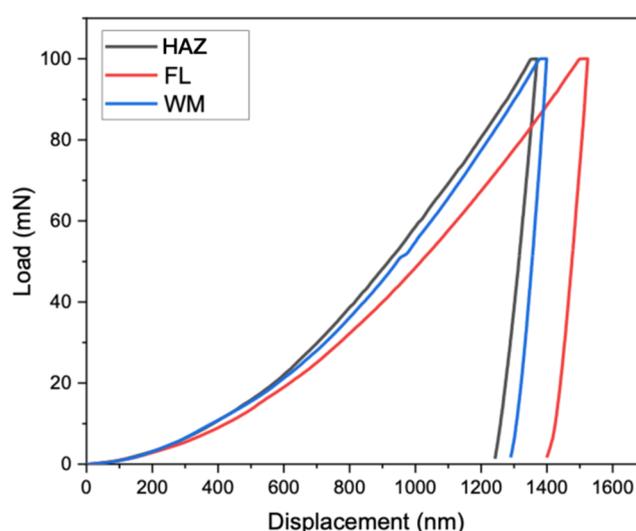
The loading and unloading curve for the fusion line area showed a maximum penetration depth, indicating the lowest deformation resistance along the fusion line, whereas the heat-affected zone and weld metal showed lower displacements, confirming the higher Vicker's hardness.

Figure 8. The load–displacement curves for the HAZ, FL, and WM, respectively.

Finally, the reason for the concentrated shear strain that has caused the crack initiation along the weld fusion boundary is most likely its being sandwiched between two stronger regions (the heat-affected zone and weld metal). Under a given load, the weld fusion line region will generate a greater displacement, as verified in Figure 8.

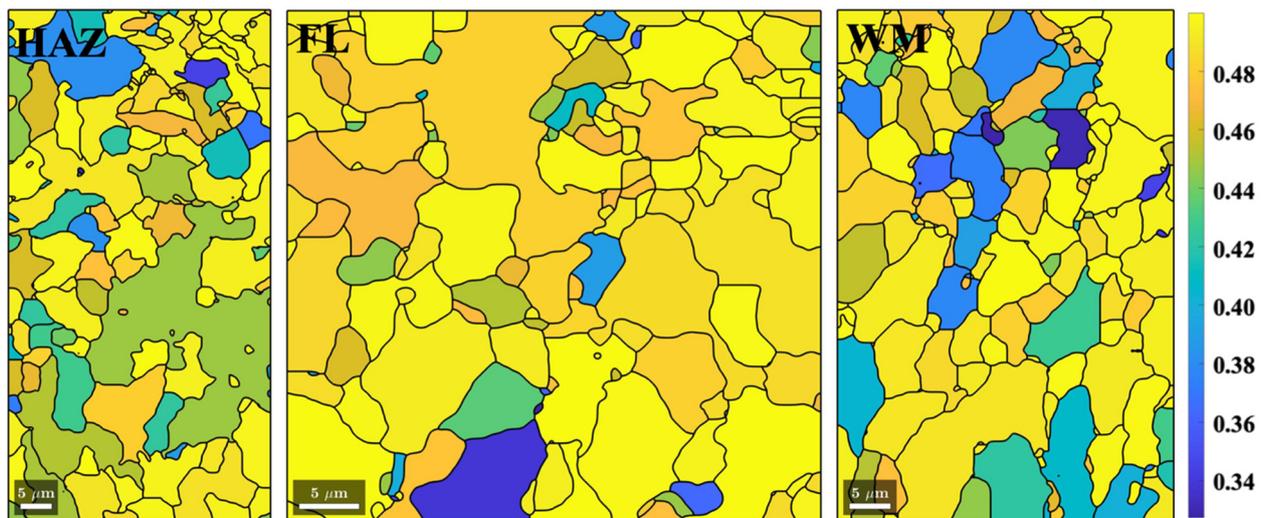
The crack initiation for flow-accelerated corrosion seems to happen preferentially along the {110} slip plane for the ferritic (BCC) microstructure. The reason for the fusion line being the weakest link for the crack initiation is because the fusion line contains the highest fraction of grains with the {110} planes aligned with it. This argument is supported by evidence shown in Figure 9, which shows the Schmid factor calculated for loading along the weld fusion line direction (or the crack propagation direction). It is evident that the grains in the fusion line region have the highest average Schmid factor (0.476), indicating more favorable slip planes are aligned with the fusion boundary. The larger the Schmid factor (i.e., closer to 0.5), the easier it is for the slip systems to be activated. In Figure 9, the heat-affected zone and weld metal contain a smaller number of grains with the slip systems aligned with the loading direction (i.e., along the fusion line).

Figure 9. Schmid factor computed for the weld fusion line loading direction. For the heat-affected zone (HAZ), the average Schmid factor is 0.467. For the fusion line region (FL), the average Schmid factor is 0.476. For the weld metal (WM), the average Schmid factor is 0.466.
