Conservation of the Beira Railway Station in Mozambique: Lessons from a 20th-Century Heritage Case Study in Africa

Keywords: 20th-century built heritage; concrete; inspection and diagnosis; non-destructive evaluation; climatic analysis; comfort

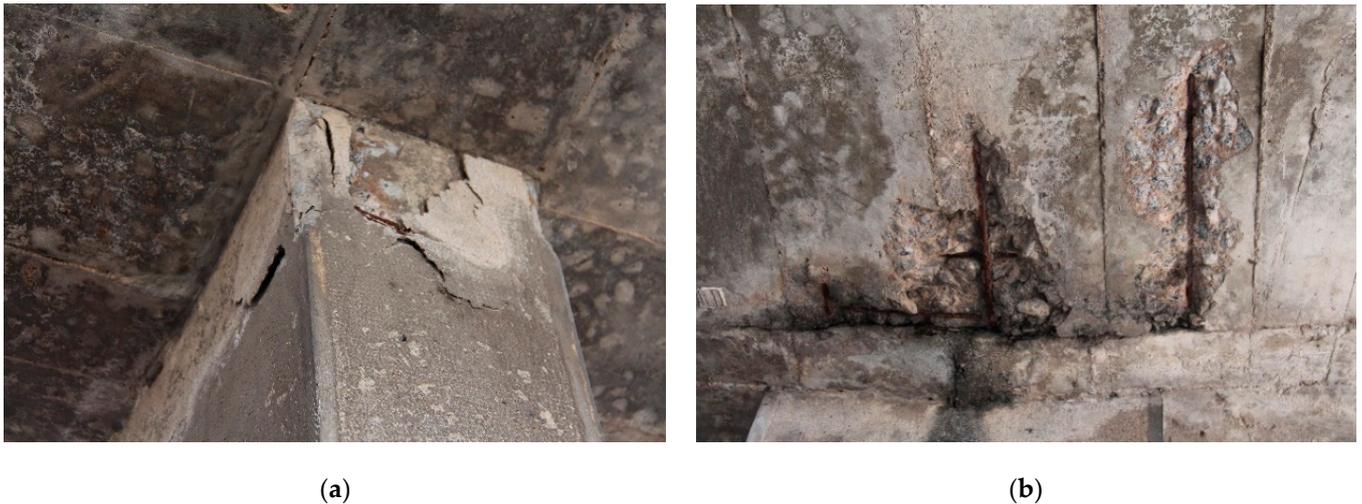
In the area of the platforms, the most significant damage observed is related to the corrosion of the reinforcement within the exposed concrete elements of the porches (Figure 6). The corrosion of steel elements is widespread throughout this area. The direct exposure of the elements to the weather and the low level of maintenance after the onset of damage aggravated the condition. As a result of the corrosion, the disintegration of the concrete is also evident, such as cracking and spalling. Damage is more intense at the construction joints, where water infiltrates easily. Leaching, efflorescence, and other water-induced deposits are also widespread on the surface. Additionally, structural and non-structural elements show mechanical damage due to impact, as a result of the use of the building.

Figure 6. Examples of corrosion of steel reinforcing bars: (a) column; (b) intrados of the roof slabs.

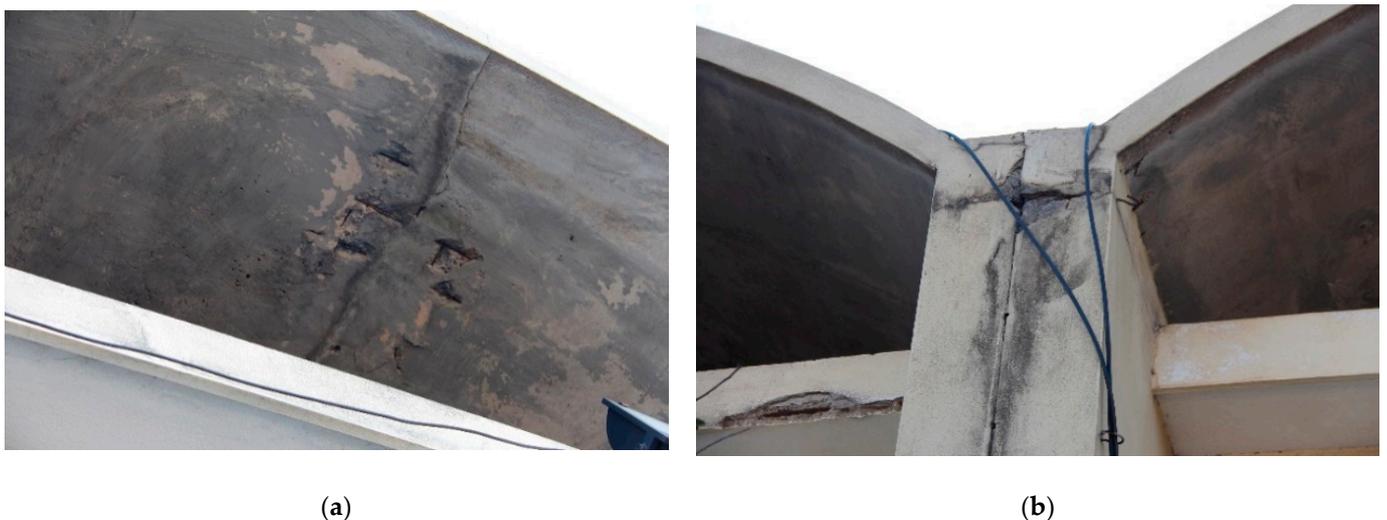
In the command body for the platforms, the most frequent damage observed is cracking at walls and beams. The corrosion of steel reinforcement is also present and widespread in the vaults and beams, which are the structural elements directly exposed to weather conditions (Figure 7). As a result, there is the recurrent spalling and cracking of the concrete. In addition, there is much non-structural damage on the walls, mostly related to the installation of air-conditioning units.

Figure 7. Typical cracking observed: (a) cracks and corroded reinforcing steel elements at the top of the vaults; (b) horizontal cracks observed on the beams.

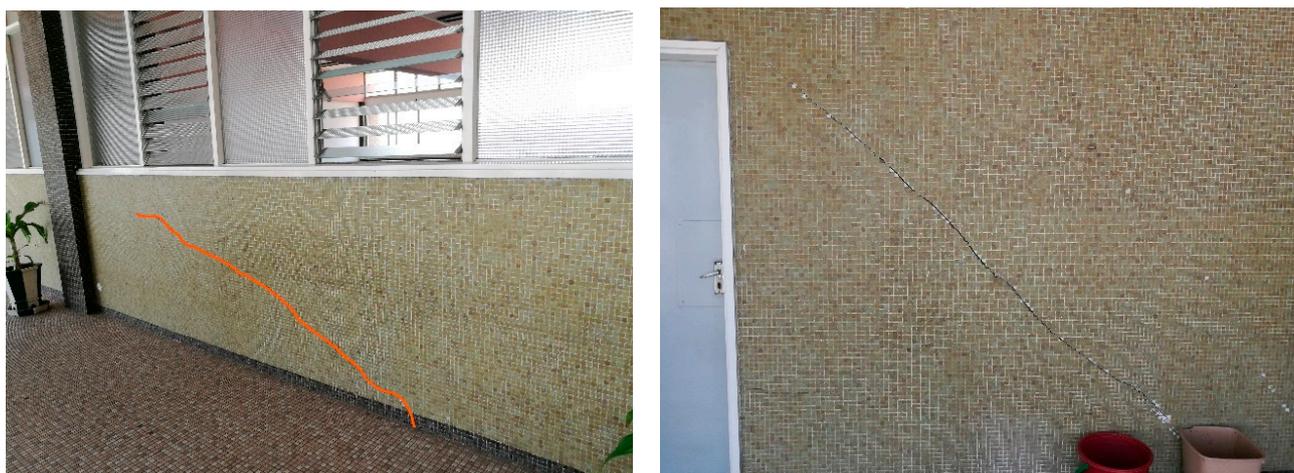
In the administrative body, the most frequent damage is cracking on the masonry walls (Figure 8). Specifically, diagonal cracks were systematically observed on the walls that separate the glazed hallway from the office area. A few cracks are also visible in the structural elements, namely beams and columns. Another recurrent damage observed is related to the windows and the *brise-soleils* of the gallery. The cyclone Idai caused the loss of many elements and damaged others. Decay was also visible through the advanced state of the corrosion of metallic elements, such as the anchors of the *brise-soleil* and the window frames. Recent interventions include the installation of new toilet facilities and modifications of the original distribution of space and have altered the original design and visual aspect of the administrative body.

Figure 8. Cracks observed on masonry walls in the administration building.

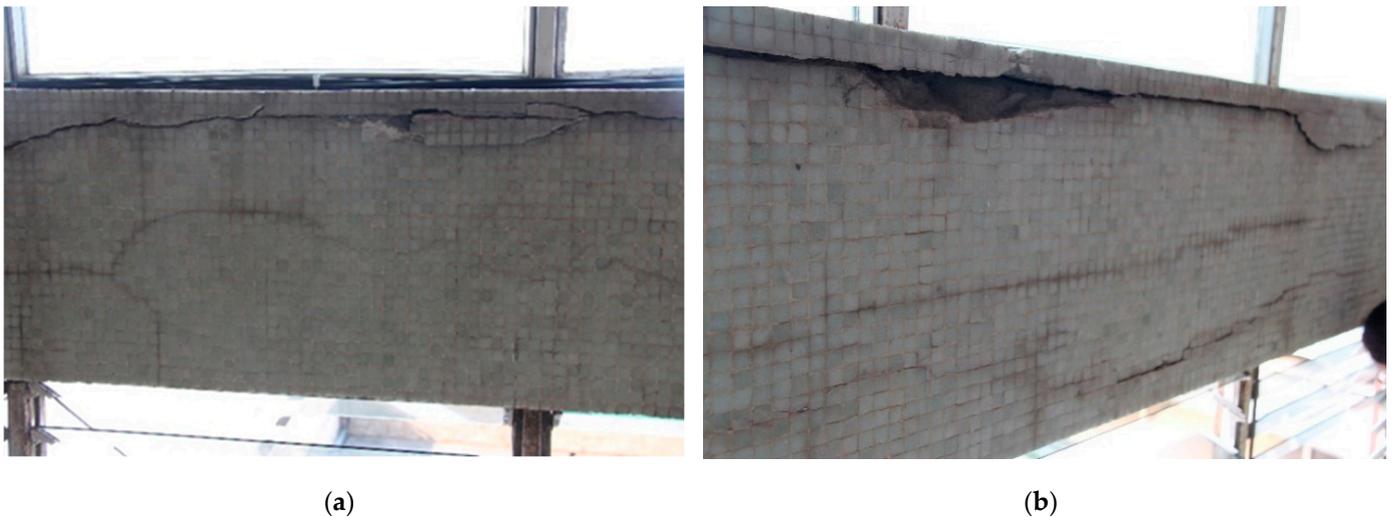
In the staircase of the administrative body, cracks are observed in the beams of the rear façade that supports the windows (Figure 9). These cracks were observed in the beams of all floors. The lateral walls of the staircase also present widespread cracking. There is a general decay of the window elements of the glazed façade, showing signs of corrosion, the deformation of metallic profiles, and missing or broken elements. Previous interventions have also altered the original aspect of the building. A systematic loss of the ceramic tiles on the steps was detected. Decorative elements also show widespread damage. Original elements are lost and others show evident signs of decay, such as corrosion or broken parts.

Figure 9. Generalized cracks observed on the beams that support the glazed façade of the staircase: (a) Level 1–2; (b) level 3–4.

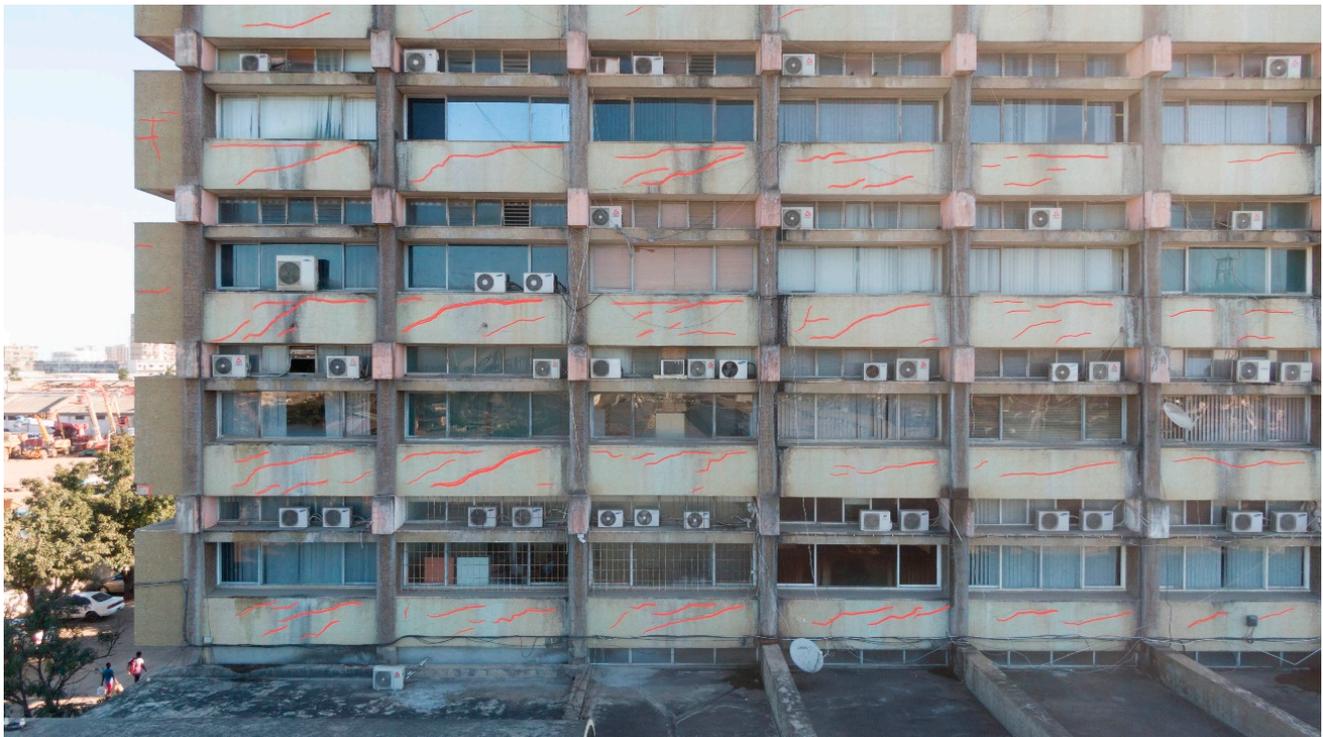
Regarding the exterior areas of the building, all masonry façades of the administrative body show significant widespread cracking, mostly following a random distribution. However, masonry walls on the ground level, including those finished with a continuous ceramic tile mosaic, show a clearer pattern involving significant diagonal cracks, also found in the administrative body (Figure 10). The generalized corrosion of metallic elements and window frames was also observed. Additionally, recent interventions involving the installation of new facilities, the construction of adjacent sheds concealing the ceramic mosaics, or the hanging of new advertisement signs have also affected the external appearance of the building, which is detrimental from the point of view of aesthetics and authenticity.

Figure 10. Widespread cracks in the masonry panels of the rear façade of the administrative body.
