# Hurricane Ian Damage Assessment Using Aerial Imagery and LiDAR: A Case Study of Estero Island, Florida

**Citation:** Hauptman, L.; Mitsova, D.; Briggs, T.R. Hurricane Ian Damage Assessment Using Aerial Imagery and LiDAR: A Case Study of Estero Island, Florida. *J. Mar. Sci. Eng.* **2024**, *12*, 668. <https://doi.org/10.3390/jmse12040668>

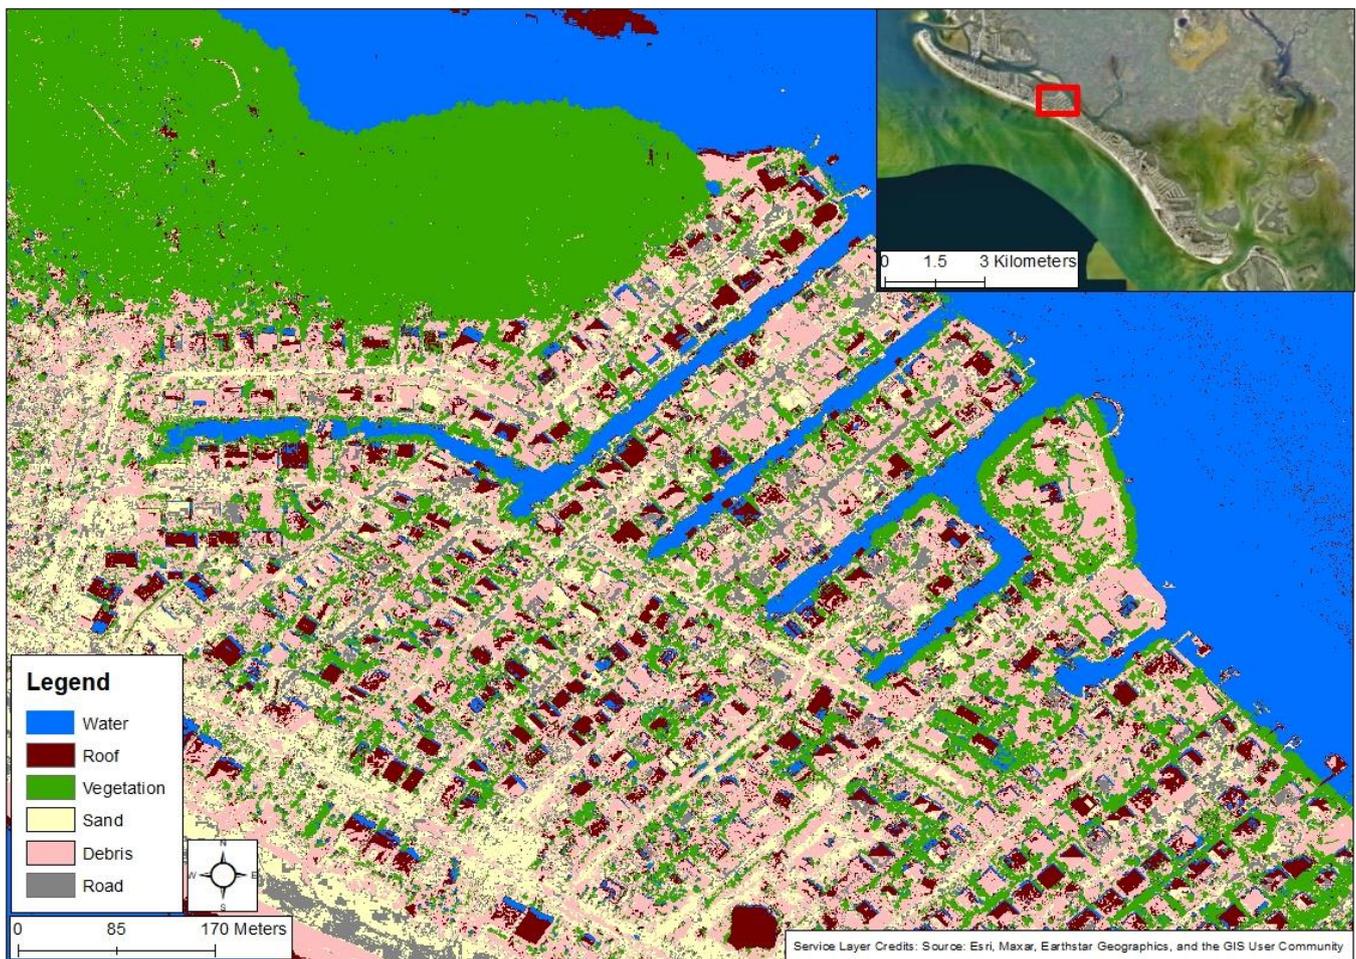
The image classification raster (Figure 2) shows debris, sand deposition, and flood-water patterns across Estero Island’s urbanized areas. The results indicated a significant overwash with heavy deposition of sand onto the most seaward roadway adjacent to the dunes and seawalls. The post-storm assessment also revealed heavy sand deposits on the roadways throughout the island. Ponding water was found hundreds of meters inland near buildings and other structures, providing evidence of the extent of inundation resulting from the storm. The algorithm also identified a substantial amount of debris throughout the study area, with increased amounts found inland and clustered near structures. Small amounts of debris were also present throughout the heavily vegetated areas and landward of the barrier island. The final processed raster image indicated areas that were classified as roofs in the pre-hurricane image and reclassified as debris in the post-storm image, illus-

trating the extent of the catastrophic damage to the area. The results showed substantial amounts of sediment and debris deposited across the barrier island.

**Figure 2.** Maximum likelihood algorithm results.

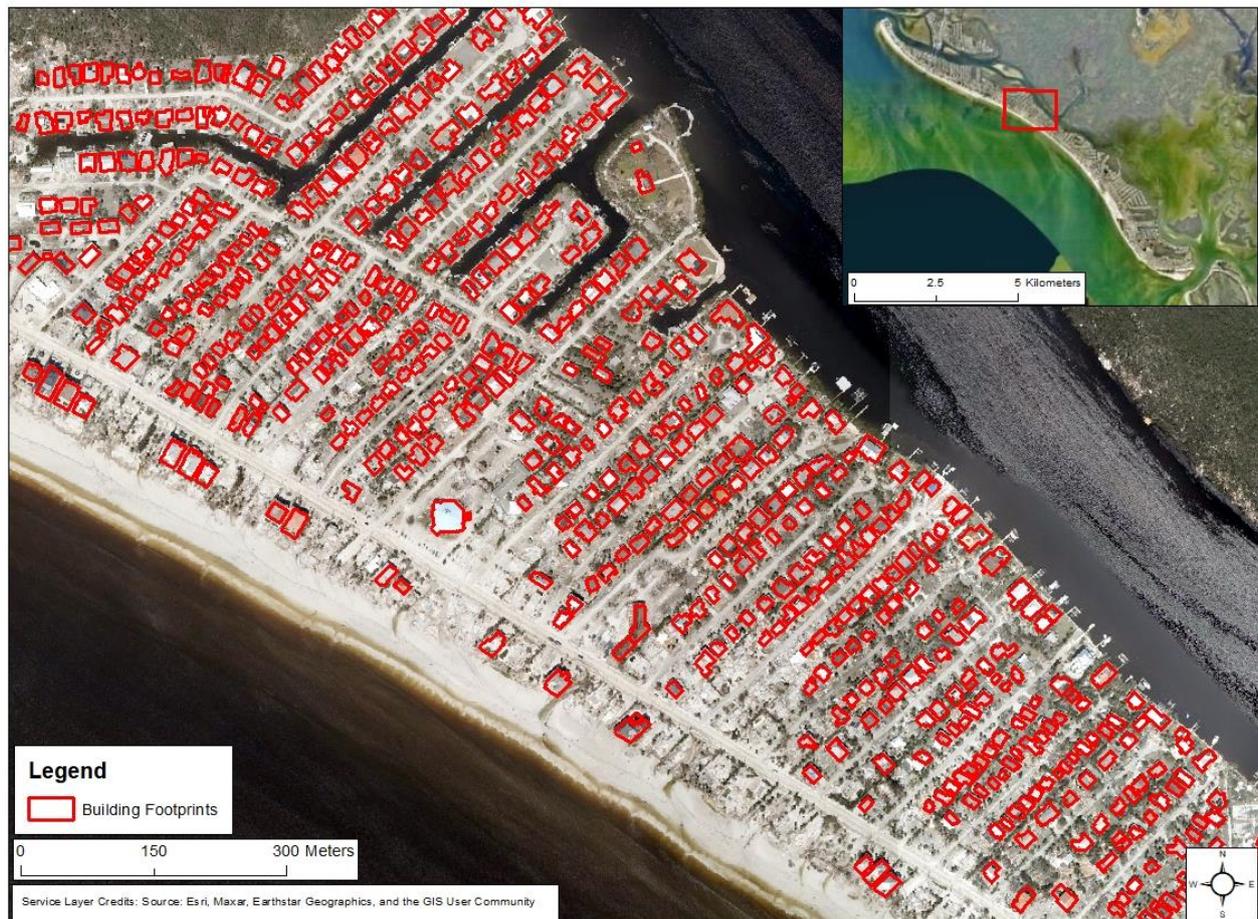
The assessment of the damages to structures in the study area after Hurricane Ian was completed using aerial imagery interpretation based on the damage classification matrix shown in Table 1. A total of 2427 structures were identified after post-processing of the LiDAR point cloud data and extraction of building footprints pre- and post-Hurricane Ian (Figure 3). The analysis identified only one structure in the study area that was classified as ‘not affected’; this structure was described as a store in the land use description of the tax appraiser data (Table 2). For this structure, no visible damage was present to the property or the roof. A total of 1523 buildings were classified as ‘affected’ with a moderate level of structural damage. Overall, 734 buildings had 30–50% structural damage. They were included in the ‘major’ damage category. The majority of the structures in both the ‘affected’ and ‘major’ damage categories were single-family and multi-family (<10 units) residences. The study identified 158 buildings that were severely damaged. Most of the structures in this category had partial or complete roof failure. A total of 11 structures were classified as ‘destroyed’. Single-family and multi-family (<10 units) residences were the majority of the structures in the ‘severe damage’ and ‘destroyed’ categories.

**Figure 3.** Results of building extraction post-Hurricane Ian after QAQC of extracted buildings pre-Hurricane Ian for a total of 2427 structures identified.

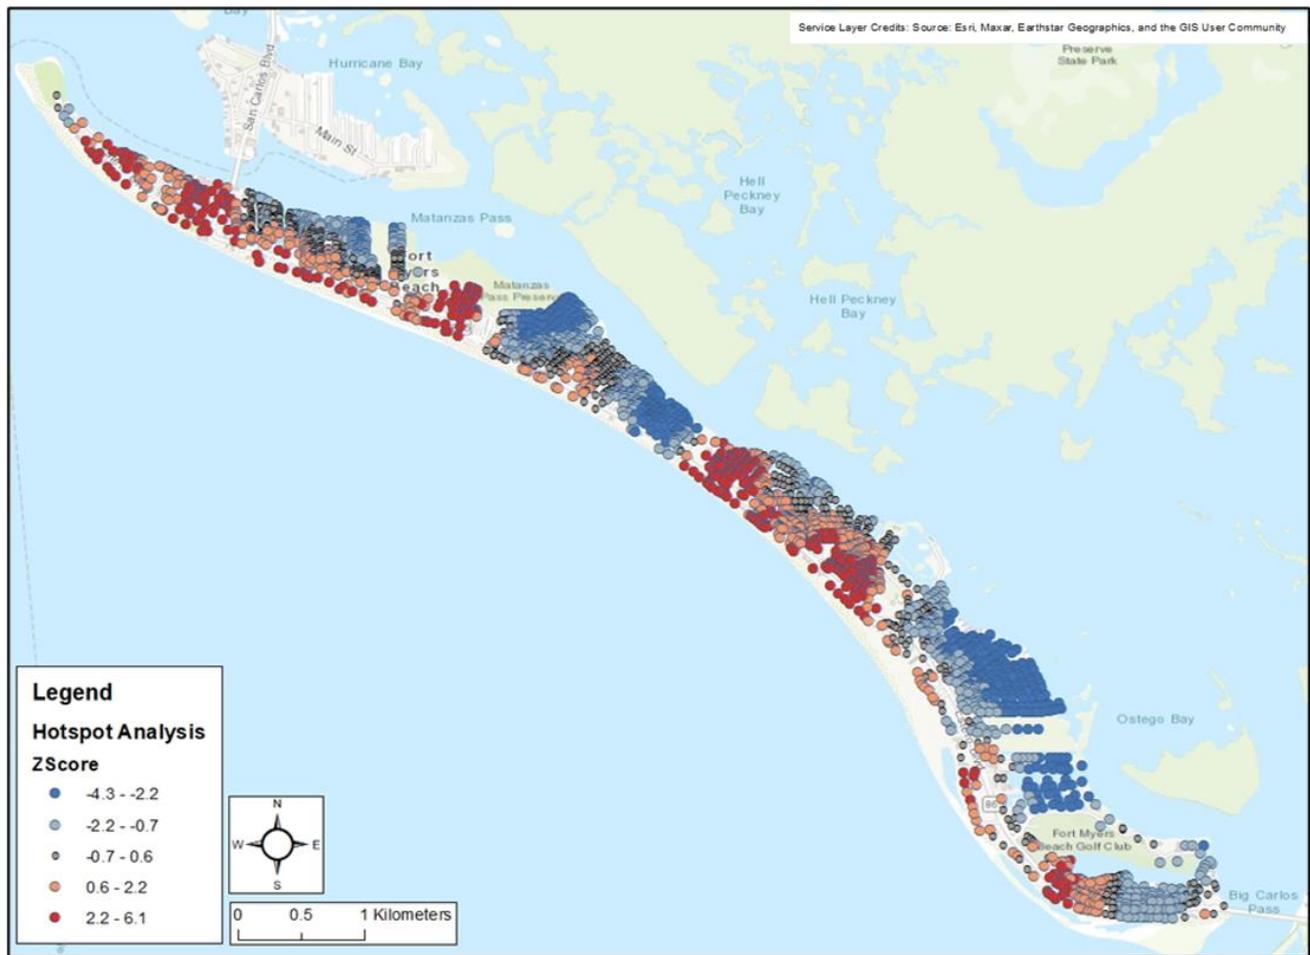
A hotspot analysis using the Getis-Ord  $G_i^*$  test statistics was conducted to identify areas of significant clustering based on damage level. The results from the hotspot analysis found a significant clustering of highly damaged structures located predominantly on the north and central seaward side of the barrier island (Figure 4). Areas with high z-scores (shown in red) indicated spatial clustering of high values in relation to high damage levels. The study results also revealed significant clustering of ‘minor’ to ‘no damage’ structures predominantly on the central seaward side and landward side of the barrier island. Areas with low z-scores indicated a spatial clustering of low values (denoted in blue). Multiple areas resulted in no significant clustering with a z-score near zero, which indicated no apparent spatial clustering (shown in gray). The areas with no significant clustering were found dispersed throughout the barrier island, and the majority were located inland.

**Figure 4.** Results of hotspot analysis indicate most severe damage occurring on the seaward side of the northern and central areas of Estero Island, Florida.

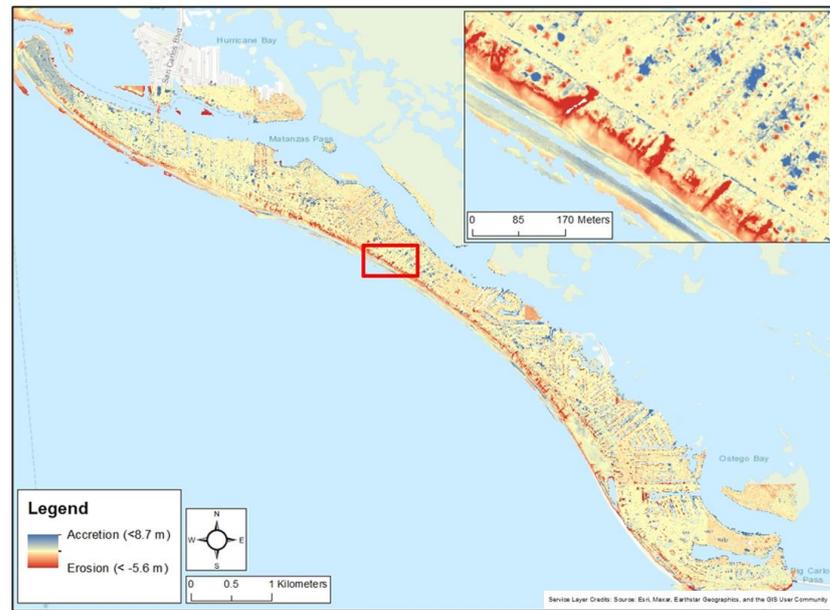
A beach morphology analysis after Hurricane Ian showed heavy erosion to the seaward side of the island and accretion to the landward side (Figure 5). Elevation loss to the subaerial beach on the seaward side ranged from  $-1$  m to  $-5$  m. Most of the elevation gain was present on the landward side, with a gain of 2 m to 8 m. Heavy accretion was present at the northern portion of the island. A number of perpendicular washouts were found along the backbeach throughout the entire barrier island, with evidence of high erosion rates to the foreshore. The assessment identified deposition from overwash behind the backbeach/dune system adjacent to the main road. A thin ridge and runnel were present at the foreshore spanning from the northern to the central portion of the island. The southern portion of the barrier island contains multiple saltwater marshes, which experienced accretion on the seaward side of the marsh, with heavy erosion to the foreshore. Inland, the barrier island had minor elevation change with areas of heavy sediment depositions and significant erosion near structures.

**Figure 5.** Results from DEM difference calculation indicate heavy erosion to the seaward side of the island and accretion to the landward side of Estero Island after the impacts of Hurricane Ian.

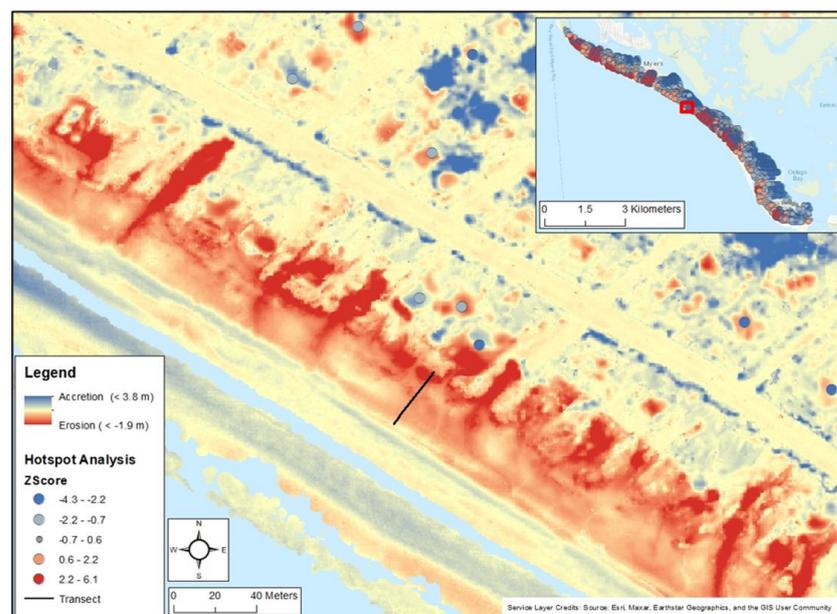
**Figure 6.** Significant clustering of an area with minimal damage to structures. Cross-shore transect represented by the black line for utilization of elevation profiles pre- and post-storm assessment.

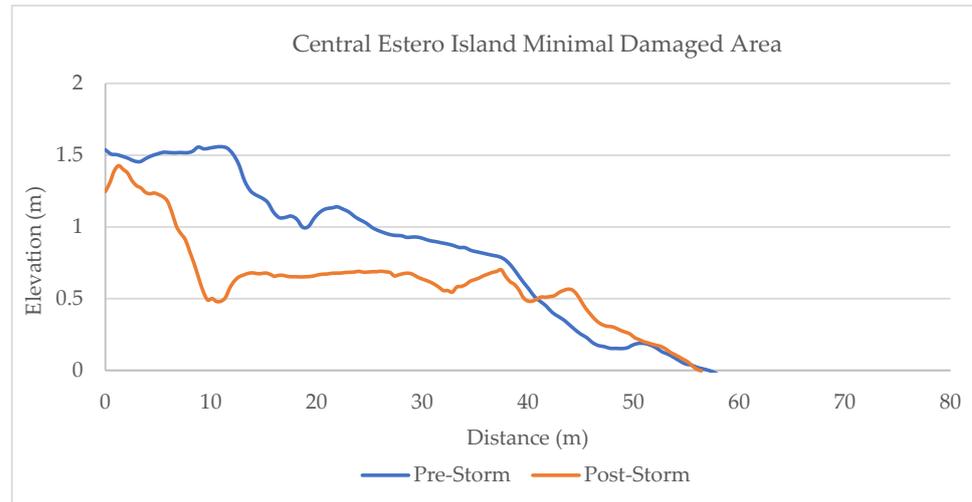
The cross-shore transect located in the area where there was the least amount of damage represented a wide beach with a gently sloping foreshore (Figure 7). The beach profile showed a 15 m wide dune system, a 20 m berm, and a gently sloping foreshore. After Hurricane Ian, the beach maintained its width but featured a small ridge and runnel system in the intertidal zone. The berm and backbeach experienced a slight elevation loss of 0.5 m. The most notable change was a meter of elevation loss to the foredune with a 2 m wide trough seaward of the foredune.

Figure 7. Beach profile for pre- and post-storm impacts for minimal damaged area.

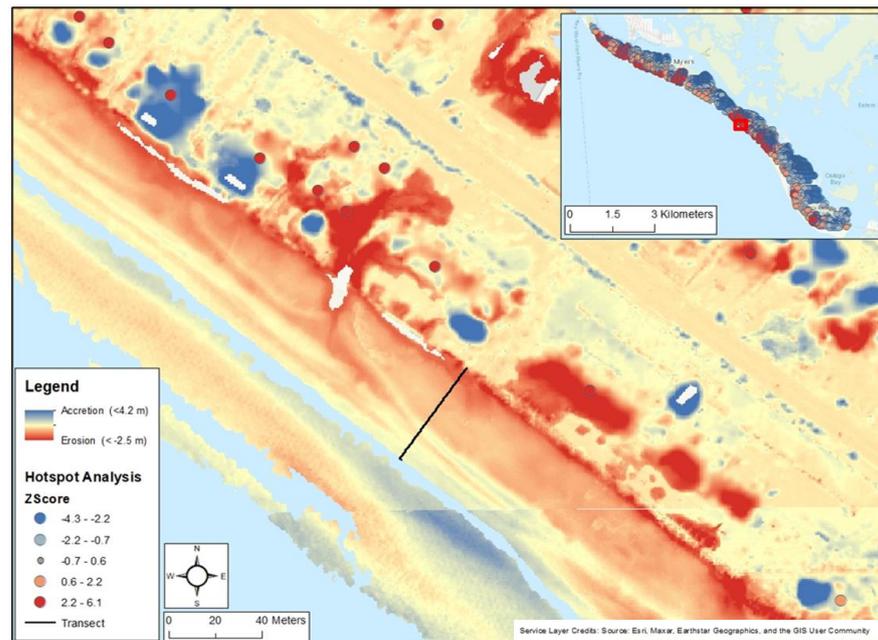
The southern area of interest had a significant clustering of structures that had substantial damage (Figure 8). The pre-storm beach profile measured 30 m wide and had a gently sloping subaerial beach with a 0.5 m seawall located on the backbeach (Figure 9). After the hurricane, ~1 m of scouring was measured at the seawall with an ~8 m wide trough on the seawall’s seaward side, resulting in a 1 m elevation loss to the backbeach. The foreshore accreted with 30 m of seaward advance with a ridge and runnel measured in the intertidal zone.

Figure 8. Significant clustering of an area with heavy damage to structures. Cross-shore transect represented by the black line for utilization of elevation profiles pre- and post-storm assessment.

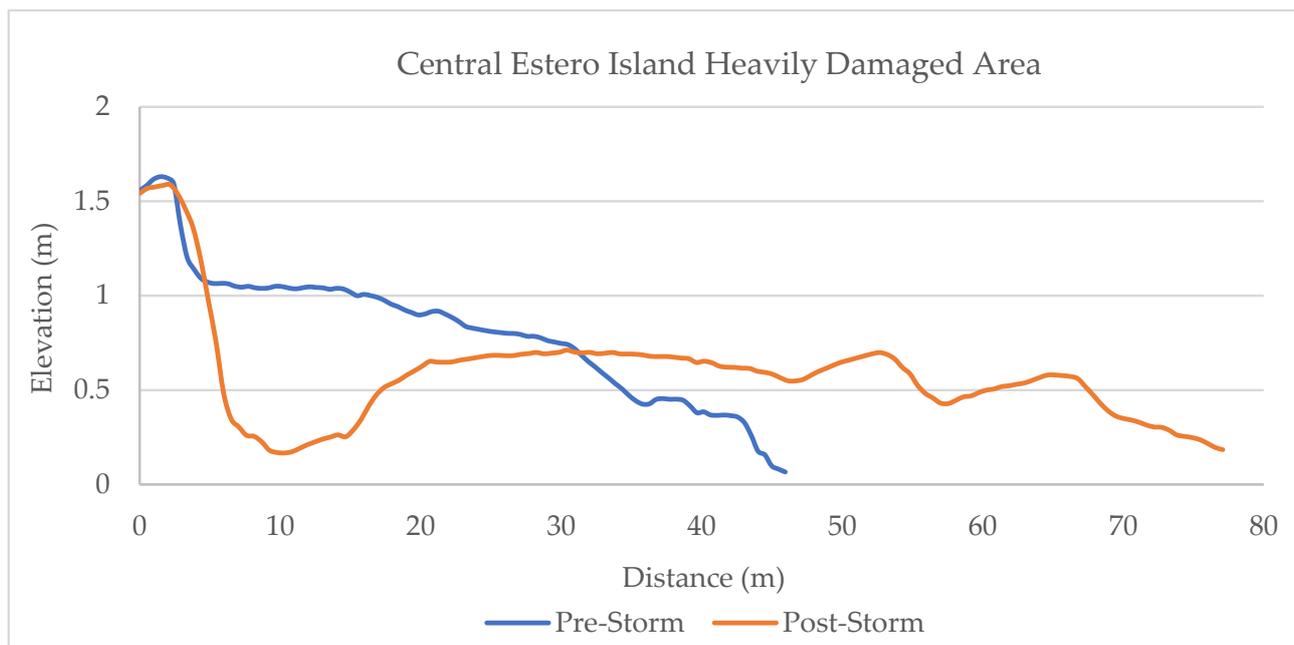
**Figure 9.** Beach profile for pre- and post-storm impacts for heavily damaged area.

The results of the pre- and post-storm beach profiles of a heavily damaged area on the central part of the island indicated significant scouring near a seawall with shoreline advance and the presence of a ridge and runnel due to significant sediment loss from the scouring. The beach profile for the minimally damaged area on the central part of the island showed increased erosion to the foredune and elevation loss to the backbeach, with the beach maintaining its shoreline position with a post-storm ridge and runnel system present. The hotspot analysis showed clustering of high and low levels of damage throughout the island. The northern portion of the island was associated with significant

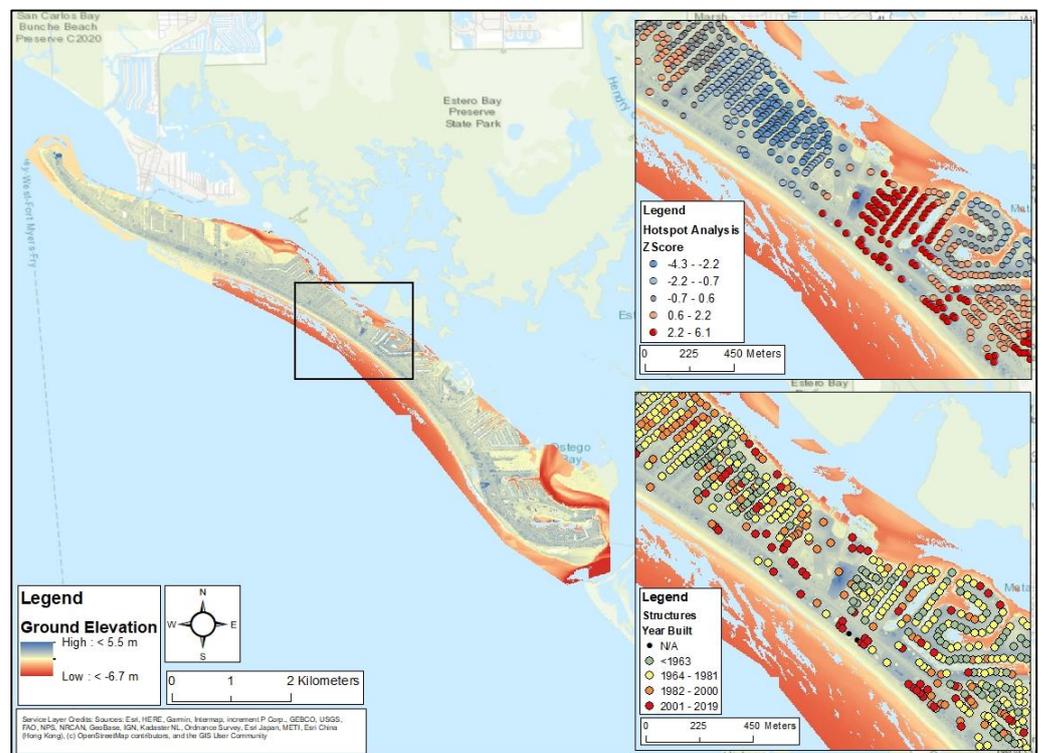
Continued efforts to incorporate more cross-shore beach profiles are necessary to gain a full understanding of beach morphological response and its relationship with structural damages. The results from this study present trends across the island of low and high levels of structural damage clustering. This trend requires further investigation, particularly in the central part of the island, where an area of minimally damaged structures is adjacent to heavily damaged structures. Ground elevations from the pre-storm DEM in the central portion of the island damages were examined and compared with structural damage and the year the structures were built (Figure 10). Before Hurricane Ian, the highest ground elevation of Estero Island was <5.5 m. When overlaying the hotspot results with DEM, no evidence was found to relate the level of structural damage to ground elevation. The year built for >2400 structures ranged from <1963 to 2019. The buildings in the areas where less damage was observed were built between 1963 and 1981. Similarly, in the areas of heavy damage, the majority of the buildings were built between 1963 and 1981. The spatial distribution of ground elevation and year built indicated no apparent trends associated with these two variables.

**Figure 10.** Ground elevation pre-Hurricane Ian for Estero Island compared to hotspot analysis and year built for structures for central Estero Island.
