Identification and Mitigation of Subsidence in Karstic Areas with Sustainable Geotechnical Structures: A Case Study in Gallur (Spain)

Abstract: In various areas of the Ebro valley in Spain, including the region discussed here, the risk of sinkholes is becoming particularly severe, particularly impacting urban areas and roadways where land subsidence from karstic processes is common. However, knowledge of the area, its geological–geotechnical configuration, and the carrying out of specific research studies are allowing solutions to be tested in an attempt to resolve these situations. A case in point is the examination of settlement issues along a stretch of the access road leading to the city of Gallur from the east (known as Camino Real) in the Zaragoza province, Spain. Numerous surface manifestations of recent subsidence and/or collapse activities have been observed, manifesting as craters and ground undercuts, some several meters in diameter. The prevalence of highly karstifiable materials in the area, evident from the existence of subsidence pockets and collapse dolines, poses significant safety concerns, particularly for traffic and town access, prompting the closure of Camino

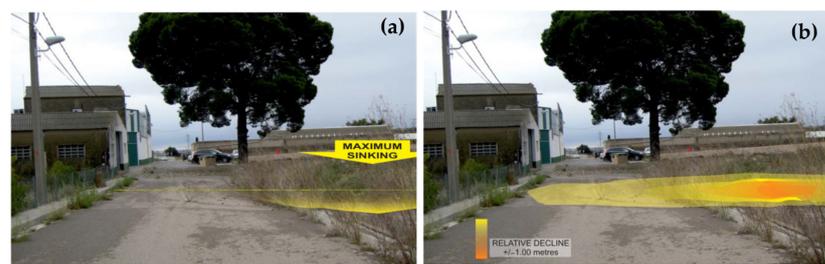
Figure 1. Panoramic images of the apparent subsidence of the road surface of the access to Gallur along the Camino Real (2015). This access had remained closed for several years. (a) The location of the maximum observed subsidence is shown. (b) The most depressed area is highlighted in color.

- There is no nearby catchment basin that could justify a process of this magnitude. The unusual influx of water into the system might be attributed to the nearby Canal Imperial de Aragón. In recent history, it is widely known that repairs were necessary on a section located immediately to the west, merely 30–40 m away. The same issue that prompted the aforementioned repair could have influenced the emergence of the new subsidence observed in this access area to Gallur.

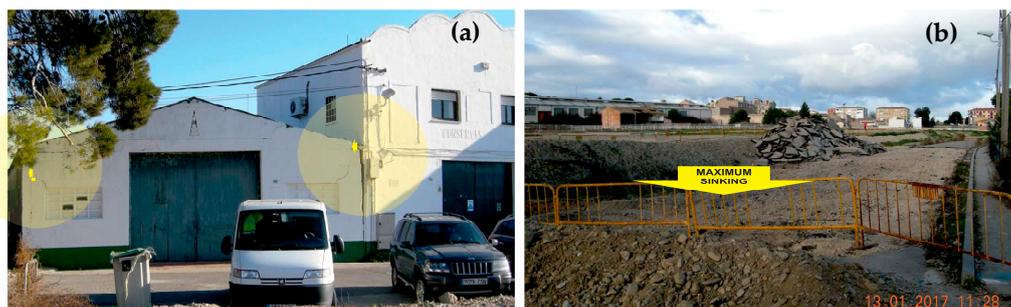
Figure 7. (a) Damage to an adjacent building is evident, highlighting points where deformations (cracks) are most pronounced, along with their indicated direction. (b) View of the street affected by the subsidence where the maximum subsidence is marked.

Finally, the solution adopted consisted of consolidating the ground in the section where the settlements were located by injecting low-mobility mortar in the center of the sunken area (Figure 7) and by the construction of an embankment reinforced with high-tensile-strength geogrids along the entire section of the affected street.

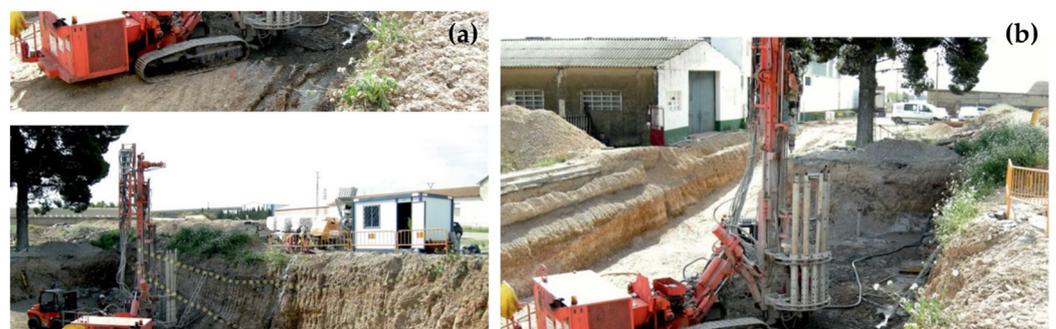
Figure 9. (a) Drilling equipment located in the excavation (at -3.00 m). (b) Excavation slope with the apparent arrangement of the ground levels in the shape of a trough, indicating the point of maximum subsidence.

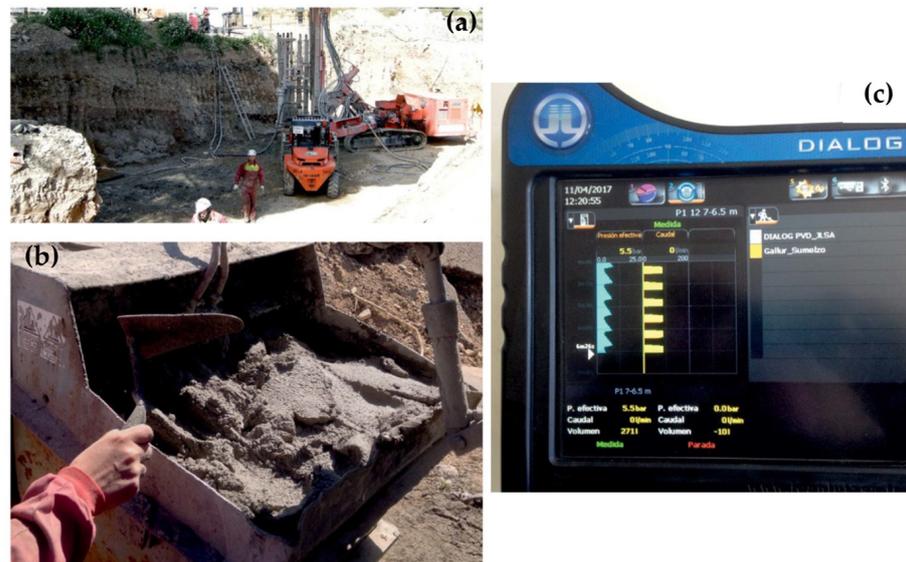
Figure 10. (a) Drilling equipment located in the excavation made at -3.00 m from the original street surface; (b) Appearance (texture and consistency) of the injection mortar in the injection pump hopper; (c) Injection control equipment: injection in the interval between -7.00 and -6.50 m; effective pressure at that time 5.5 bar; mortar intake volume, after 6.26 min: 271 l.

3. Execution of low-mobility mortar injections (compaction grouting), in the excavation made (Figure 10), at -3.00 m from the current street level. Maximum planned consumption of 150 L/m, including drilling into the ground. The mortar was injected

at a pressure up to 20 bar and with an Abrams cone value of less than 8 to 12 cm. The pumping speed was limited to less than 60 L/m in order to produce infiltration-displacement of the soil without breaking its structure.

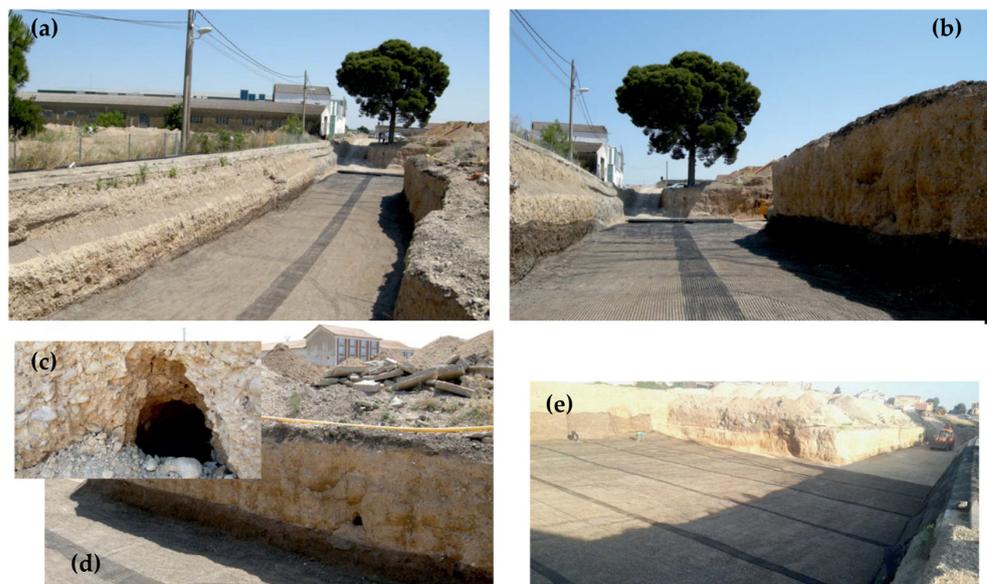
Figure 13. Photographs showing part of the reinforced backfill solution shown in Figure 12: (a,b) Longitudinal profile area; (c–e) Transverse profile area. (c) shows in detail a karstic cavity detected during the treatment.

In the area where the settlements reflected a greater subsidence, a deeper treatment was carried out (Figure 12), consisting of a 3 m soil remediation, injections, a bidirectional reinforcement (two uniaxial layers), and subsequent reconstruction by means of reinforced fill and a lighter treatment on both sides of this area of greater deformation (following the route of the road).

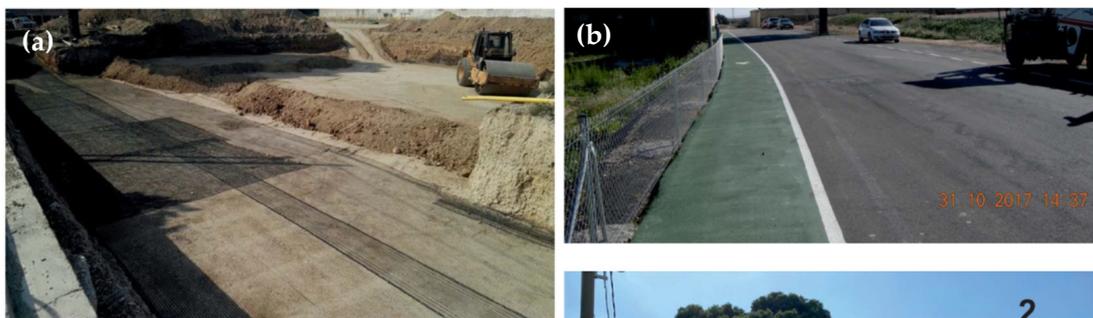
Figure 14. (a) Construction of the backfill with granular material; (b) Final state of the area after treatment and asphaltting.

Finally, the construction of the backfill was carried out with selected granular material, spread, moistened, and compacted in 20 – 30 cm thick layers (compaction degree 95% of the modified proctor), up to -3.00 m (Figure 14).
