Analysis of Causes and Protective Measures against Corrosion Perforation in the Shell-Side Outlet Flange of a Sour Water Steam Heater

Citation: Liang, H.; Duan, Z.; Li, W. Analysis of Causes and Protective Measures against Corrosion Perforation in the Shell-Side Outlet Flange of a Sour Water Steam Heater. *Coatings* **2024**, *14*, 306. <https://doi.org/10.3390/coatings14030306>

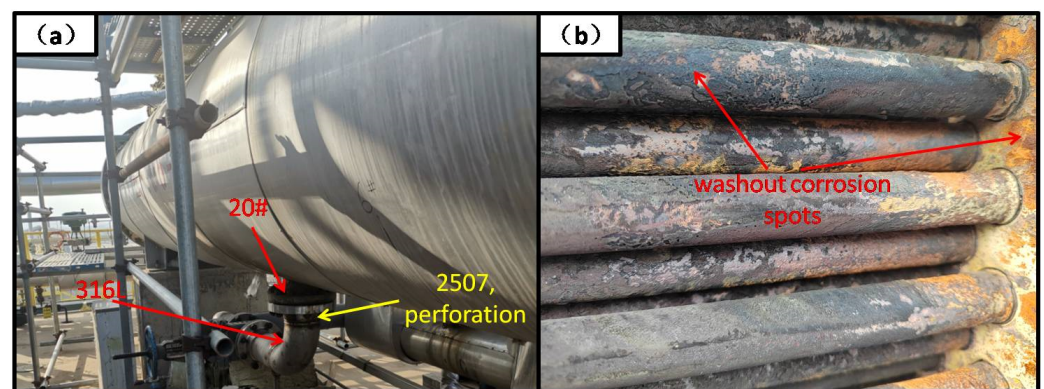
Although many types of studies have been conducted on exchanger failures, each type of equipment has its own failure situation due to the different operating conditions and working media of the equipment [1,3,25]. The heat exchanger investigated in this study was used in the sour vapor recovery system of a petrochemical company, and after one year of operation, corrosion perforation was observed in its outlet flange (DN150*SCH10S, $\delta = 3.5$ mm). The flange was made of 2507 duplex stainless steel. This heat exchanger was a third-stage side-gas cooler in the stripping tower of the sour steam recovery unit. The tube-side medium was circulating water and the shell-side medium was NH_3 , H_2S , and H_2O gas. The operating temperature was approximately 35 °C, the pressure was approximately 0.39 MPa, and the flow rate was approximately 1796 nm^3/h , as shown in Table 1. The overall shape of the heat exchanger is shown in Figure 1, and the corrosion perforation occurred in the shell outlet flange, as indicated by the yellow arrow in Figure 1a.

Disassembly of the heat exchanger revealed that both the buckle plate and the tube bundle at the shell outlet had obvious scour marks, as shown by the arrows in Figure 1b. The flange had only been in service for approximately one year, but the corrosion rate was as high as 3–4 mm/y. In contrast, the corrosion rates for the carbon steel short tubes and flanges at the exchanger outlet were approximately 1–2 mm/y, while the corrosion rate for the austenitic stainless-steel weld was approximately 2–3 mm/y. We did not find any significant corrosion thinning in the 316L elbow parts after taking thickness measurements.

Figure 1. The overall shape of the heat exchanger. (a) macroscopic morphology and corrosion sites; (b) corrosion morphology of the tube bundle and tube sheet at the outlet.

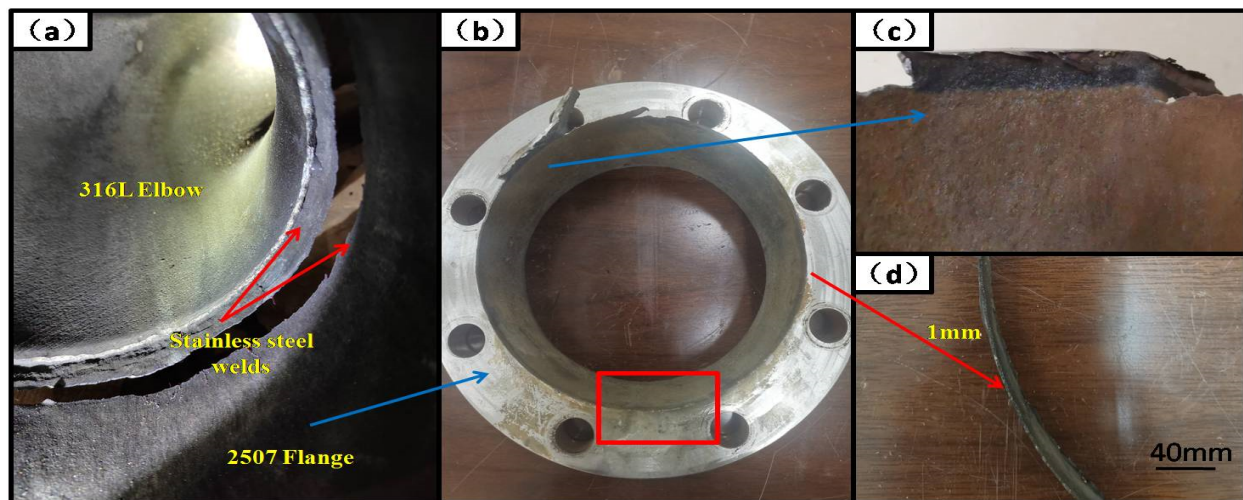
Figure 2 shows the macroscopic morphology of the corroded flange, revealing the uniform corrosion thinning within the flange. The neck of the flange (near the weld, shown by the red arrow in Figure 2a,b,d) had thinned to less than 1 mm, and the austenitic stainless-steel weld connected to the flange had also experienced significant corrosion thinning, with a remaining thickness of approximately 1 mm. Corrosion evidence could also be observed on the inner surface of the elbow (see Figure 2a). From the macroscopic corrosion morphology, it could be seen that the corrosion of the heat exchanger shell outlet tube was uniform, with the severity ranking as follows: 2507 duplex stainless steel > austenitic stainless-steel weld > carbon steel short tube and flange > 316L elbow. Therefore, in this study, flanges were sampled and analyzed as the object of study (see Figure 2b–d). Figure 2c,d are partially enlarged views of Figure 2b.

Figure 2. Corrosion macromorphology: (a) inner wall morphology; (b) 2507 duplex steel flange; (c) mechanical break; and (d) corrosion thinning perforations.

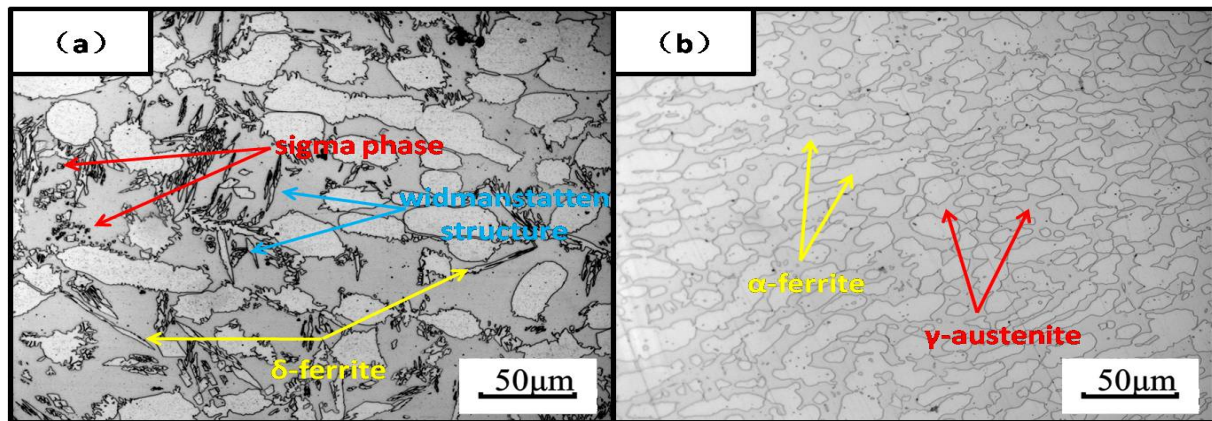
Samples were taken for metallographic organization analysis, as shown in the red box in Figure 1b, while samples from different batches of new flanges were taken for comparison and tested according to the method in GB/T13298-2015 [29]. Duplex stainless steel has the most appropriate ratio of ferritic and austenitic, approximately half each, and neither material can exceed 65% to ensure the comprehensive performance of the duplex steel. If the ratio of the two phases is out of proportion, the corrosion resistance in some media will be reduced. Figure 3a shows that the metallographic organization of the corroded flange consisted of α -ferrite + γ -austenite + δ -ferrite + Widmanstatten structures + sigma phase (the elongated dark phase is the sigma phase). The ratio of α -ferrite to γ -austenite was 45:55, which met the requirement for the proportion of a duplex stainless-steel structure. However, there were larger numbers of δ -ferrite and Widmanstatten structures

and a small amount of σ -phase, which did not meet the requirements of duplex steel organization [30]. Figure 3b shows that the metallographic organization of the new flange consisted of α -ferrite + γ -austenite, with a ratio of α -ferrite to γ -austenite of 50:50, which met the requirement for the proportion of duplex stainless-steel structure.

Figure 3. Metallographic organization: (a) corroded flange; and (b) new flange.

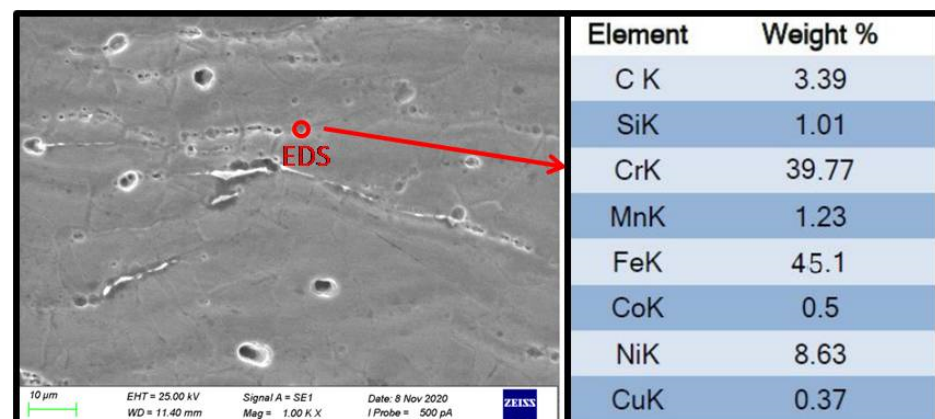
To verify the presence of sigma phase, electron metallography was performed using a scanning electron microscope, and an energy spectrum analysis was performed to obtain the values of Fe and Cr, as shown in Figure 4. The results of the energy spectrum analysis showed that the value of Cr was significantly higher than the matrix content. Sigma phase is a kind of intermetallic phase that often appears in high-alloy steel, and a small amount of sigma phase in steel will make the toughness and plasticity of the steel drop sharply, while the precipitation of sigma phase makes its surrounding poor in chromium and molybdenum, thus reducing the steel's corrosion resistance [31]. Because the working condition of the flange was 35 °C, the sigma phase should have been produced in the manufacturing process of the flange, and some research has shown [32] that duplex stainless steel (in a solid solution state, hot rolled state, or cold rolled state) precipitates sigma phase when it is heated or slowly cooled at temperatures ranging from approximately 600 to 1000 °C. Therefore, the sigma phase produced by an improper heat treatment will have an accelerated corrosion effect on a flange.

Figure 4. Electron metallographic and spectroscopic results.

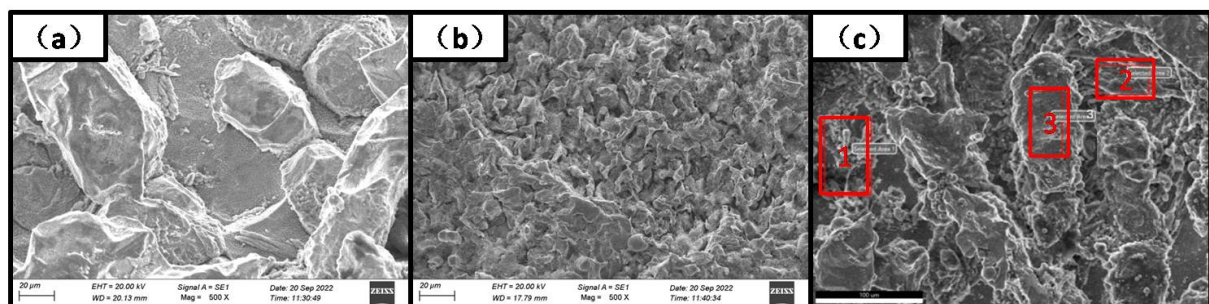
To further analyze the characteristics and causes of corrosion, the inner surface of the flange was subjected to scanning electron microscopy analysis. Figure 5a shows the microstructure of the corroded inner surface of the flange, where distinct grains and grain boundaries can be observed, indicating that the corrosion of the 2507 duplex stainless steel

was intergranular selective corrosion, with preferential corrosion occurring at the grain boundaries and γ -austenite phase. The area analyzed by energy dispersive spectroscopy is shown in Figure 5c, and the results are shown in Table 3, which indicate that the corrosion products on the inner surface of the flange were mainly composed of elements such as carbon (C), oxygen (O), iron (Fe), chromium (Cr), nickel (Ni), molybdenum (Mo), and sulfur (S). The sulfur contents detected were 2.73 wt% and 6.05 wt%, with no chlorine (Cl) element detected. Therefore, the major corrosion product was sulfide. Figure 5b shows the microstructure of the corroded weld, which was similar to the corrosion morphology of the corroded flange. Clear grains and grain boundaries could also be observed, indicating that the corrosion of the austenitic weld associated with the flange was intergranular selective corrosion, with preferential corrosion occurring at the grain boundaries and in the austenite phase.

Figure 5. Micro-morphology and energy spectrum: (a) flange corrosion site; (b) weld corrosion site; and (c) energy spectrum region.

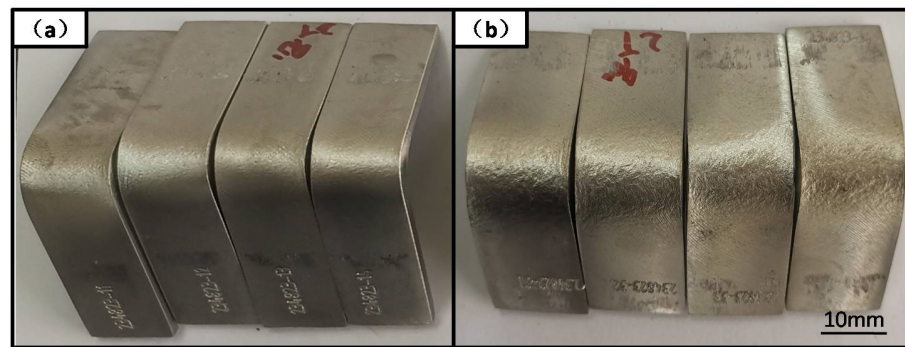
Intergranular corrosion tests were performed on the corroded flange and new flange specimens according to the test method specified in GB/T4334-2020, *Corrosion of Metals and Alloys—Intergranular Corrosion Test for Austenitic and Ferritic-Austenitic (Duplex) Stainless Steels—Ferric Chloride Solution Method (F Method)* [33], under the conditions shown in Table 4. We employed the chemical immersion intergranular corrosion test method, that is, the specimen was immersed in a certain state of the solution to maintain a certain period of time, and through the test and before and after the test, the specimen changed to characterize the material intergranular corrosion sensitivity. The evaluation indicators are generally the following three: ① the corrosion rate, through the test and before and after the test, as the change in the mass of the specimen and the exposed area to be calculated; ② the corrosion depth, determined using a specimen cross-section after grinding and polishing and the use of metallurgical microscopy to examine the surface of the specimen's corrosion depth for the intergranular corrosion; ③ the bending morphology, where the specimen is bent and observation of the bending parts of the external surface morphology is conducted. The results of the tests are shown in Figure 6, where no intergranular corrosion was observed in either the corroded flange or the new flange specimens. No cracking was observed after bending, indicating a low susceptibility to intergranular corrosion in the flange materials.

**Figure 6.** Bending test results after the intergranular corrosion test: (a) corroded flange; and (b) new flange.

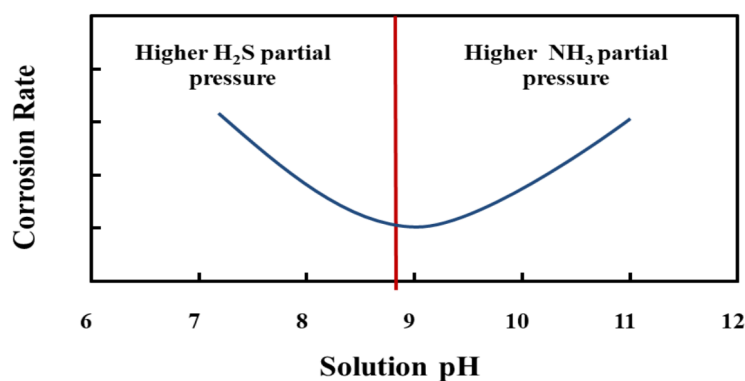
Experimental corrosion studies have shown [38–40] that the main influencing factors of alkali-sour water corrosion include pH, NH_4HS concentration, flow rate (shear stress), hydrogen sulfide partial pressure, metal material composition, etc. In general, the corrosion rate increases with increases in NH_4HS concentration, flow rate (shear stress), and hydrogen sulfide partial pressure. The effect of pH is more complicated. As shown in Figure 7, when the pH is in the range of 7–9, the corrosion in alkaline-sour water corrosion is dominated by H_2S , and the corrosion rate decreases with increases in pH. When the pH is in the range of 9–11, the corrosion in alkaline-sour water corrosion is dominated by NH_3 , and the corrosion rate increases with increases in pH [38]. In addition, the corrosion resistance of the metal material varies under the two corrosion modes of H_2S -dominated corrosion and NH_3 -dominated corrosion.

Figure 7. Effect of pH on the corrosion of NH_4HS [41].
