Influence of the Manufacturing Process on Defects in the Galvanized Coating of High Carbon Steel Wires

Abstract: This study is a detailed failure analysis of galvanized high carbon steel wires, which developed coating cracks during the torsion test performed as a quality control at the end of the manufacturing process. Careful visual inspections showed that the cracks are already present in the coating before the torsion test. In order to explain the origin of these cracks, systematic metallographic investigations were performed by means of optical and scanning electron microscope on both the wires and the rods that have been cold drawn to produce the wire. The chemical composition of the galvanized coatings was evaluated by means of energy dispersive spectroscopy. Micro bidimensional X-ray diffraction experiments were also performed to measure the residual stresses in the galvanized coating. The results showed that the failure is related to two main factors: the relatively high content of silicon in the steel and the unsuitable cooling rate of the rods at the exit from the galvanizing bath. The mechanism proposed to explain the origin of the defects was supported by Finite Elemen

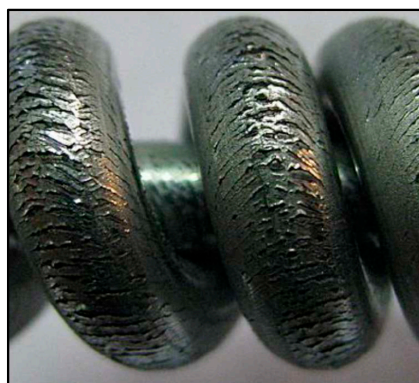
In the present case, as reported by plant operators, the wire produced with specific steel batches at the end of the torsion test showed the formation of several circumferential cracks, randomly distributed along the circumference and length (Figure 2). A preliminary analysis showed that these cracks are limited to the Zn layers, suggesting that the coating could have some problems of adhesion or excessive brittleness.

Figure 2. Circumferential cracks on steel wire after the torsion test.

The visual inspections of the wires belonging to the failed batch revealed the presence of fine circumferential cracks in the zinc coating also before the torsion test was performed. These cracks are difficult to detect by the naked eye, but they became evident when the torsion test is performed because they are enlarged by the applied shear stresses. To understand if the cracks are a consequence of the cold drawing process or if they come from the galvanized rod, both the wire and the rod have been analyzed.

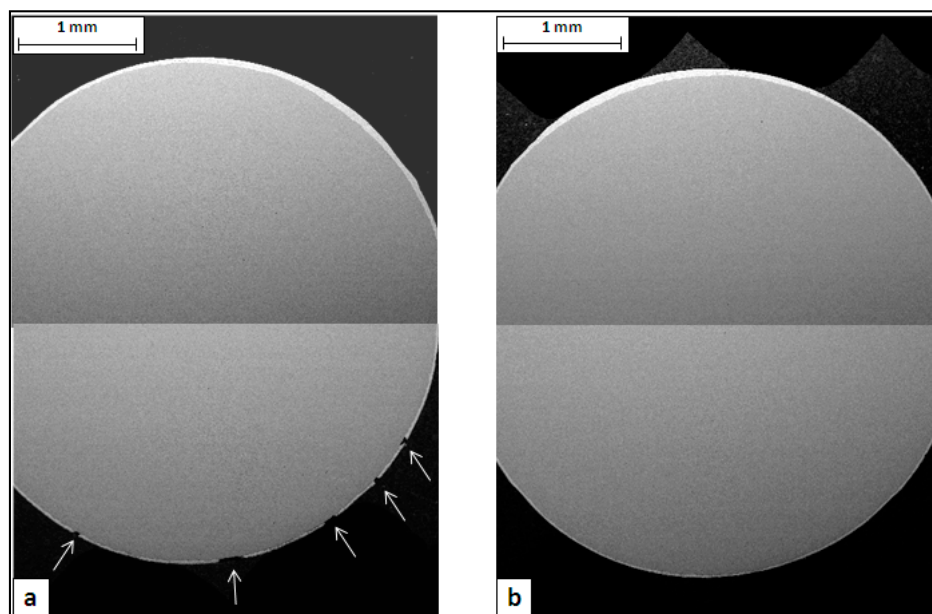
The metallographic analysis started considering the transversal sections of wires made with Steel 1 and 2 (Figure 4). The images, collected by SEM in backscattering mode at low magnification, show the zinc-rich coating as a thin white layer on the grey steel substrate. In both cases, it is evident that the thickness of the zinc layer is not uniform along the circumference. This is probably due to an excess of molten zinc that remained attached on the rod surface at the exit from the galvanizing bath. The analysis of rod cross sections showed the same uneven coating thickness, confirming this hypothesis. It is interesting to observe that in the failed wire, the defects are located only in one part of the cross section, where the coating is thinner (Figure 4a).

Figure 4. SEM images of wire cross sections after the torsion test: (a) Steel 1 and (b) Steel 2.

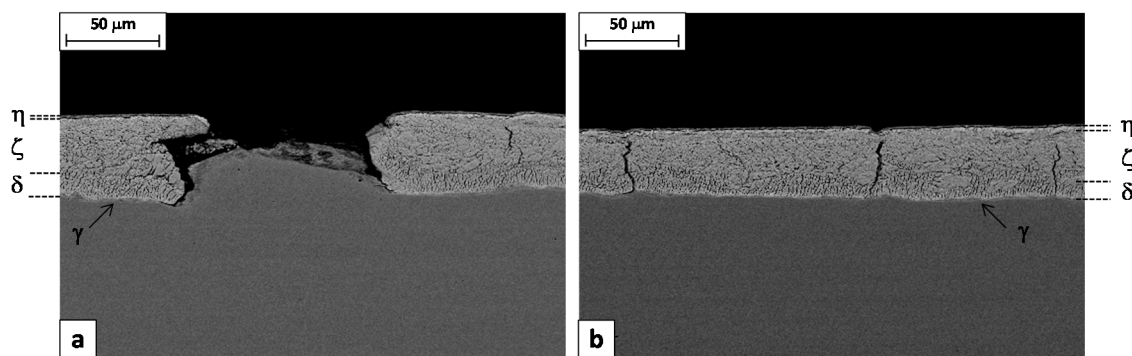
Figure 5a shows the longitudinal cross section of a defect responsible for the macroscopic failure of the wire during the torsion test. It consists of the local delamination of the Zn coating, which is missing for a length of about 100 μm . The steel substrate in the delaminated area is not flat but it shows a microscopic bulging.

The residual zinc coating appears severely deformed by drawing, with the formation of several thin short cracks perpendicular to the substrate. Such cracks are confined to the delta layer, which is reasonable considering that this phase is more brittle than the others [20].

Long vertical cracks are also frequently present in the rest of the coating, at intervals of about 100–150 μm (Figure 5b). These cracks start from the interface with the substrate or from the gamma/delta interface and propagate along both the delta and the zeta layers, stopping when in contact with the eta phase that is soft and ductile.

It is interesting to observe that the length of the detached fragment is similar to the distance between two consecutive long cracks. Furthermore, in Figure 5a, one can observe that the left edge

of the micro-bulged substrate fits almost perfectly into the cracked coating. These two observations suggest a possible mechanism for the formation of this kind of defect. It consists of two steps: (1) pulling the rod through the first drawing dies, a small fragment of the coating in between two long cracks is detached, (2) passing in the remaining dies, the steel substrate is coined in the “free space” remaining between the substrate and the die, giving the final appearance to the defect.

Figure 5. SEM images of Steel 1 wire sections: (a) defect cross section and (b) far from the defect and EDS chemical analysis of the bulged steel surface.

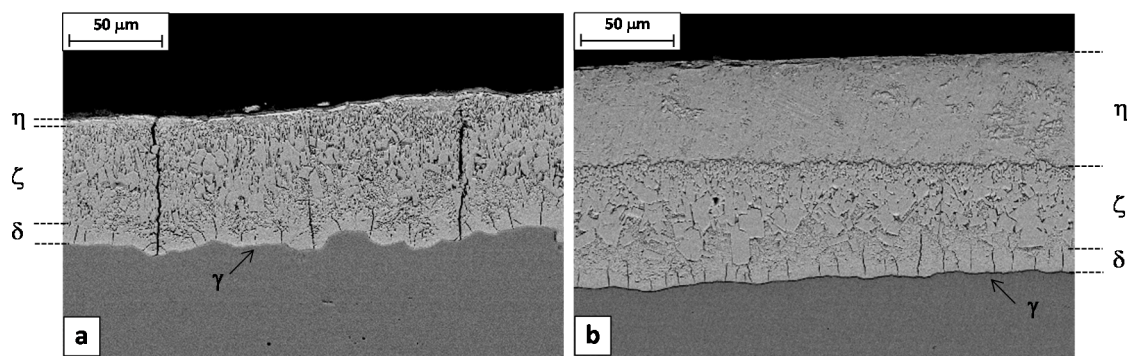
Figure 6a shows that the long vertical cracks are already present in the coating before the rod is drawn. In the region where the coating is thinner and the eta layer is almost absent, the cracks are able to pass the zinc coating completely. On the contrary, where the coating is thicker, the extra thickness consisting of the ductile eta layer avoids the propagation of the crack to the outer surface (Figure 6b).

This is in agreement with the previous observation that the defects are normally absent where the coating is thicker. The beneficial role of the ductile eta layer would be to mitigate the coating failure, sustaining cracked fragments of the brittle zeta, delta and gamma layers during the forming process.

Figure 6. SEM images of Steel 1 rod longitudinal sections.

This result supports the hypothesis that the origin of failure is the detachment of a coating fragment during the first drawing steps, favored by the presence of through-thickness cracks (Figure 6b).

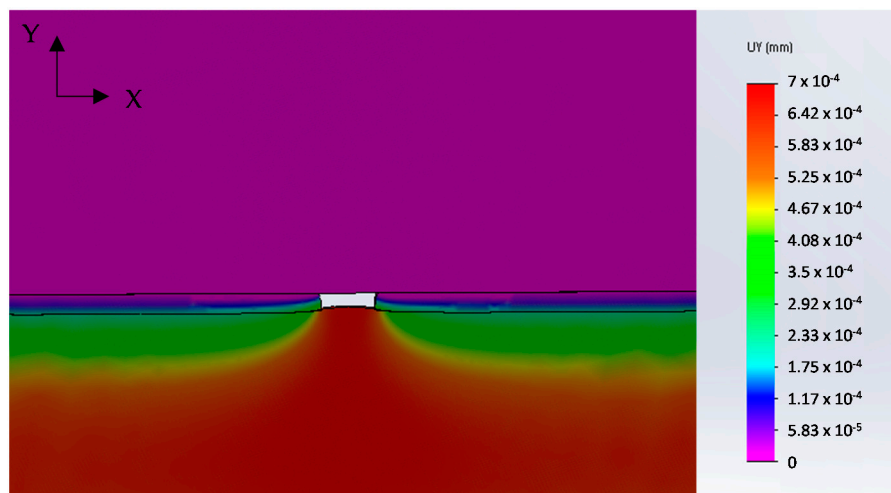
Numerical analysis was applied to simulate the drawing of a galvanized steel wire containing the full detachment of the coating for a length of 40 µm. The results are presented in Figure 7 that shows the Y-displacements distribution in the area close to the defect. The tendency of steel substrate to protrude into the “free space” left by the coating is evident, in agreement with the morphology observed in Figure 5a.

Figure 7. FEM simulations results: Y-displacements distribution.

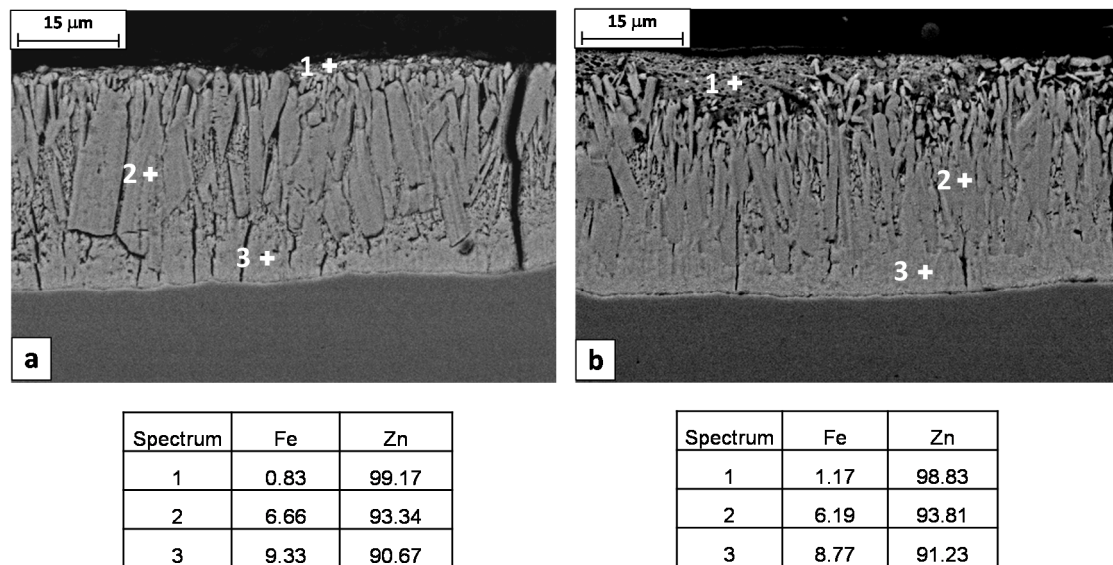
The EDS chemical analysis of the coating layers also confirms that the Steel 1 has a higher reactivity with the molten zinc respect to Steel 2, showing higher contents of Fe in both zeta and delta phases (Figure 8).

Figure 8. SEM images of longitudinal sections of (a) Steel 1 and (b) Steel 2 rods and EDS chemical analysis of the different coating layers (wt. %).

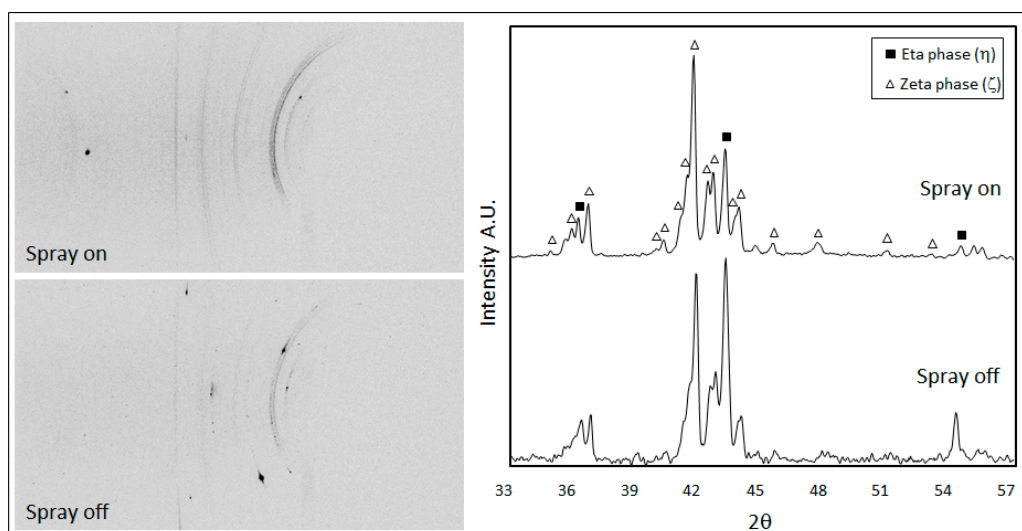
The longitudinal residual stresses were measured on these samples by means of μXRD^2 technique. Figure 9 shows the 2D diffraction images collected from the samples 9A and 9B and the relative integrated diffractographs. According to the limited penetration depth of X-rays and the small incidence angle used in the experiments, only the diffraction peaks of the outer layers were detectable: the hexagonal eta phase (PDF#04-0831) and the monoclinic zeta phase FeZn_{13} (PDF#65-1238). In both samples, the Debye rings are not continuous but spotty, which means that the crystalline domains are rather large. This is true especially in the case of steel sample 9B, where the air–water spray was switched off giving more time to crystallites to solidify and grow.

Figure 9. 2D diffraction images and integrated patterns from steel 9A (spray on) and 9B (spray off) samples.

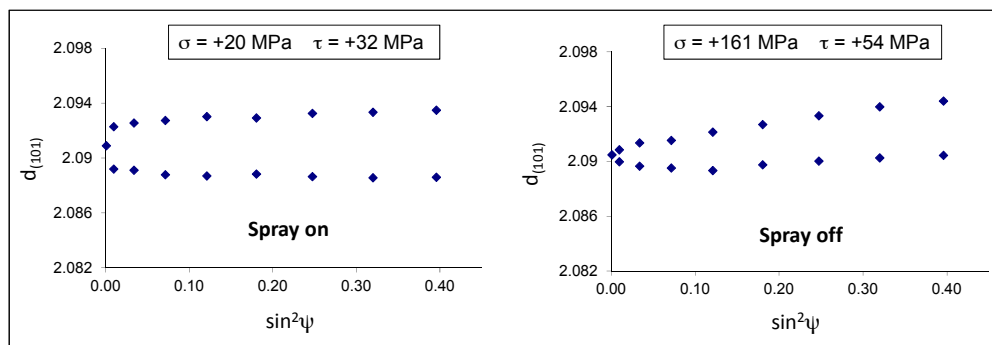
The residual stresses were calculated for the eta phase by measuring the deformation of the (101) Debye ring. Positive and negative ψ angles were considered. The $d\text{-sin}^2\psi$ graphs in both samples show an elliptical curvature, named ψ -splitting [26], due to shear stresses near the sample surface, probably related to interfacial stresses between the eta and zeta layers (Figure 10). It is interesting to observe that the air-cooled sample 9B developed normal tensile stresses (+161 MPa) much higher than those present in the spray-quenched one (+20 MPa).

In the present case, the spray quenched sample shows residual stresses close to zero, probably because many microcracks developed in the eta layer and relaxed the tensile stresses almost completely. On the contrary, in the sample 9B, the slower cooling rate gave more time to accommodate the misfit between the coating and the steel by means of elastic and plastic deformation.

Figure 10. $d\text{-sin}^2\psi$ diagrams of steel 9A (spray on) and 9B (spray off) samples.

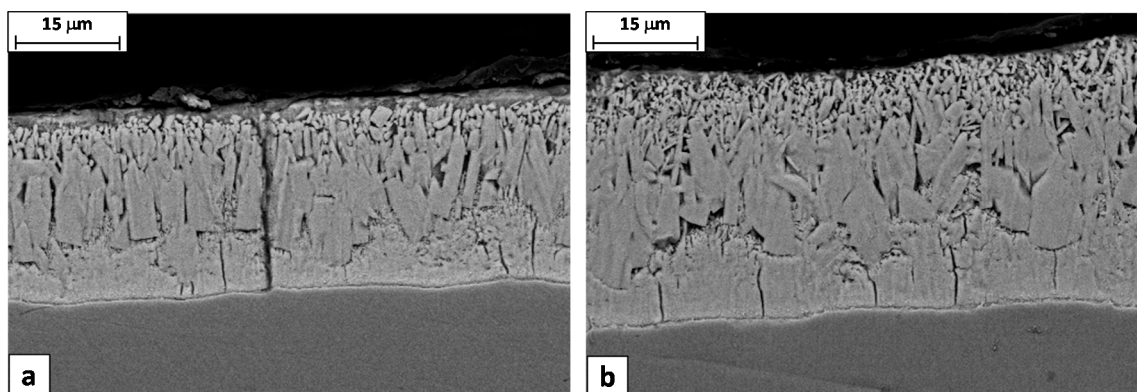
Longitudinal cross sections cut from the samples 9A and 9B confirmed this interpretation, showing that the through-thickness cracks are frequently encountered in the spray-quenched sample, while in the other one the cracks are always confined just in the delta layer (Figure 11). So, as expected, the soft cooling reduced the coating tendency to cracking. It is worth noting that the wire produced with the steel 9A had a high percentage of failures during the torsion test, while no failures were observed in the case of wire produced with the steel 9B.

Figure 11. SEM images of longitudinal sections of (a) steel 9A and (b) steel 9B samples.

In conclusion, the proper countermeasure to prevent this type of failure was to reduce or completely switch off the air–water sprays when the Si_{eq} index of the rods' steel exceeds the critical value of 0.21%.
