Case Report

Copper Tube Pitting in Santa Fe Municipal Water Caused by Microbial Induced Corrosion

Thomas D. Burleigh ^{1,*}, Casey G. Gierke ², Narjes Fredj ¹ and Penelope J. Boston ²

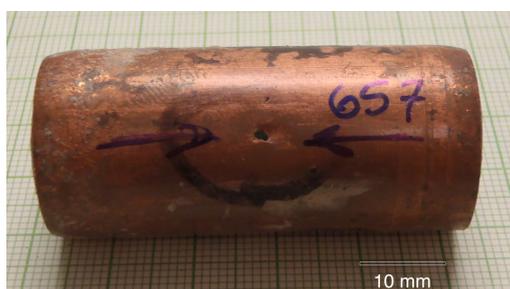
Copper tubing #657 with a typical pinhole leak is shown in Figure 1. The high velocity water exiting the pinhole washed away all of the features that were associated with the initiation of the pinhole leak. Therefore nearby regions of the tubing were examined in order to find corrosion pits that had not yet perforated the complete wall thickness. The interior of the tube was typically covered by a green layer (later identified as malachite) with various sized mounds (or caps) as shown in Figure 2.

Figure 1. A typical pinhole leak in the copper tubing.

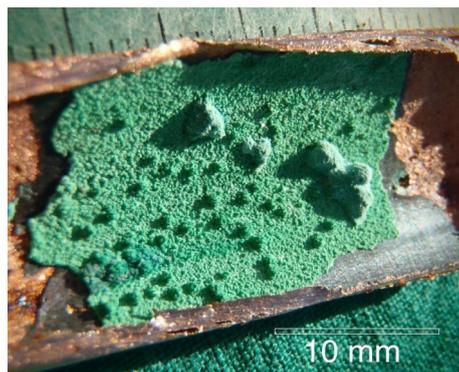
Figure 2. The malachite mounds found on the interior of the copper tubing.

Examination of Figure 2 reveals four distinct regions. First are the large and small green mounds, ranging from several millimeters in width and height, to less than 1 mm in width and height. Second is the uniform green layer that is very brittle and easily spalls. Beneath the green layer is a third layer that is a black, thin, featureless copper oxide. When the black oxide was chipped off, the shiny, underlying copper surface was seen. (The XRD results for the green and black oxide layers are shown in the next section.) The hot-water copper surfaces that corroded by MIC according to Labuda [14] were completely different from the cold-water copper surfaces observed in this investigation.

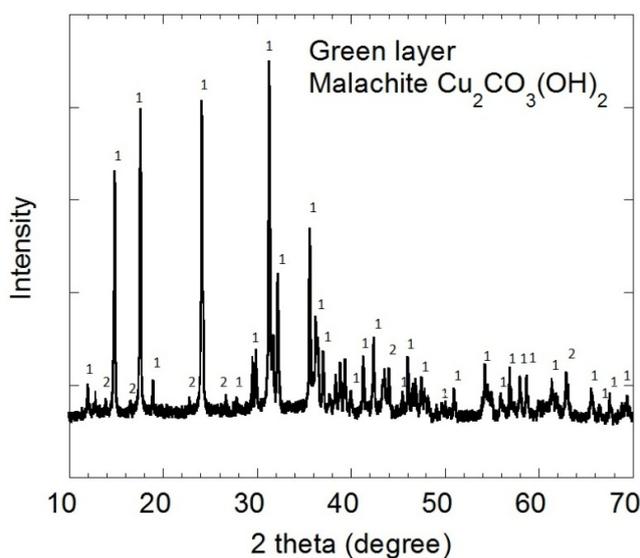
The surface oxides inside tubing #806 were characterized by X-ray diffraction (XRD) and glancing angle X-ray diffraction (GAXRD). The XRD spectra of the upper green layer in Figure 3 corresponds to malachite, $\text{Cu}_2\text{CO}_3(\text{OH})_2$, peaks labeled “1”. The GAXRD pattern for the underlying black oxide in Figure 4 corresponds to cuprite, Cu_2O , peaks labeled “3”. There is trace malachite “1” on top of the cuprite “3” in Figure 4. The peaks labeled “2” are trace unknowns.

Figure 3. The XRD spectra for the green layer correspond primarily to malachite (peaks labeled “1”).

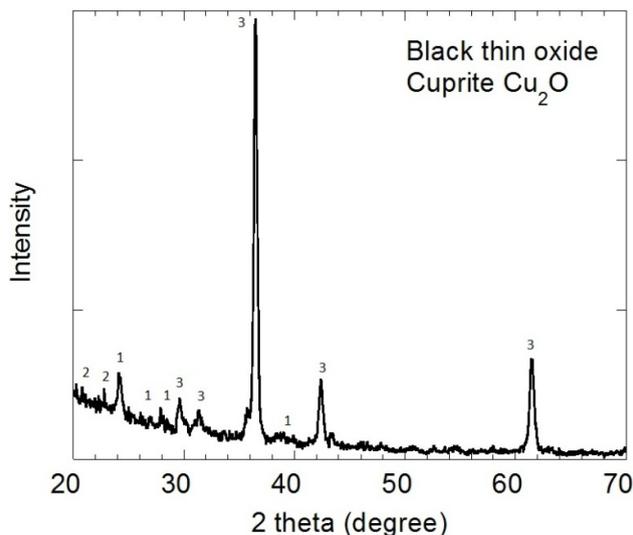
Figure 4. The XRD spectra for the black oxide layer correspond primarily to cuprite (peaks labeled “3”).

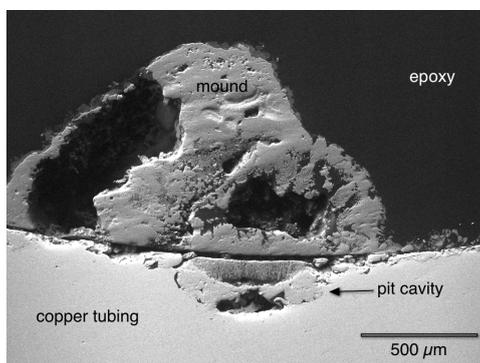
Figure 5 shows the cross-section of a copper pipe that was polished to the middle of a mound. The large mound was not solid, but rather porous, and was located directly above the corrosion pit in the copper tubing. The Energy Dispersive Spectroscopy (EDS) analysis (not shown here) verified that the mound contained primarily copper (Cu), oxygen (O), and carbon (C), which is in agreement with malachite. The upper part of the mound contained trace sulfur (S) and inside the bottom of the pit, contained trace chloride (Cl), similar to previous reports [5].

Figure 5. The cross-section of a mound shows that it was directly above a corrosion pit cavity.

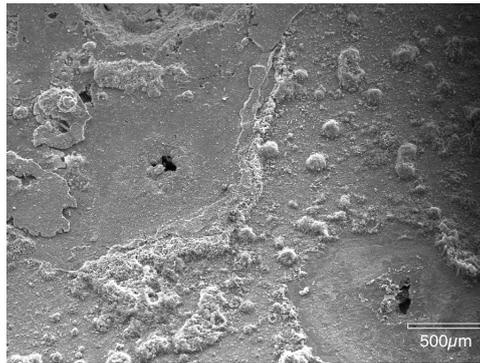
Figure 6. Once the mound was removed, the cuprite membrane shows small openings to the pit cavity.

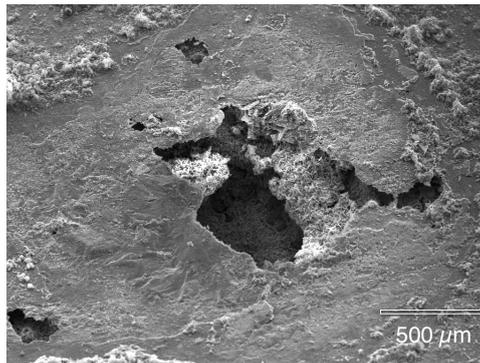
Figure 7. When the cuprite membrane was fractured, the larger underlying pit cavity was seen.

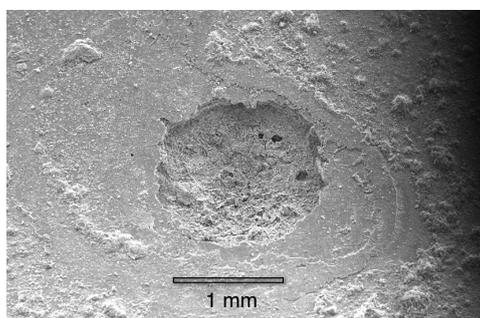
Figure 8 shows a corrosion pit that was exposed by completely fracturing the fragile cuprite membrane by tapping the copper tube.

Figure 8. A corrosion pit, after both the malachite mound and cuprite membrane were removed.

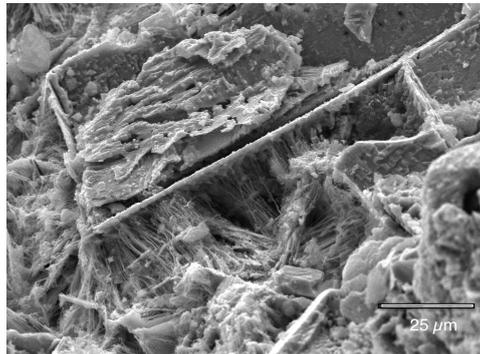
Figure 9. Microbial filaments deep inside a corrosion pit (hexamethyldisilazane (HMDS) fixation).

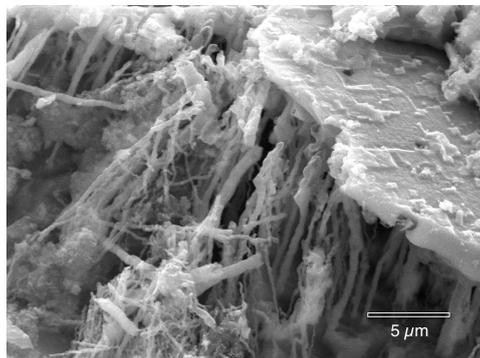
Figure 10. Microbial filaments deep inside a corrosion pit (HMDS fixation).

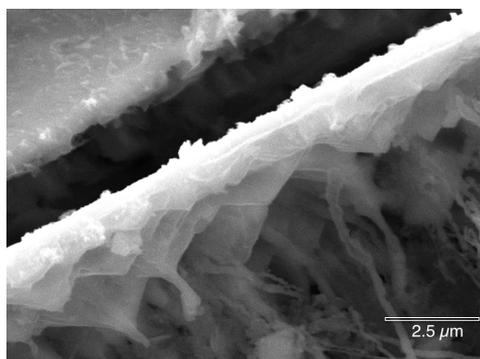
The crystallographic pyramids in Figure 11 demonstrate how the bacteria attach to the surface, and protect their foothold from corrosion, while the rest of the surface is dissolved.

Figure 11. Microbial filaments attached to the copper inside a pit (HMDS fixation).

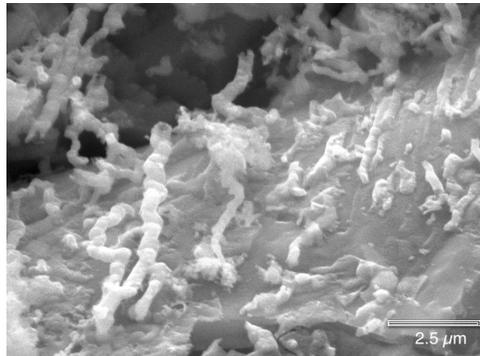
Figure 12 shows clusters of microbes, similar in appearance to Actinobacteria (to be discussed in the next section), across the interior of the copper pit surface.

Figure 12. Clusters of microbes similar to Actinobacteria are deep inside a pit (HMDS fixation).

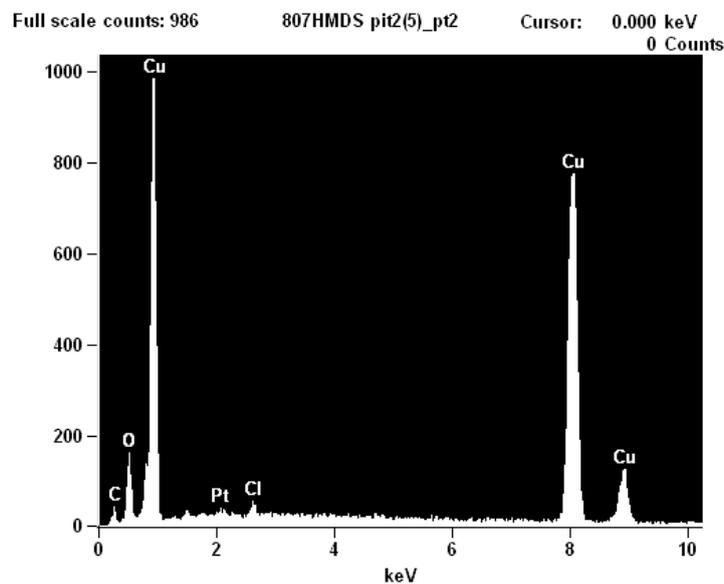
EDS analysis (Figure 13) inside the pit consistently indicates only the presence of Cu, C, O and Cl, regardless of whether the beam was focused on the microbes or on a crystallographic surfaces. It was difficult to obtain a strong EDS signal inside the pit due to the sides of the pit absorbing the emitted

Figure 13. EDS (Energy Dispersive Spectroscopy) analysis of the microbes inside the pit shows only Cu, C, O and Cl.

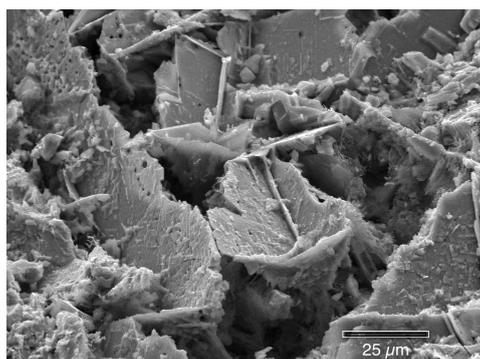
X-rays. The crystallographic surfaces in Figure 14 show that the copper has been etched away due to either the microbial metabolism or the acidic nature of the pit. This surface topography provides many locations for the microbes and their biofilm to reside and to adhere.

Figure 14. The copper crystallographic surfaces inside the pit (HMDS fixation).

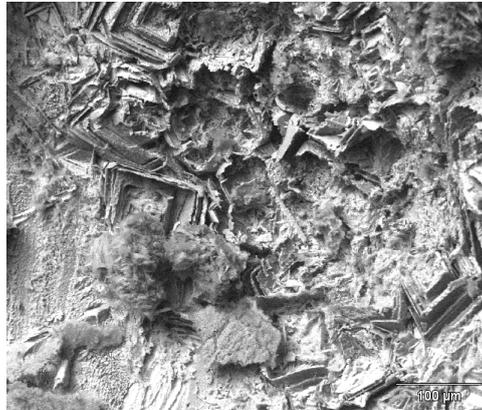
Figures 15 and 16 show tube #806 that was not fixed in the HMDS. Figure 15 shows crystallographic attack revealing the copper grains boundaries and the internal crystallographic planes. Figure 16 shows the one micron diameter filaments protruding from one copper grains. As shown in Figure 16, it is possible to find microbial evidence inside pits that were not fixed in HMDS, but the air-dried microbes tend to dehydrate and collapse, or explode in the vacuum or under the electron beam, and thus are not easily identifiable.

Figure 15. The copper crystallographic surfaces inside a pit (not fixed in HMDS).

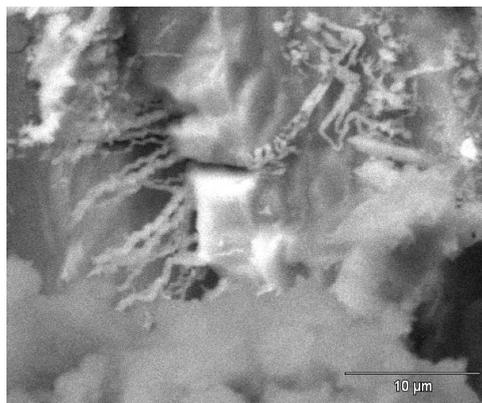
Figure 16. The micron-size filaments inside the crystallographic gaps (not fixed in HMDS).
