# Evaluation of Compressive Geophysical Prospecting Method for the Identification of the Abandoned Goaf at the Tengzhou Section of China's Mu Shi Expressway

Shukun Zhang \*, Peng Jiang, Lu Lu, Shuai Wang and Haohao Wang

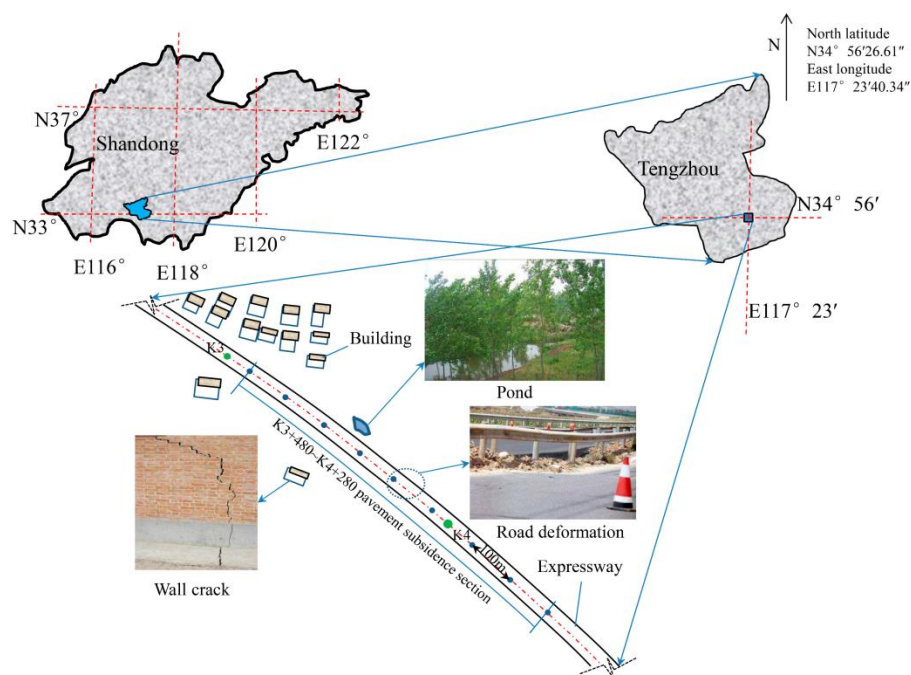
**Figure 2.** Highway and surface disaster location relationship.

**Surface subsidence deformation and collapse pit investigation:** In Figure 2, on the north side of the expressway, an elliptical pond has been formed due to surface subsidence. The short axis of the pond is 10.5 m long, and the long axis is 38.9 m long. The direction of the long axis is basically parallel to the direction of the expressway. The position of the pond is close to the maximum deformation position of highway subsidence, and the edge of the pond exhibits different degrees of tensile cracks. On the two sides of the highway K3+480~K4+280, there are a number of small collapse pits, and the edge of the pit near K3+760 also has circular cracks with different widths. At present, most of the subsidence areas are still likely to be active, thereby forming new concave areas.

**Residential deformation survey:** In Figure 2, a private residence is located at K3+780 on the south side of the expressway, and the cross-range of the highway subgrade is approximately 30 m. A residential housing survey revealed that the wall has a crack of approximately 2 cm. Upon inquiry to the residents of the household, it was learned that the wall had gradually cracked and the crack had continuously expanded since 1997; in addition, crack growth was the fastest after 2000. The residents were evacuated for safety reasons. The cracks continued to expand from 2000 to 2006 and have basically stabilized since 2006. Other walls have cracks of varying degrees.

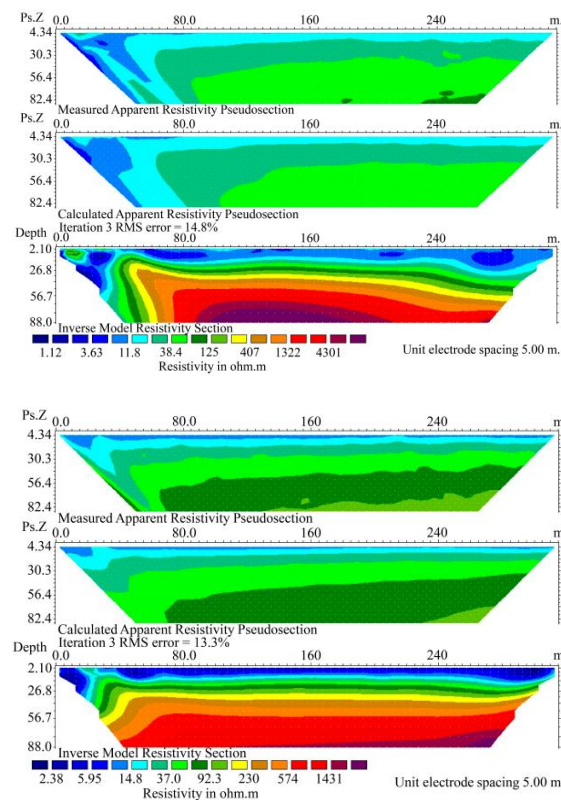
**Figure 4.** Resistivity profiles of the K3+480~K3+800 and K3+640~K3+960 section diodes in line 1.

In survey line 1, for the K3+480~K3+960 segment, reciprocating measurements are taken. As electrical profiling reflects that the test depth is shallow, the results of the measured profile extracted using the two-section double-pole device are shown in Figure 4. From top to bottom, the actual acquisition apparent resistivity profile, the calculated apparent resistivity profile, the interpreted profile and the follow-up line measurement profile are similar. The interpreted profile shows that the apparent resistivity of the rock and soil within a depth of 15 m is less than 10  $\Omega\text{m}$ . This layer is mainly a quaternary cover layer, which is low in resistivity due to atmospheric precipitation. The burial depth is between 15 and 50 m, and the apparent resistivity is between 10 and 600  $\Omega\text{m}$ . This layer is mainly composed of sandstone and shale with different degrees of weathering. The K3+640~K3+760 and K3+820~K3+900 segments exhibit an anomalous high-resistivity area at a depth of 50 m, and the apparent resistivity is between 700 and 7000  $\Omega\text{m}$ . According to the preliminary drilling data, the layers are mostly siltstone and sandstone. Generally, the resistivity of sedimentary rocks is within 1000  $\Omega\text{m}$ , and it is preliminarily concluded that there are well-developed fractures in the rock mass below 50 m. When the detection depth is increased to 88 m, the high-resistance anomalous area does not form a closed area, and the distribution characteristics of the exposed goaf are not distinct. It is inferred that the abandoned goaf in this section is likely to be filled by collapsed rock.

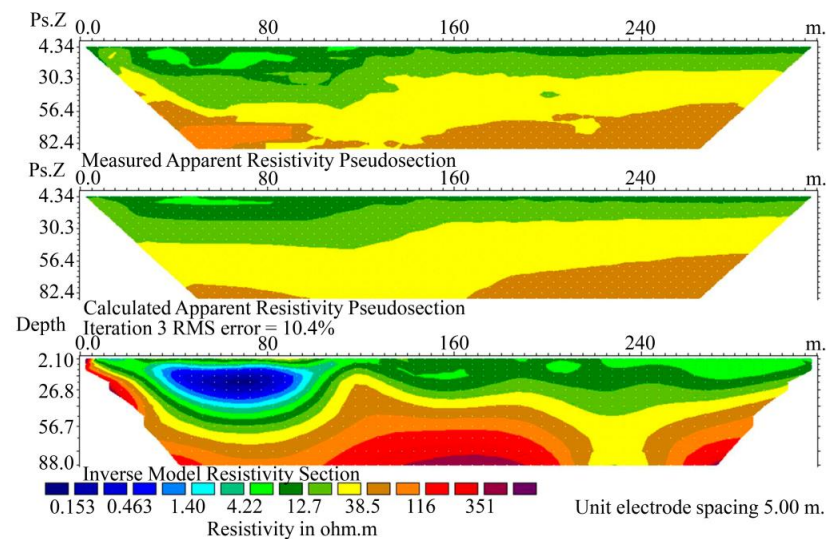
**Figure 5.** Line 2 K3+790-K3+470 section detection results.

In survey line 2, for the reciprocating measurement in the K3+630~K3+790 section, the measurement direction is from large to small pile numbers, and the detection results are shown in Figures 5 and 6. From the detection results, it can be seen that the high-resistance characteristics of the goafs in the K3+650~K3+780 and K3+795~K3+820 sections of line 2 are distinct. Since the electrical profile reflects a shallow depth, the data of the measured cross-section of the double-pole device are extracted to clarify the electrical anomalous reaction in the goaf. The area below a depth of 60 m is also characterized by high-resistance goaf characteristics, and the exploration depth is increased to 80 m. There is no distinct anomalous area in the goaf distribution, indicating that the deep goaf is filled with collapsed rock.

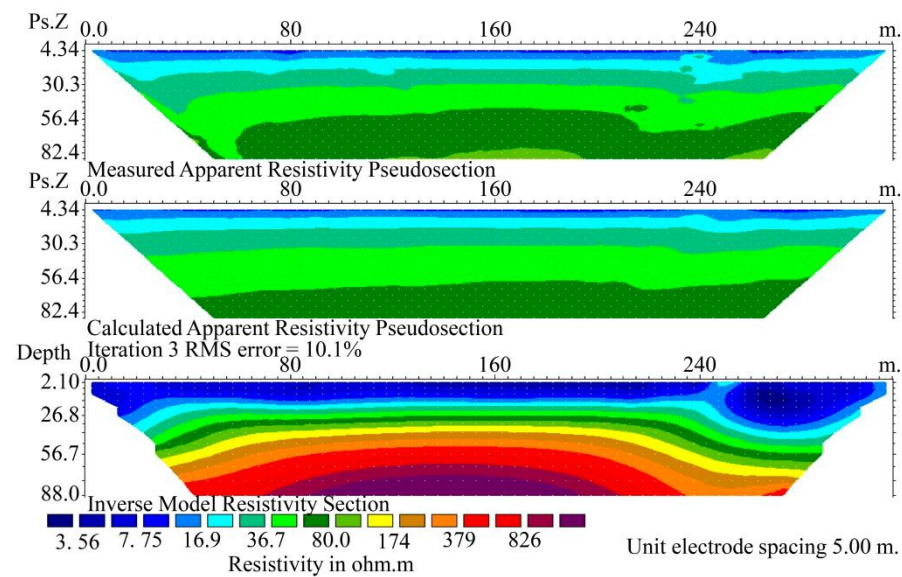
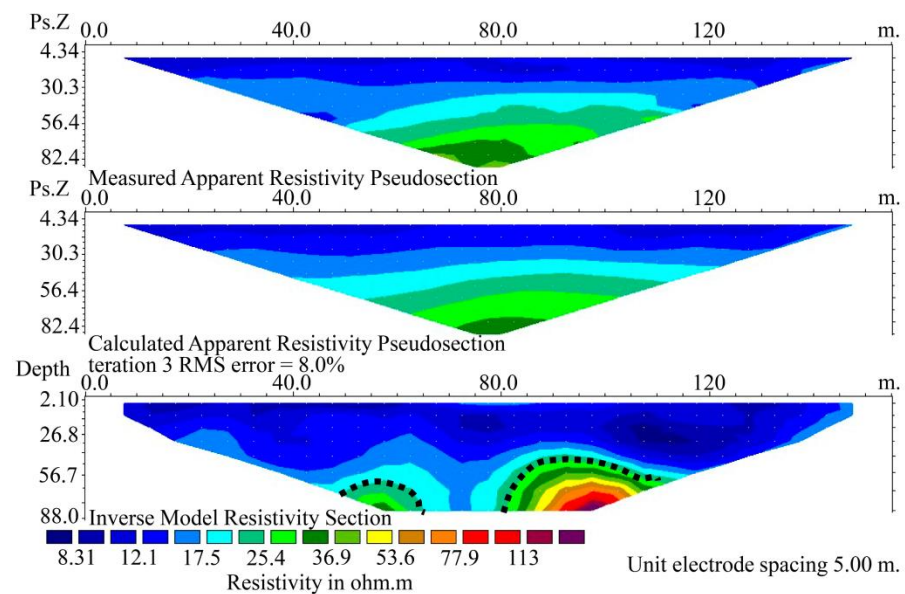
Survey line 3 is arranged in section K3+750~K3+905, the most severely distorted section of the expressway, based on detection results of survey lines 1 and 2, and measurements are obtained from large to small pile numbers. As shown in Figure 7, the shallow depth is 40 m, and the internal resistivity is less than 50  $\Omega$ m. The survey line is located 30 m on the south side of the roadbed. Considering that there is a subsidence pond at this location, the water system is connected due to the development of bed cracks, and the apparent resistivity is significantly reduced. In the K3+865~K3+835 and K3+820~K3+795 sections, at a burial depth from 56~76 m, there is a semi-closed anomalous high-resistivity area, which is inferred to be the impact range of the goaf; the boundary top interface is indicated with dashed circles in the figure.

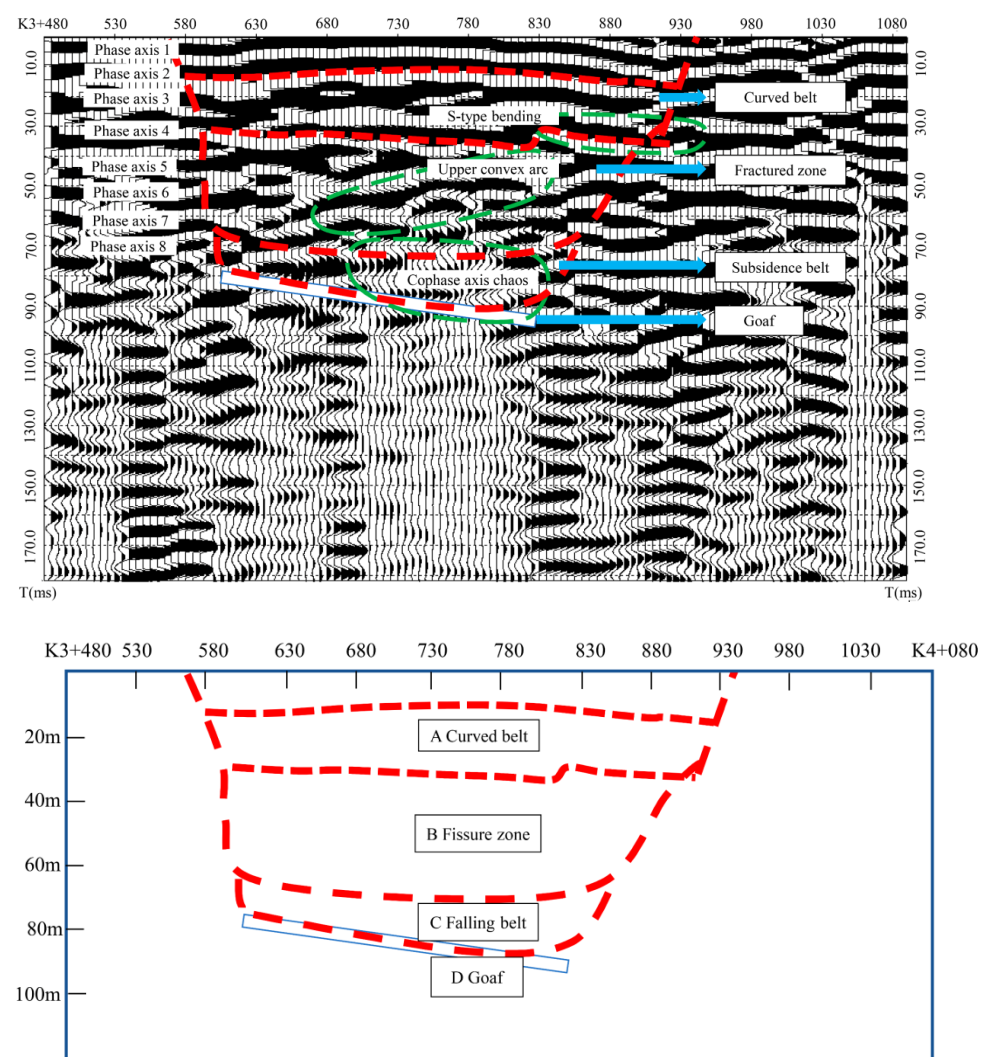
Figure 8. Line 4 detection results.

Interpretation of the detection results: The reflected waves in the goaf have the following general behavior of the seismic image: for the same curve, fractures or discontinuities occur along the same phase axis, and the waveform of the reflection profile appears to be oscillating or periodically increasing. From the test results in Figure 8, the in-phase axis group is relatively continuous, the in-phase axis is clearly identifiable, and there are many features. The arrival times of the first, second and third in-phase axes are approximately 5 ms, 15 ms and 25 ms, respectively. The in-phase axis is continuous and has irregular bending. This phenomenon indicates that there are many sets of sedimentary layers in the quaternary overburden and weathered rock strata, and the reflection characteristics of the bedrock surface are very notable; the regional lithology is consistent, and the in-phase axis is continuous. It is inferred that this part is the curved subsidence zone affected by the goaf, and the seismic test results are consistent with the resistivity test results.

The wave arrival time of the fourth in-phase axis is approximately 35 ms, the phase is relatively continuous, and there is an S-bend between K3+830 and K+930. The arrival times of the 5th and 6th in-phase axes are 45 ms and 55 ms, respectively, and the in-phase axis is relatively continuous overall, but it is more disordered; an upper convex arc is present between K3+730 and K3+830. Goaf collapse has caused many cracks in the rock formation, and the fissure zone can attenuate the energy of the emitted wave, resulting in the emission wave's in-phase axis disorder. It is inferred that this part is the water-filled fractured zone affected by the goaf.

The wave arrival times of the 7th and 8th in-phase axes are 65 ms and 75 ms, respectively, and an upper convex arc is also present between K3+630 and K3+730; in addition, the in-phase axis is very disordered. The depth of exploration continues to increase, the in-phase axis of the same phase is more disordered and difficult to identify, and there is in-phase axis loss between K3+680 and K3+800. This finding indicates that the site is affected by mining activities, resulting in a large number of gravel collapses and cavities. The broken rock mass and the unfilled cavity form a strong reflection interface and a region in which the reflected wave energy is rapidly depleted. The multiple interface reflections and dissipation of reflected wave energy lead to chaotic observations and loss of in-phase axis. It is inferred that this part is the goaf zone. This finding is consistent with the actual mining data.

According to the characteristics of the seismic reflection waves and the results of the above electrical method, combined with the general position correspondence of the three belts, a comprehensive analysis is carried out to determine the location of the abandoned goaf and the specific limits of the three belts. The range of the abandoned goafs that have a significant impact on the expressway is as follows: along the expressway, with regards to the K3+580~K3+830 section on the north side and the K3+580~K3+900 section on the south side, the lateral distance of the north-south sides along the expressway axis is within 30 m. Among these sections, the burial depth is approximately 35 m, which is a subsidence and deformation zone. The burial depth is between 35 and 75 m, which is the water-filled

fractured zone. The subsidence zone is between 75 and 90 m, and the unfilled cavity of the goaf is approximately 2~8 m.

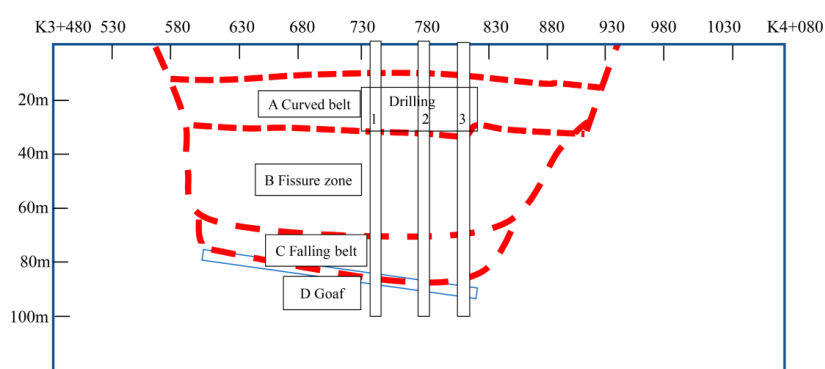
Figure 10. Drilling position map.

Drilling data are shown in Table 1. The relative drilling position to seismic line 4 is shown in Figure 10. According to the drilling data, the depth of the borehole is basically the same, indicating that the cavity formed by caving is not excessively inclined. The hole height detected by the drill pipe is different, indicating that the goaf is in a filled or semi-filled state with no clear regularity. According to the drilling data and related experiments, the 30 m depth is mainly composed of quaternary sediments and strongly weathered mudstones and sandstones. Its saturated uniaxial compressive strength is less than 0.26 MPa and the softening coefficient is less than 0.17, indicating a significant water-weakening effect and a certain degree of expansion and relative water repellency; the depth between 30 and 80 m mainly consists of weak weathered siltstone and sandstone, and below 78 m, the drilling phenomenon appears. The thickness of the drill pipe is approximately 3~5 m, and the goaf is filled with groundwater due to the existence of a large number of connected fissures. The semi-filled goaf is currently in equilibrium, and the drilling quality is basically consistent with the position of the three belts determined from the geophysical results. According to the drilling data, it is observed that the range of the fractured and caving zones is slightly larger compared to the geophysical exploration results, which may be caused by different degrees of disturbance to the rock sample in drilling sampling.

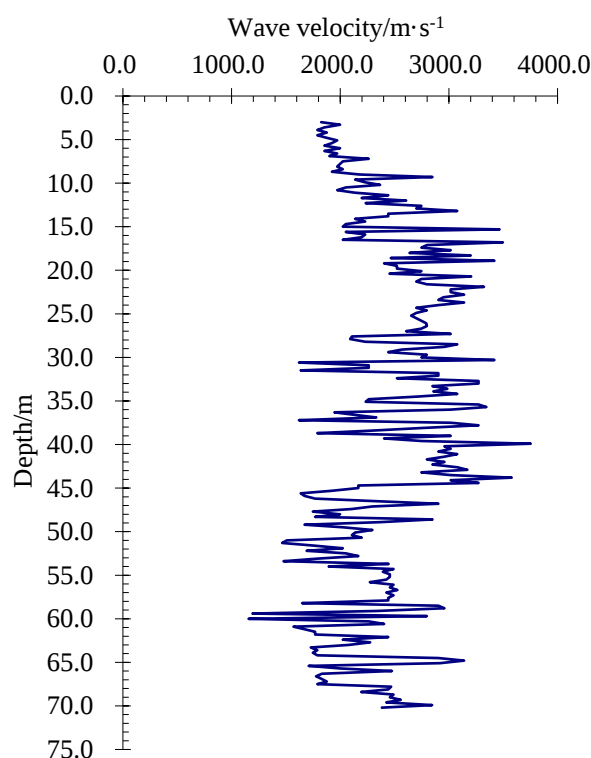
**Figure 11.** Acoustic wave detection curve [24].

The distribution range of three belts is further corrected, and the acoustic detection of boreholes is carried out. The data processing of the borehole wave velocity test is based on Equation (1), discussed in the Methodology section. The No.2 borehole is selected as the test hole to perform acoustic wave detection and then the acoustic wave test data are processed to plot the acoustic wave test curve, as shown in Figure 11. The rock mass velocity at a depth of 50 m in the borehole is basically between 1800 and 3500  $\text{ms}^{-1}$ , which is a normal value range. This section is mainly composed of quaternary sedimentary cover and strongly weathered mudstone and sandstone. The abovementioned detection results show that this area mainly belongs to the curved subsidence zone in the three belts of the goaf. The rock mass velocity below the 50 m depth drops sharply to between 1200 and 3000  $\text{ms}^{-1}$ , which is mainly composed of broken, weak weathered siltstone and sandstone. However, the wave velocity of generally weakly weathered siltstone should be above 4000  $\text{ms}^{-1}$ , indicating that a large number of fissures and unfilled voids are present in the rock mass of this section, which is consistent with the characteristics of the caving zone. The characteristics of the No. 2 hole wave velocity along with the depth are basically consistent with the distribution characteristics of the overlying strata in the goaf detected by the high-resolution seismic method.

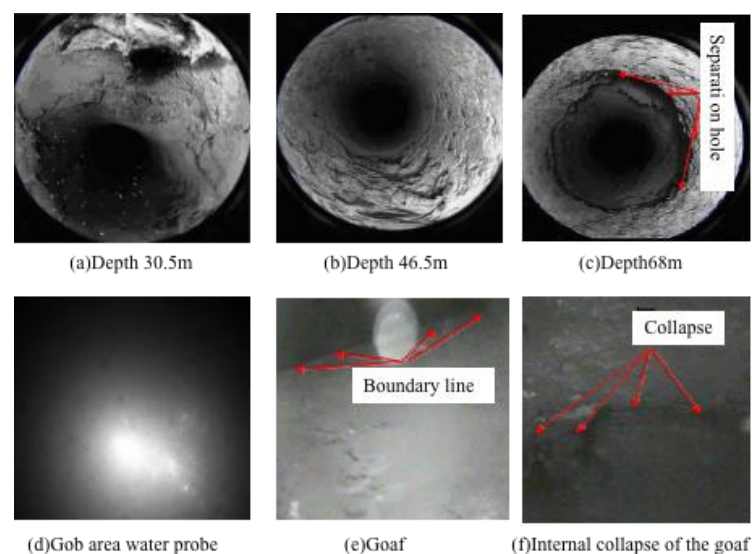
**Figure 12.** No. 2 borehole TV images [24].

The borehole TV imaging method is more intuitive [25]. The No. 2 drilling feature position image is analyzed and the feature boundary image is captured, as shown in Figure 12. Figure 12a shows that when the probe enters the hole at 30.5 m, the rock wall of the hole is notably rough and uneven, and the weathering is severe. The probe penetrates to 46.5 m, as shown in Figure 12b, and although the wall of the hole is smooth, cracks in the rock are clearly visible. The probe gradually descends, and the wall of the cracked hole is observed; the borehole wall is uneven. Figure 12c shows a separation void formed by rock mass collapse at 68 m, indicating that groundwater has reached the goaf and that the groundwater is visible. The pores of the fracture zone are developed, and the pores are filled with groundwater. As shown in Figure 12d, the drilling probe penetrated into

the groundwater-filled area. The water is turbid due to disturbance, and it is difficult to see the surrounding environment despite the intense lighting. After approximately 1 h at a stationary position, the probe continues to descend, and it is observed that there is no round hole shape, which is accompanied by a clearly visible boundary line. It is determined that the boundary line should be the boundary between the roof and the two gangues of the goaf, as shown in Figure 12e. Based on the other observed probe angles, it is found that there are many roadway collapse zones filled with gravel and goaf filled with groundwater, and the field of view is not very clear, as shown in Figure 12f. At a depth of 85.0 m, the descent cannot be continued because the bottom has been reached. The drilling details in the goaf are clearly recorded by borehole TV imaging technology. The verification results show that the range of rock formation changes is consistent with the geophysical results; although goaf collapse is severe, and the goaf is in a semi-filled state and filled with groundwater, it still has distinct roadway features.
