## Building Damage and Business Continuity Management in the Event of Natural Hazards: Case Study of the 2004 Tsunami in Sri Lanka

**Keywords:** BCM; BPM; tsunami; building damage; Sri Lanka; restoration

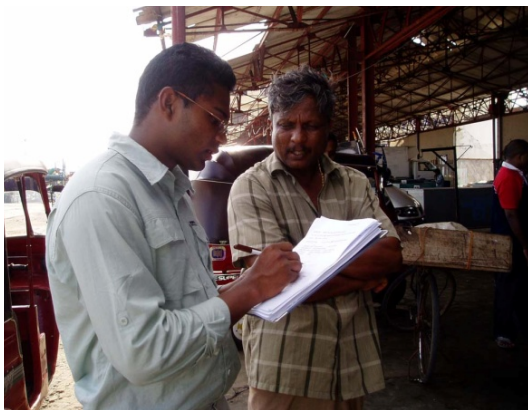
(a) Field survey at Galle

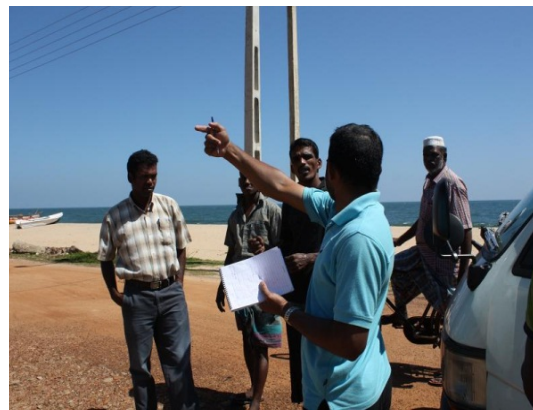
(b) Field survey at Ampara
