Building Damage and Business Continuity Management in the Event of Natural Hazards: Case Study of the 2004 Tsunami in Sri Lanka

Chandana Dinesh Parape ^{1,*}, Chinthaka Premachandra ², Masayuki Tamura ¹, Abdul Bari ³,
Ranjith Disanayake ³, Duminda Welikanna ¹, Shengye Jin ¹ and Masami Sugiura ⁴

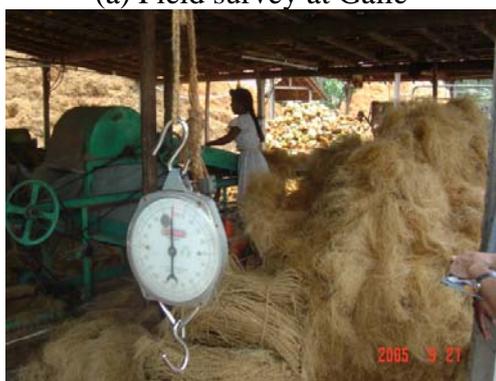
(c) Construction Material
(Coconut fiber loop factory)

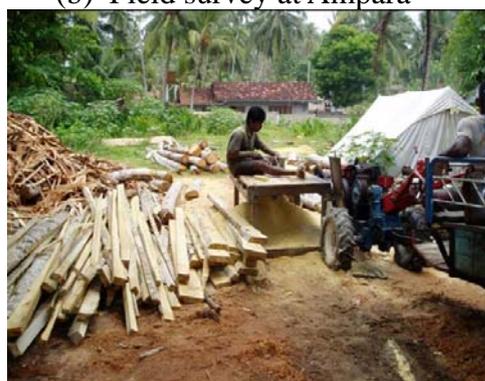
(d) Construction Material
(wood)

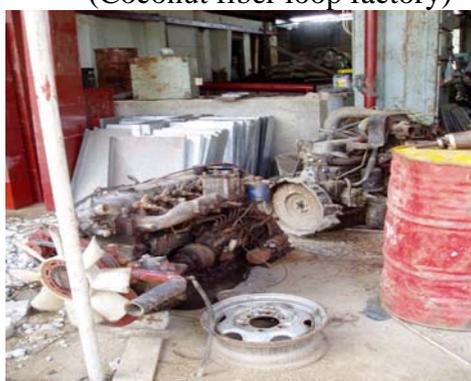
(e) Damaged Ice Plant
