# Development of a GIS Tool for High Precision PV Degradation Monitoring and Supervision: Feasibility Analysis in Large and Small PV Plants

This study aims to evaluate the potential of a specifically designed GIS tool in the location of PV faults and analysis of the degradation effects on PV power plants working in real operating conditions. As a case study, the proposed tool was applied to two representative PV plants: a 108 kW peak power (kWp) grid connected power plant and a 9 kWp self-consumption power plant.

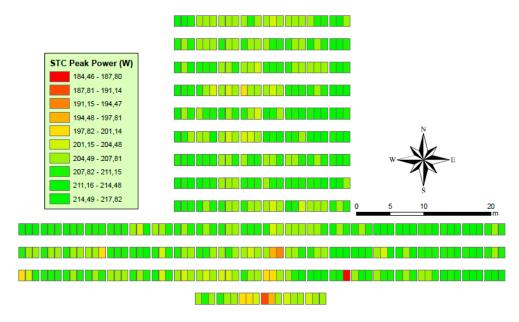
Figure 8. STC peak power distribution analysis (108 kWp PV plant).

Figure 8 shows lower peak power values for STC conditions in the center of the lower part of the installation, whereas the extremes show significantly higher values. This effect may be caused by the temperature distribution through the PV modules and the refrigeration by air convection conditions. The lowest STC peak power was 184.46 W, where the highest value was 217.82 W (18.09% difference). Figure 18a shows the distribution of the peak power values, where it can be noticed that more than 70% of the modules are in the 205–211 Wp range.

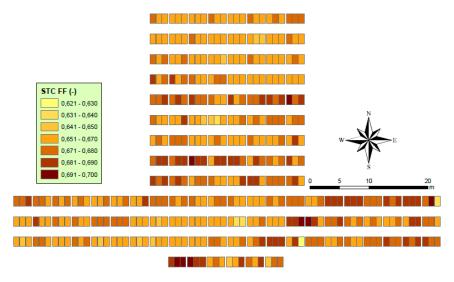
Figure 9. STC fill factor distribution analysis (108 kWp PV plant).

In a similar way, Figure 9 shows the fill factor of the PV modules transformed to the reference STC. Figure 18b shows the histogram for these values. It can be noticed that the PV modules are affected by a significant rate of degradation where 80% of the modules are in the range 0.66–0.68, when the nominal fill factor (FF) given by the manufacturer achieves 0.8018 (see Table 3). Less than 1% of the PV modules present a FF > 0.695. Moreover, it can be observed that those modules with lower values for peak power in Figure 8 show also lower values of FF in Figure 9. However, higher variations of the FF can be noticed in this late figure rather than on the peak power analysis. The fill factor distribution shows not to be homogeneous in the installation and, thus, modules with high values of FF are linked to modules with very low values for FF. Some cases show differences up to 10.53%. This may affect significantly the overall performance of the string series.

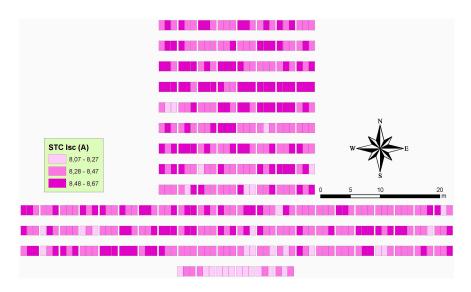
Figure 10. STC short circuit current distribution analysis (108 kWp PV plant).

Figures 10 and 11 show the STC short circuit current and STC open circuit voltage distributions respectively. Moreover, Figure 18c,d shows their histograms. From these figures it can be observed that there exist very slight variations on the short circuit distribution (0.6 A max), but significant variations (up to 3.28 V) in the open circuit voltages. Both distributions in the spatial field are absolutely not homogeneous.

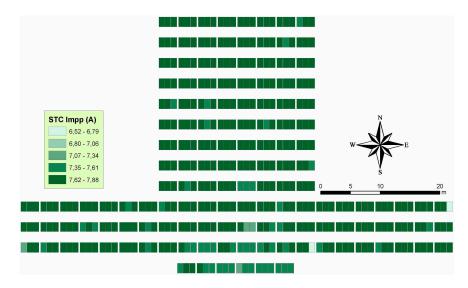
Figure 12. STC maximum power current distribution analysis (108 kWp PV plant).

In Figure 12 the STC maximum power current can be easily distinguished between the groups of PV modules with high values. Distribution on the PV field of this electrical value is not uniform and low values can be correlated with low values of the STC maximum power voltage in Figure 13. Undoubtedly, those PV panels must be inspected with special caution. It can be noticed that higher differences in this value between close located PV modules can be found than when analyzing the maximum power voltage distribution.

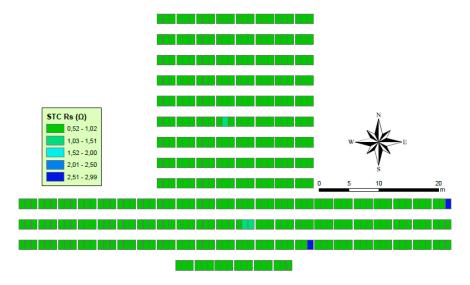
Figure 14. Series resistance distribution analysis (108 kWp PV plant).

Figures 14 and 15 show the distributions of the series resistance and parallel resistance of the PV modules respectively. Although both distributions are not the same, extreme values are located on the same PV modules. As can be verified in Figure 15, these modules which have high values of series resistance and abnormally low values of parallel resistance, also present a significant high number of hot spots and burn marks (between 1 and 8). Moreover, according to Figure 8, these modules have very low power output. Thus, the whole string series production is affected. These PV panels must be replaced immediately. Fortunately, the rest of the series seem not to have been affected seriously. Figure 18g,h shows the histograms for both electrical parameters. The average for the series resistance is 0.7515 Ohm, while for the parallel resistance it is 286.1831 Ohm. Both values are significantly different (higher in the case of the series resistance and lower for the parallel resistance) from the nominal ones, leading to a considerable degradation rate.

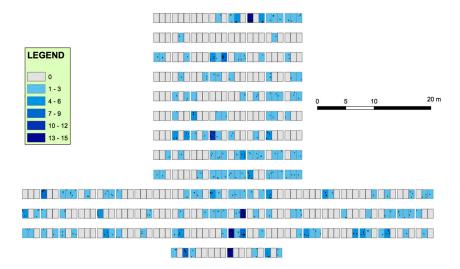
Figure 16. Snail tracks distribution analysis (108 kWp PV plant).

Figures 16 and 17 include the most relevant PV defects on the installation: snail tracks and hot spots and burn marks. The snail tracks distribution in the power field seems not to be homogeneous but we cannot also infer a clear high density zone. PV modules affected by this PV fault seem to have from 1 to 3 defects. However, 15 defects of this type can be found on single modules. No significant correlations with electrical measurements are detected in this case.

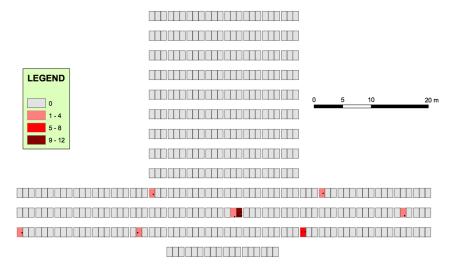
Figure 17. Hot spots and burn marks distribution (108 kWp PV plant).

Figure 17 shows the hot spots and burn marks found on the PV modules. Fortunately, very few of these defects were found in the installation. In this case, its distribution is clearly concentrated in the lowest part. Moreover, it is remarkable that the module with the highest number of hot spots and burn marks is also the one with the highest number of snail tracks. Its STC peak power output is also lower than the average.
