# Detection of Porosity in Impregnated Die-Cast Aluminum Alloy Piece by Metallography and Computer Tomography

**Abstract:** The porosity of die-cast aluminum alloys is a determining factor for the quality of the product. In this paper, we studied the porosity of a selected part of a die-cast AlSi9Cu3(Fe) compressor part by computer tomography and metallography. In the case of this part, the achievable resolution by CT, a non-destructive testing method, was 30  $\mu\text{m}$ —this method could not detect smaller cavities. Based on metallographic analysis, the percentage of defects larger than 30  $\mu\text{m}$  ranges from 10 to 30% of the total number of defects, which represents 75–95% of the defective area (area ratio). Impregnation with methacrylate resin (used to seal cavities to prevent leakage) can be detected with UV-illuminated optical microscopic examination on metallographically prepared specimens. As confirmed by scanning electron microscopy, partial filling and partial impregnation can occur in a system of shrinkage cavities.

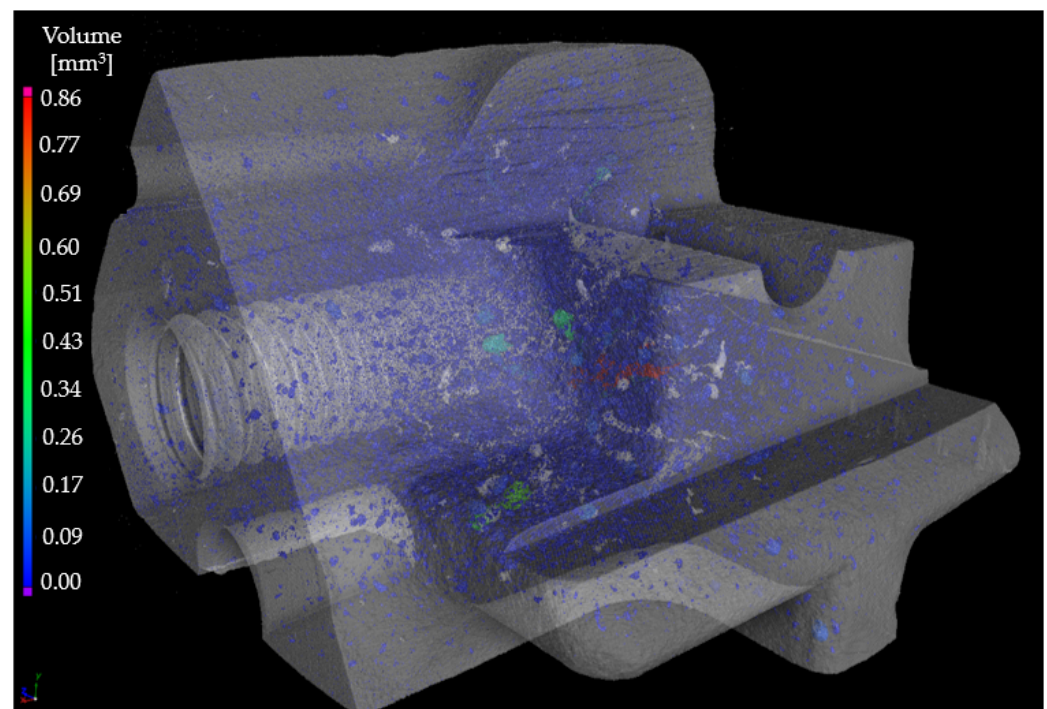
**Figure 2.** Volumetric distribution of porosities in a 3D reconstructed CT image at 60% transparency.

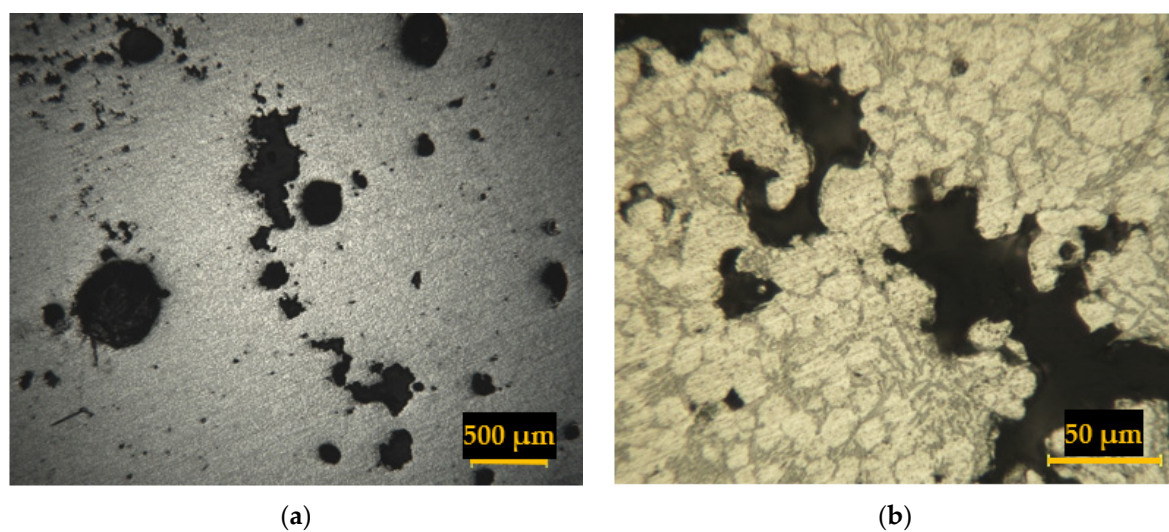
Shrinkage cavities, gas porosities and other discontinuity defects in the polished surface section of the test specimen, revealed by metallography, were identified by optical microscopy. We observed gas porosities and microcavities on the metallographically prepared surfaces. Figure 3 shows some characteristic defects of the studied part at a distance of 0.7 mm from the base plane (level 1). Spherical gas pores and discrete shrinkage cavities are clearly visible at low magnifications; however, the characterization of microcavities requires higher resolutions. Figure 3a,b show the typical appearance of gas pores, shrinkage cavities and microcavities.

**Figure 3.** Porosity, as shown by optical microscopy; (a) gas porosities and shrinkage; (b) microporosity.

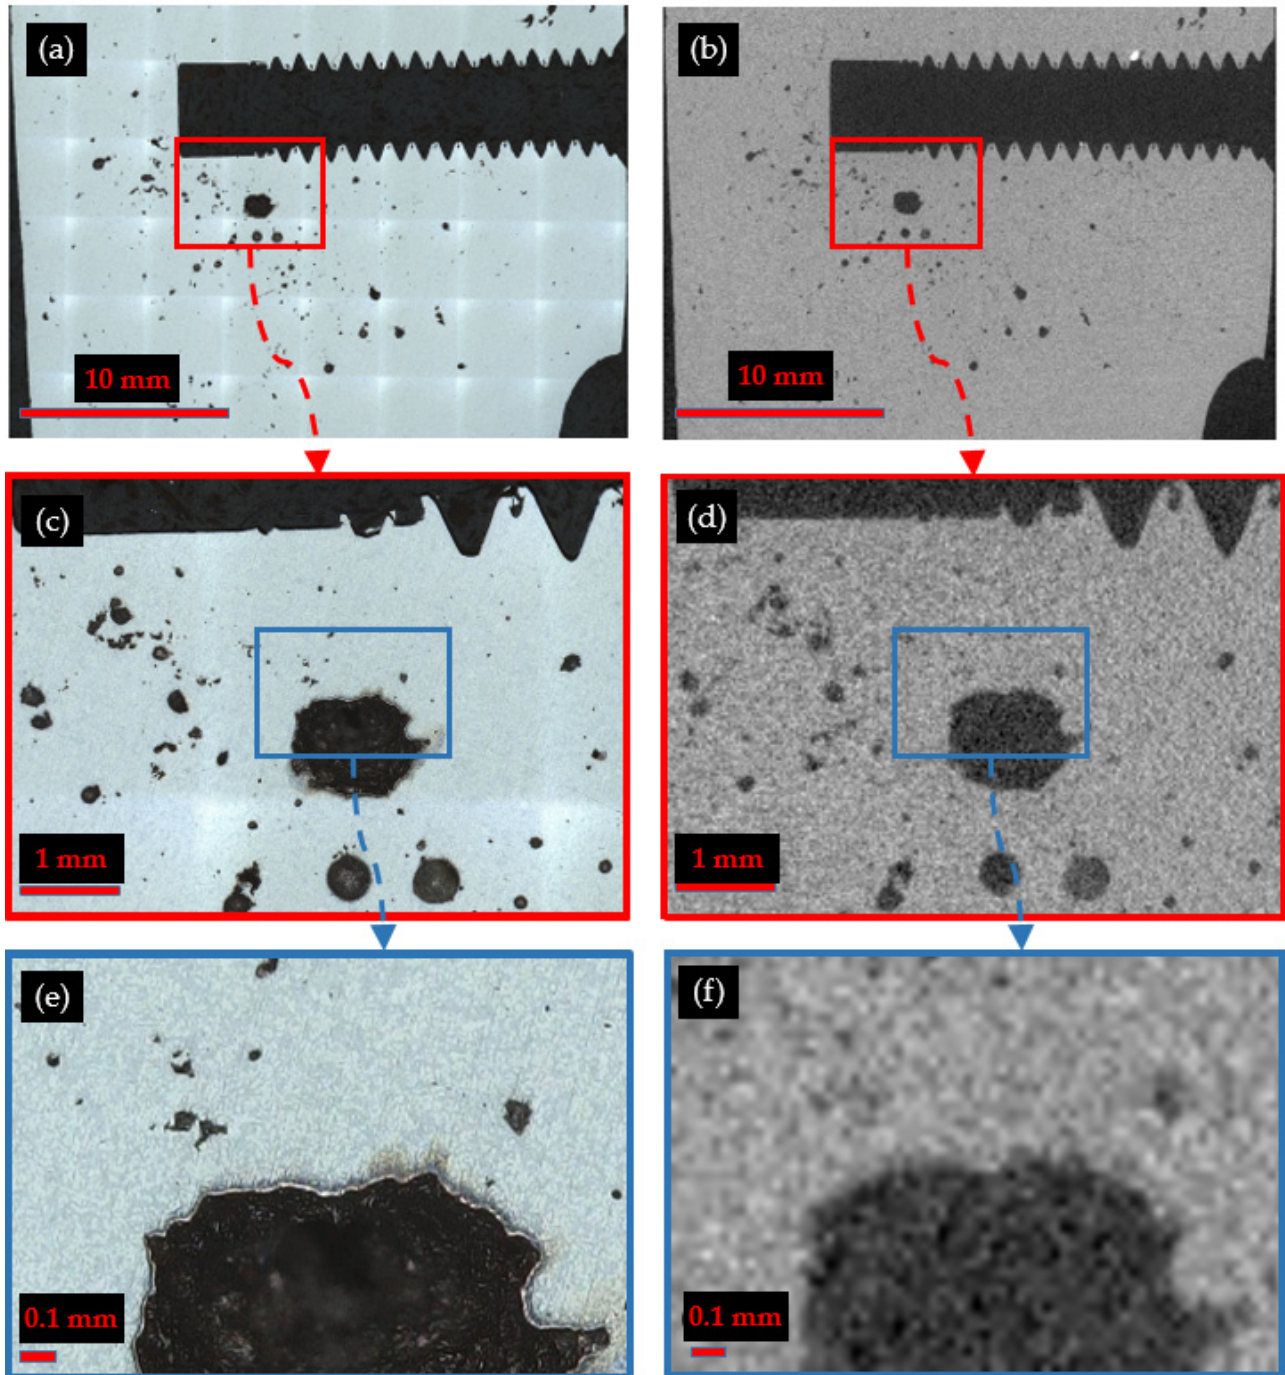
We performed a systematic comparison of the optical and CT examination results in nine examined planes. The sections were marked in a position parallel to the base plane (see Figure 1) at a distance of 0.7–7.1 mm from it. Figure 4 shows the cross-section explored in a plane that is 3.9 mm from the base plane (cross-section 6). The images in Figure 4a,b show the total area of the sample; in this section, the convex area of the sample is 6.3 cm<sup>2</sup>. The position of the threaded hole and the location of the larger individual defects show that the metallographic section and the 2D CT image represent the same plane. The cross-section examined shows a large number of small to large continuity gaps, most of which can be matched with the two inspection methods. The enlarged images of the section marked in Figure 4a are shown in Figure 4c. Again, the larger individual continuity defects look the same with both methods; however, the identification of the smaller defects is not straightforward. The one order of magnitude lower resolution of the CT image and its inherently poorer image quality result in blurred contours of smaller defects and, thus, an uncertain identification of shapes. This difference is clearly visible with a higher magnification of the surface area, as shown in Figure 4b (Figure 4c). The

contour of the large cavity is significantly blurred, and some small cavities are not even identifiable in the CT image. Although the resolution of the CT images is  $30\ \mu\text{m}$ , the lower limit of the sizes of objects that can be identified with confidence is around  $50\ \mu\text{m}$  due to image quality.

**Figure 4.** Optical microscopy (left) and micro-CT (right) images of cross-section 6. (a) Image of the complete section by optical microscopy (LOM); (b) image of the section by CT; (c) magnification of the marked area in (a) (LOM); (d) magnification of the marked area in (b); (e) magnification of the marked area in (c); (f) magnification of the marked area in (d).

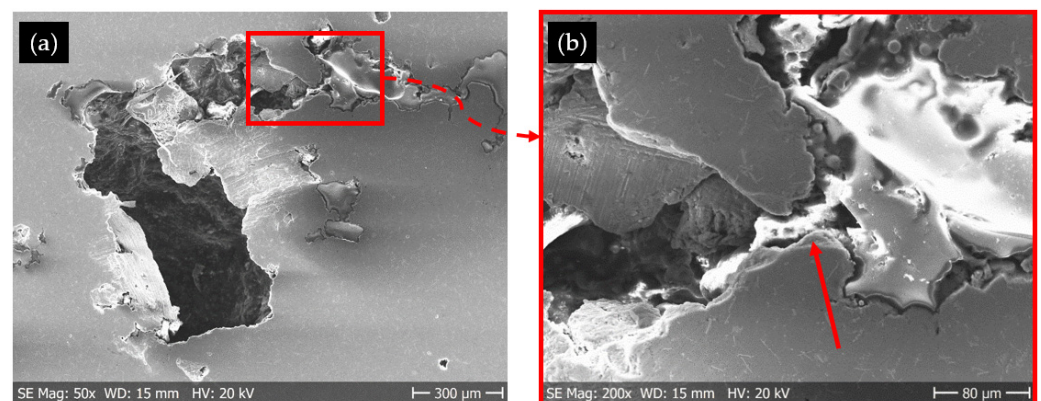
**Figure 7.** Some characteristic cavities identified on the metallographically prepared surface in section 5. (a) Complex cavity; (b) magnification of the area marked in (a).

Figure 7 shows a complex cavity partially filled with resin. The continuity gap extending below the plane of the section on the left side of Figure 7a forms a system with a thinner channel on the right. The meeting point of the smaller and larger cross-sectional cavity

sections—the detail marked in Figure 7a—is shown enlarged in the image in Figure 7b. In the cavity system, a 15–20  $\mu\text{m}$  constriction can be identified in the section marked with an arrow, the right side of which contains resin, while the left side does not. It can be assumed that during impregnation, the resin flowed into the cavity system through the cavity section on the right; however, for some reason, the filling of the left-hand section could not be completed. The constriction marked by the arrow must have increased the flow resistance, and thus the pressure difference or the time available was probably not sufficient to fill the cavity on the left.

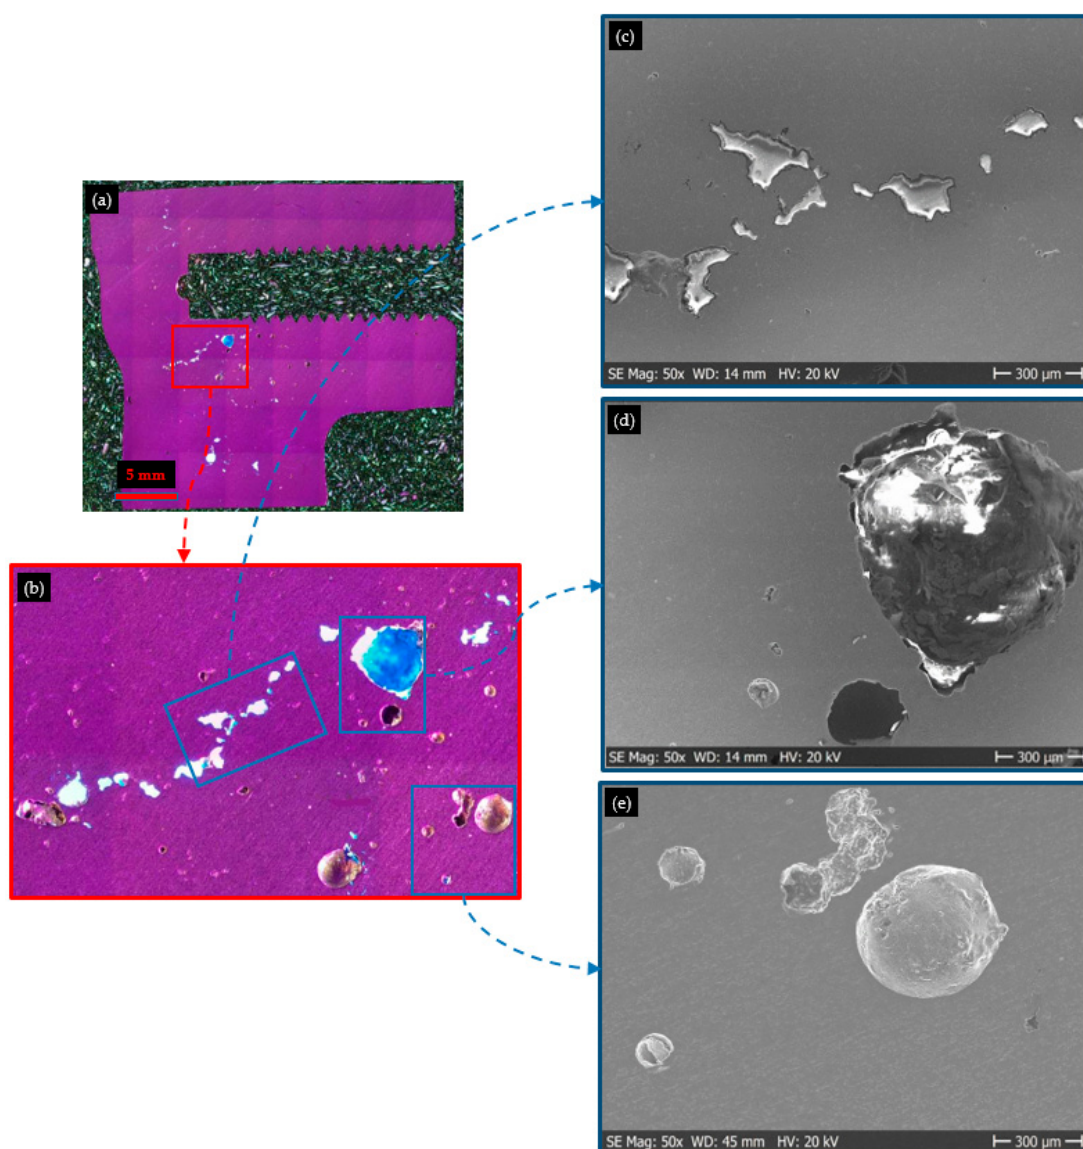
Figure 8a shows the entire surface of cross-section 9 using LOM when the sample is under UV light. Due to the fluorescence of the impregnation resin, the discontinuities filled with resin glow in a bluish-white color, while the base matrix has a purple tint. The structure of the metallographic embedding resin is visible around the part and in the bore in Figure 8c,d.

**Figure 8.** Material continuity defects identified in cross-section 9. (a) The entire surface under UV illumination (LOM); (b) the appearance of cavities under UV; (c) cavities filled with resin (SEM image); (d) a large cavity with resin (SEM image); (e) spherical cavities without resin (SEM image).

each area at higher magnifications reveals that the impregnating resin covers approximately half of the total cavity surface. The number of unsaturated cavities, mainly small ones, is significantly higher than the number of saturated cavities. The spherical continuity gaps, with a few exceptions, are generally free of resin and can probably be considered separated gas inclusions.

Figure 8b shows a larger magnification of the resin-filled cavity near the hole. Figure 8d shows a scanning electron micrograph of the larger cavity and its surroundings in the upper-right-third of the image. The large cavity clearly contains resin, and the surrounding smaller cavities, which are spherical and irregular in shape, do not. The presence of resin is also clearly visible in the scanning electron micrograph of the string-like shrinkage cavity row (Figure 8c), but the impregnating agent cannot be identified in the spherical cavity in Figure 8e (the cavities in the lower-right-third of Figure 8b). The UV-illumination optical microscopy inspection procedure clearly identifies cavities containing an impregnating resin on the metallographic section in our experience.
