Metallurgical Failure Analysis of Closed Water Circuit Containing Molybdate-Based Inhibitor

Abstract: In this work, two industrial heating/cooling circuits are compared. One of the two systems failed in a short time showing severe corrosion damage and a through thickness crack close to one of the welds. The main difference between the circuits is the presence of a sodium molybdate-based corrosion inhibitor in the damaged one. The addition of these substances is very frequent in such applications, and they generally work very well in preventing serious corrosion attacks. Nevertheless, the technical literature reports other cases in which systems working with fluids containing such inhibitors failed prematurely. The authors performed a failure analysis of the damaged circuit focusing their attention on the regions where fluid leaks were observed because of through thickness cracks. This damage was located close to the pipe–flange weld. These zones were investigated by visual examination, radiographic and scanning electron microscope (SEM) analyses, metallographic observations by light optical microscope (LOM), Vickers micro-hardness tests and optical emission spectroscopy (OES) chem

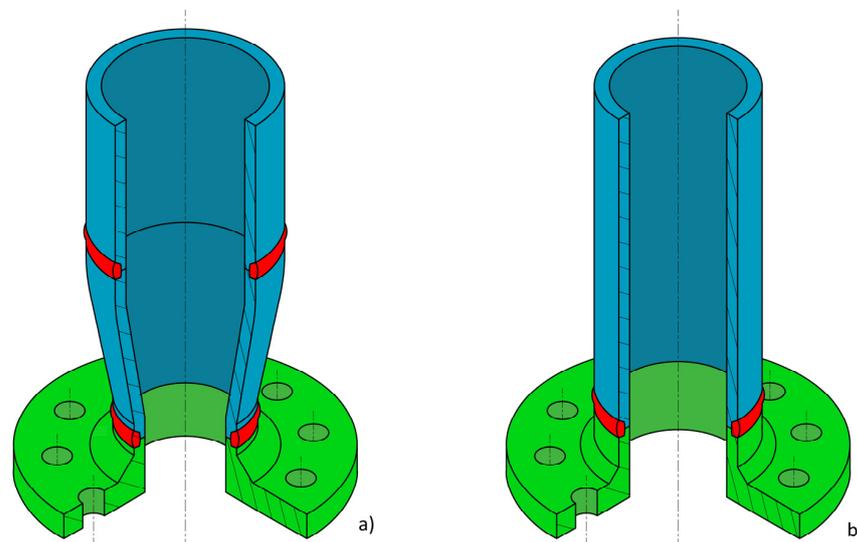
Figure 1. Drawings of the two types of welded joints under investigation. In Figure (a,b), the welded zones are in red. The thickness of the pipes is 5 mm, and the outer diameters are 110 mm (a) and 100 mm (b). The lengths of the two parts taken from Circuit n.2 are about 500 mm.

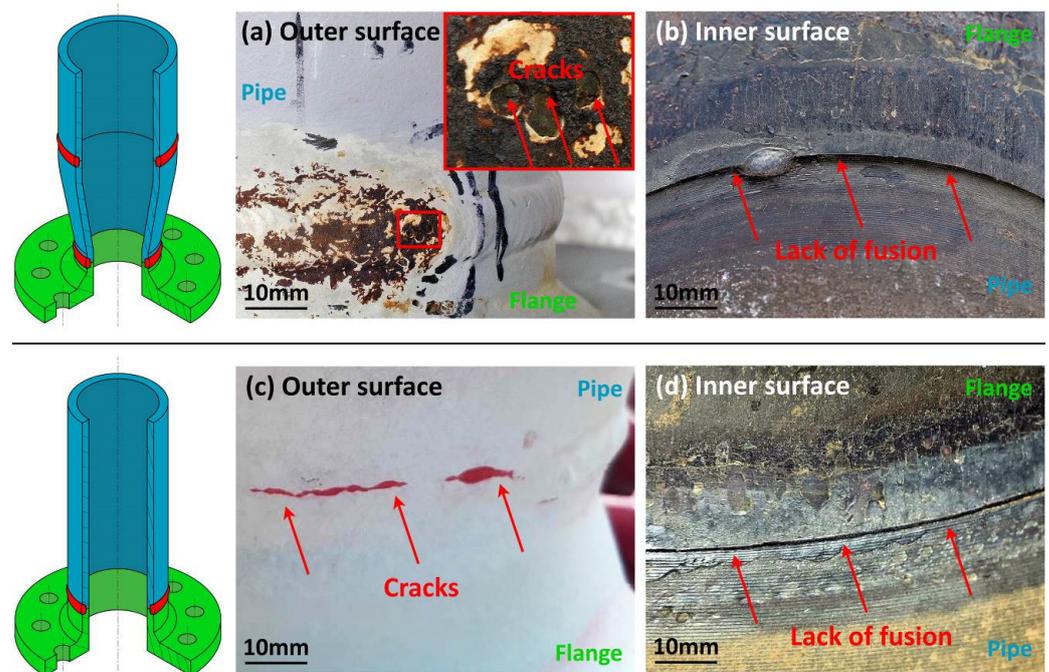
The investigation was concentrated on Circuit n.2, where some leaks were detected. As reported in Figure 2, the outer surface displayed some cracks, both on the welded and the heat-affected zones. The inner surface, instead, showed a step on the whole circumference in the contact region between the welded parts. Figure 3 denotes the presence of many corrosion pits in the region next to the welding bead. Away from the welded zone, the inner pipe and flange surfaces are free from corrosion defects.

Figure 2. Outer and inner surfaces of the two types of welded joints under investigation. Cracks next to the welding bead are clearly visible in pictures (a,c). Pictures (b,d) show the lack of fusion and the step in the contact region between the welded parts.

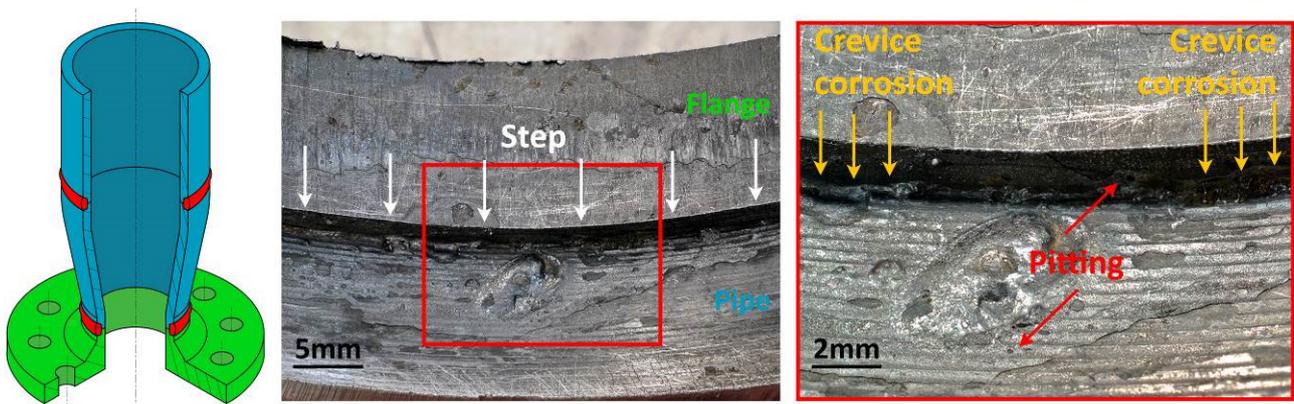
Figure 3. Joints' inner surfaces after cleaning. Pictures show the step between the welded edges; pitting and crevice corrosion are highlighted with red and orange arrows, respectively.

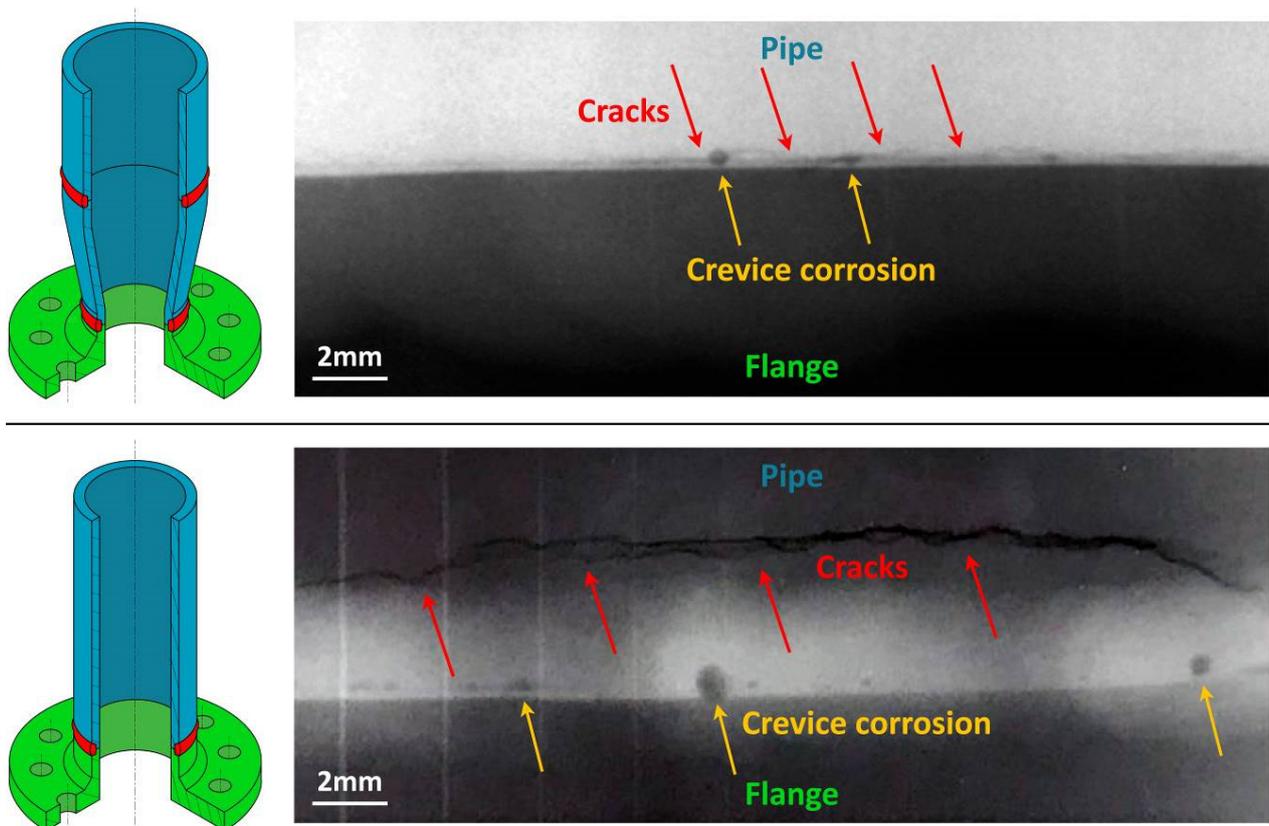
The radiographic investigation (Figure 4) revealed that the cracks observed on the outer surface extended through the whole thickness and were characterized by many branches. Further, the X-ray analysis demonstrated a critical welding defect, i.e., the lack of fusion along the whole circumference. These defects generated a narrow gap between the pipe and flange edges, enhancing the development of many corrosion pits with a size between 0.5 mm and 2 mm.

Figure 4. X-ray analysis. Welds are characterized by lack of fusion that generated crevice corrosion between the pipe and flange edges (orange arrows). Branched cracks are visible in welded area and heat-affected zone (red arrows).

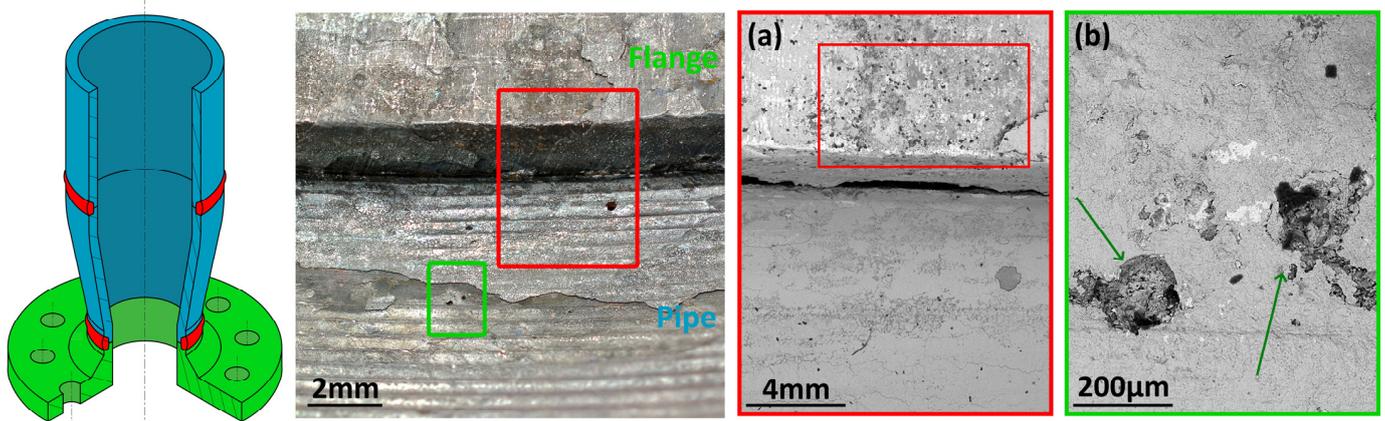
The observation of the fractured surfaces was performed using SEM on two areas: the first one is the region characterized by the step between the two welded edges, whereas the second one is close to the observed cracks. These analyses are shown in Figures 5 and 6, respectively.

Figure 5. SEM investigation of the region characterized by the step between the two welded edges. Picture (a) shows lack of fusion and crevice. Picture (b) shows some of the observed corrosion pits.

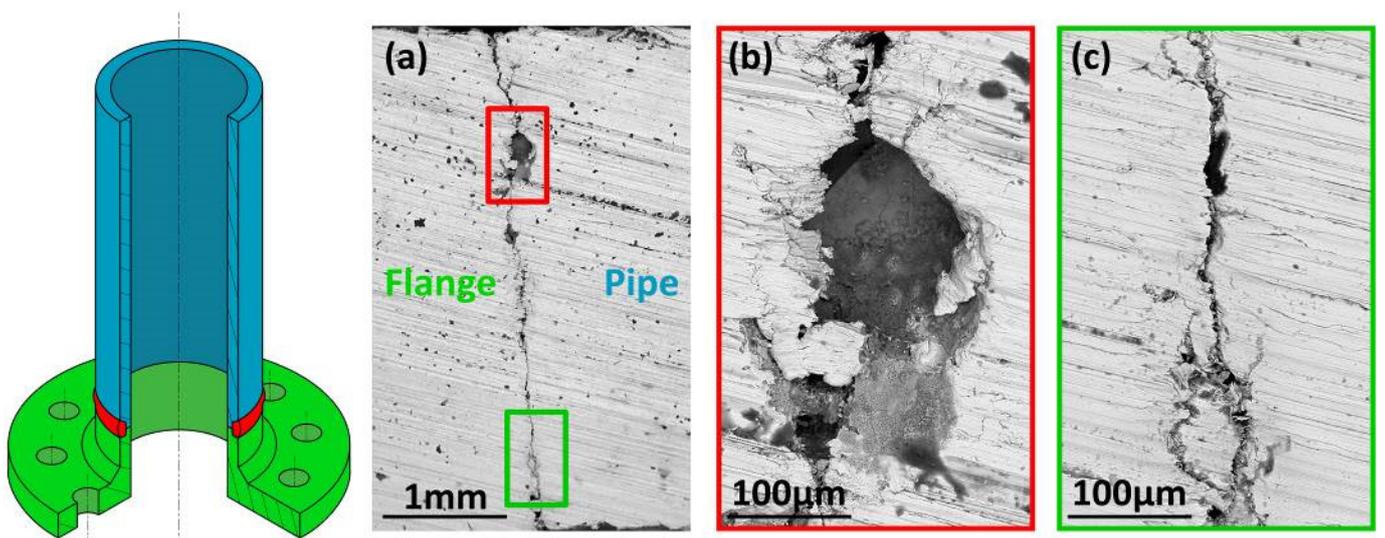
Figure 6. SEM analysis of one cracked area. Cracks are characterized by many branches and corrosion cavities. Images (b,c) are magnifications of picture (a).

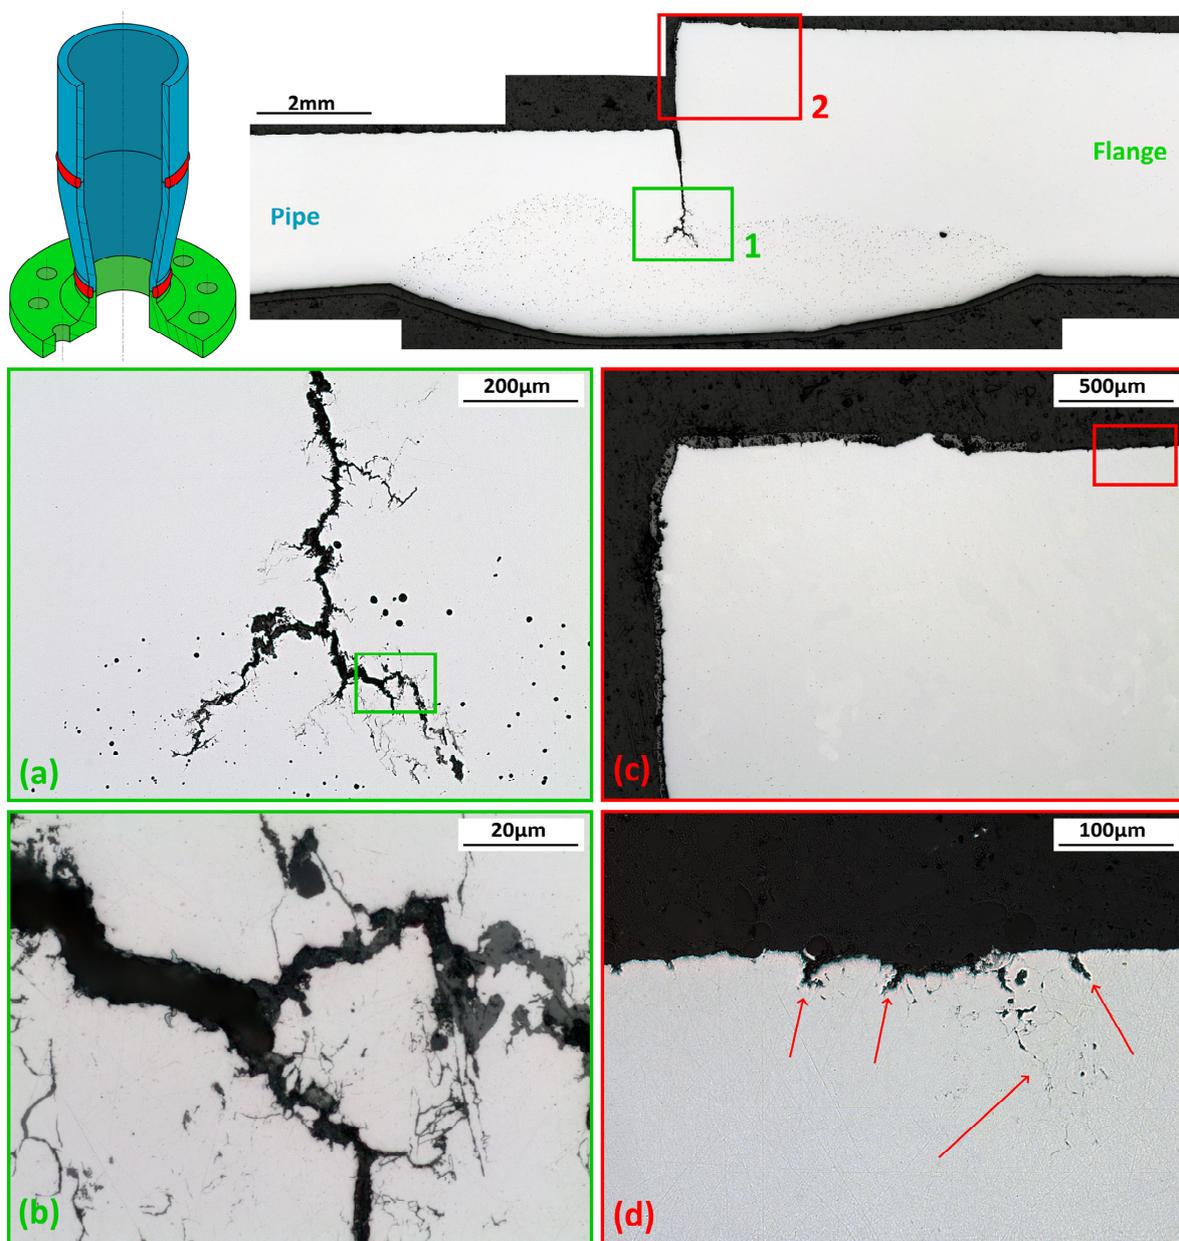
The pictures in Figures 7 and 8 showed that the crack path is both trans- and inter-granular with many secondary branches. From a microstructural point of view, both the base materials are prevalently ferritic, even if the flange ferrite content is slightly lower and its grain size is slightly finer than the pipe's (15–20 µm and 25–40 µm, respectively) [17].

In the heat-affected and welded zones, both the flange and the pipe microstructures are characterized by ferrite and pearlite with morphologies different from the base metal's because of the fast cooling rates. No bainite or martensite were detected. The metallographic analysis confirms the lack of fusion during the welding operation. The pipe surface next to the welding bead is covered by a 20–30 µm thick oxide, below which 10–30 µm deep corrosion pits are visible. Moreover, a 150 µm deep inter-granular crack was generated from one of them as shown in Figure 7d.

Figure 7. Metallographic analysis of one cracked region. All the cracks have a high number of secondary branches. Pictures (a,b) are magnifications of Zone 1, and pictures (c,d) are magnifications of Zone 2.

The described mechanisms can also explain the SCC cracks shown in Figure 7d. The iron oxide generated during welding prevented the correct formation of the molybdate-rich layer on the heat-affected zone surface. This generated a strong potential difference

between this area and the neighboring zones where the inhibitor worked correctly. Under such conditions, pitting corrosion can activate, as demonstrated by the observed pits. Moreover, the local composition of the fluid changes according to the well-known phenomena associated with this corrosion type [32,33].

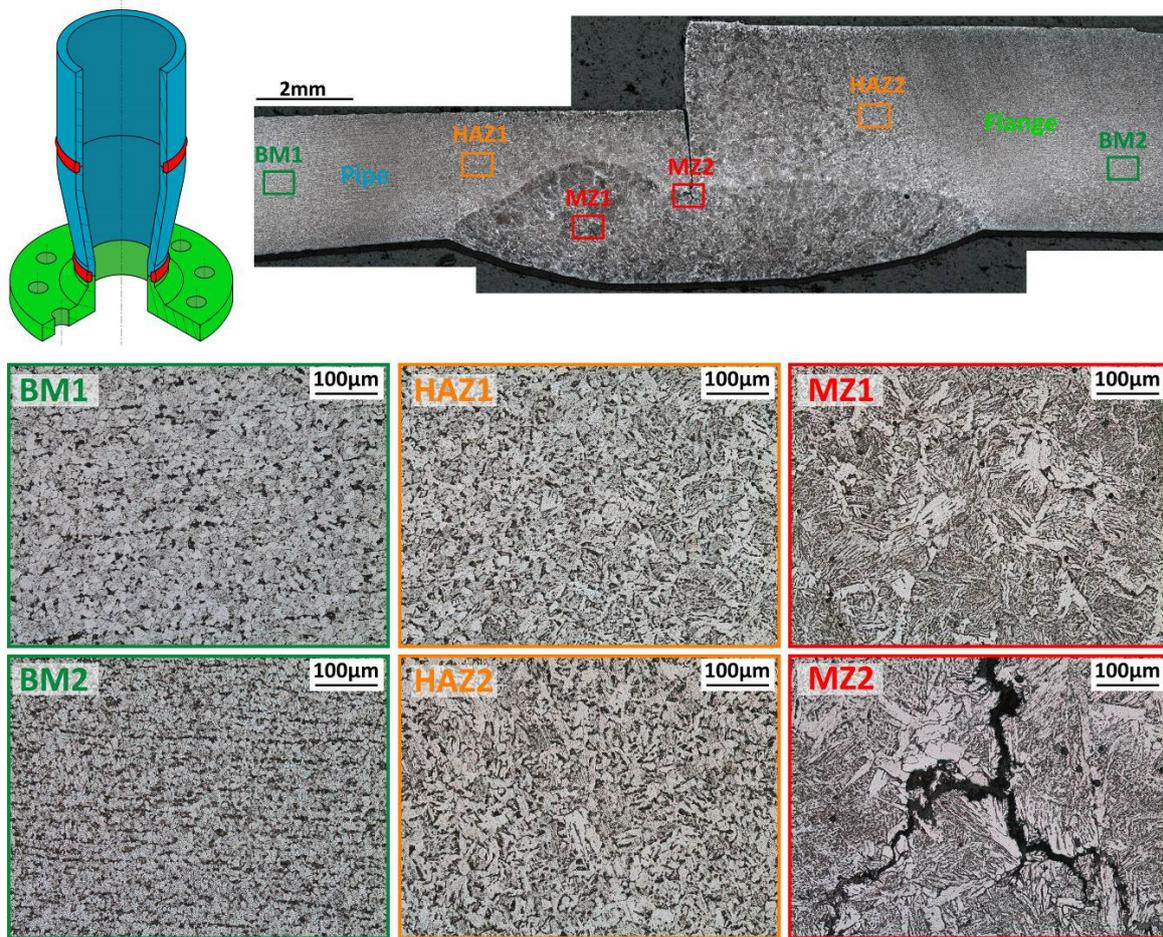
Figure 8. Metallographic analysis of one cracked region after etching using Nital 2% reagent. Bainitic microstructures characterize the heat-affected and melted zones. A branched crack is clearly visible at the crevice tip (MZ2).

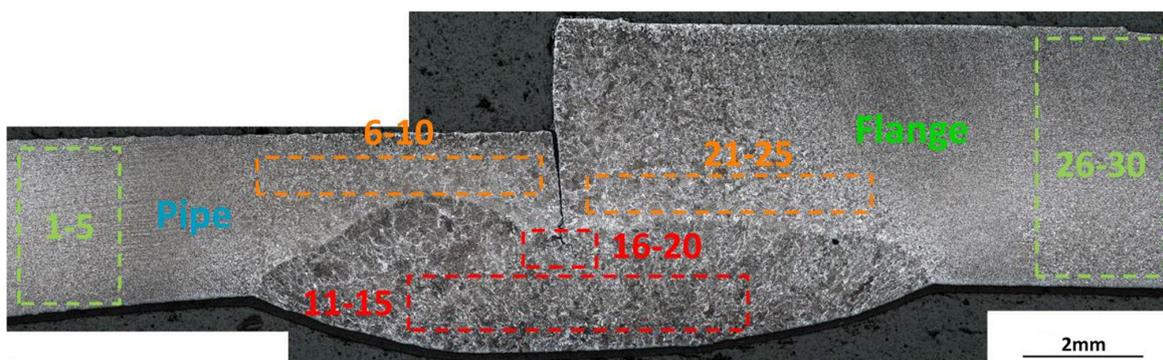
After the metallographic investigation, HV0.3 micro-hardness tests were performed on the etched section. The whole welded joint was considered, with particular attention to the base metal, heat-affected and melted zones. The results are reported in Figure 9. The base metal's hardness is compatible with that of general-purpose steels such as the P235TR2 and P245GH grades. The heat-affected and welded zone data are higher than those of the base metal's (but the difference is always lower than 100 HV), even if their values are justified by the thermal cycle induced by the welding operation.

Figure 9. HV0.3 micro-hardness values obtained in the base metal and the heat-affected and welded zones. The micro-hardness values in the heat-affected and melted zones are higher than those of the base metal's according to the observed microstructure shown in Figure 8.
