# Failure Analysis of High Strength Galvanized Bolts Used in Steel Towers

**Abstract:** This paper analyses the failure of three bolts used in the structural connections of a number of steel towers located in northern Europe. The analysis comprises optical and scanning electron microscopy, microstructural and hardness analysis, mechanical testing and structural integrity assessments. The three bolts present very similar failure processes, with a circumferential external crack that led to the final failure. The morphology of the crack propagation is typical of Hydrogen-Induced Stress Corrosion Cracking (HISCC), with mixed intergranular-transgranular micromechanisms, tearing processes and secondary cracking. The cracks then grew subcritically until they reached their critical size. Quench cracking or fatigue processes have been ruled out.

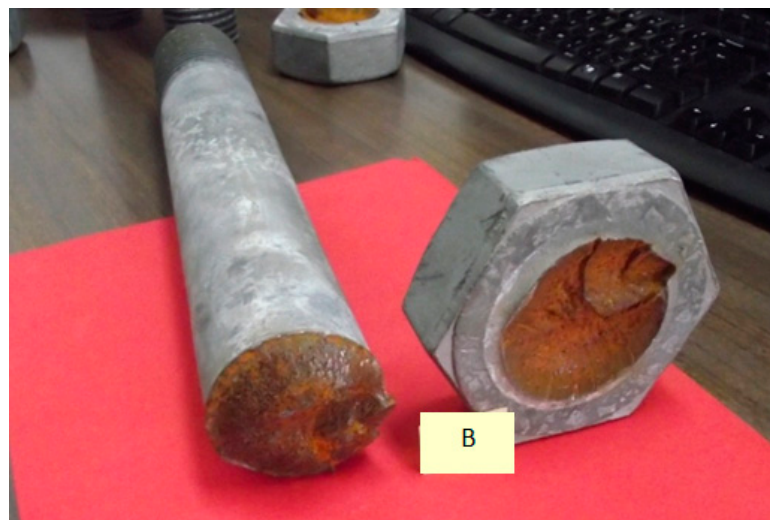
**Figure 1.** Bolt B at reception, showing the failure section.

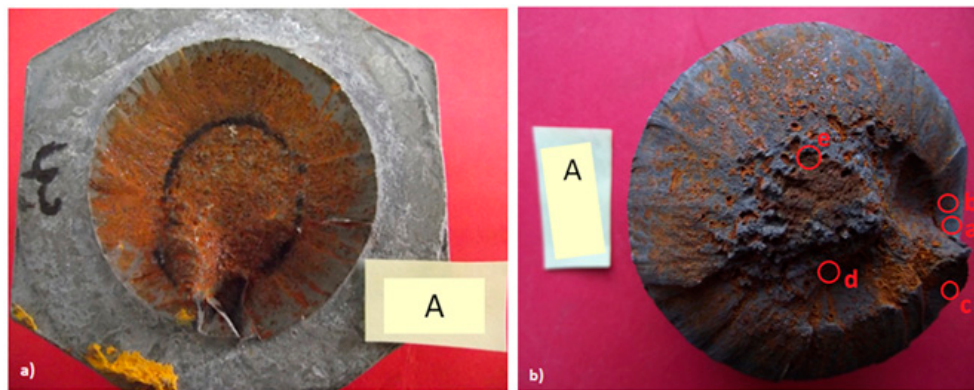
The failure sections of the three bolts presented two clearly different areas: a smooth one all along the external perimeter, and a quasi-circular rough area located in the centre. This appearance has been previously reported in a number of similar failures (e.g., [1]), where the smooth area was related to subcritical crack propagation processes and the rough central area was identified as the final resistant ligament with the presence of ductile micromechanisms. As an example, Figure 2 shows the fracture surface of bolt A at both the head and the shank.

**Figure 2.** Fracture surfaces at reception of bolt A. (a) Head; (b) shank.

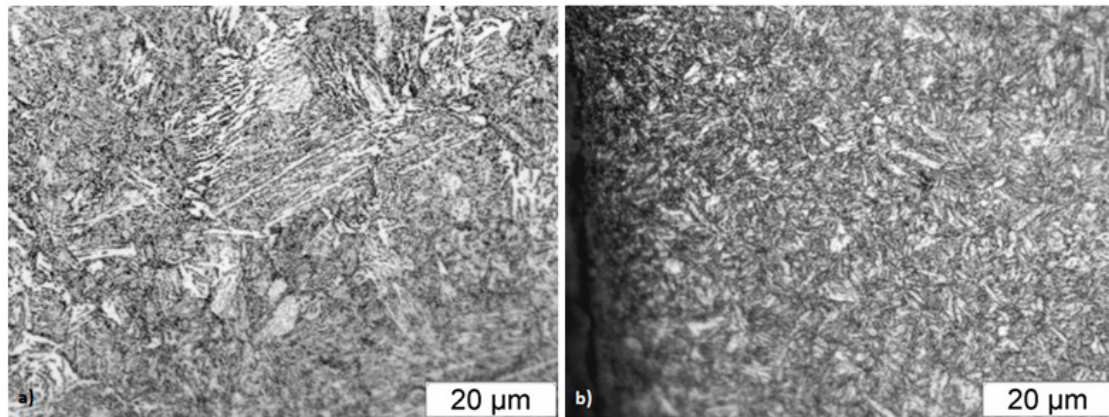
Samples 2.1 and 2.2 were polished and etched in 3% nital solution. The corresponding microstructures were obtained along a radius of Section 2. Figure 4 shows the results obtained in the centre (sample 2.1) and from the surface (sample 2.2) of Section 2. It can be observed that the centre of the section (Figure 4a) presents tempered martensite together with bainite, whereas the microstructure on the surface of the bolt is basically tempered martensite. This agrees with the material specification.

**Figure 4.** Microstructures observed in bolt A. (a) Centre of the section (sample 2.1); (b) sub-surface material (sample 2.2).

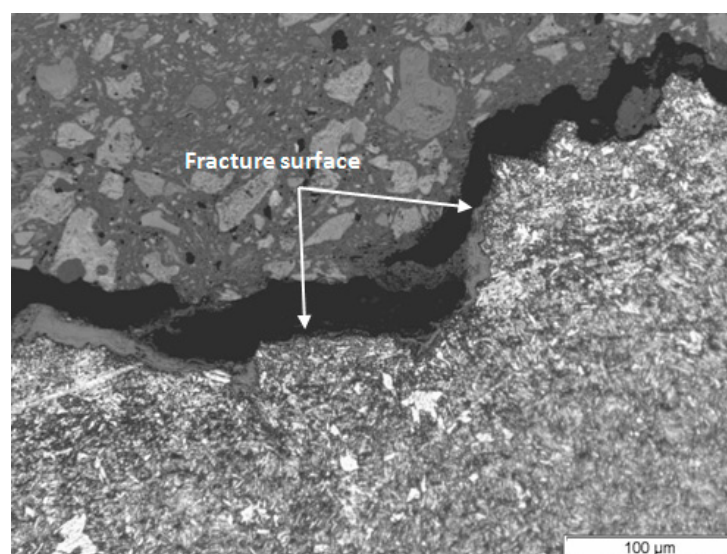
The heads of the three bolts were also cut (see Figure 5) into three sections (named 3, 4 and 5). Different samples were obtained from Section 4 in order to analyse the corresponding microstructure. This was analysed at different points (A to D, as shown in Figure 6). In all cases, tempered martensite was found to be the dominant microstructure, with bainite in the centre of the section (point D, see Figure 7).

**Figure 7.** Microstructure observed in the head of bolt A (sample 4.3, point D).

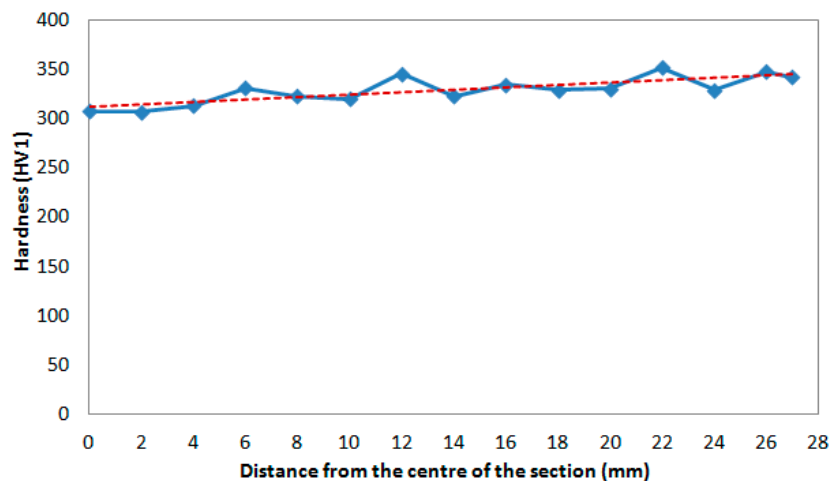
**Figure 8.** Hardness measurements along the radius of the bolt shank (bolt A). The dotted line shows the trend line.

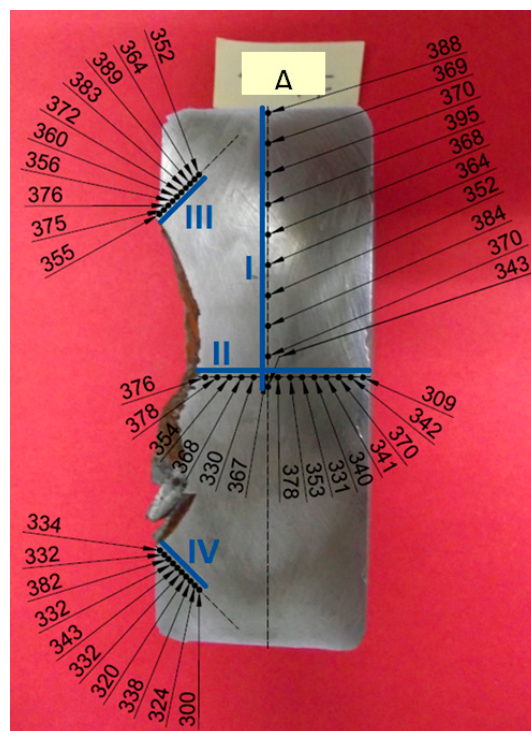
**Figure 9.** Hardness measurements (HV1) in the bolt head (bolt A).

The results reveal an average hardness value between 350 and 370 HV1 in paths I, II and III, and slightly lower than 350 in path IV. In any case, the hardness values observed in the bolt head are higher than those measured along the radius of the bolt shank (which vary from 300 HV1 up to 350 HV1).

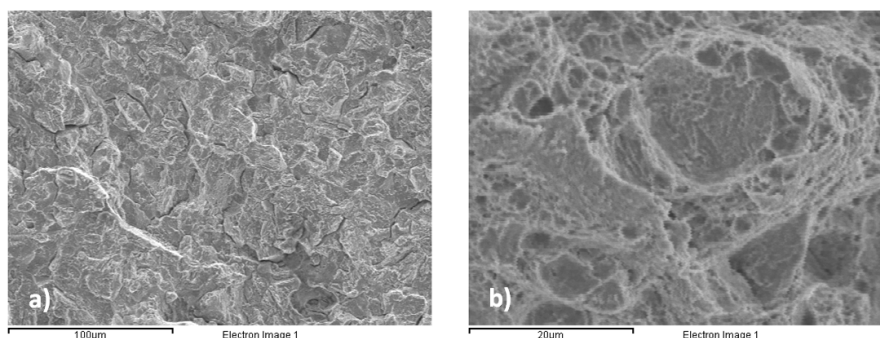
The fracture surfaces of the three bolts were analysed in a Scanning Electron Microscope (SEM). Images were taken from different areas of the fracture surfaces, as shown in Figure 2b (points “a” to “e”) for bolt A. The most significant observations are shown in Figure 10: the perimeter of the section (i.e., points “a”, “b”, and “c”) presented a mixed fracture surface combined with a predominant intergranular fracture with transgranular tearing and secondary cracking (Figure 10a). This confirms a subcritical crack propagation process prior to final fracture; the inner part of the fracture surface (i.e., points “d” and “e”) reveals a ductile fracture with multiple microvoids, corresponding to the remnant ligament of the section at failure.

**Figure 10.** Fracture surface of bolt A. (a) Point “b”; (b) point “d”.

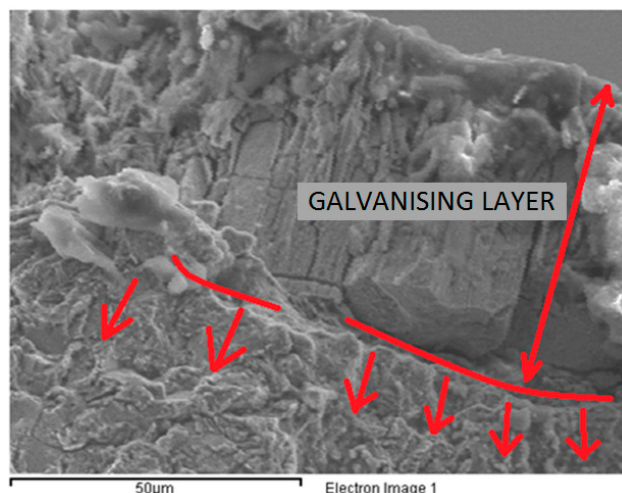
Figure 11, taken at point “c”, shows the galvanising layer with an important presence of cracks. Cracks are also observed in the interface between the galvanising layer and the base material of the bolt, with multiple initiation points.

**Figure 11.** Zone “c” of the fracture surface, showing subcritical crack growth starting at the interface between the base material and the galvanising layer.

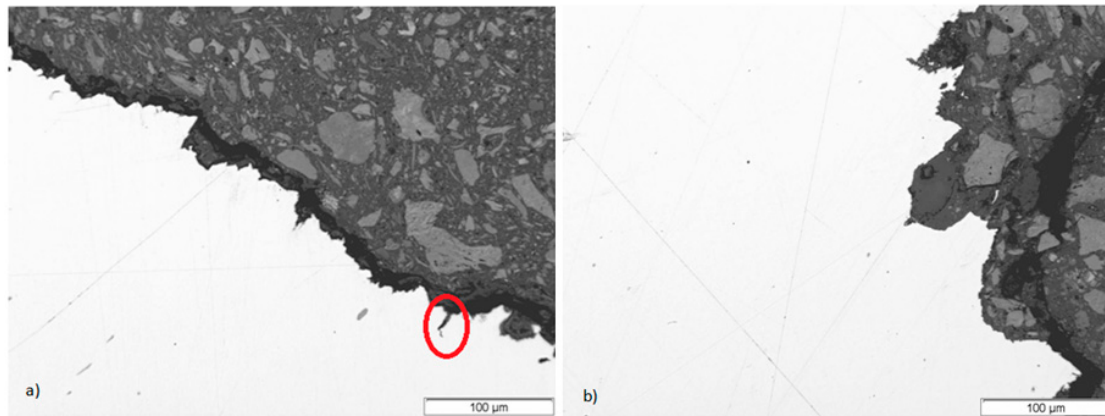
The profile of the fracture surface was also analysed using optical microscopy. As an example, Figure 12 shows some significant results. Figure 12a corresponds to an area located in the external perimeter, near point “b”. A brittle aspect with secondary cracks emerging from the primary quasi-plane crack path can be observed, proof of the HISSC mechanism; Figure 12b corresponds to an area around point “d”, revealing a much more ductile behaviour.

**Figure 12.** Profile of the fracture surface in bolt A: (a) Brittle aspect of the external perimeter (the red circumference shows secondary cracking); (b) ductile aspect of the inner area.

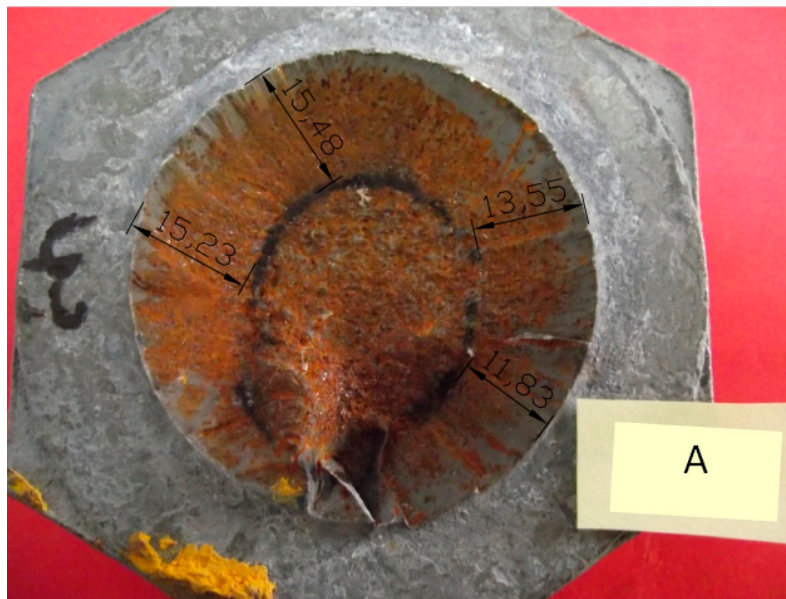
**Figure 13.** Approximate measurement of the external perimeter. Bolt A.

Concerning the crack size, the results shown above (at both the macro- and microscopical levels) reveal that the fracture surfaces present two distinct zones: an external smooth perimeter corresponding to a mixed fracture surface combining a predominant intergranular fracture with transgranular tearing, and an internal area with a clear presence of ductile micromechanisms. The external perimeter seems to correspond to subcritical crack propagation prior to final failure, and it has been macroscopically marked out in the three bolts, as shown in Figure 14 for the particular case of bolt A. The extension (thickness) of this perimeter, corresponding to the crack size at failure, generally varies between 11.5 mm and 16.5 mm, although it may be punctually lower.

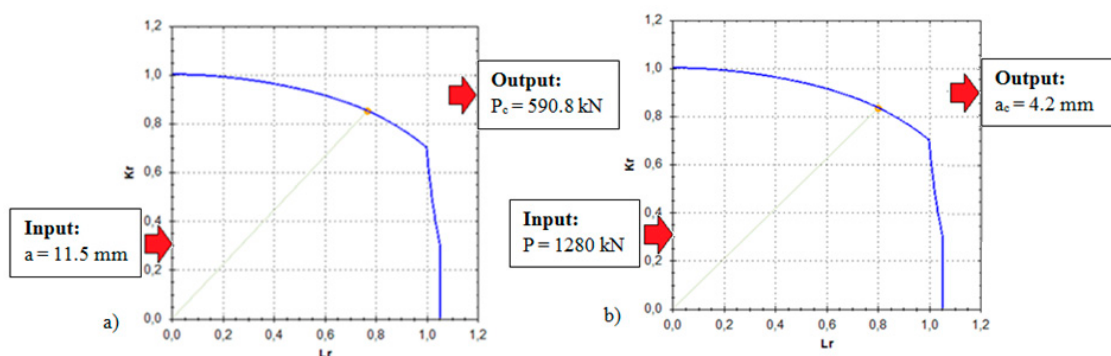
Figure 16 shows the corresponding results obtained for analysis Option 1 [19,20], which defines the FAL from both the yield stress and the ultimate tensile strength of the material (Equations (4)–(9)). In the first analysis (Figure 16a), the critical load is 5908 kN, which is noticeably lower than the applied preload. This discards that the notion that the external smooth area found in the fracture section corresponds to a pre-existing crack (e.g., quench cracking), given that, in such a case, the application of the preload (1280 kN) would have caused the failure of the bolts. The discarding of quench cracking is also supported by the lack of zinc deposits in the surface of the pre-existing cracks.

Figure 16. FAD analysis of the bolts: (a) critical load ( $P_c$ ) for a 11.5 mm crack size ( $a$ ); (b) critical crack size ( $a_c$ ) for a 1280 kN load ( $P$ ).

The second analysis (Figure 16b) provides a critical defect of 4.2 mm. This corresponds to the maximum crack size in the bolts during the application of the preload (larger cracks would also have caused failure).
