# Assessment of the Residual Life of Steam Pipeline Material beyond the Computational Working Time

**Abstract:** This paper presents the evaluation of durability for the material of repair welded joints made from (13HMF) 14MoV6-3 steel after long-term service, and from material in the as-received condition and after long-term service. Microstructure examinations using a scanning electron microscope, hardness measurements and creep tests of the basic material and welded joints of these steels were carried out. These tests enabled the time of further safe service of the examined repair welded joints to be determined in relation to the residual life of the materials. The evaluation of residual life and disposable life, and thus the estimation and determination of the time of safe service, is of great importance for the operation of components beyond the design service life. The obtained test results are part of the materials' characteristics developed by the Institute for Ferrous Metallurgy for steels and welded joints made from these steels to work under creep conditions.

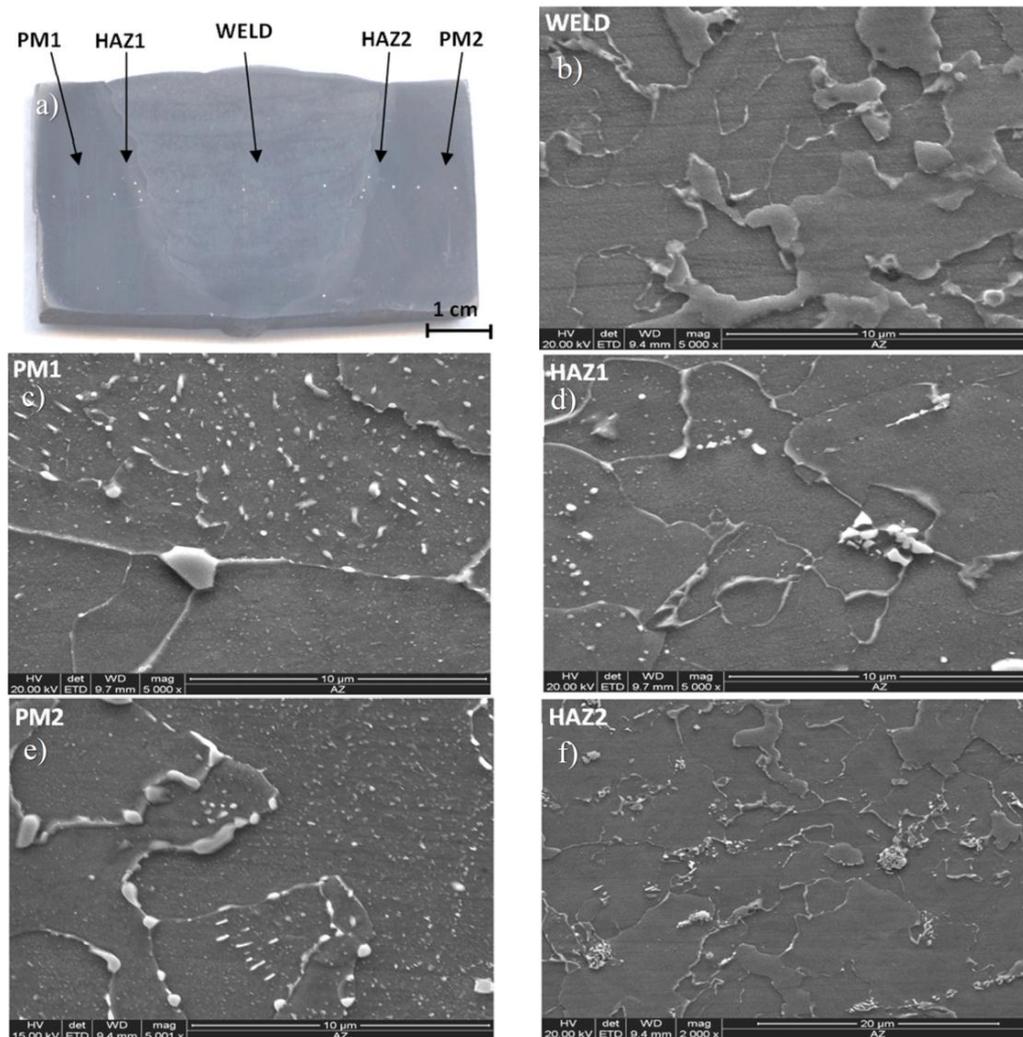
**Figure 3.** Structure of the material of components of the repair welded joint marked ZS1 made from 14MoV6-3 steel after 169,000 h service; microstructure investigation locations (a): parent material marked (c) PM1, (e) PM2; heat affected zone marked (d) HAZ1, (f) HAZ2; weld marked (b) WELD.

The parent material of the welded joints marked ZS1 (PM1, PM2) and ZS2 (PM2) after service was characterised by a ferritic microstructure with partially coagulated bainite areas. At the ferrite

In the microstructure of the materials of the examined repair welded joints, no discontinuities or microcracks, nor initiation of internal damage processes due to creep, were observed.

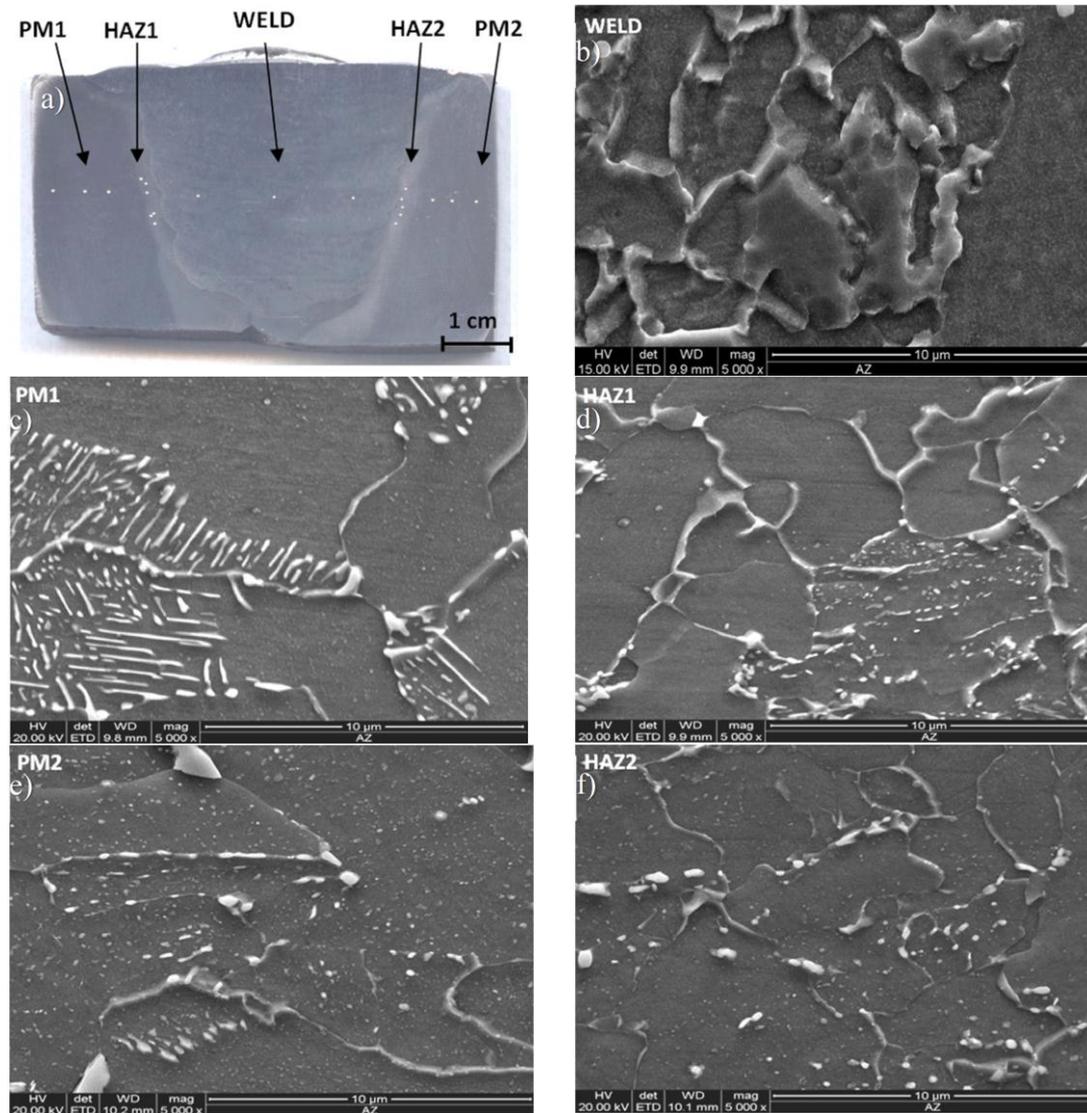
The microstructure of the parent material of the welded joint marked ZS2 (PM1) in the as-received condition was characterised by ferritic-bainitic microstructure, which is typical for this type of steel.

**Figure 4.** Structure of the material of components of the repair welded joint marked ZS2 made from 14MoV6-3 steel in the as-received condition and after 169,000 h service; investigation performance locations (a): parent material marked (c) PM1, (e) PM2; heat affected zone marked (d) HAZ1, (f) HAZ2; weld marked (b) WELD.

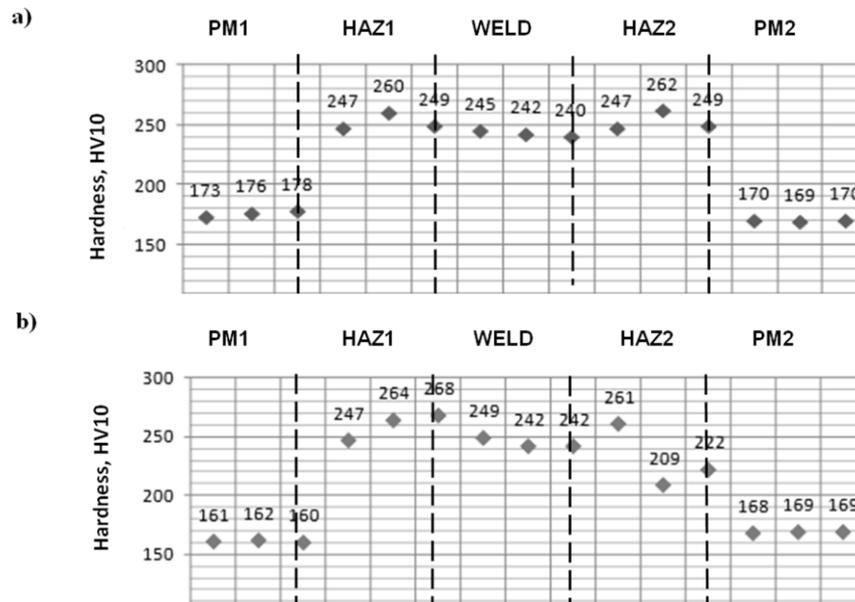
**Figure 5.** Distribution of the results of HV10 hardness measured on transverse microsections of the repair welded joint made from 14MoV6-3 steel. Test location—transverse microsection: (a) ZS1; (b) ZS2.

Hardness for all the examined components of repair welded joints is lower than the maximum permitted one, which is 350 HV10 for joints in the as-received condition and ranges from 160 to 179 HV10 for the parent material, from 209 to 268 for the heat-affected zone and from 240 to 249 HV10 for the weld material. This suggests that the examined welded joints were properly heat-treated after welding and will be able to transfer the required considerable loads, including those that occur during water pressure tests, shut-downs and start-ups. Hardness measurements have also shown no sudden changes when passing through the individual zones of the joint. Hardness for the 14MoV6 steel repair circumferential welded joint made from materials after 169,000 h service is, on average, 173 HV10 for the parent material, while in the weld it increases up to 262 HV10. Hardness for the 14MoV6 steel repair circumferential welded joint made from a material in the as-received condition and after 169,000 h service is, on average, 165 HV10 for the parent material, while in the weld it increases up to 268 HV10.

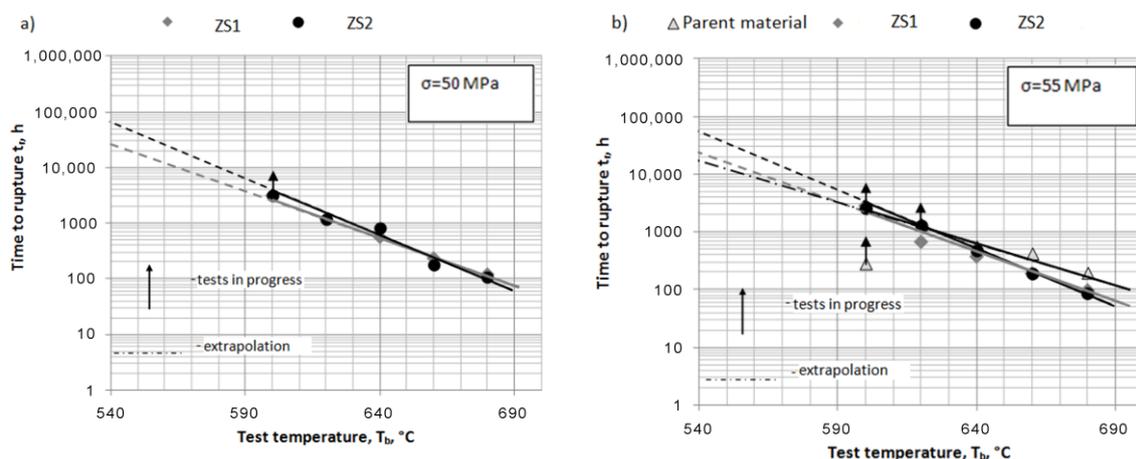
Figure 6. Result of abridged creep tests on the examined ZS1 and ZS2 repair joints and parent material in the form of  $\log t_{re} = f(T_b)$  for the adopted stress level of further service (a)  $b = 50$  MPa; (b)  $b = 55$  MPa.

The comparison of the results of abridged creep tests in the form of  $\log t_r = f(T_b)$  at  $\sigma_b \approx \sigma_r = 50$  MPa for the repair welded joint made from 14MoV6-3 steel after 169,000 h service and the repair welded joint made from 14MoV6-3 material in the as-received condition and 14MoV6-3 material after 169,000 h service is presented in Figure 6a.

The comparison of the results of abridged creep tests in the form of  $\log t_r = f(T_b)$  at  $\sigma_b \approx \sigma_r = 55$  MPa for the parent material of 14MoV6-3 after 169,000 h service and the repair welded joint made from materials of 13HMF (14MoV6-3) after 169,000 h service and the repair welded joint made from 14MoV6-3 steel in the as-received condition and 14MoV6-3 steel after 169,000 h service is presented in Figure 6b.

The residual life  $t_{re}$  determined for the adopted stress level of 50 MPa for the repair welded joint of the materials after service, marked ZS1, is 25,000 h and its estimated disposable life  $t_b$  is 15,000 h (Figure 6, Table 4), while the residual life  $t_{re}$  determined for the repair welded joint of the material after service and the material in the as-received condition, marked ZS2, is 60,000 h and the estimated disposable life is 36,000 h.

The residual life  $t_{re}$  determined for the adopted stress level of 55 MPa for the repair welded joint of the materials after service marked ZS1, is 23,000 h and the estimated disposable life  $t_b$  is approx. 14,000 h, while the residual life  $t_{re}$  determined for the repair welded joint of the material after service and the material in the as-received condition, marked ZS2, is 58,000 h and the estimated disposable

life is approx. 35,000 h. For the parent material after service marked PM1, the residual life is 20,000 h, and the estimated disposable life is  $t_b$  12,000 h.

The time of further safe service of the examined new repair welded joints may be assumed to be 15,000 h for the ZS1 joint and 36,000 h for the ZS2 joint at the further service stress  $\sigma_e = 50$  MPa, while for the adopted further service stress  $\sigma_e = 55$  MPa the time of further safe service of the examined new repair welded joints may be assumed to be approximately 14,000 h for the ZS1 joint and approximately 35,000 h for the ZS2 joint.
