Aging Phenomena during In-Service Creep Exposure of Heat-Resistant Steels

Abstract: An investigation of aging phenomena during creep exposure has been conducted for HP-Nb cast reformer tubes for several exposure conditions. Aging was manifested by carbide precipitation, carbide coarsening, and carbide transformation. The transformation of primary M_7C_3 to the more stable $M_{23}C_6$ carbide takes place at high exposure temperature (910 °C and above). The primary MC carbides transform to the Ni-Nb silicide or G-phase during creep exposure. The presence of Ti in the steel prevented the transformation of MC carbides to the G-phase. Morphological changes like needle to globular transitions, rounding of carbide edges, and carbide coarsening take place during creep exposure. The room-temperature tensile elongation and ultimate tensile strength are significantly reduced during creep exposure. The above aging phenomena are precursors to creep damage.

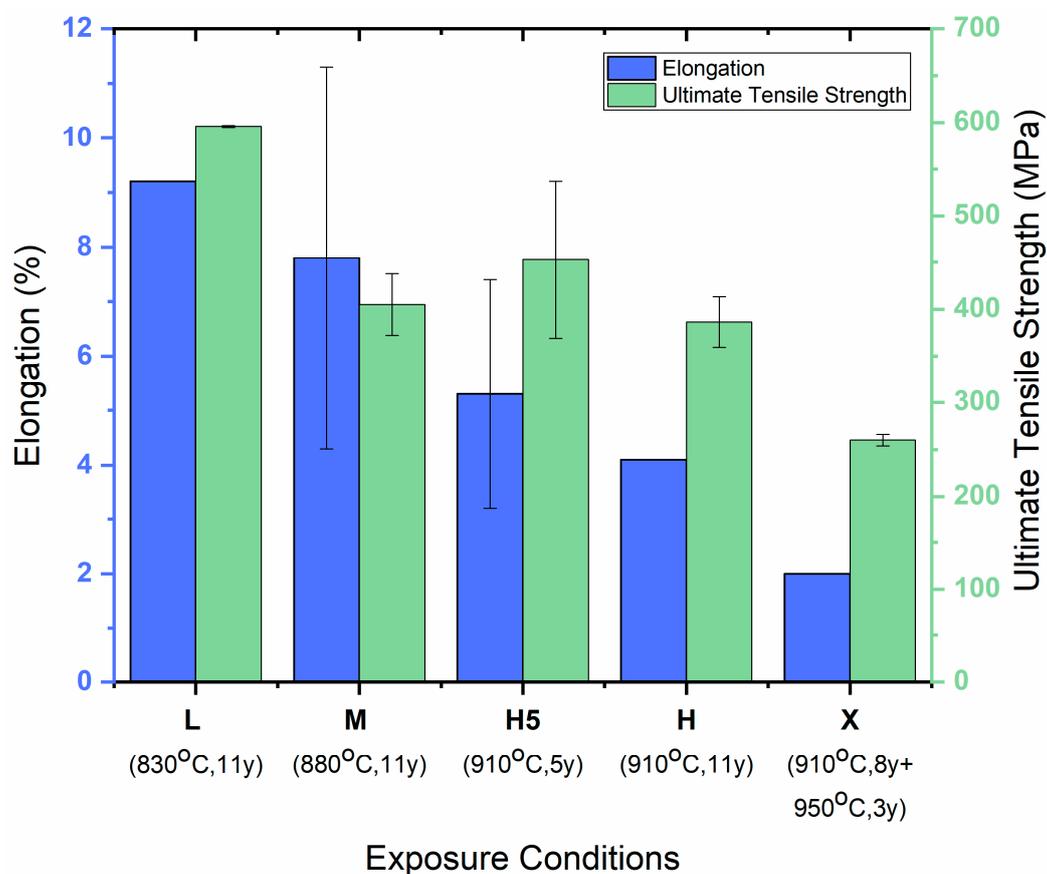
Room temperature tensile testing results are shown in Figure 1. The results indicate a decrease of the ultimate tensile strength (UTS) and a considerable reduction in tensile elongation (strain to failure) with exposure temperature, as a result of aging. Condition H5 also exhibits considerable reduction in elongation, however the elongation is higher than the elongation of condition H. Similar reductions in tensile ductility have been reported by Pan et al. [11] after 36,000 h at 910 °C (4.12 years), and Monobe et al. [13] after exposure for 200 h at 720–780 °C. The aging phenomena and carbide transformations are discussed in the following section.

Figure 1. Room-temperature tensile properties vs. creep exposure conditions.

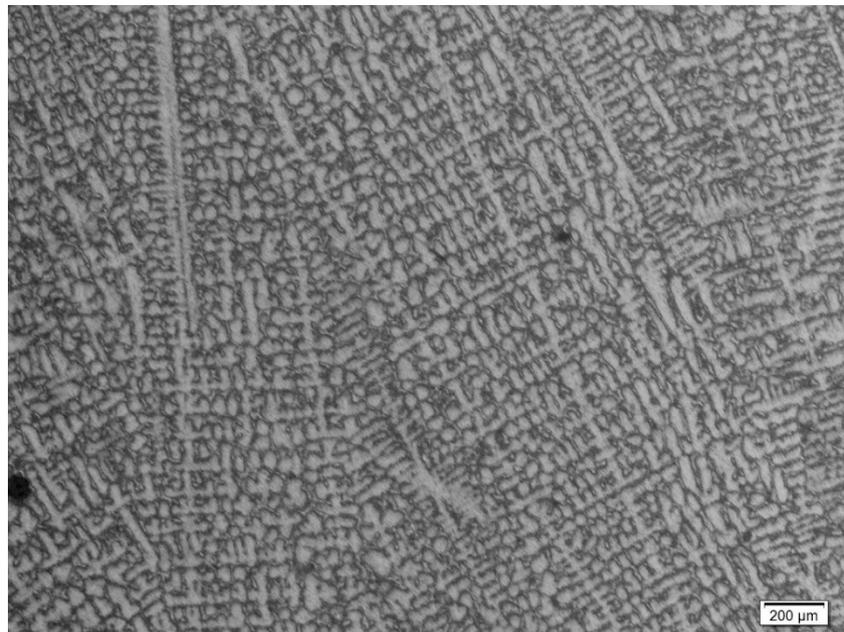
The microstructure of the alloy consists of an austenitic matrix, forming dendrites, and a network of primary carbides. The dendrite length varies from 0.3 to 6.5 mm with an average length of 1.4 mm as depicted in Figure 2. The dendrites are oriented in the radial direction from the inner diameter (ID) to the outer diameter (OD) of the tube. Some dendrites are very long with a length being a significant

Figure 2. Microstructure of HP-Nb steel with austenite dendritic structure and carbide network in the interdendritic regions.

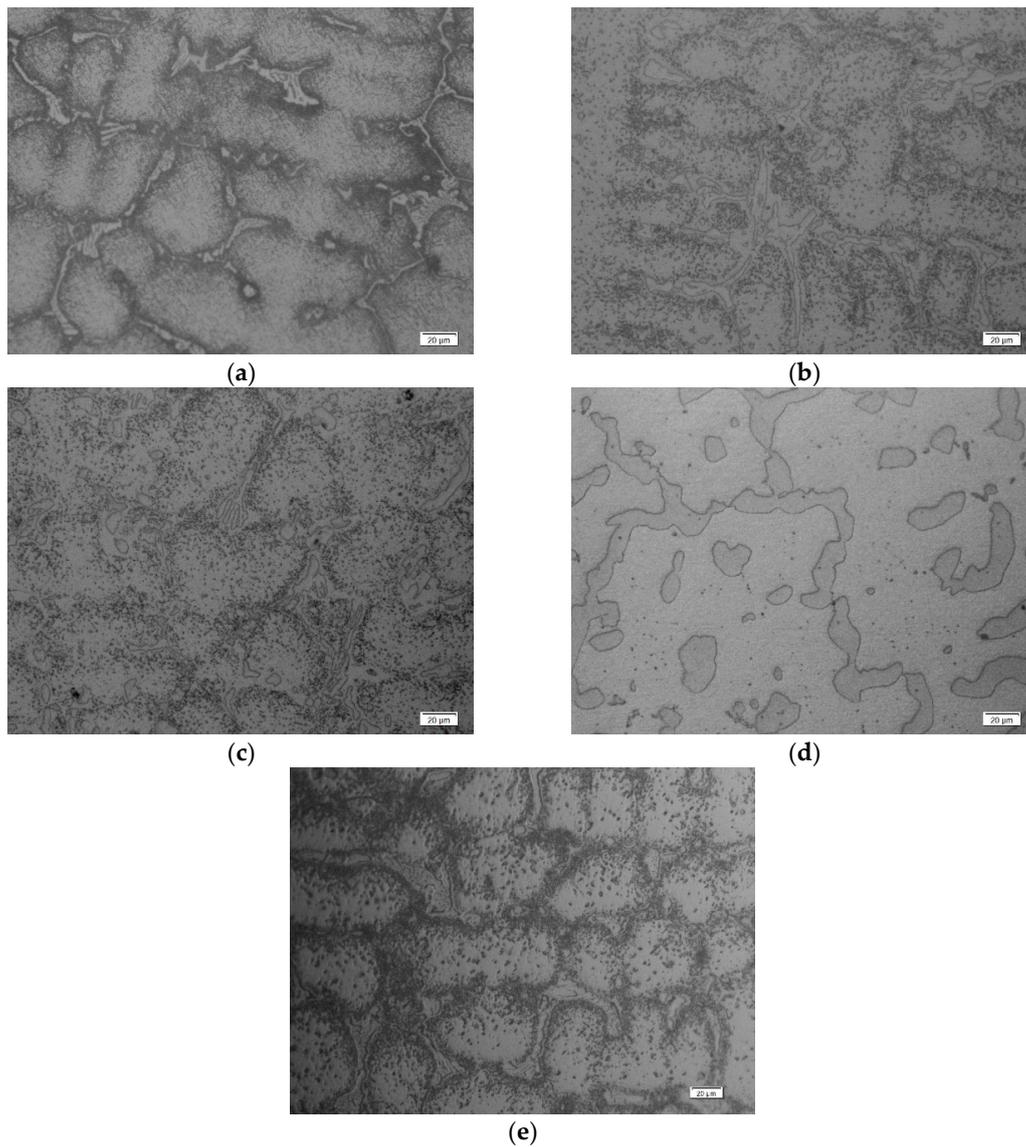
Condition L (830 °C/11y): The microstructure is depicted in Figure 3a, consisting of M_7C_3 carbides. Identification of M_7C_3 carbides was based on SEM/EDX analysis of Figure 4. The numbers in Figure 4 correspond to EDX composition analysis, which is presented in Table 2. These carbides exhibit a “Chinese script” morphology. In addition to this morphology, M_7C_3 carbides appear with a needle morphology (Figures 3a and 4b).

Condition M (880 °C/11y): The microstructure is depicted in Figure 3b. The “Chinese script” morphology of M_7C_3 carbides is preserved with considerable rounding of edges. However, the needle-shaped M_7C_3 carbides have undergone a morphological transformation and exhibit a globular shape. This morphological transformation has been observed in directionally solidified HP-Ni steel [4]. The NbC carbides, originally present in the as-cast microstructure, transformed to a Ni-Nb silicide, the G-phase, with nominal composition $Ni_{16}Nb_7Si_6$, as depicted in Figure 5a,b. The numbers in Figure 5 correspond to EDX composition analysis, which is presented in Table 2. This transformation has been observed, in Ti-free alloys, by Pan [11] and by Soares et al. [17]. The G-phase is hard and brittle and, therefore, prone to cavity formation when the material is subjected to temperature excursions [11,17]. However, it should be noted that no cavities formed on the G-phase were detected at this operating condition. In addition, no $M_{23}C_6$ carbides were detected in condition M, indicating that the transformation of M_7C_3 to $M_{23}C_6$ carbides had not taken place.

Figure 3. Microstructure revealed by metallography: (a) Condition L, (b) condition M, (c) condition H, (d) condition X, and (e) condition H5.

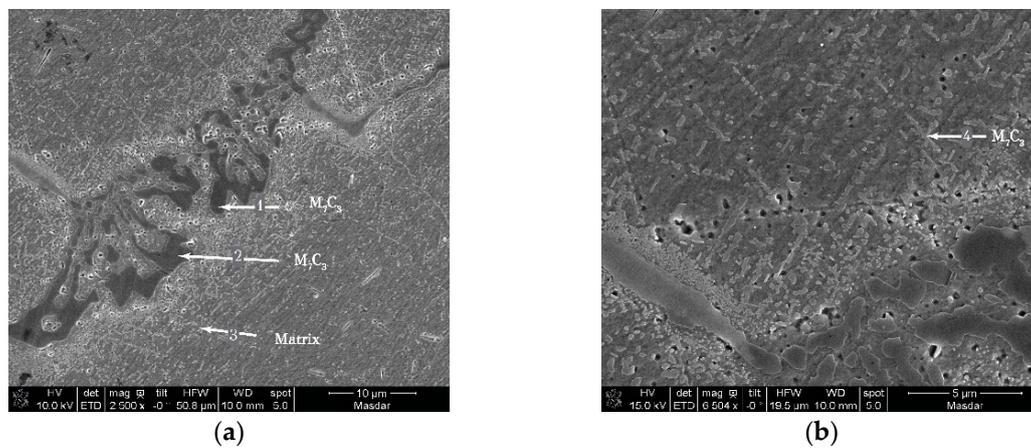
Figure 4. SEM image depicting M_7C_3 carbides in condition L. (a) “Chinese script” morphology; (b) needle morphology. Numbers indicate EDX composition analysis in Table 2.

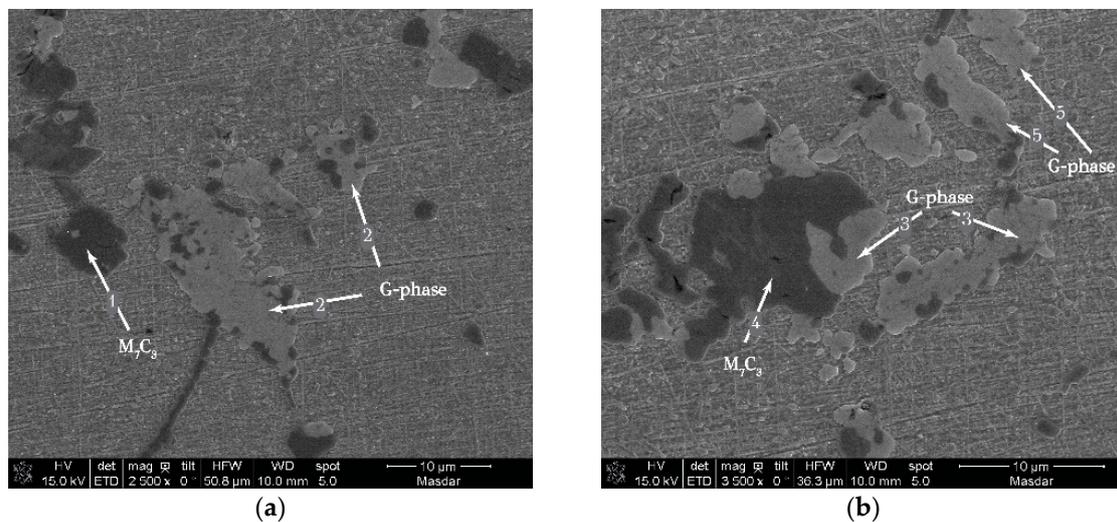
Figure 5. SEM images, (a,b), depicting M₇C₃ carbides and G-phase in condition M. Numbers indicate EDX composition analysis in Table 2.

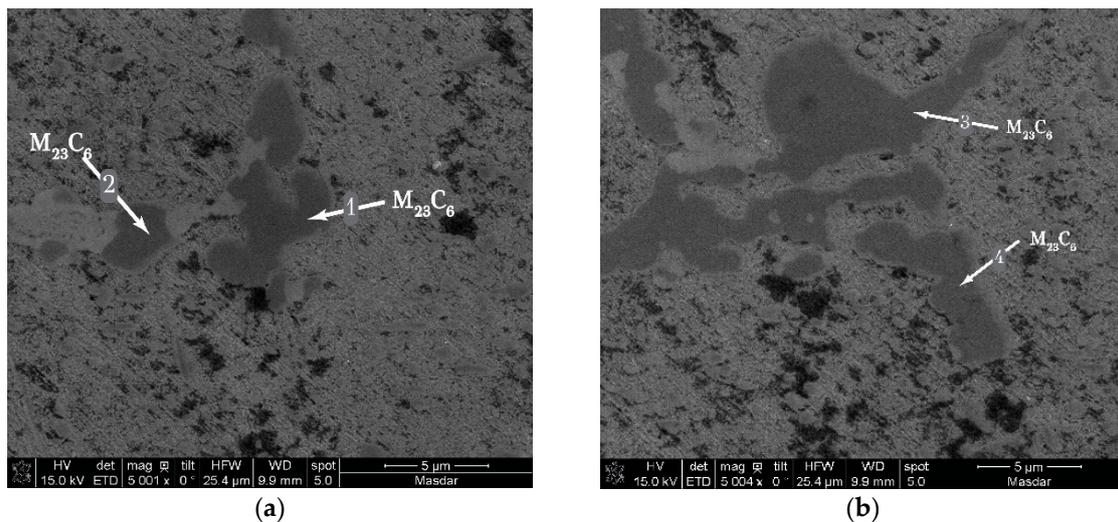
Condition H (910 °C/11y): The microstructure is depicted in Figure 3c. Most of the M₇C₃ carbides have transformed into the more stable M₂₃C₆ carbides as shown in Figure 6a,b. The numbers in Figure 6 correspond to EDX composition analysis, which is presented in Table 2. Significant coarsening of the M₂₃C₆ carbides has also taken place driven by the reduction in interfacial energy.

Figure 6. SEM images, (a,b), depicting $M_{23}C_6$ carbides in condition H. Numbers indicate EDX composition analysis in Table 2.

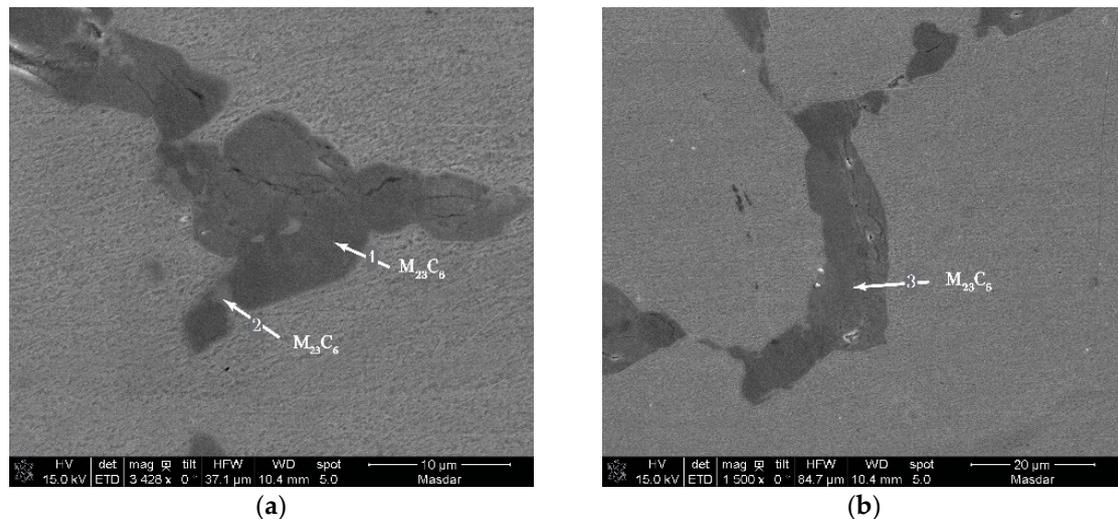
Condition X (910 °C/8y + 950 °C/3y): The microstructure is depicted in Figure 3d. All carbides are of the $M_{23}C_6$ type and significant coarsening has taken place due to exposure at high temperature (950 °C). Nb has also been incorporated in the $M_{23}C_6$ carbides as indicated in Figure 7a,b. The numbers in Figure 7 correspond to EDX composition analysis, which is presented in Table 2.

Figure 7. SEM images, (a,b), depicting coarse $M_{23}C_6$ carbides in condition X. Numbers indicate EDX composition analysis in Table 2.

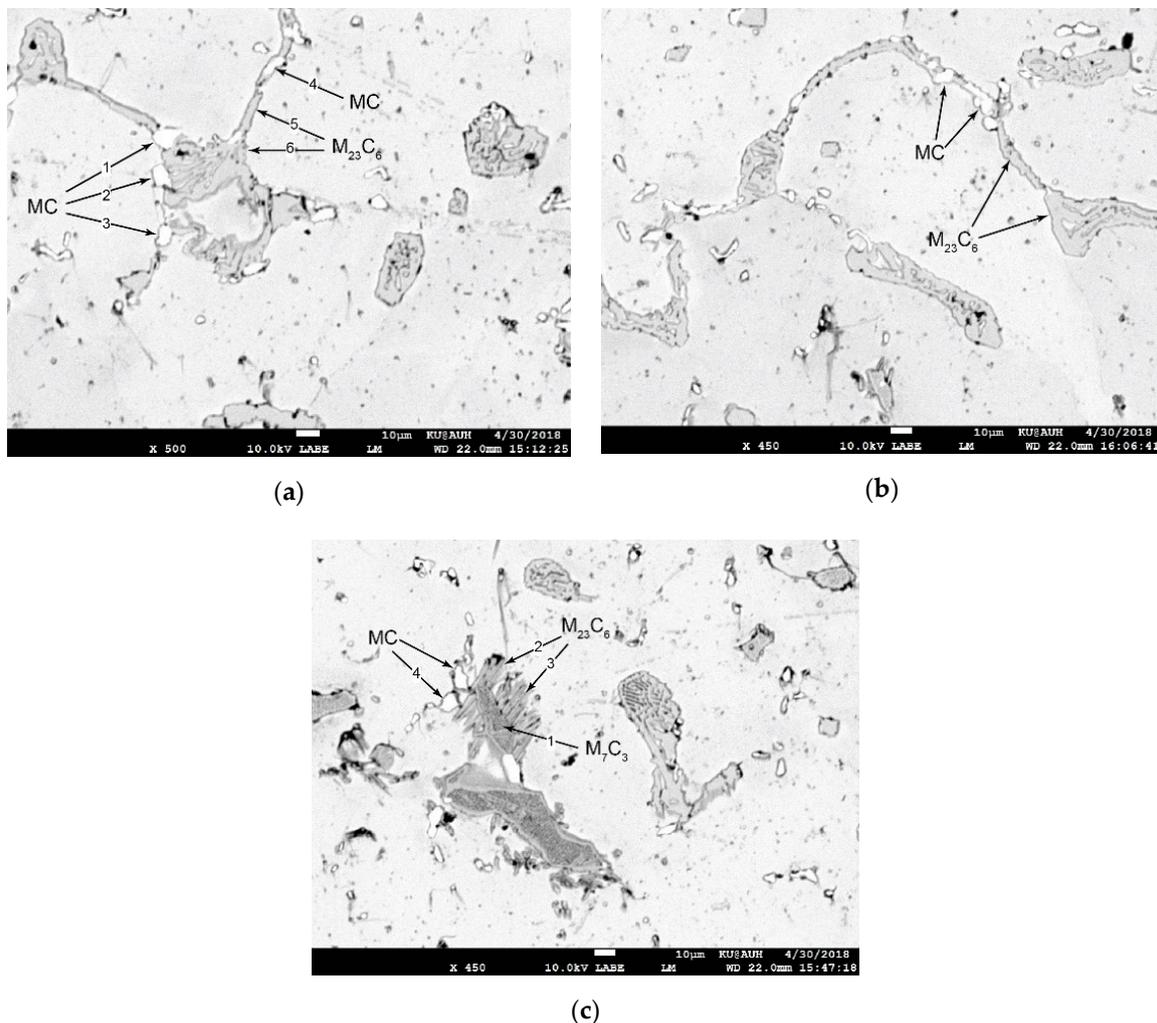
Condition H5 (910 °C/5y): It is noted that the H5 condition concerns the material containing Ti. The optical micrograph of the microstructure is depicted in Figure 3e. The microstructure of H5 material was investigated with SEM operating in the SE and BSE modes. Typical microstructures are depicted in Figure 8. The numbers in Figure 8 correspond to EDX composition analysis, which is presented in Table 2. MC carbides (Nb-rich), appear white, while $M_{23}C_6$, Cr-rich carbides appear dark grey in the BSE images due to the difference in atomic number between Nb and Cr. SEM-BSE imaging has been used by other researchers for carbide identification in cast heat-resistant steels [6,15]. The results indicate that MC carbides contain Ti, which according to Swaminathan et al. [18], stabilizes the MC carbide against transformation to the G-phase. This explains the fact that no G-phase was detected in the H5 material. Most probably, the transformation of the primary M_7C_3 carbides to

$M_{23}C_6$ is partial, contrary to the H condition where the transformation was complete. This partial transformation is depicted in Figure 8c with the associated EDX analysis of carbides in Table 2.

Figure 8. SEM-BSE images depicting: (a,b) MC and $M_{23}C_6$ carbides in condition H5; (c) transformation of M_7C_3 to $M_{23}C_6$ carbide after creep exposure of 5 years. Numbers correspond to EDX composition analysis in Table 2.
