# Root Cause Analysis of Surface Cracks in Heavy Steel Plates during the Hot Rolling Process

Abbas Bahrami <sup>1</sup>, Mahdi Kiani Khouzani <sup>1</sup>

, Seyed Amirmohammad Mokhtari <sup>1</sup>, Shahin Zareh <sup>2</sup> and Maryam Yazdan Mehr <sup>3,\*</sup>

<sup>1</sup> Department of Materials Engineering, Isfahan University of Technology, Isfahan 84156-83111, Iran

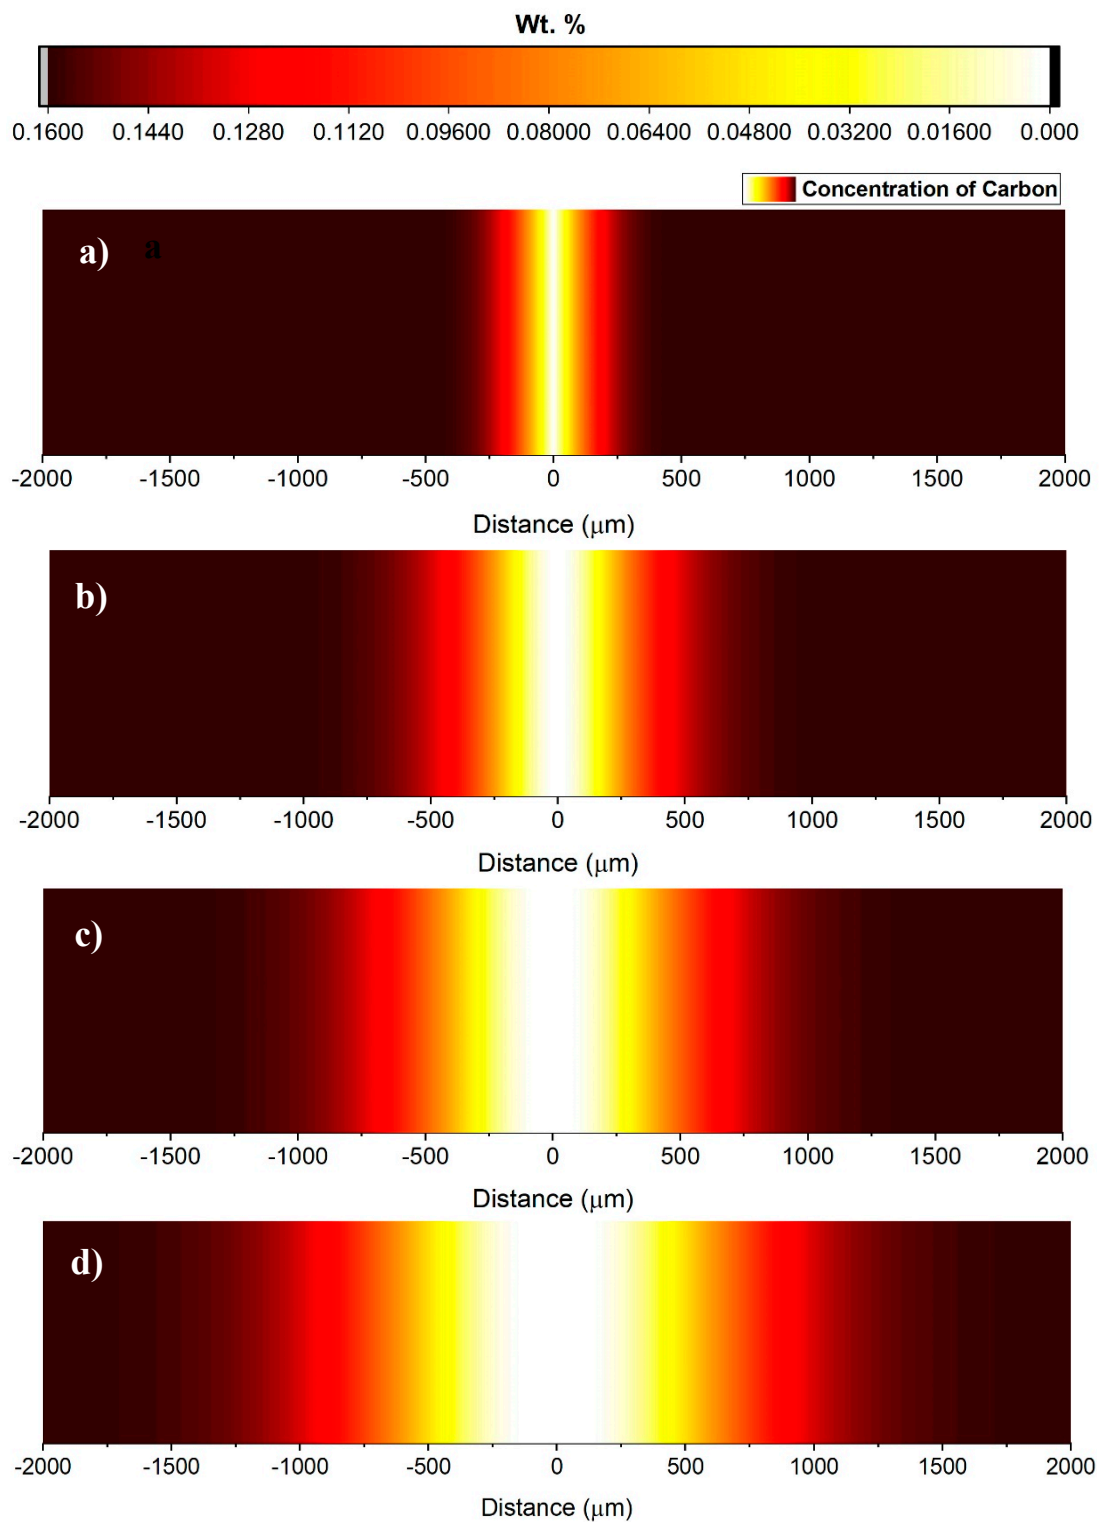
where  $D_0 = 2.3 \times 10^{-5} \text{ m}^2/\text{s}$ ,  $Q = 148 \text{ kJ/mol}$ , and  $R = 8.314 \text{ J/mol}\cdot\text{K}$  [20]. An average value of  $1100^\circ\text{C}$  was assumed for the rolling temperature. Figure 7 shows the contour of carbon diffusion across the crack. Results show that after 16 passes carbon is heavily depleted in approximately  $300\text{--}400 \text{ }\mu\text{m}$  distance from the crack. It is also seen that with increasing pass numbers, the depletion layer gets wider. According to Fe-C diagram, pearlite is not expected to form in carbon content less than  $0.008 \text{ wt. \%}$ . Results of this calculation is very well in accordance with the experimental results.

**Figure 7.** Contour of carbon diffusion in and around areas of a crack (a) after 1 pass of hot rolling, (b) after 5 passes, (c) after 10 passes, and (d) after 16 passes.
