# Failure-Analysis Based Redesign of Furnace Conveyor System Components: A Case Study

Beatriz González-Ciordia <sup>1,2</sup>, Borja Fernández <sup>1,2</sup>, Garikoitz Artola <sup>3</sup>

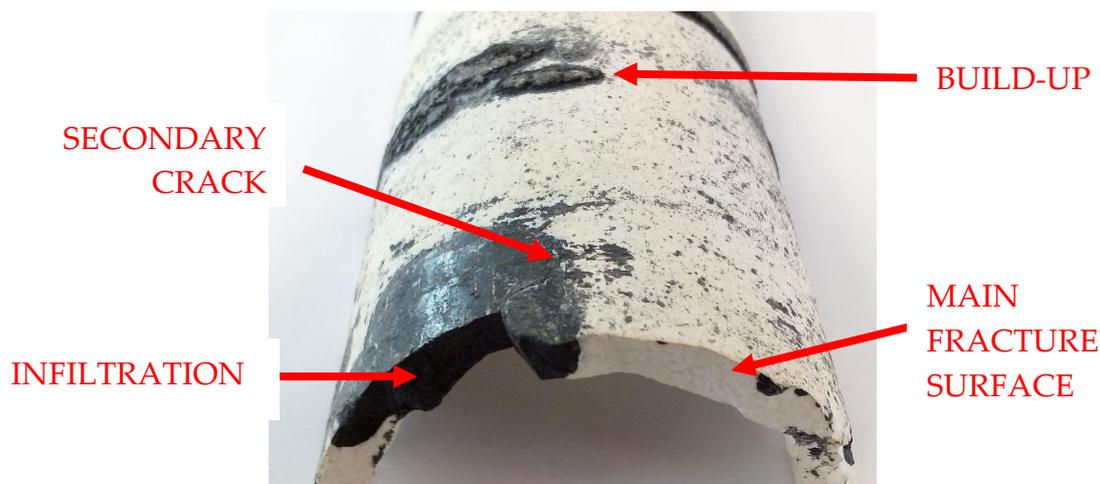
requirements are increased by the predominance AlSi coated steel sheet in the press hardened products. The AlSi coating damages the ceramics rollers in two ways (Figure 1):

- It can partially melt and adhere to the roll, generating a build-up that leads to format trajectory deviation inside the furnace. Therefore, the formats do not exit the furnace in a proper position for robotic transferring to the stamping press.
- The molten AlSi can infiltrate in the pores and micro-cracks in the roll surfaces. When the furnace is cooled down for a stop or an energy saving condition, such as a weekend stand-by, the infiltrated metal solidifies and acts as a wedge, which leads to roller fracture.

**Figure 1.** Picture of a cracked roller showing both aluminum build-up due to adhesion and aluminum infiltration across the full thickness of the roller wall.

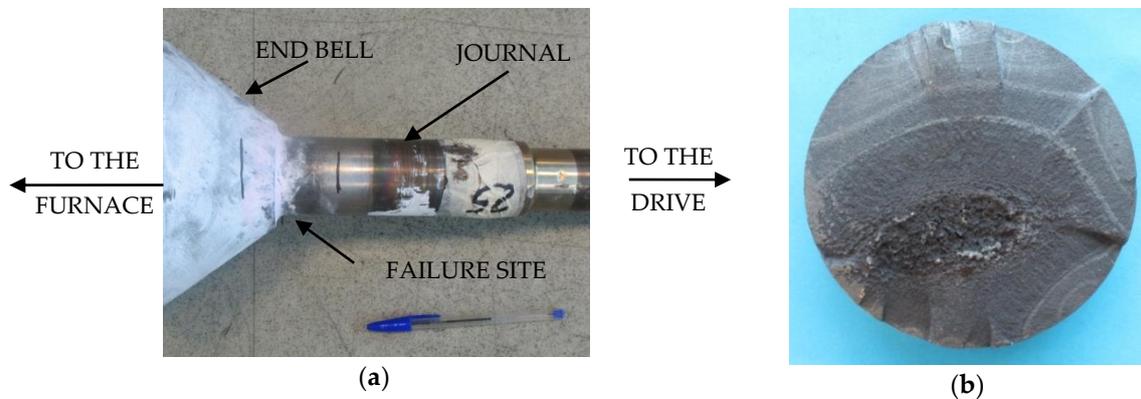
2 m of the chamber) failed in the fillet between the end bell and the journal that connected the roller to the drive (Figure 2a). The fillet fractured across the diameter where it met the journal and showed clear fatigue marks (Figure 2b).

**Figure 2.** General description of the failure site: (a) overview of the fracture location in the drive end of the roll; (b) detail of the fracture surface.

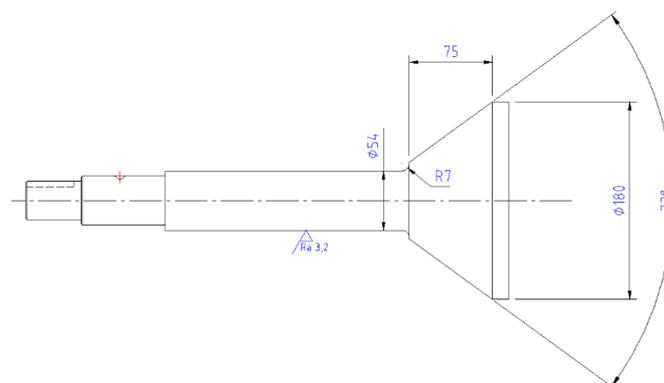
**Figure 3.** Most relevant dimensions of the original bell and journal design (dimensions in mm).

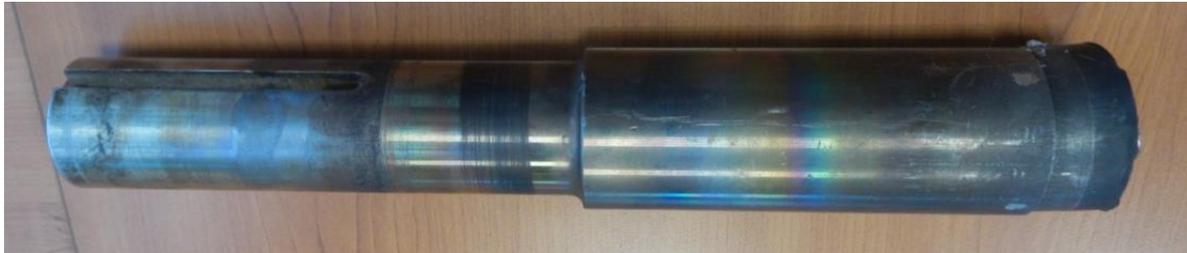
The materials employed for the study corresponded to two rollers (identified as BR1 and BR2) that were found collapsed during furnace maintenance stops, both showing the fracture in the motor side journal (Figure 4). Both rollers were in the first section of the furnace, where the formats enter the austenitizing chamber. Following the detection of the two broken rollers, all journal fillet radiuses,

**Figure 4.** Sample of broken roll 1 (BR1) that was inspected.

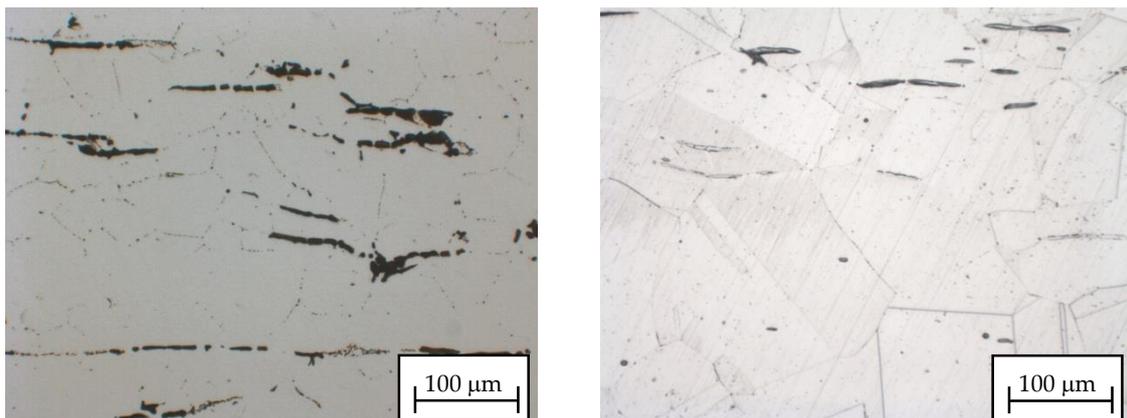
The metallographic analyses of the materials were performed by means of light microscopy (Leica Microsystems, Wetzlar, Germany). The inspections showed that the fracture area was submitted to high temperatures, in excess of  $550$  °C, as extensive sigma phase evolution and intergranular carbide precipitation were observed (Figure 5 left). The material did not show this microstructure in origin, as evidenced by the inspection of the cold journal zone fitting the motor (Figure 5, right).

**Figure 5.** Micrographs of the broken journals. Left. Carbide precipitation in grain boundaries and sigma phase nucleation in the fractured zone. Right. Regular solution annealed austenitic microstructure free of carbides and sigma phase in cold zone of the journal.

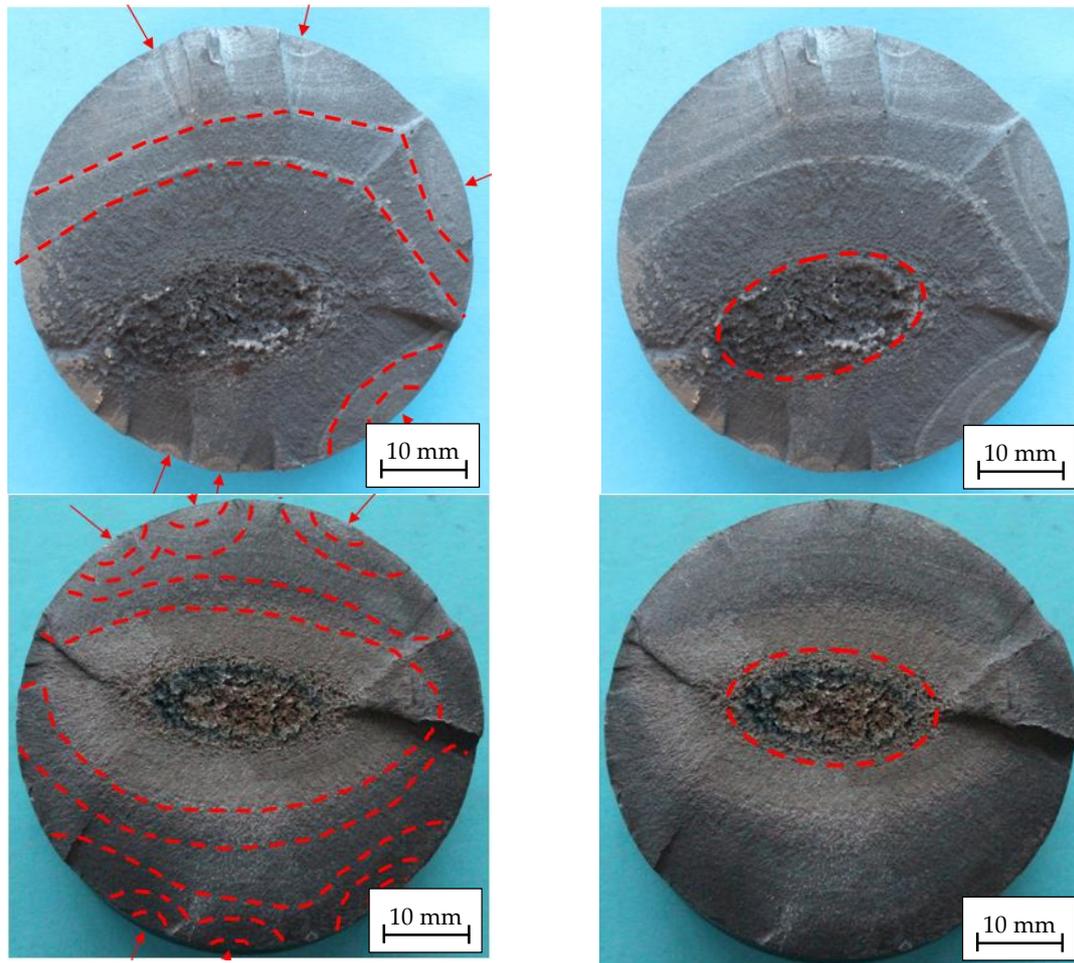
Regarding macroscopic inspection of the fracture surfaces of BR1 and BR2 (Figure 6), both samples looked very similar, indicating that the mechanical damage progress was analogous. In both cases, fractures showed several fatigue crack nucleation sites. The fatigue crack growing pattern left lighter color growing marks, which are interpreted as crack stops during bank-holidays and preventive

maintenance furnace stand-by periods. The final ductile collapse of the rollers is displaced from the geometrical section of the roll because of the different loads that the rollers must bear depending on their angular position.

**Figure 6.** Fracture surface of broken roll 1 (BR1) (top) and BR2 (bottom). Left. Several fatigue nucleation sites marked by arrows and crack stop lines marked with discontinuous lines. Right. Final ductile collapse surface of the roll.

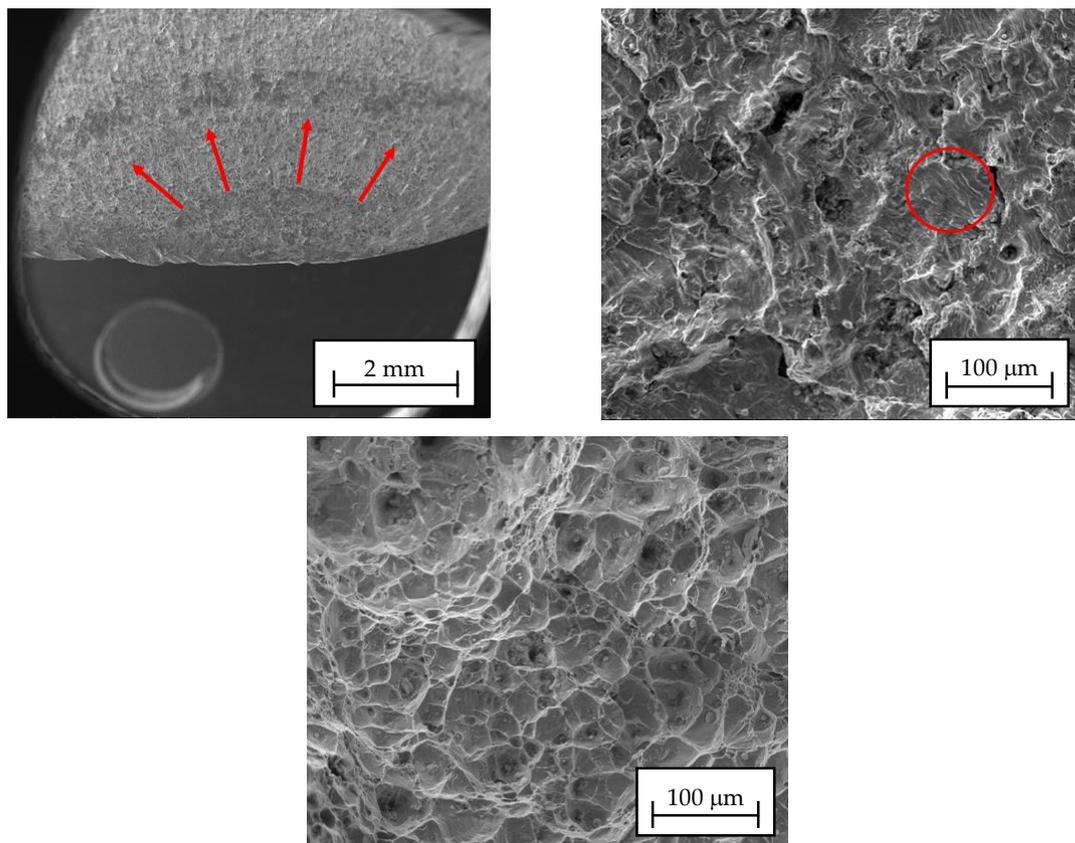
Scanning electron microscopy (FEG-SEM, Ultra Pluss, Carl Zeiss AG, Oberkochen, Germany) inspection confirmed the macroscopic observations. Most of the surface showed oxidation, which meant that some features were hidden, but fatigue nucleation, fatigue crack growth, and ductile fracture patterns (Figure 7) were found. In consequence, the failure mechanism was undoubtedly a fatigue failure, which was probably enhanced by thermal deterioration of the mechanical properties. This deterioration consisted of carbide precipitation and sigma phase evolution coinciding in the fractured section.

**Figure 7.** Scanning electron microscopy (SEM) micrographs of the three main fractographic features observed in BR1 and BR2. Top left. Fatigue nucleation site with the crack growth direction marked by arrows. Top right. Fatigue lines on the oxidized surface of the fatigue cracked area. Bottom. Ductile dimples in the final collapse zone.

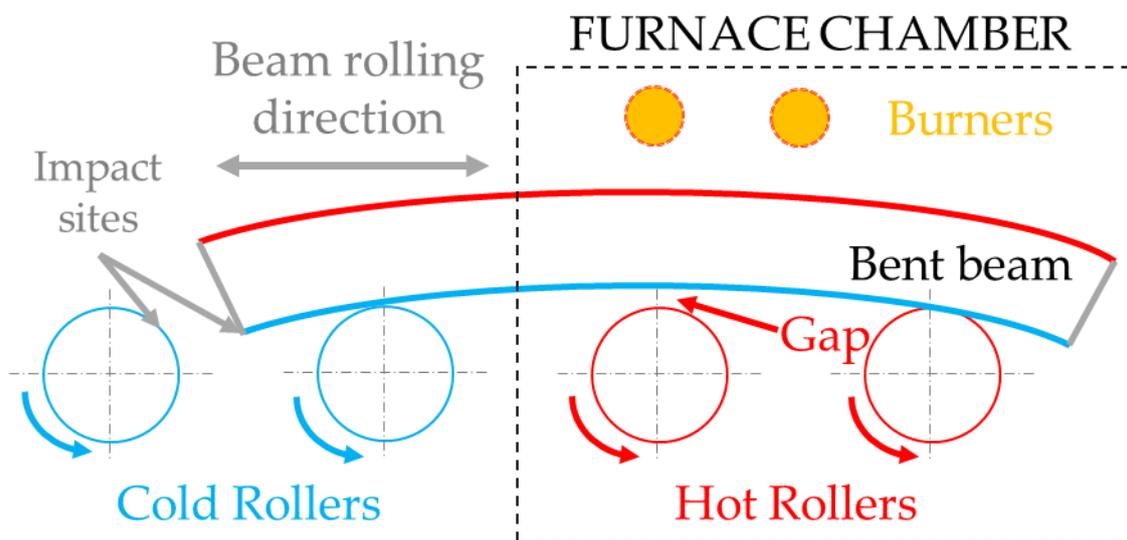
Regarding the working loads, careful inspection during service allowed identifying an unexpected vibration during the conveying movement, right when the tip of the first walking beam contacted the rolls in the back and forth trajectory. This beam worked half stroke outside the furnace, as it dragged the formats from the feeding platform to the inside of the furnace and was directly heated by the ceiling burners. While the bottom of the beam was cooled down by the contact with the cold rollers, the top of the beam was unable to cool down at the same pace and a thermal distortion was generated. It was found that the beam was bent as shown in Figure 8. This caused the vibration that was observed when the leading edge of the beam hit the rollers. It also meant the presence of a gap between the beam and its expected contact points. Consequently, the weight of the beam was not evenly distributed between three to four rollers, but between two instead. Complex deformation of machines in other processes was also studied [20], but in their case, the main cause was mechanical deformation due to process forces.

**Figure 8.** Scheme of the effect of temperature differences between the top and the bottom of the beam. The rollers marked as “hot rollers” correspond to the fractured ones.

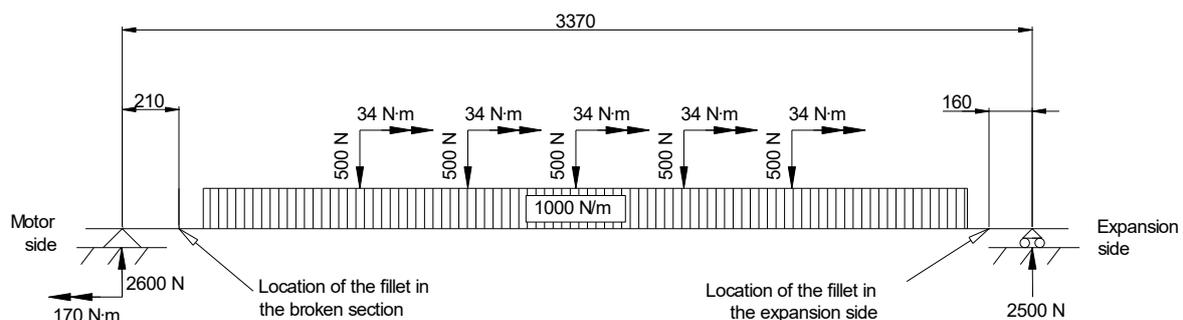
It must be also remarked that the rollers and the applied loads were not symmetrical (Figure 9); the distance between the bearing reaction point and the fillet radius at the expansion side was 30% shorter than in the motor side, leading to lower stress and explaining why cracking was observed only in one side of the rollers.

**Figure 9.** Loading scheme of the roller when the beams are sitting on four rollers at the same time (dimensions in mm).

Considering the load scenario from Figure 9 with a classical approach [21], the maximum bending and torsional stresses applied on the broken Ø54 mm should have been 35 MPa (Equation (1)) and 6 MPa (Equation (2)), which gives maximum principal stress of 36 MPa (Equation (3)). No thermal stresses were considered because of the installation of a slider in the expansion side of the roller, which allowed the unrestrained expansion of the component. This meant a creep design safety factor over 3.

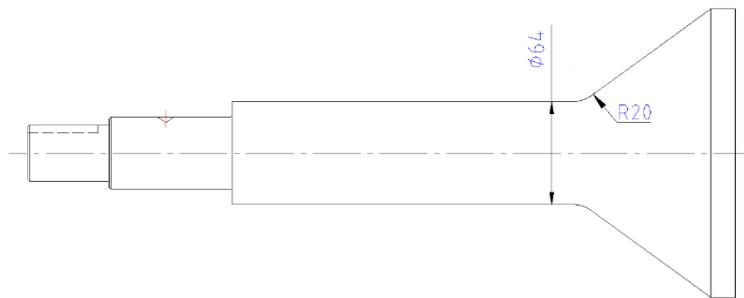
**Figure 10.** Final journal design that substituted the original geometry (dimensions in mm).

1. The insulation of the area was improved and a temperature reduction of 50 °C was achieved in the affected area, slowing down the carbide precipitation kinetics and arresting sigma phase embrittlement.
2. The thermal differences leading to beam bending were evened with radiation deflectors and a proper sitting of the beam on three or four rollers, depending on the stroke's position, was achieved. Working loads were corrected this way, reducing the stress in the fillet radius.
3. The design of the roll was made more robust by increasing the journal diameter from Ø54 mm to Ø64 mm and by reducing the stress concentration factor thanks to a fillet of R20 mm and tangent to the cone instead of a truncated R7 mm fillet (Figure 10).

- The stress concentration factor was reduced to 1.25 ( $r/d = 0.31$  and  $D/d = 1.12$  from the bending stepped round bar with a fillet chart in the work of [22]). Also introducing the scale (1.25) and roughness (1.1) leaves a peak stress of  $1.25 \times 1.25 \times 1.1 \times 21 = 39$  MPa.

Adding up all the actions, the peak stress for the  $R = -1$  fatigue condition in which the rollers work changed from 154 MPa in initial service to 39 MPa in the redesigned condition. The four-fold reduction of stress led to an improvement effect fatigue wise, as reflected in the fact that the modified rolls were in production for double the initial roll failure time without any trace of cracking after penetrant dye inspection. The new design was implemented in all the furnaces of the same family. This result emphasizes the importance of performing mechanical calculations that must consider all factors involved in service when designing new equipment.
