Fatigue-Prone Details in Steel Bridges

Reza Haghani *, Mohammad Al-Emrani and Mohsen Heshmati

Civil and Environmental Engineering Department, Division of Structural Engineering,
Chalmers University of Technology, Sven Hultins Gata 8, 41296 Gothenburg, Sweden;
E-Mails: Mohammad.Al-Emrani@chalmers.se (M.A.-E.); mohsen.heshmati@chalmers.se (M.H.)

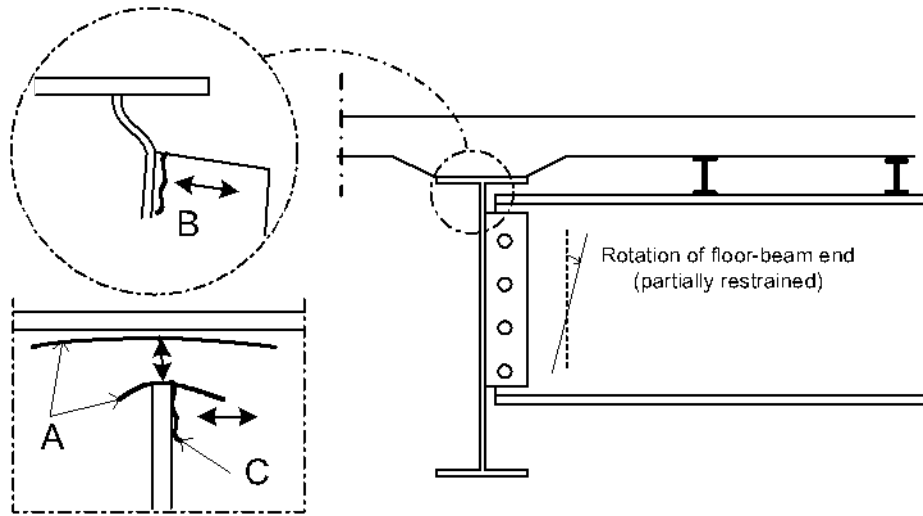
Figures 17 and 18 show two examples of fatigue cracking caused by the restrained rotation of floor-beam ends. In mechanically fastened connections, the fatigue damage is generally found in the connection angles or the rivets (or bolts) connecting the angles to the main load-carrying element [5,14], see also Figure 15. In welded details, where the floor beam is connected to a welded transverse plate, cracking has been reported in the main girder web (types A and C in Figure 18) or in the connection plate along its fillet weld to the main girder web (type C) [4,5,10].

Figure 18. Fatigue cracking in a floor beam welded to the main girder connection.
