## The 2011 Earthquake in Simav, Turkey and Seismic Damage to Reinforced Concrete Buildings

**Abstract:** Reinforced concrete buildings suffered significant damage in the region affected by the 29 May 2011 earthquake in Simav (Kütahya), Turkey. Typical building damage is classified and potential causes of damage are investigated. Reinforced concrete moment resisting frames with hollow brick infill walls are the most common structural system in and around the Simav city center while masonry construction is common in rural areas. Although the Simav earthquake, with a magnitude of 5.7 to 5.9, can be classified as a moderate earthquake, many buildings experienced damage varying from frequent diagonal cracking and brittle failure of infill walls to collapse or severe damage to frames due to short columns, soft stories or other reasons including insufficient or poor detailing of reinforcement. This study investigates and presents the seismicity of the region, characteristics of the measured ground motions, seismic load demands including response spectra, and damage mechanisms, potential causes and classification of observed damage in reinforced concrete buildings.

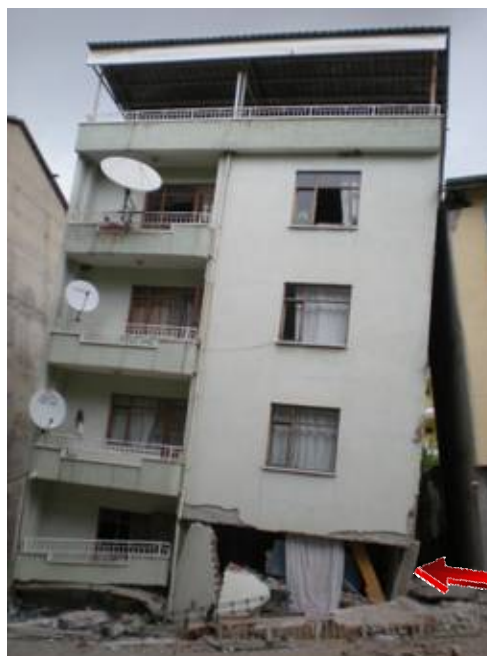
world [13,14]. In the building shown in Figure 8, first story columns were severely damaged which led to collapse while the upper stories suffered virtually no damage. Even the windows are not broken in the upper stories because the deformation demand in the upper stories was limited.

**Figure 8.** Building collapse due to first story failure during the Simav earthquake.

Existing buildings with a soft or weak story can be strengthened by increasing the stiffness and strength of the soft or weak story. The TEC [9] recommends addition of structural walls as a practical retrofit method. This strengthening is currently mandatory for existing buildings in seismic zones 1 and 2, which are the two seismic zones with the highest earthquake risk with corresponding ground acceleration  $a_g \geq 0.4g$  and  $0.3g$ , respectively. These buildings typically consist of reinforced concrete flat slab, bare or infill joist system, and waffle slab system with columns and beams not satisfying the requirements for high ductility level.

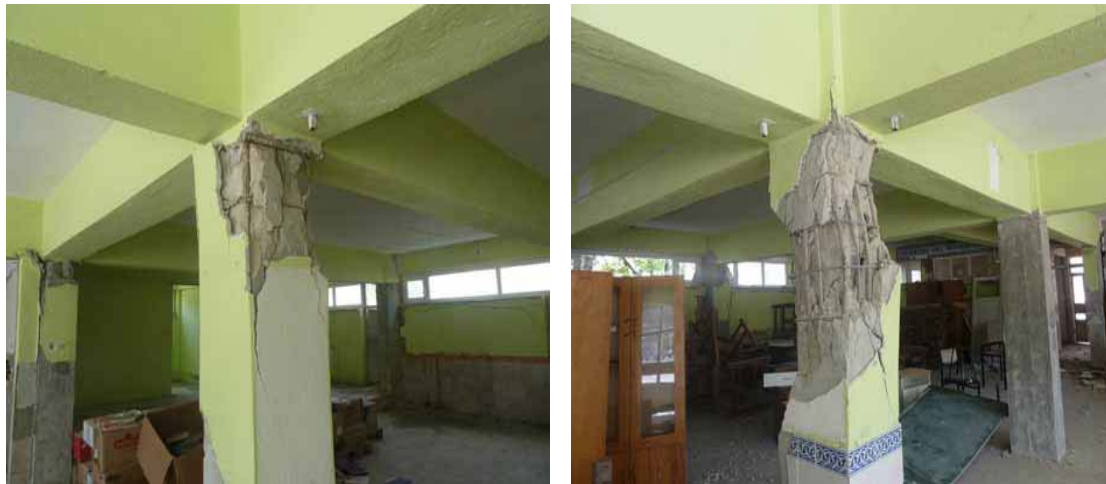
Reinforced concrete frames need to be designed for both strength and ductility in order to prevent severe damage that can be caused during a strong earthquake. Strength is the maximum shear, axial or moment capacity of a structural member or the structural system to resist the earthquake loading, and ductility is related to maximum deformation capacity. In order to avoid collapse during an earthquake, columns need to be designed stronger than the beams in a reinforced concrete frame. This phenomenon is called strong column and weak beam concept. The beams are supposed to be ductile and controlled damage or plastic hinges are supposed to occur at end of beams rather than in columns. In order to dissipate sufficient energy within the plastic hinges, plastic hinge regions should have special reinforcement detailing to improve the energy absorption capacity and ductility. However, reinforced concrete frames with weaker columns suffer brittle shear and axial failure while the stronger beams remains elastic. This undesirable behavior is also seen in the 2011 Simav earthquake. Figure 9 shows column failures in a building with strong beams and weak columns.

**Figure 9.** The failure of strong beam-weak column.

Figures 9 and 10 show the large transverse reinforcement spacing in the columns. Widely spaced and insufficient transverse steel leads to: (1) lower column shear strength; (2) less effective confinement of the core concrete and lower core concrete strength; and (3) buckling of the longitudinal bars under increased axial and lateral loads. The effects of inadequate transverse reinforcement are further discussed below.

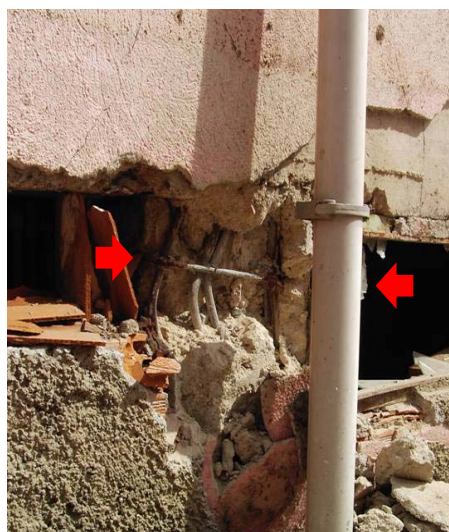
Many reinforced concrete buildings were seriously damaged in past earthquakes due to presence of short columns [10,15]. Short columns can be classified into two groups. The first group consists of columns that are designed or constructed shorter than other columns in that story. The second group includes columns that are shortened during construction by adding partial walls or panels on both or either side of the columns although their specified height is the same as other columns in that story in the original design. Damage in these short columns is often in the form of X-shaped cracking due to brittle shear failure. Examples of short column failures from the 2011 Simav earthquake are shown in Figure 10.

**Figure 10.** Short column and non-ductile column failure.

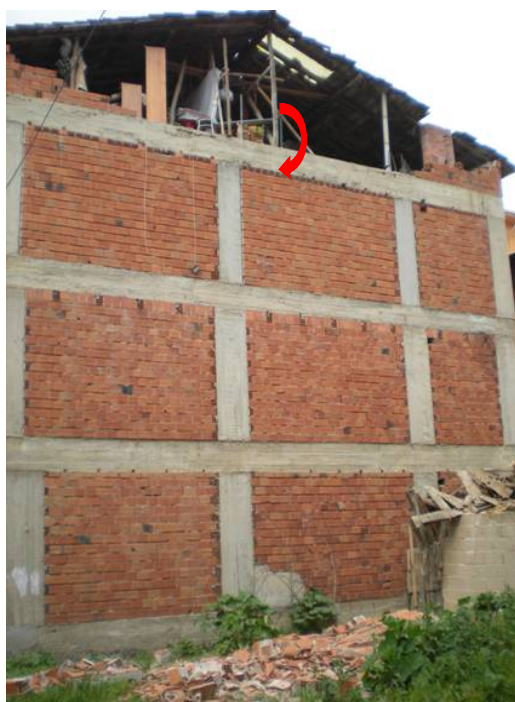
Unconfined gable wall damage has been common in recent earthquakes in Turkey. Although the structural integrity of the building is not compromised due to the gable wall damage, such damage results in falling hazard that leads to financial loss, injuries and even fatalities [11]. An example of unconfined gable wall damaged in the Simav earthquake is shown in Figure 11. In order to limit the gable wall damage, the Turkish earthquake regulations [9] require vertical and inclined concrete beams within the wall if the roof gable wall is taller than 2.0 m (Figure 12).

**Figure 11.** Unconfined gable wall damage.

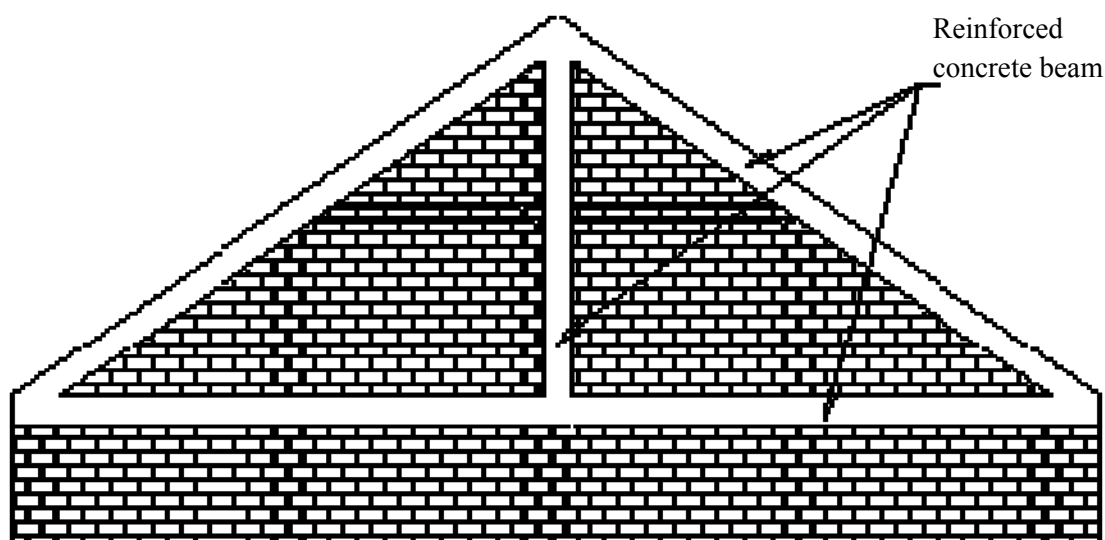
**Figure 12.** Recommended reinforced concrete elements for gable walls.

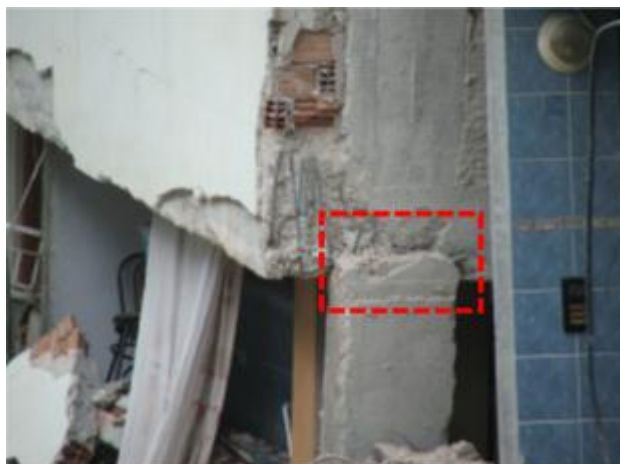
Beam-column joints are designed to transfer moments and resist lateral loads within the beam-column moment frame system. Transverse reinforcement needs to be provided within the joint region to resist shear forces and confine concrete [17]. Some buildings were damaged in Simav because of insufficient lateral reinforcement in the beam-column joints (Figure 13). No confinement or lateral reinforcement exist in most joints, making them unable to achieve the required ductility. Beam-column joints of high ductility frame systems are classified as confined or unconfined joints in the TEC [9]. A beam-column joint is defined as a confined joint if beams frame into all four sides of a column and the width of each beam is not less than three quarters of the adjoining column width. In practice, it is rather difficult to satisfy this requirement. All joints not satisfying the above given conditions are defined as unconfined joints.

TEC [9] requires 135-degree hooks at the end of seismic transverse reinforcement, because 90-degree hooks easily open and lose their effectiveness. As the labor or installation is difficult, transverse steel with 135-degree hooks has not been used until recently. However, with more government oversight and better supervision at the construction site, TEC [9] requirements appeared to be carefully applied in the field within the last five years.

**Figure 13.** Inadequate transverse reinforcement in beam-column joints.

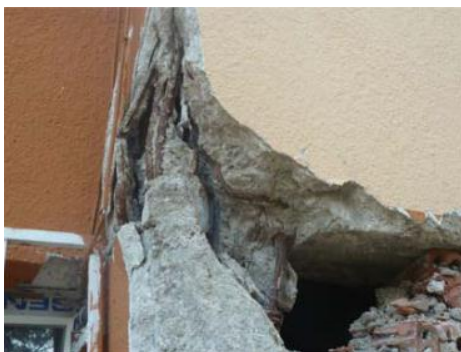
As discussed in the previous section, reinforcement detailing is critical in seismic design of reinforced concrete structures because the ultimate strength and displacement ductility highly depend on the amount and detailing of the reinforcement. The authors observed severe damage and collapse of structures mainly due to poor reinforcement detailing (Figure 14). Most common problems included insufficient or lack of longitudinal bars, and insufficient development length, lap splices, or anchorage of rebar. These problems were exacerbated by corrosion of rebar and concrete damage and spalling. Although the corrosion was typically not severe in longitudinal bars in buildings damaged during the earthquake, some corroded rebar were spotted typically at the column-foundation interface.

**Figure 14.** Poor reinforcement detailing at a column end [6].

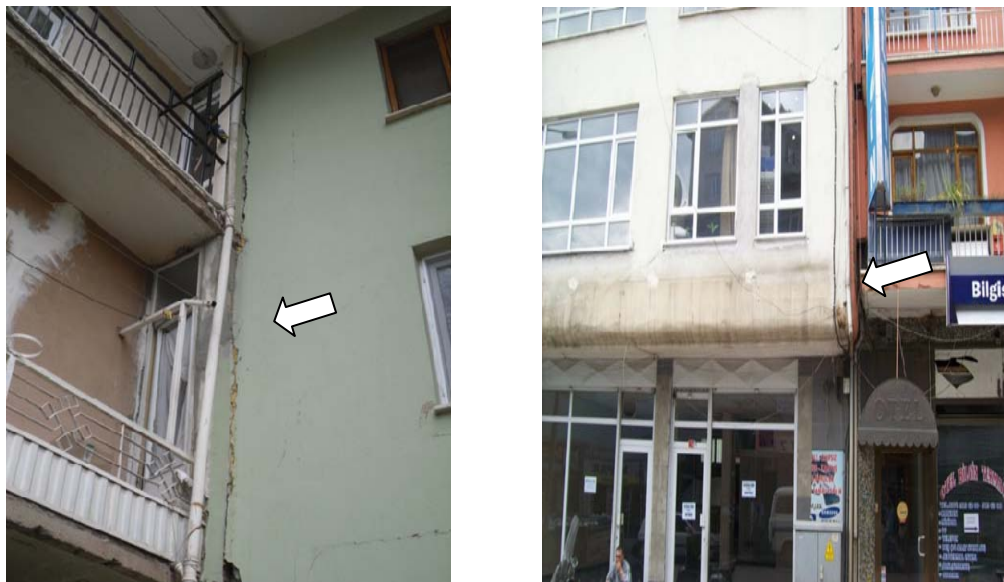
periods of two adjacent structures cannot always be the same because periods of the buildings depend on variation of mass and structural system stiffness of the building. Dynamic properties of structures, properties of ground motion and gaps between closely spaced structures have influence on the location and magnitude of pounding. In addition, soil type can affect the structural response in terms of both fixity of the building foundations and periods of the structures. The simplest and most practical way to prevent this impact and reduce damage is to provide enough separation. Corner buildings are expected to experience more damage than interior buildings because of pounding, since corner buildings are free to move in many directions. If the required sufficient space or gap cannot be provided, an alternative solution is to decrease the lateral motion and drift of buildings. Pounding of closely spaced buildings is frequently observed during earthquakes in Turkey because it is very common to have very small separation or no gap between adjacent buildings. Two pounding examples resulting from inadequate gap between adjacent buildings are shown in Figure 15.

**Figure 15.** Pounding between closely spaced buildings.

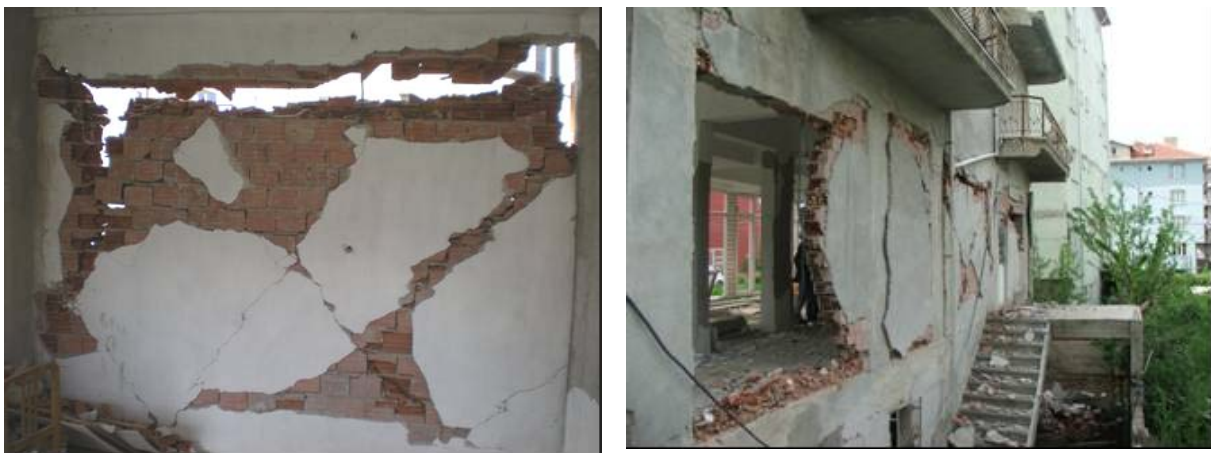
Unreinforced hollow clay bricks were used in infill walls of almost all reinforced concrete buildings in the region affected by the 2011 Simav earthquake. Unreinforced infill walls have relatively low lateral strength and usually brittle once their strength limit is reached. Diagonal cracks, a sign of shear failure, in infill walls were commonly observed in reinforced concrete buildings. Depending on the magnitude of the lateral load applied on the building, the level of observed wall damage varied from light diagonal cracks in the walls to separation from the structural frame or out-of-place buckling (Figure 16).

**Figure 16.** Infill wall damage in reinforced concrete buildings. Damage Caused by Multiple Earthquakes.

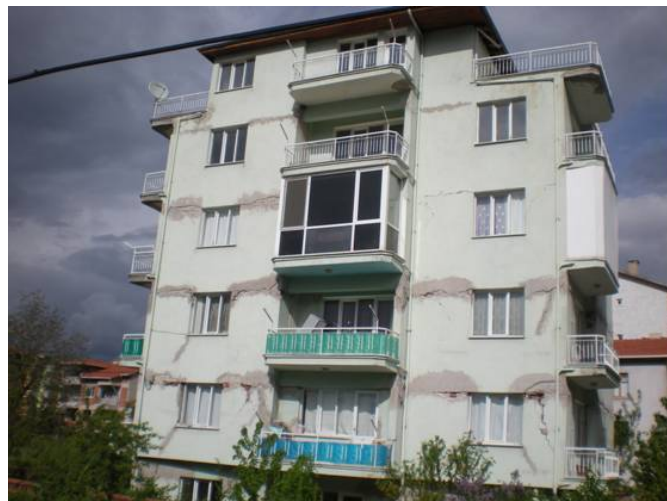
Simav was also hit by a magnitude 5 earthquake in 2009, causing damage in some reinforced concrete buildings. Most of these damaged buildings apparently were not repaired or strengthened, instead they were plastered and painted. The 2011 Simav earthquake caused further damage in those buildings usually at or near the areas damaged during the 2009 earthquake. Figure 17 shows one such building with damaged beams and infill walls plastered after the 2009 earthquake. Large cracks caused by the 2011 earthquake are visible in the second floor, e.g., near the right end of the wall in the second story.

**Figure 17.** Building damaged during the 2009 and 2011 earthquakes.
