Analysis of Cylindrical Masonry Shell in St. Jacob's Church in Dolenja Trebuša, Slovenia—Case Study

Keywords: masonry shell; cracks in shells; static analysis; strengthening

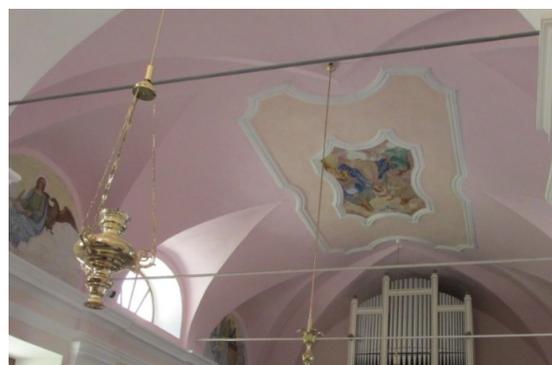
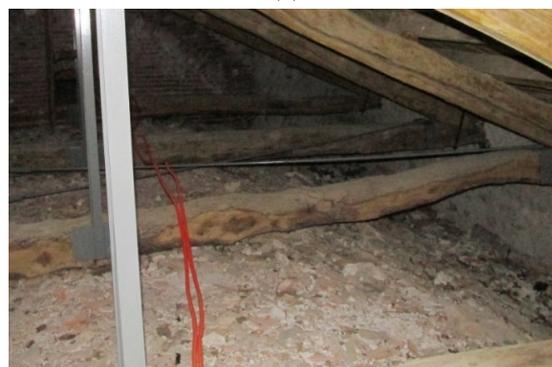
Figure 3. Analysed stone masonry barrel vault from bottom (a) and top (b).

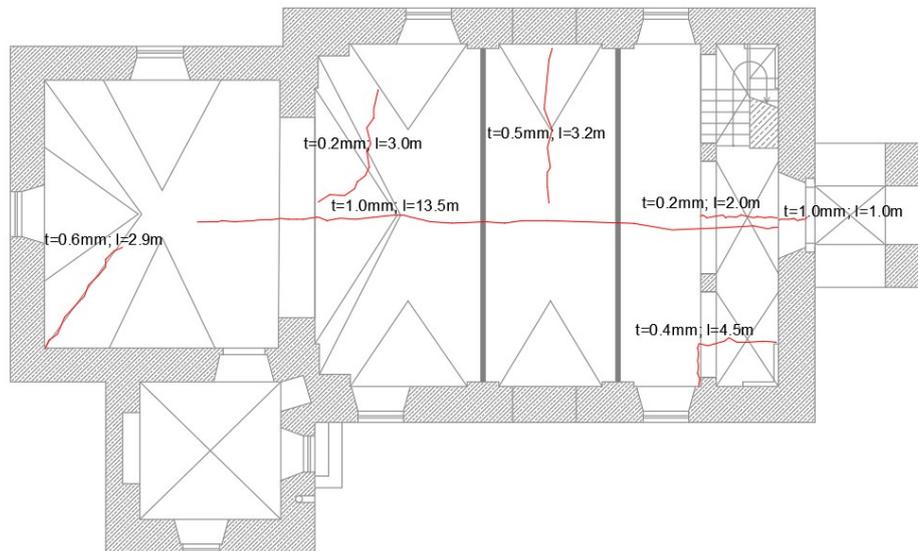
Before rehabilitation and strengthening of the church in 2013, numerous cracks in the walls and vaults were listed. In the middle area of the analysed vault there was a crack running along the entire length of the nave, which continued through the supporting arch and presbytery vault with length of 13.5 m and thickness of 1.0 mm. Other cracks were also present on the vaults, especially in the area of the transverse vaults although of smaller width and length (Figure 4).

Figure 4. Registered crack pattern of analysed barrel vault before rehabilitation in 2013 [6].

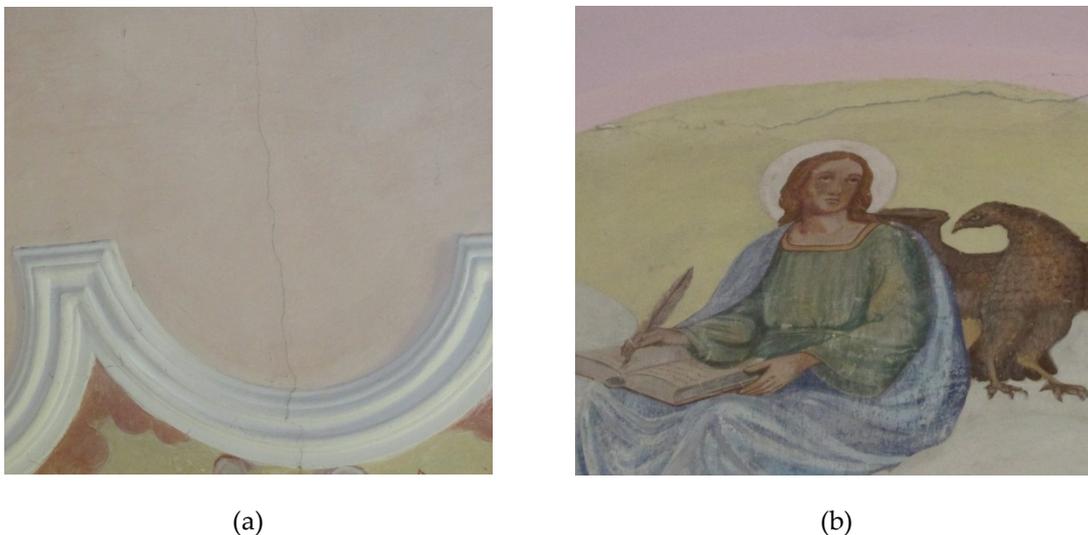
The cracks although to a lesser extent, reopened in the same places after the repair works in 2013 (Figure 5).

Figure 5. Reopened crack in the analysed shell (a) and in wall near transverse vault (b).

Based on the results of the analysis of the considered shell, it can be concluded that the cracks formed mainly due to direct loading of the middle upper part of the shell (simulation of maintenance works in load case “3”). Considering the fact that cracks reappeared in the same areas after repair works in 2013, it is recommended that monitoring of the shell be carried out with an emphasis on the longitudinal crack in the middle part of the shell. In the case that the widening of that crack continues, strengthening of the shell will be required. Strengthening could be done by applying reinforced concrete layer either using FRP (fiber reinforced polymer) or FRM (fiber reinforced mortar) on the critical area. However, if the monitoring does not confirm any propagation (widening and/or length extension) of cracks, strengthening considering unchanged loading condition is not necessary. Nevertheless, the problem in the case of loading of the shell during maintenance works should be solved for any potential future works as the numerical simulations show that the shell is locally overloaded even by weight of a single maintenance worker. A possible simple solution for this problem is a working platform not only for access of the maintenance team but generally also for any secure access to the area above the shell [8]. The weight of the platform could be partially carried by the existing wooden roof structure and mainly by the stronger stone-masonry walls of the church structure.

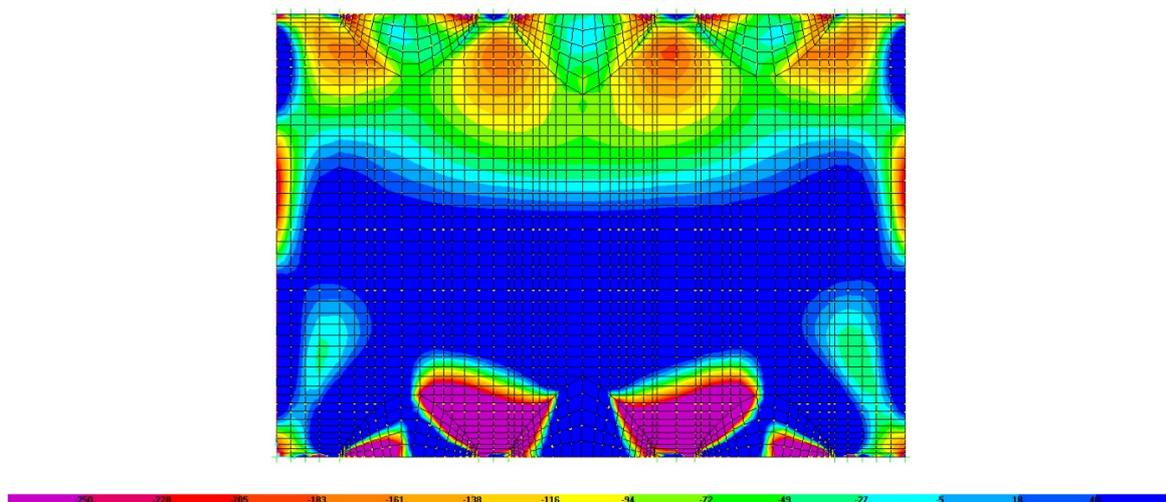
**Figure 10.** Stresses σ_{11bot} [kN/m²]*—load case »2«.*

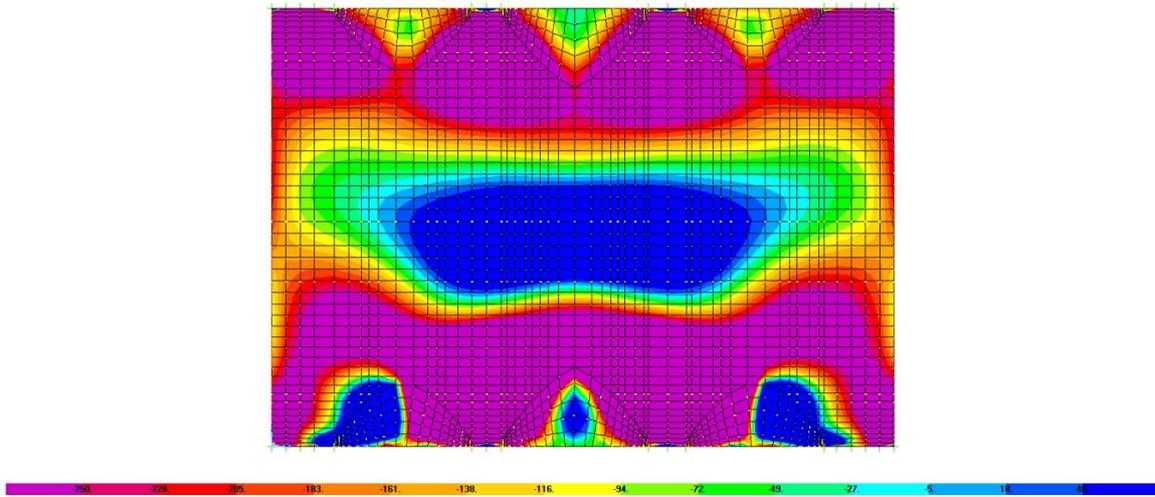
Figure 11. Stresses σ_{22bot} [kN/m²]*—load case »2«.*

In load case »2« vertical displacement ($\Delta_z = -0.5$ cm) of outer supports on one side was considered which simulates differential settlement of foundations. In this case, high tensile stresses occur in the top area of the shell (Figure 11), which may cause the recorded longitudinal crack. Differential settlement of foundations can thus be one of possible causes for the registered crack pattern. However, the results of this load case otherwise show high stress levels also in other parts where no damage of the actual shell has been recorded.

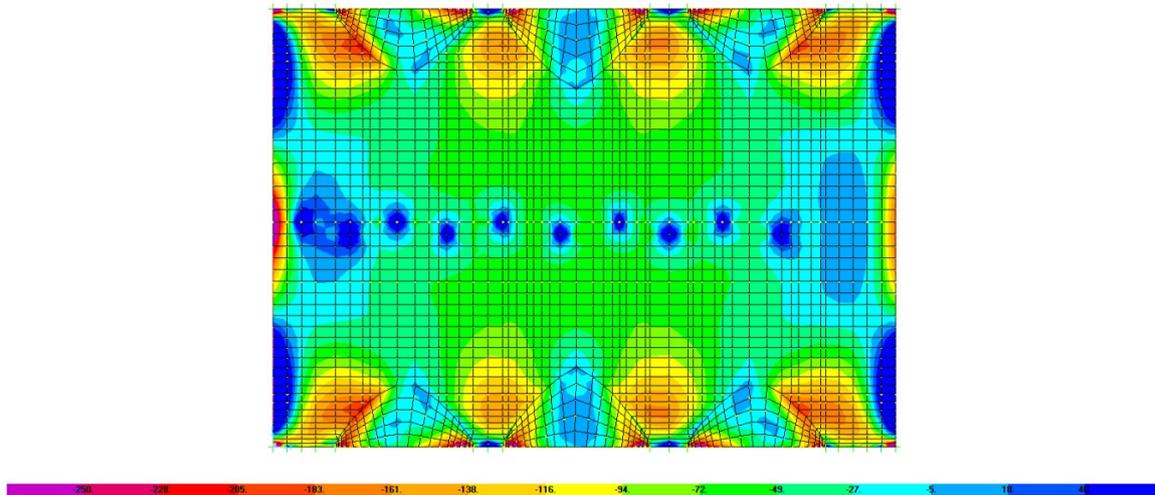
Figure 12. Stresses σ_{11bot} [kN/m²]*—load case »3«.*

Load case “3” took into account the self weight of the structure, weight of the rubble layer and weight of the maintenance team. In this case, compressive stresses in the upper middle part (Figure 13) as well as tensile stresses in the lower middle part (Figure 12) of the analysed shell are exceeded, which coincides with the registered crack pattern. This loading combination can therefore be considered as the most possible cause for the formation of a longitudinal crack [8].

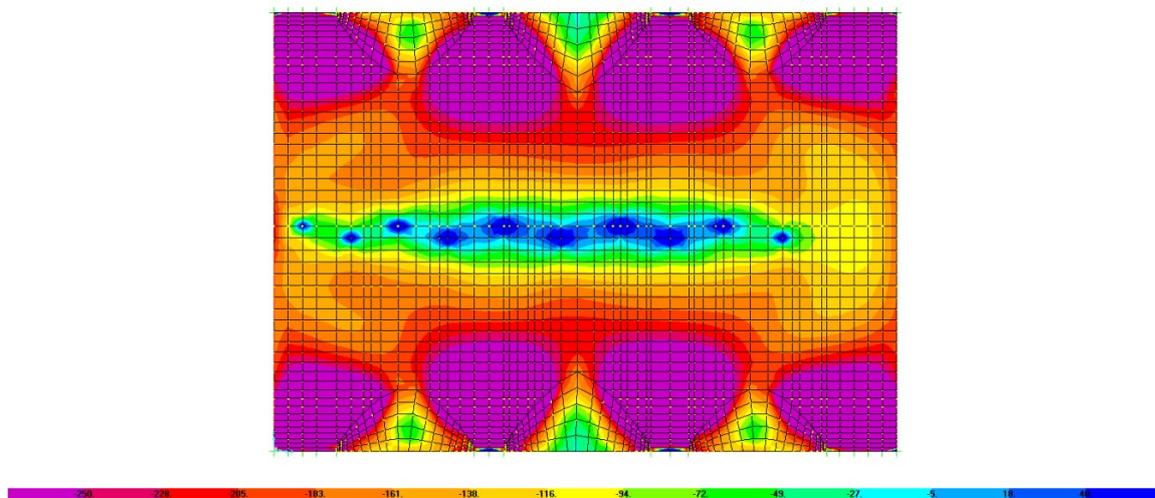
Figure 13. Stresses σ_{22bot} [kN/m²]*—load case »3«.*
