# Field Reconnaissance and Earthquake Vulnerability of the RC Buildings in Adıyaman during 2023 Türkiye Earthquakes

**Abstract:** The 6th February 2023 Pazarcık and Elbistan earthquakes ( $M_w = 7.7$  and  $M_w = 7.6$ ) caused great destruction in many cities and were the disaster of the century for Türkiye. The greatest destruction was caused in the provinces of Hatay, Kahramanmaraş, and Adıyaman during these earthquakes, which were independent of each other and occurred on the same day. Information about earthquakes and strong ground motion records is given within the scope of this study. Reinforced concrete (RC) structures which constitute a large part of the urban building stock in the earthquake region were exposed to structural damage at different levels. The structural damage in the RC structures in the city center, Gölbaşı, and Kahta districts of the province of Adıyaman was evaluated within the scope of earthquake and civil engineering after field investigations. Insufficient RC, low-strength concrete reinforcement problems, RC frame failure, heavy overhang, short columns, soft story, and pounding effect are the main causes of the earthquake damage. The presence of these

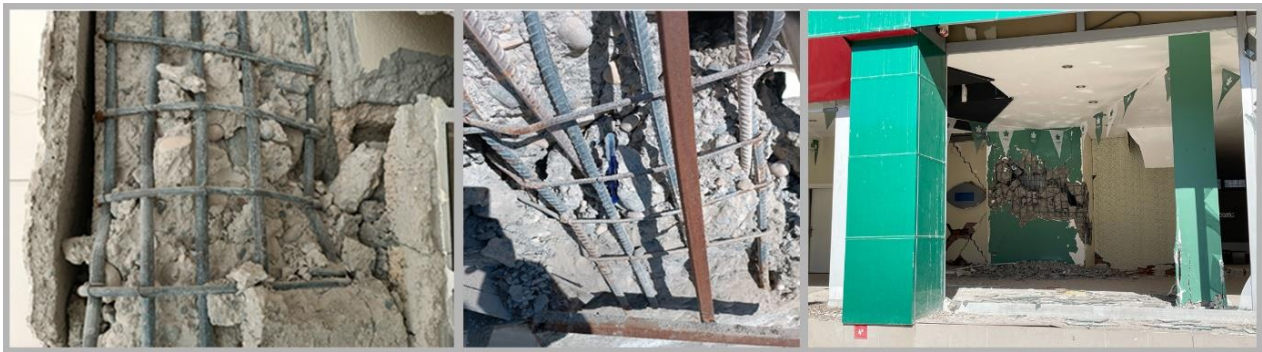
The strength of the materials that make up the structures directly affects the seismic behavior of the structure. The weak point of reinforced concrete structures is the concrete material formed by many stages [43–46]. Coarse aggregate in larger sizes than necessary, which does not have an appropriate particle size distribution, has insufficient adherence between concrete and reinforcement (Figure 9).

**Figure 9.** Inappropriate particle size distribution.

In concrete casting, adequate supervision should be carried out to pay maximum attention to vital issues such as preparation, transportation, temperature, weather conditions, casting time, compaction, taking test sampling, post-casting maintenance, and curing.

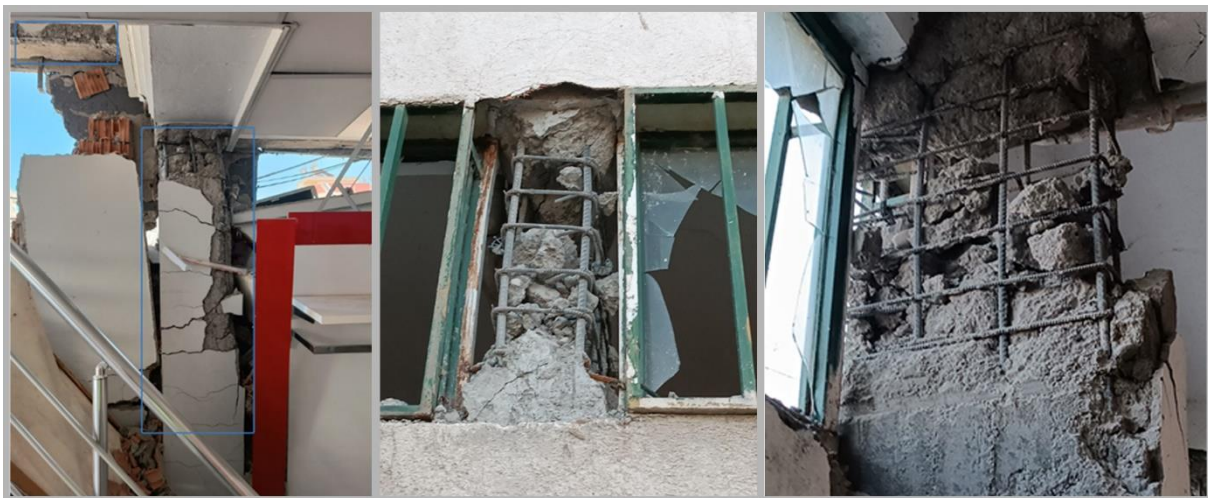
In concrete casting, failure to pay attention to significant issues such as preparation, transportation, temperature, weather conditions, casting time, compaction, taking test samples, post-casting maintenance, and curing also causes low concrete strength. As a result, the concrete did not provide sufficient strength due to segregation and buildings were built using poor-quality concrete with insufficient strength (Figure 10).

**Figure 10.** Examples of the use of poor-quality concrete and damage.

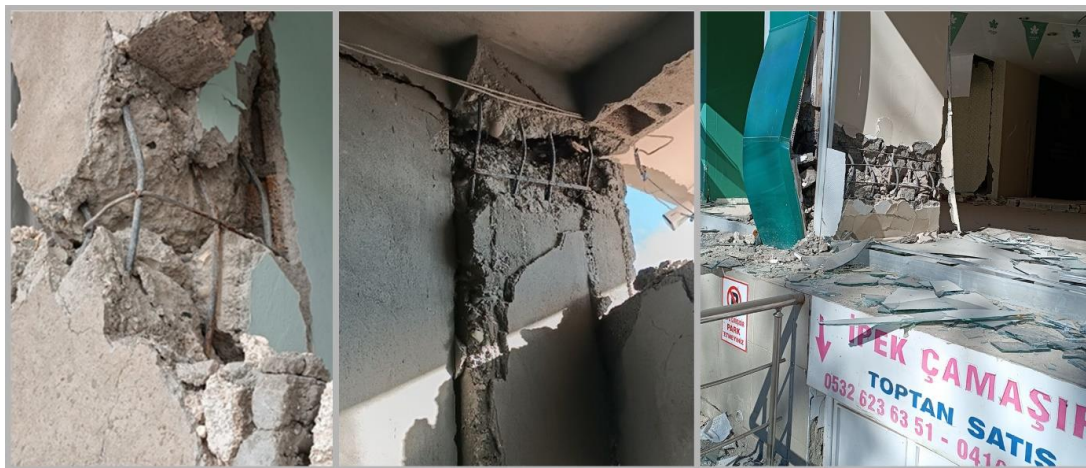
Reinforcements are used to resist tensile stresses in reinforced concrete. Inadequate and inappropriate reinforcement, as well as poor workmanship, increase reinforcement-related structural damage [47,48]. The buckling of the longitudinal rebars has been observed in the structural system elements, where sufficient stirrup reinforcement is not used. This damage, which occurs in the lower and upper parts of the column, where the earthquake-induced internal forces are greatest, is shown in Figure 11. In addition, the plain reinforcement rebar used in the reinforced concrete is one of the important reasons for the damage caused by the reinforcement and the low adherence between the concrete and the reinforcement. Particularly, it was observed that the outer column longitudinal steel bar buckled within the foundation height where stirrups were either missing or widely spaced.

**Figure 11.** Examples of damage caused by reinforcement.

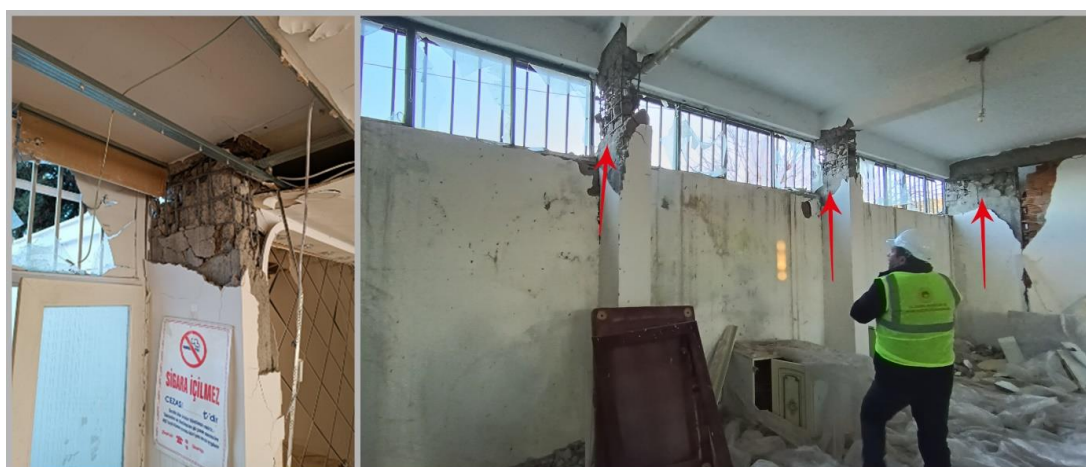
Column dimensions may vary within a building due to a mezzanine floor, band-type window, or hill slope effect in buildings. Band-type windows made for lighting purposes, especially on the ground and basement floors, create different heights in the column, resulting in a short column mechanism [49–51]. Short column damage is shown in Figure 12. Despite the use of adequate reinforcement, the low concrete strength triggered this damage. Such captive column failures led to story collapses in some structures.

**Figure 12.** Examples of short column damage.

Columns in frame structures may be stretched up to their plastic moment capacity when subjected to horizontal loads. An immense moment gradient and hence a significant shear force occur in the case of short columns with significant bending capacity. Before the plastic moment capacity is achieved, a shear fracture frequently occurs. Therefore, it is best to avoid using short columns. The shear capacity must be enhanced to account for the excessive strength of the vertical reinforcement. An alternative is to design and detail the columns following capacity design criteria.

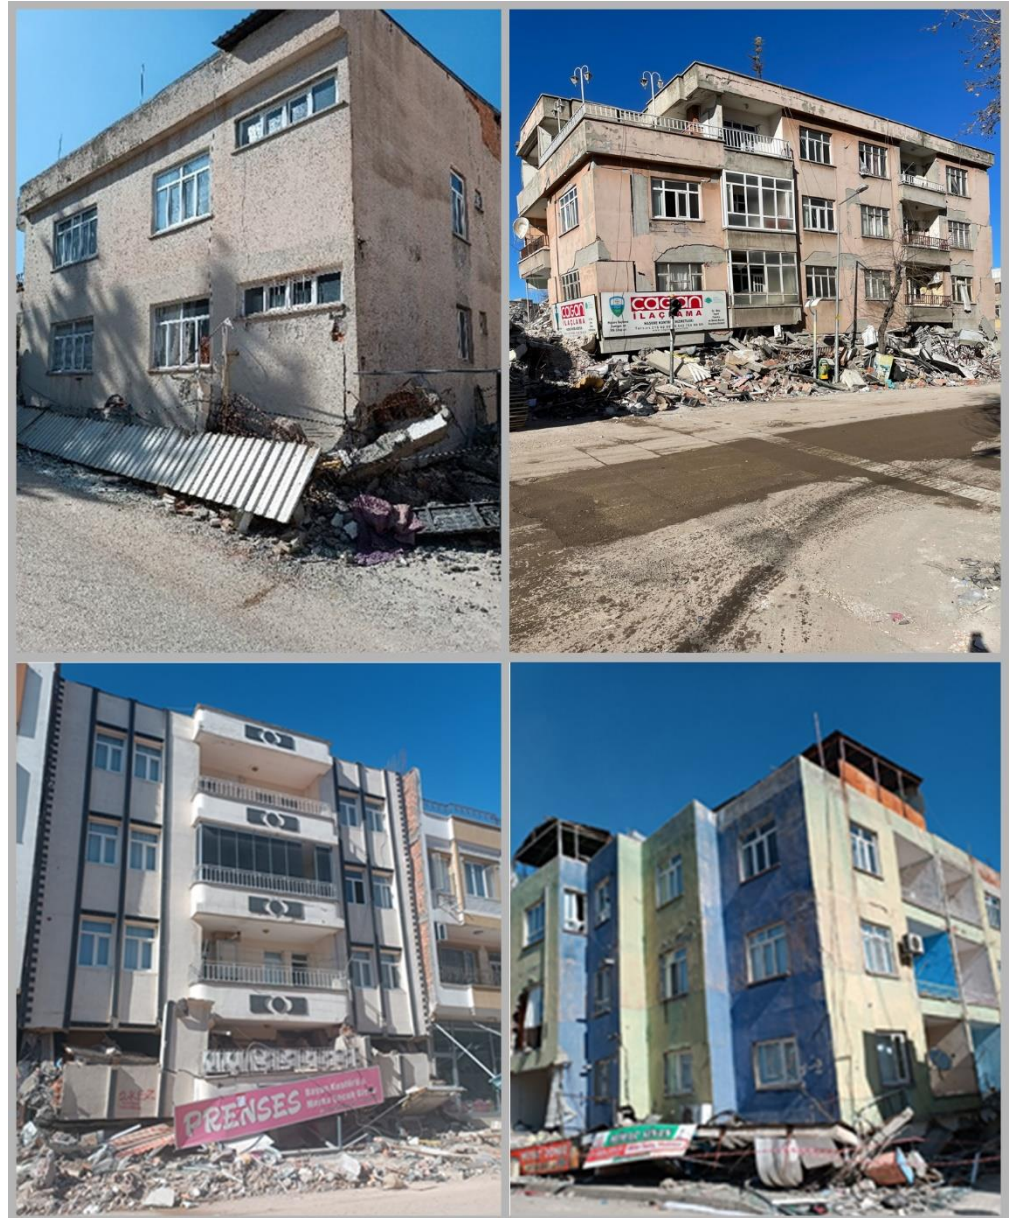
As a result of the stiffness and strength differences between the stories in buildings, significant differences occur between the relative story drifts. In this case, the soft story mechanism is formed and the ground floors in particular experience the collapse mechanism. This situation has been observed frequently in buildings where there are large commercial enterprises on the ground floors and there are residential sections on the upper floors [52–55]. In Adıyaman, it is observed that considerable structural damage occurred, notably in some RC buildings with high residual drift as a consequence of soft/weak stories. Such structural damage is shown in Figure 13.

**Figure 13.** Complete collapse of the ground story as a result of soft story damage.

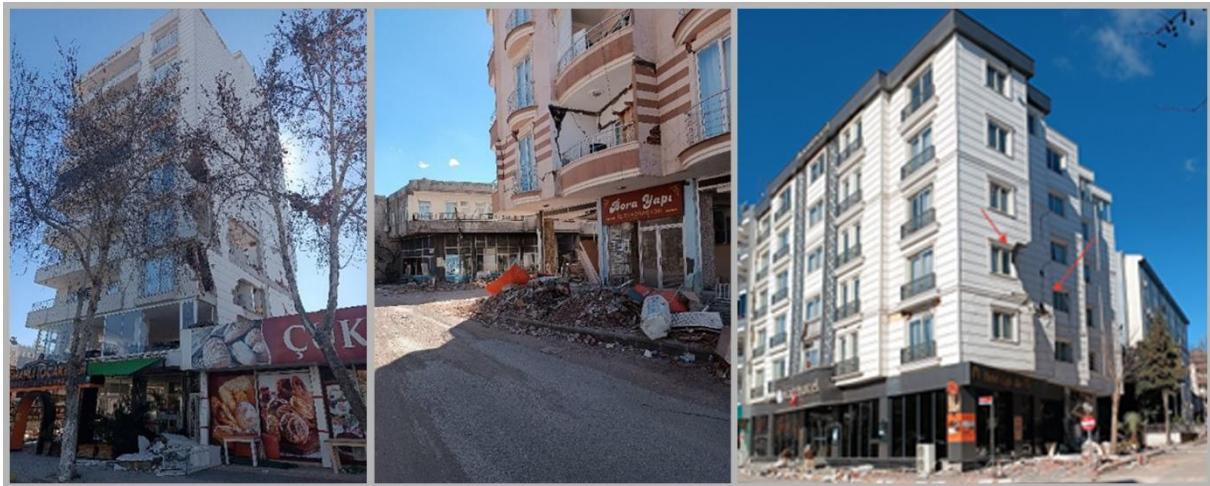
One of the causes of damage in reinforced-concrete-type structures is heavy overhangs in the structure. Heavy overhanging structures are generally seen in buildings where the upper-floor building areas are larger than the ground-floor building areas [56–58]. Damage occurring at different levels in these parts is shown in Figure 14.

**Figure 14.** Structural damage in RC structures due to heavy overhangs.

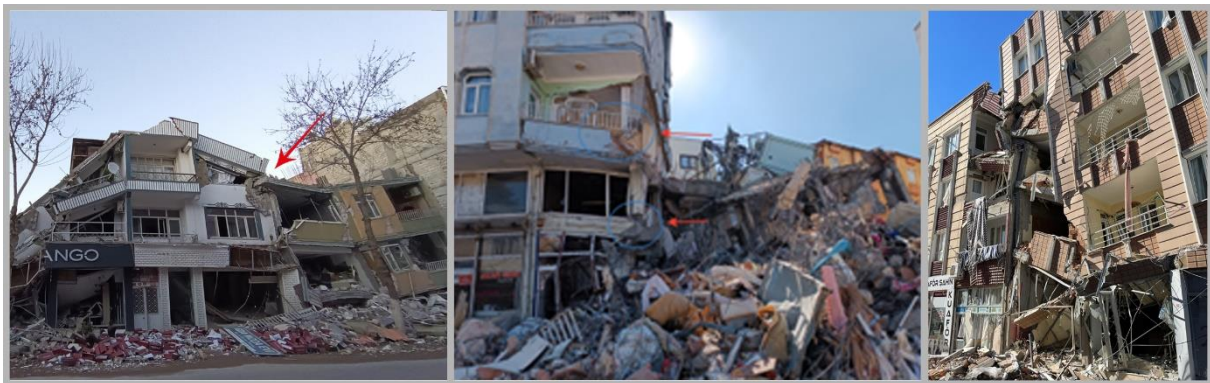
Adjacent structures collide with each other as a result of the pounding effect during an earthquake. The main problem here is that the floor levels in adjacent buildings are not the same. The shear forces that occur in structures with different floor levels create additional shear forces on the vertical structural members in the other structure, causing the shear capacity of these columns to be exceeded. It is observed that the damage occurred at dilatation joints where pounding had occurred between adjacent structures and the location of poor concrete consolidation during construction. Damage caused by the pounding effect is shown in Figure 15.

**Figure 15.** Examples of damage caused by the pounding effect.

When necessary, dilatation joints appropriate for their technique should be used; otherwise, adjacent constructions should be abandoned. Additionally, it is important to make sure that the floors of all nearby structures are level with one another. Otherwise, it will be inevitable that the additional shear forces that will occur due to the pounding effect from the neighboring floors during the earthquake will cause significant damage.

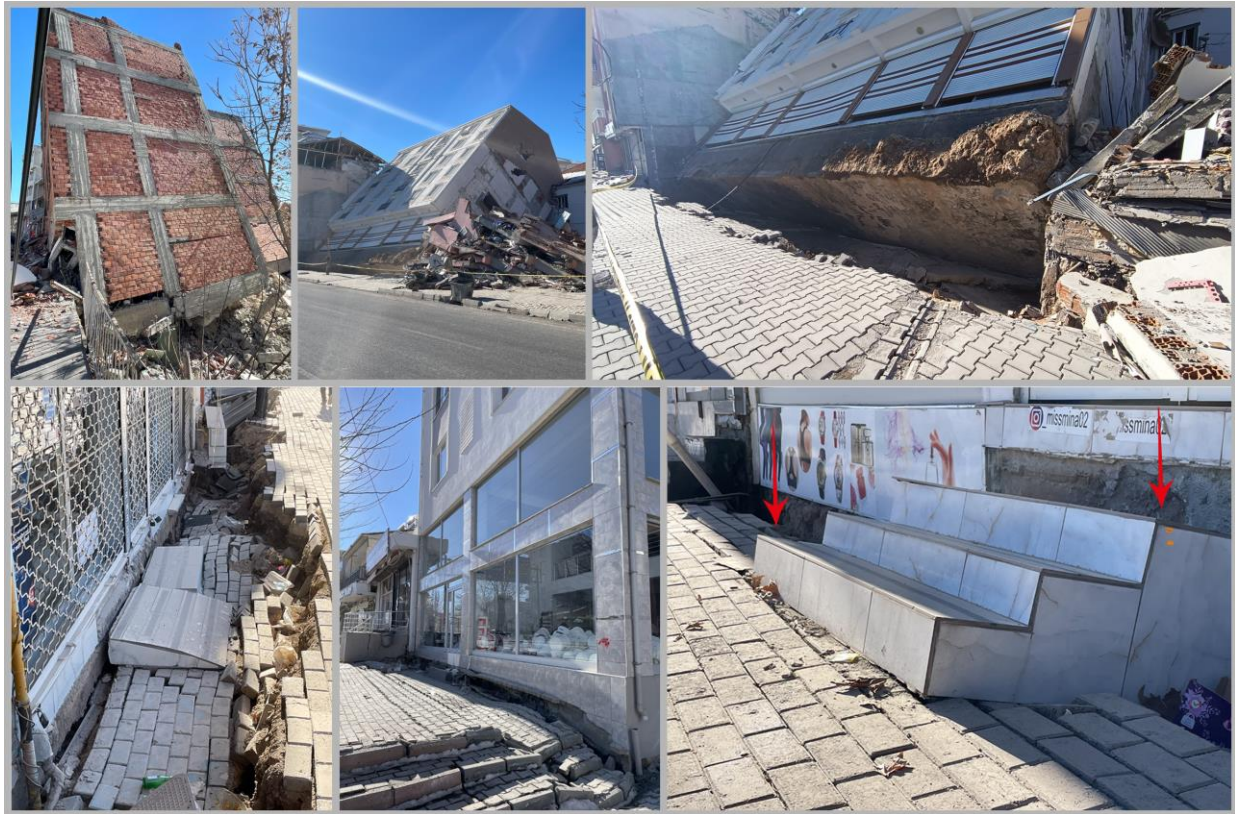
Low soil bearing capacity and insufficient foundation depth caused structural damage under lateral loads. Soil-related damages are shown in Figure 16. One of the reason of the damages is insufficient foundation depth prevented the structure from transferring the superstructure loads to the ground correctly. At the same time, although there is no structural damage to the structural system members, the structure is separated from its equilibrium position because the overturning moment capacity is exceeded as a result of both insufficient foundation depth and low soil bearing capacity. Soil-related damage is more common in Gölbaşı district. Some more soil-related damages observed in Gölbaşı after both major earthquakes is shown in Figure 16.

**Figure 16.** Examples of soil-related damage.

Sandy or silty soils that have been saturated with water may have a sufficient ability to carry a static load. However, they suddenly behave like a liquid when shaken, such as during an earthquake. If the soil is unevenly or inhomogeneously liquefied, buildings might tilt or completely collapse, which is frequently unavoidable. Therefore, the possibility of liquefaction of such soils should be investigated. Precautions should be taken against soil-related problems when necessary with measures such as injections, piled foundations, etc.

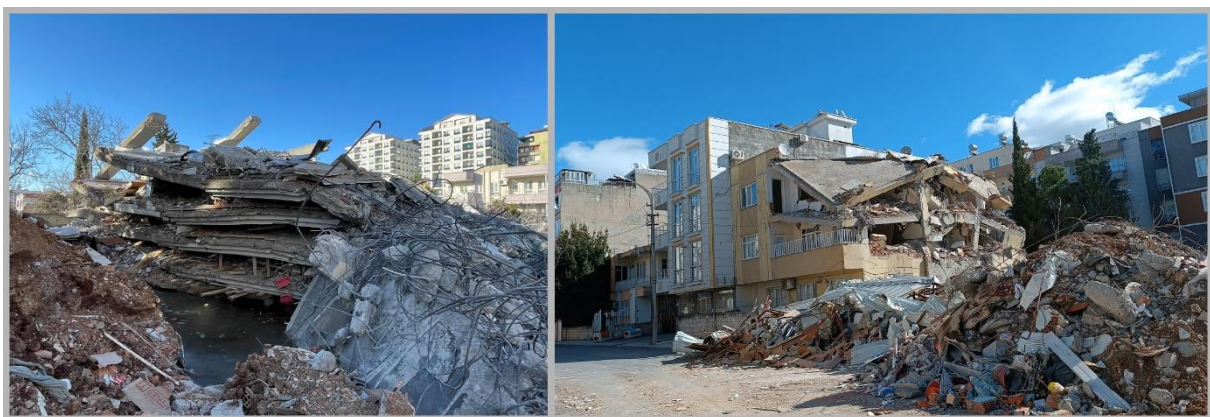
Insufficient connections between the horizontal and vertical structural members of the reinforced concrete (RC) structural system mean that the frame members transfer loads independently. In this case, frame members that do not work together increase the probability of structural damage, causing the structure to suffer much more damage (Figure 17).

**Figure 17.** Failure due to insufficient RC frame.

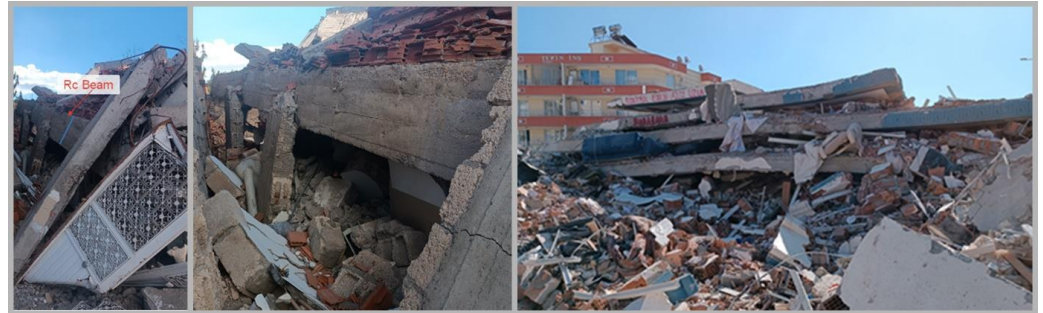
Column–beam dimensions of RC frame systems must be compatible. This situation is explained in the regulations as the end moments required to carry the columns should be 20% more than the total beam end moments, and it is stated that the columns should be built stronger than the beams [59,60]. However, due to this situation, which was not

taken into account during the project and implementation phase, heavy structural damage occurred as shown in Figure 18. As a result of this situation and frame failure, the floors collapsed on top of each other, causing pancake-style collapse.

**Figure 18.** Examples of strong beam–weak column failure.

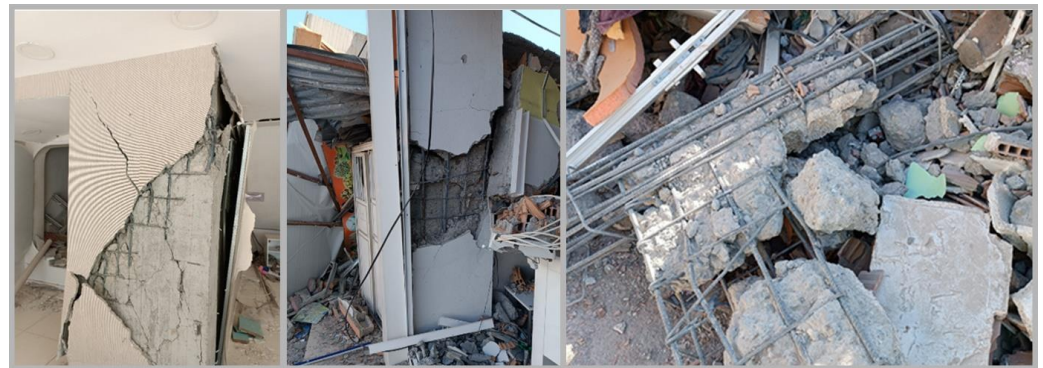
The concrete cover is an important detail that protects the reinforcement from external effects and should be built as a part of the reinforced concrete. However, too little concrete cover, due to poor workmanship, is then covered with plaster [61]. As a result of this, with elements that cannot provide sufficient adherence between concrete and reinforcement, the concrete cover spills, and the structural element is damaged. Examples of such damage are shown in Figure 19.

**Figure 19.** Examples of damage caused by insufficient concrete cover.

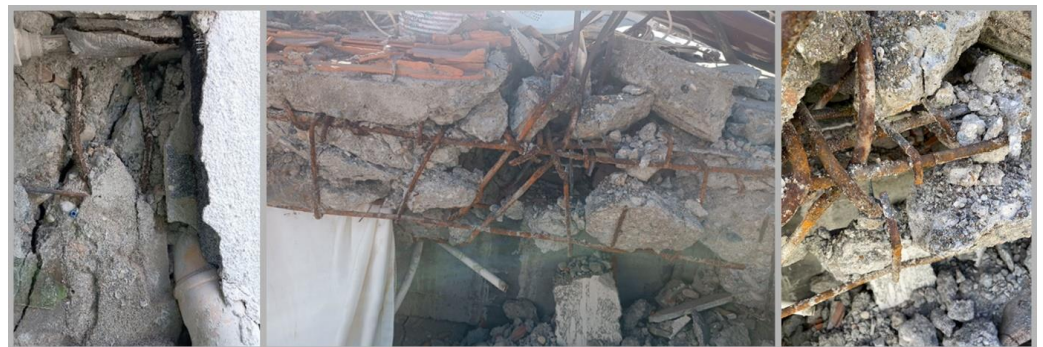
In addition, insufficient concrete cover causes a loss of mass due to corrosion of the reinforcement over time, and as a result, it causes ruptures in the reinforcement and damage by separating it from the concrete. Such damage is shown in Figure 20.

**Figure 20.** Damage due to corroded reinforcement.

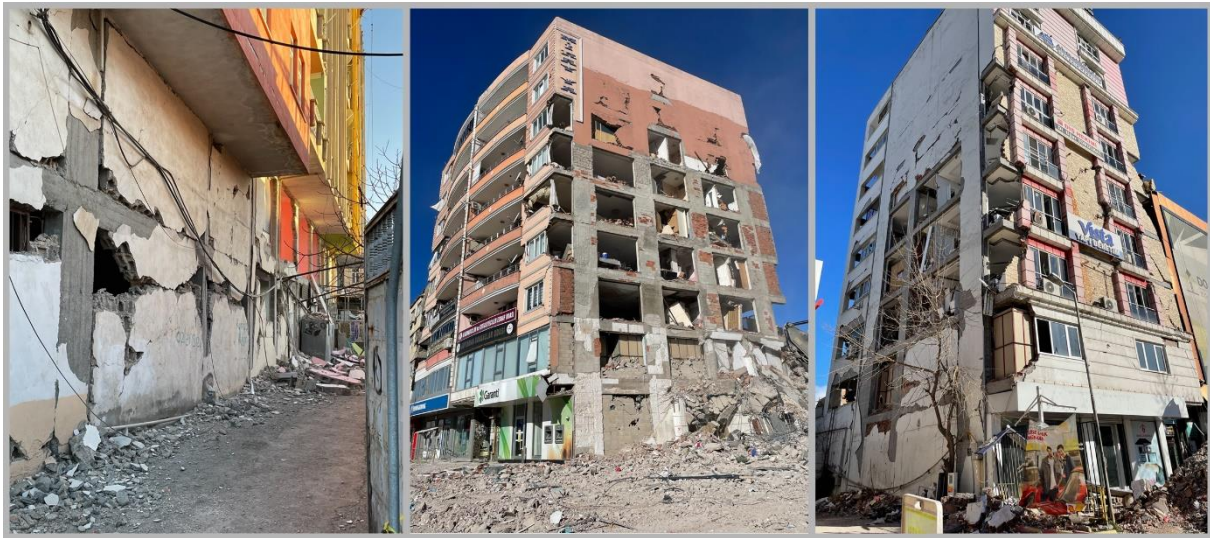
The damage that occurs on the infill walls, which are used for the purpose of dividing and closing the spaces in reinforced concrete structures and which are considered only as a load in the building design, is shown in Figure 21. Infill walls, which are generally constructed of materials with low tensile and shear strength, increase the extent of damage to these members due to poor workmanship. The infill wall damage was widespread, including in- and out-of-plane failures.

**Figure 21.** Examples of infill wall damage in RC structures.

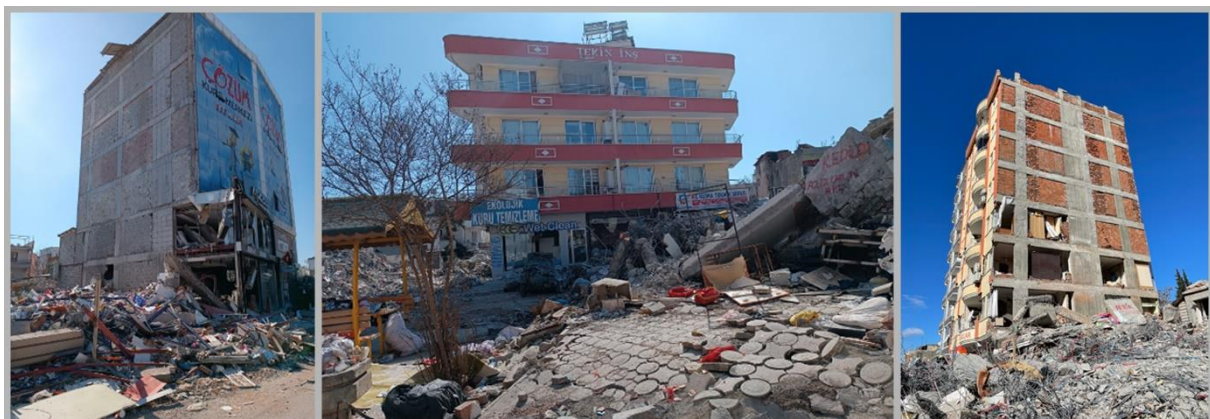
Despite minor structural damage, the safety of life and property was preserved in the structures that were constructed in accordance with the technique requirements during the construction phase by receiving engineering services. In particular, the shear walls used in RC structures have positively supported the behavior of the structures under the influence of earthquakes. Example structures that provide life and property safety are shown in Figure 22.

**Figure 22.** RC buildings that provide life and property safety despite minor damage.

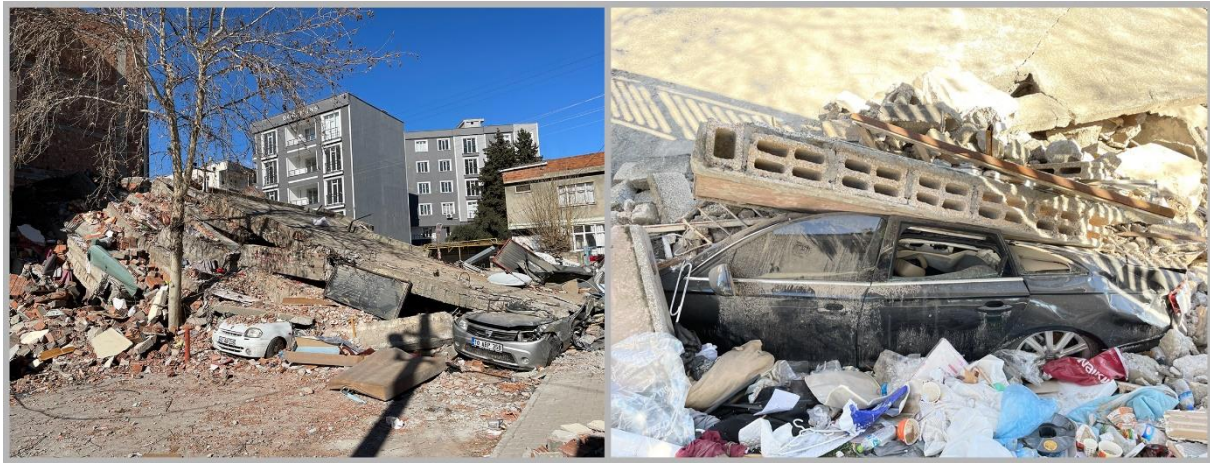
RC buildings that were heavily damaged and collapsed as a result of the earthquake also caused economic losses. In particular, many vehicles have become unusable due to damage by building debris. This damage is shown in Figure 23.

**Figure 23.** Examples of vehicles damaged by collapsed structures.
