A Case Study on the Rehabilitation of a Fire-Damaged Structure

Abstract: This paper presents a case study on the rehabilitation of a fire-damaged structure and describes the results of a site investigation and tests, leading to a plan for the rehabilitation of the structure. The fire took place in the main control room of a thermal power plant and lasted about three hours until it was finally extinguished. To set up a rehabilitation plan for the damaged structure, a visual inspection of the damaged condition was first carried out, which was followed by analysis and on-site material tests indicating the degree of neutralization progress in the remaining structure. Specimens of damaged concrete and reinforcing bars were sampled and tested for their residual strengths. As a conclusion, two methods of rehabilitation were suggested considering the current condition of the structure and the sequence of construction.

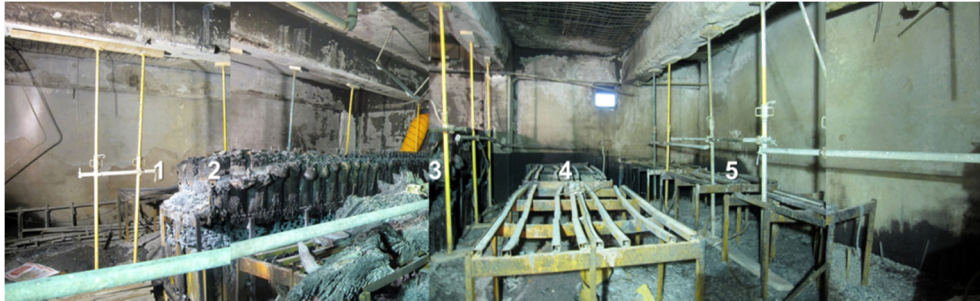
The visual inspection revealed that most of the batteries in the room were burned down, especially the Batteries #1, #4, #5 and #6. For Batteries #2 and #3, part of the battery structures still remained as

shown in Figure 2. This condition coincides with accounts stating that the fire burned longest in the region of Batteries #4 and #5. As a result, the structural elements located above Batteries #1, #4, and #5 experienced relatively severe damage compared with those located above Batteries #2 and #3.

Figure 2. Panoramic view of the battery room during visual inspection.

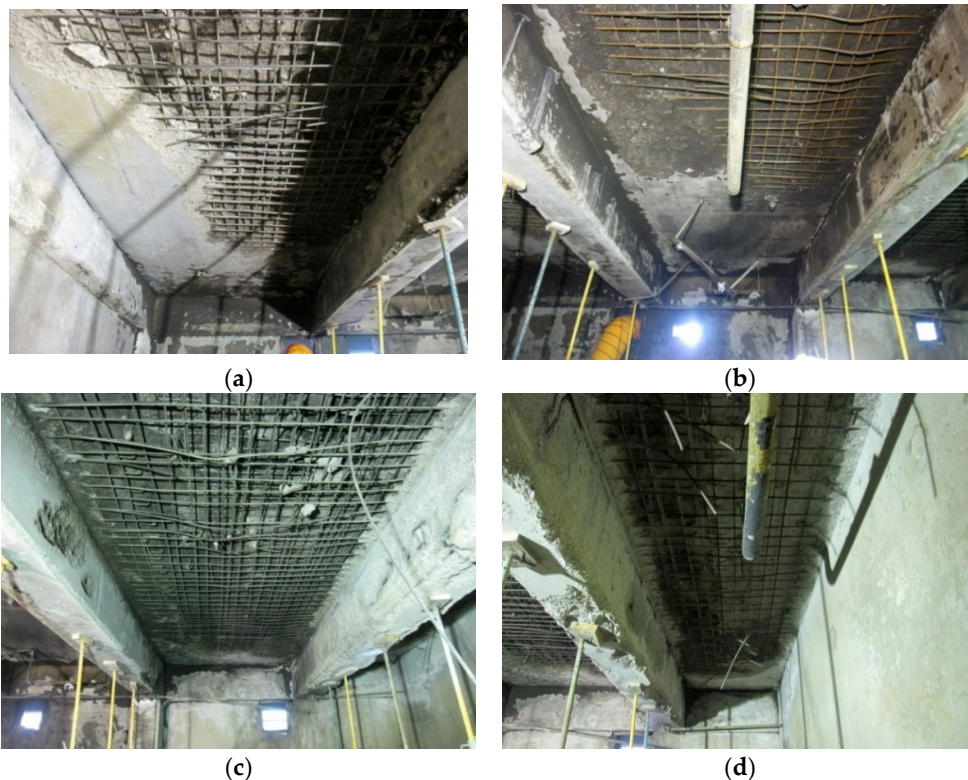
The soffit of the slabs were mostly damaged due to fire as shown in Figure 3. The concrete in the bottom cover and at mid-depth spalled, exposing the reinforcing bars. The damage was more severe in Slabs #3 and #4 than in Slabs #1 and #2. The condition of each slab can be summarized as below:

- Slab #1: More than 50% of the concrete spalled and 60% of bottom reinforcing bars were exposed.
- Slab #2: About 50% of the concrete spalled and 50% of bottom reinforcing bars were exposed.
- Slab #3: More than 90% of the concrete spalled. About 90% of bottom reinforcing bars and 40% of top reinforcing bars were exposed.
- Slab #4: More than 90% of the concrete spalled. About 90% of bottom reinforcing bars and 30% of top reinforcing bars were exposed.

Figure 3. Damage in each span of slab on its soffit, observed from the north. (a) Slab #1, (b) Slab #2, (c) Slab #3 and (d) Slab #4.

Having lost more than half of the concrete volume, all the spans from Slabs #1 to #4 are judged to have degradation in their structural capacity. The main role of the slab is to transfer the transverse load on the slab to adjacent girders and beams. This role must be restored by either replacing the damaged span of slab with new ones or by providing additional load carrying capacity to the slab. The exposed reinforcing bars might have experienced a strength reduction due to the elevated temperature during the fire. To identify the degree of the strength reduction, tests on the rebar specimens from the respective spans of slab were necessary. Although not identifiable at the time of inspection, the floor slab of the room was assumed to have retained its structural capacity and needed no retrofitting.

(5) It is recommended that the slabs be replaced with new ones, and the girders and beams be retrofitted. The columns and walls only need surface treatment without a structural retrofit.

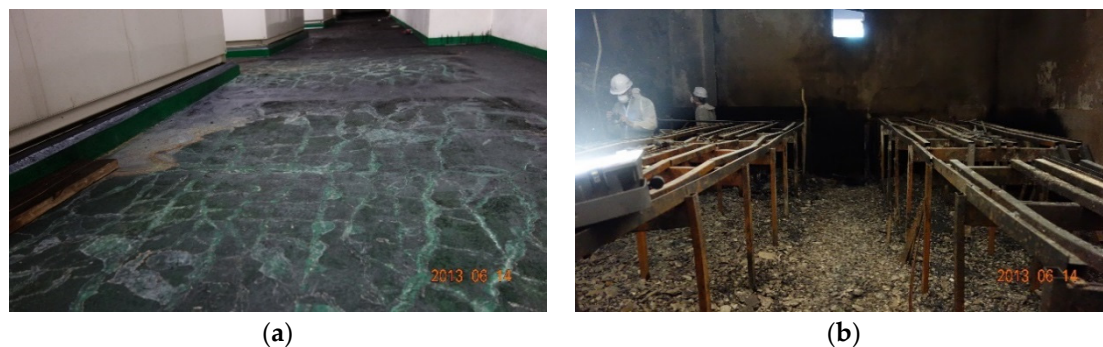
Figure 4a shows the floor conditions of the HVAC (Heating, Ventilation and Air Conditioning) room, which is located right above the battery room where the fire occurred. It indicates that, in the area where the concrete has spalled, a network of cracks has developed on the top surface of the floor slab. At the time of the visual inspection, the damage to the floor slab of the battery room was not identifiable, since the debris on the floor had not been removed (see Figure 4b). Inferring from the fact that the steel structures supporting the batteries remain without excessive deformation, it is assumed that there was little or no structural damage to the floor slab.

Figure 4. (a) Damage to top surface of Slab #3 and (b) pileup of debris under Slab #3 and #4.

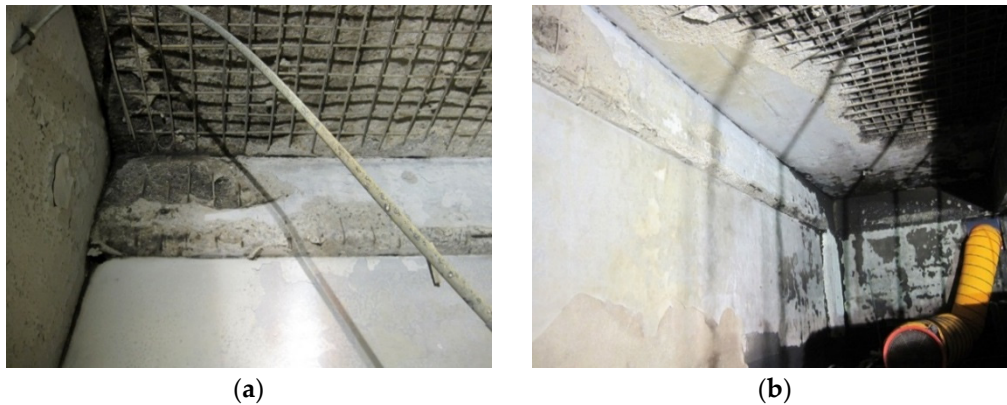
- Girder #1: One longitudinal rebar at the bottom corner was exposed by 1–2 m, and 7 stirrups were exposed due to the spalling of concrete both at side cover and inside the stirrups.

In spite of the spalling of the concrete cover and the exposure of reinforcing bars, the girders and beams were deemed to still retain their designed structural capacity, judging from the fact that neither flexural cracks at mid-span nor diagonal cracks toward the span-ends were found, and deflection at the center of the element was not detected with the naked eye. However, a possible degradation in

Figure 5. Damage to Girder #1. (a) Exposed stirrups in the north region. (b) West side of girder seen from the north.

the load-carrying capacity must be retrofitted by testing the strength of the damaged concrete and the exposed reinforcing bars, and then by providing the required amount of reinforcement to compensate for the degraded capacity.

- Surface repair by epoxy-injection or mortar-grouting.
- Structural retrofit by bonding carbon fiber sheet or by anchoring steel plate around the damaged surface.

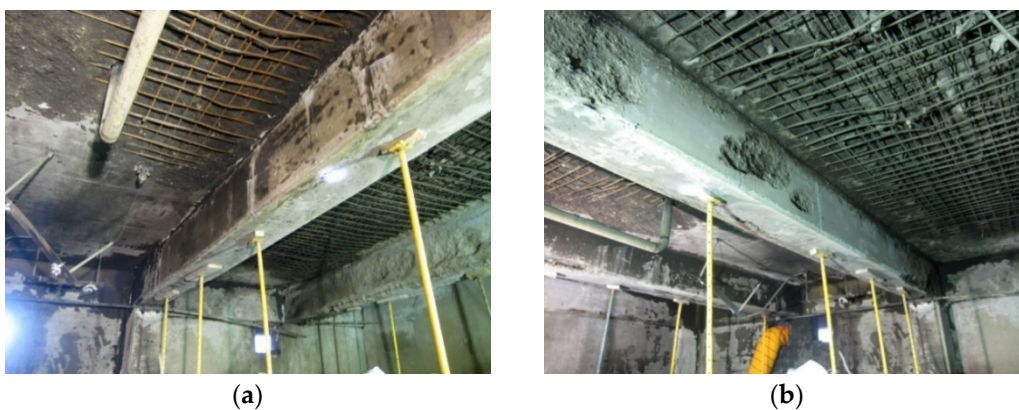
- Girder #2: No marked exposure of the longitudinal rebar was observed. Concrete spalled on the side of Slab #3 at a slight depth. Two stirrups were partly exposed toward the end of the span at the location of Column #3.

Figure 6. Damage to Girder #2. (a) East side of girder seen from the north. (b) West side of girder seen from the north.

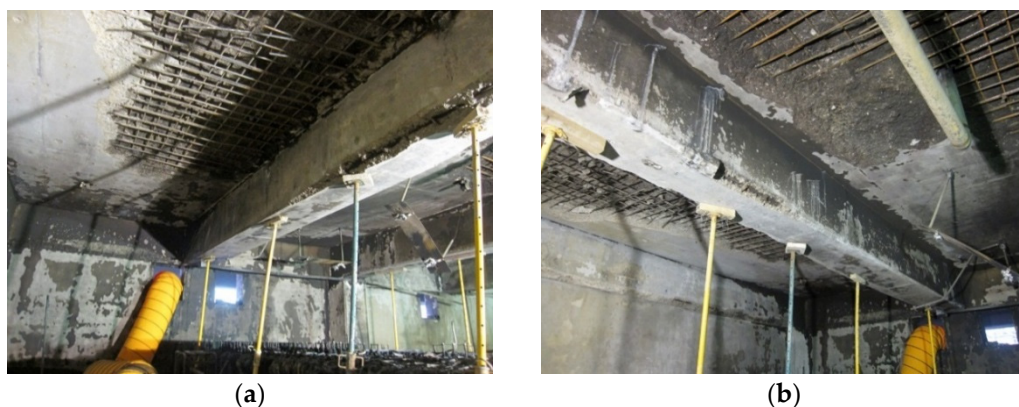
- Beam #1: Longitudinal rebar was exposed at each corner by about 4 m. Sides of the beam are not deemed to have been affected by fire.
- Beam #2: Extensive spalling of the concrete cover both at bottom and sides was observed. Longitudinal rebar was exposed at the corners, and stirrups were slightly visible at some areas.

Figure 7. Damage to Beam #1. (a) East side of beam seen from the north. (b) West side of beam seen from the north.

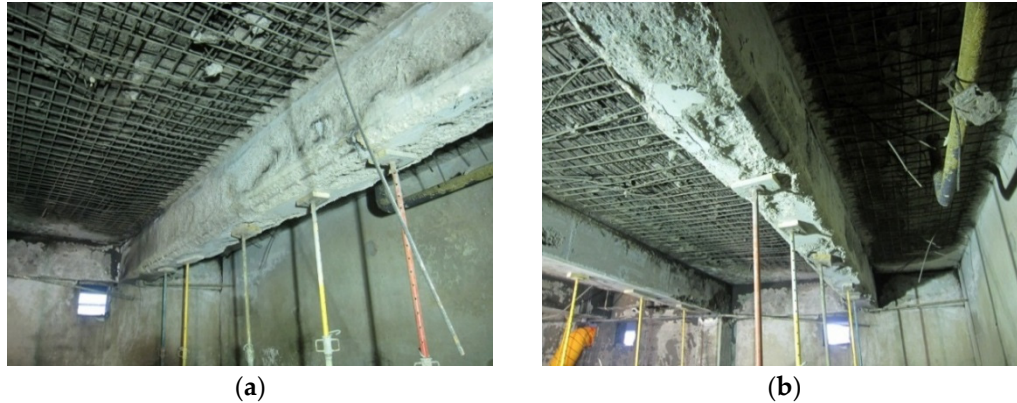
Figure 8. Damage to Beam #2. (a) East side of beam seen from the north. (b) West side of beam seen from the north.

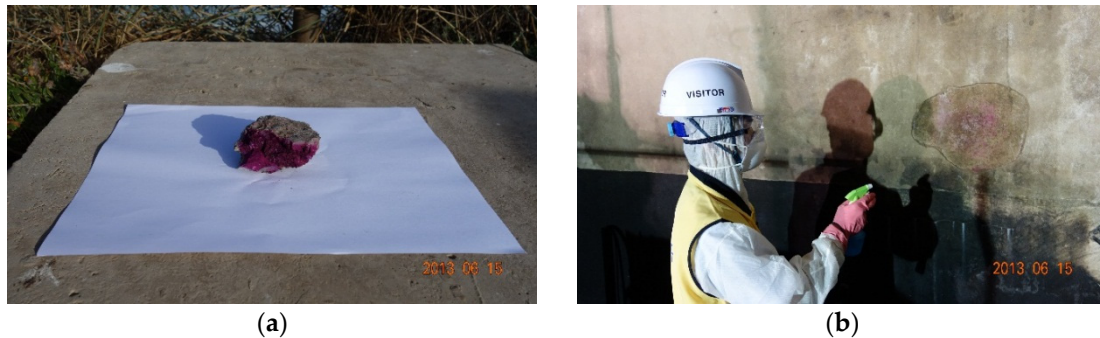
The test was first performed on a sample piece of concrete popped out from the slab and on a part of wall where the plaster had already spalled, respectively, and then on small part of Girder #1 and Beam #2, both on the surface and inside the side cover. Both the piece of concrete and the part of the wall changed color almost instantaneously when the phenolphthalein indicator was applied as shown in Figure 9.

Figure 9. Neutralization tests on damaged concrete. (a) Tests on a sample piece of slab concrete. (b) Test on the surface of wall.

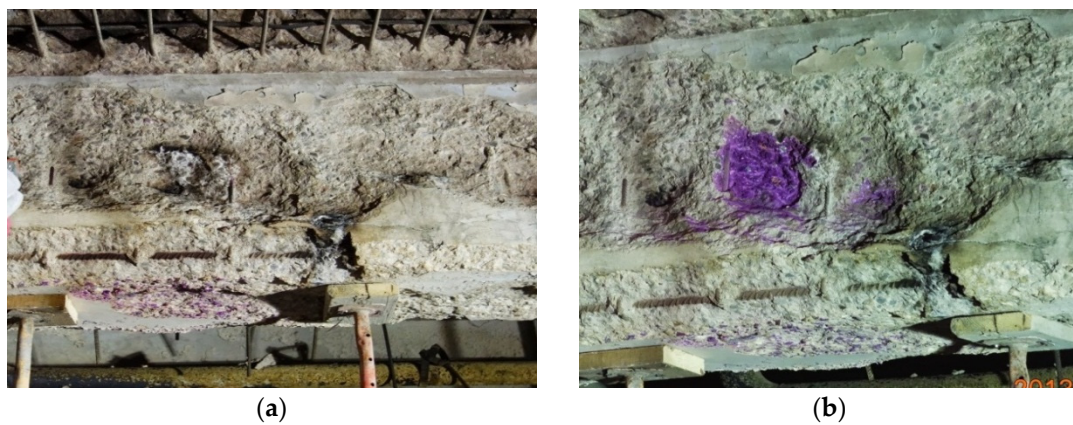
During the test on the girder and the beam, 1% phenolphthalein solution was first applied to their side surfaces that were affected by the fire without treating the surfaces. As shown in Figure 10a, the

color did not change in most of the region, with a purple area where the alkaline concrete reacted to the indicator. When the indicator was applied after chipping out the surface of concrete by 10 mm, a significant change in the color was immediately observed as shown in Figures 10b and 11. Therefore, the girder and beam are judged not to have experienced a maximum temperature of more than 500 °C and, as a result, have remained sound. We infer that the concrete in the girders and beams spalled during the fire not due to the degradation of the concrete itself, but to the sudden increase in temperature at the upper level in the room. The elevated temperature is deemed to have caused the expansion of the aggregate inside the concrete and to have weakened the so-called transition zone between the aggregate and the cement matrix.

Figure 10. Neutralization test on (a) the side surface and (b) inside of Beam #2.

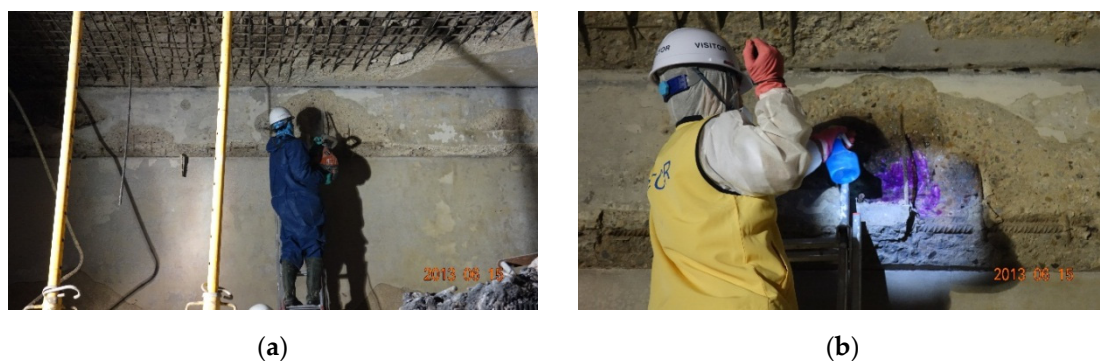
Figure 11. Preparation of the surface of Girder #1 (a) and application of phenolphthalein indicator (b).

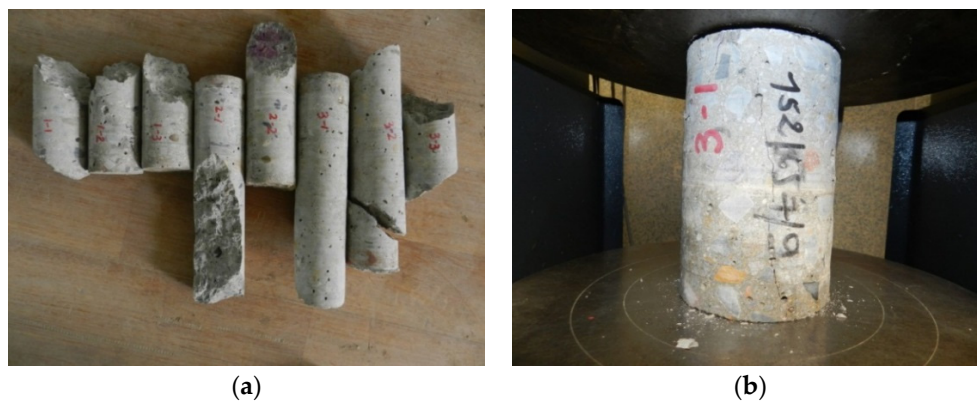
Figure 13. (a) Cored specimens and (b) specimen 3-1 after the test.

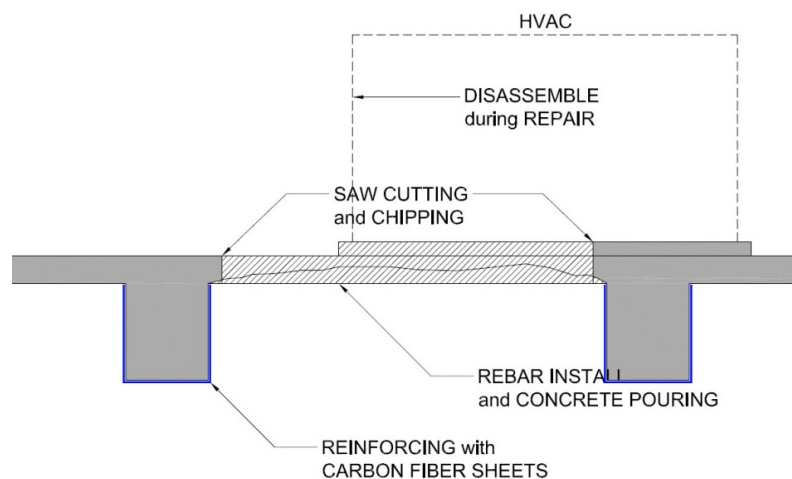
Figure 17. Rehabilitation plan with HVAC (Heating, Ventilation and Air Conditioning) removed during rehabilitation work.

Regarding the retrofit methods of the damaged slabs, there are two options depending on the handling method of the HVAC system located right above the battery room. The differences between the two options are analyzed in Table 4. They are also illustrated in Figures 17 and 18 respectively.

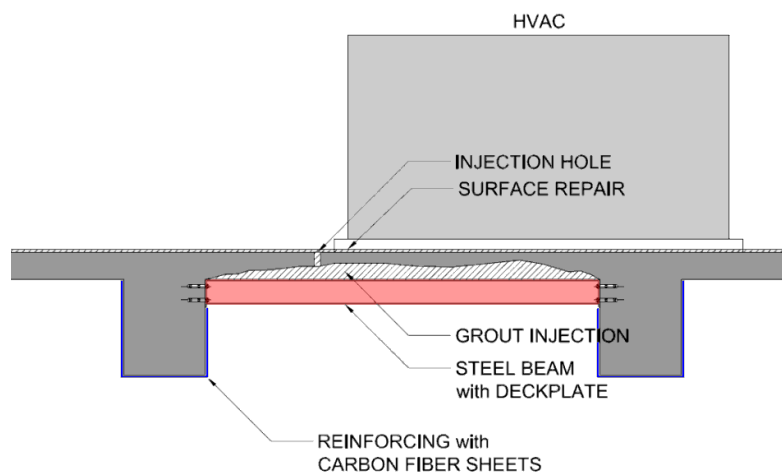
Figure 18. Alternative rehabilitation plan with HVAC remaining in position during rehabilitation work.

(6) Considering the tight construction schedule and complexity of rehabilitating work, including the dismantling and reassembly of HVAC system in upper floors, a more efficient method of work is proposed as an alternative plan: a series of steel beams and deck plates perform the role of temporary slabs during the rehabilitation work and act as permanent supplementary slab when the rehabilitation work is over.
