# Failure Analysis of Topside Facilities on Oil/Gas Platforms in the Bohai Sea

**Keywords:** jacket platform; ice-induced vibration; failure mechanism; ice-resistant cone

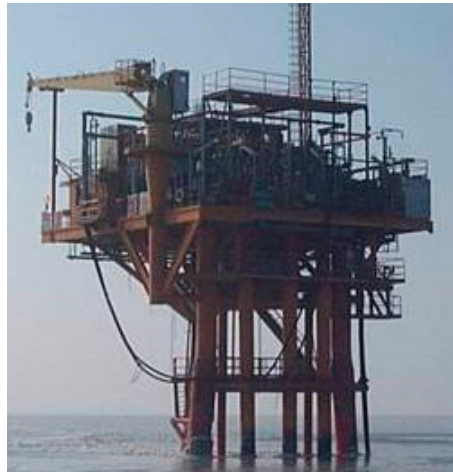
**Figure 1.** The natural gas platform where the accident took place.

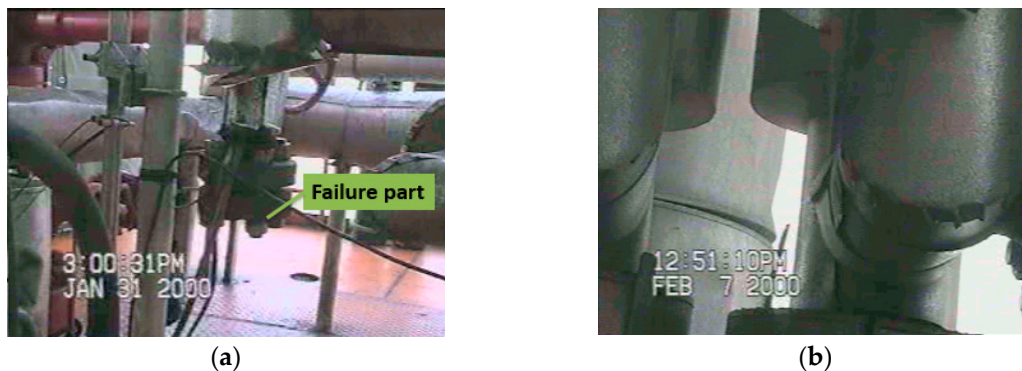
**Figure 2.** Sea-ice damage to platforms in Bohai: (a) Rupture of a blow down pipeline. (b) The loose flange.

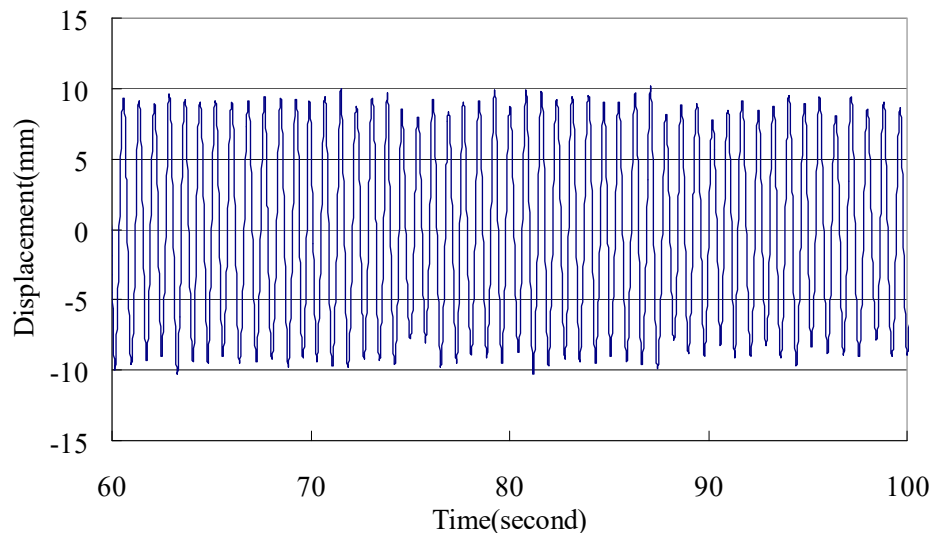
Natural gas pipelines are an important component of offshore platforms. During a period of intense ice formation, the blow-down pipeline in the upper platform shook violently and was fractured. The ice-induced vibration resulted in the leakage of natural gas. In the vibration curve, obtained by field monitoring (Figure 3), it can be seen that there was a strong steady-state vibration of the platform when the accident occurred.

**Figure 3.** Displacement curve of the top deck when the pipeline fracture occurred.

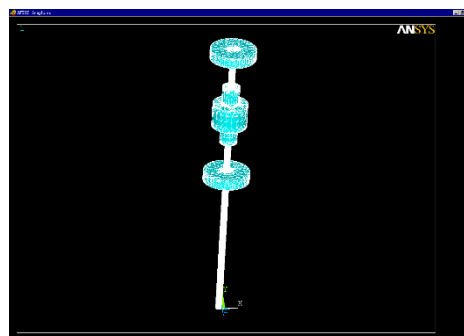
Figure 4 shows a part of the blowdown pipeline after the accident. Mechanical analysis revealed that the blowdown pipe belongs to the cantilever structure and the fixed part is connected to the deck. The horizontal ice-induced shaking that occurred on the fixed part of the pipe was found to be equivalent to the bending vibration caused by a seismic load. This eventually caused a whiplash effect.

**Figure 4.** Partial structure of the blowdown pipe.

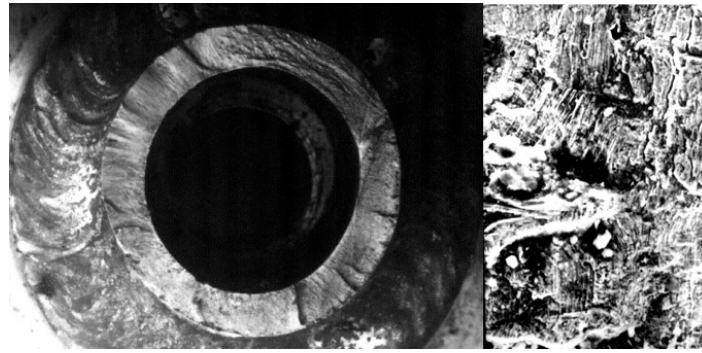
A fracture analysis of the affected section of the blowdown pipe (Figure 5) identified the following characteristics:

1. The fractured surface, which was a typical fatigue fracture, had an obvious fatigue source zone, a fatigue crack propagation zone, and a fatigue fracture zone.
2. The fracture was perpendicular to the axis, which meant that the fatigue fracture was caused by a bending load.
3. The fracture surface was uneven, with no obvious fatigue curve, and the distance between fatigue striations was large, illustrating low-cycle fatigue fracturing under high stress.

Study of the fixed part of the blowdown pipe indicates that the fatigue fracture load was a bending load. The following conclusions were made by analyzing the macro- and micro characteristics of the fracture: The fracture of the blowdown pipe had obvious fatigue features, and it exemplified a low-cycle fatigue fracture under a bending load. When the damage caused by alternating external loads reached a certain degree, it resulted in fatigue failure. The severe ice-induced vibration accelerated the fatigue failure of the blowdown pipe and eventually caused the ejection of high-pressure natural gas.

**Figure 5.** The fractured edge of the blowdown pipe.

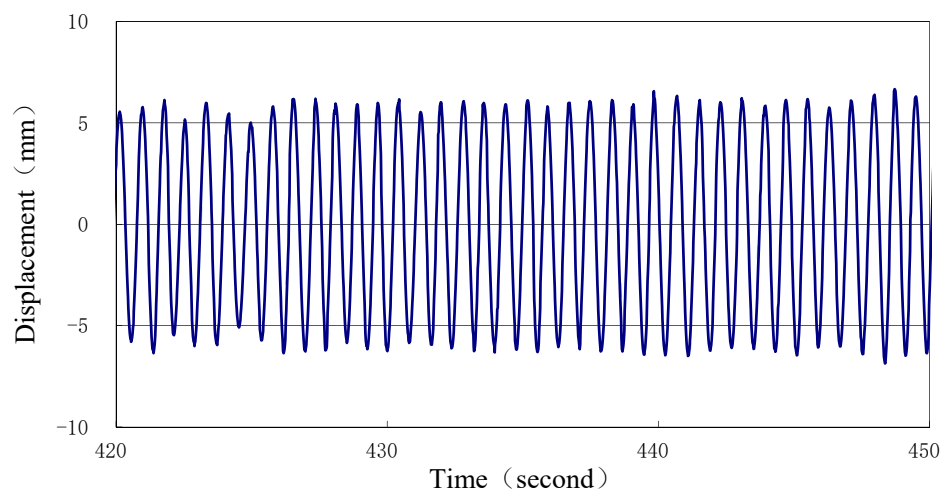
Figure 6 shows the severe ice-induced vibration, which resulted in loosening of the flange of the platform's upper deck valve, and subsequent leakage of natural gas. An inspection of the platform after the accident revealed that the graphite spiral gasket flanges had 47% loose bolts, and the remaining had pretightening force of at least 50 N-m, after the system was fully depressurized. It was revealed that the reduction in flange pretightening force caused by bolts loose was the main reason for the flange failure.

**Figure 6.** Displacement curve of the top deck when the accident occurred.

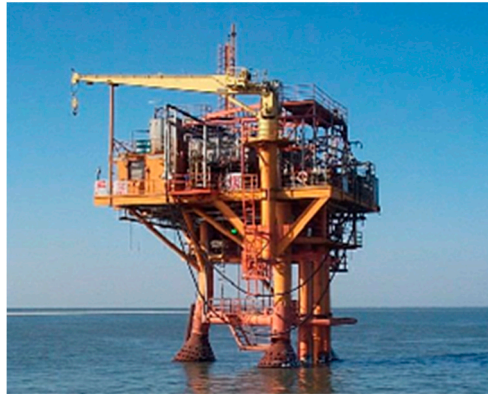
**Figure 16.** The ice-resistant modification of the platform.

The analysis discussed above resulted in an ice-resistant platform being created in the winter following the accident (Figure 16). By installing an ice-resistant cone, the ice sheet damage model changed from crushing destruction to bending destruction, thereby eliminating ice-induced self-excited vibration. In addition, continuous field-monitoring data was recorded, and the effect of the ice-resistant modification was evaluated.
