Condition Assessment of Solar Modules by Flash Test and Electroluminescence Test

István Bodnár, Dávid Matusz-Kalász *, Rafael Ruben Boros and Róbert Lipták

Institute of Physics and Electrical Engineering, University of Miskolc, 3515 Miskolc-Egyetemváros, Hungary; vegybod@uni-miskolc.hu (I.B.); elkruhen@uni-miskolc.hu (R.R.B.); elkrobi@uni-miskolc.hu (R.L.)

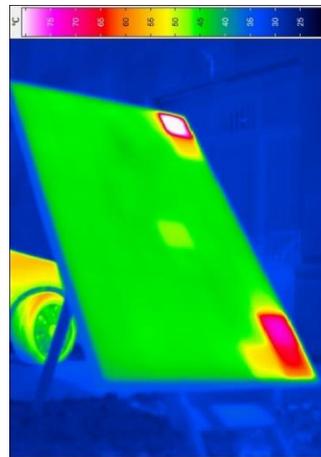
test results, it can be stated that the panel was in good condition. However, dirt deposited in the corners can cause damage. The two contaminated corners shown in Figures 2 and 3 were covered only by a thin layer of deposited dust.

Figure 2. Thermal image of a dirty solar module.

In order to prevent this problem, more attention should be paid to the effect of surface contaminants. It is advisable to perform thermal camera examinations more frequently using flying drones. The degree of air pollution must be taken into account when starting

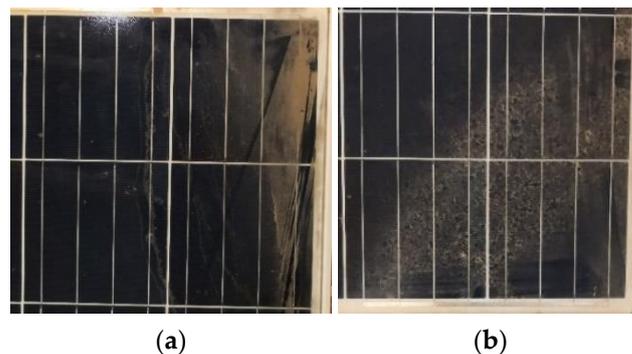
Figure 3. (a) Deposited dirt in the top corner; (b) Deposited dirt in the bottom corner.

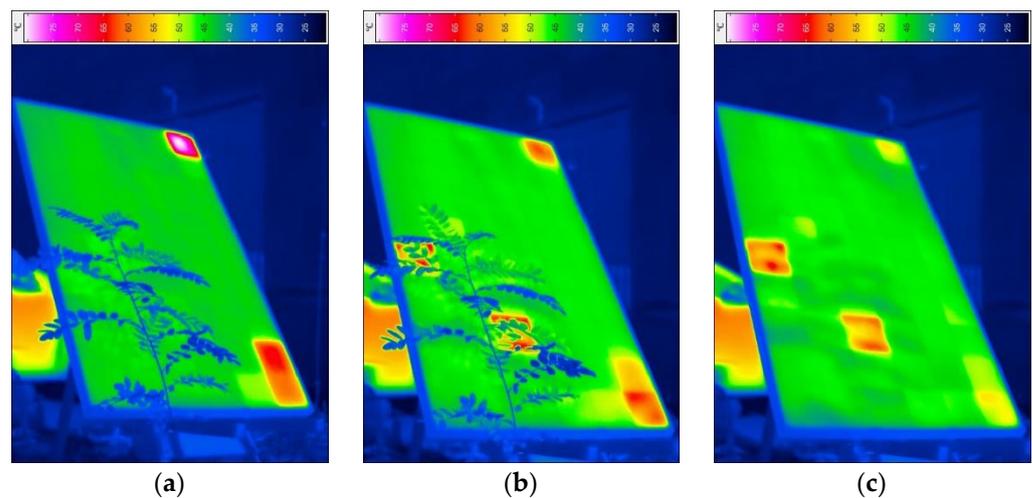
Figure 4 shows the additional tests that prove the correctness of Figure 2. In the first step, we placed a tree branch in front of the panel (Figure 4a). The tree branch caused moderate cooling in a significant area as the sunrays could not reach the solar cell surface. However, in the case of cells that were completely shaded, intense warming occurred. The explanation is the same as for the effect of surface contamination. As a second step, we cleaned the corners causing them to cool (Figure 4b). Finally, we removed the tree branch (Figure 4c).

Figure 4. (a) Tree branch placed in front of the examined solar module; (b) The module after cleaning the corners; (c) The module with the cooled corners after the tree branch was removed.

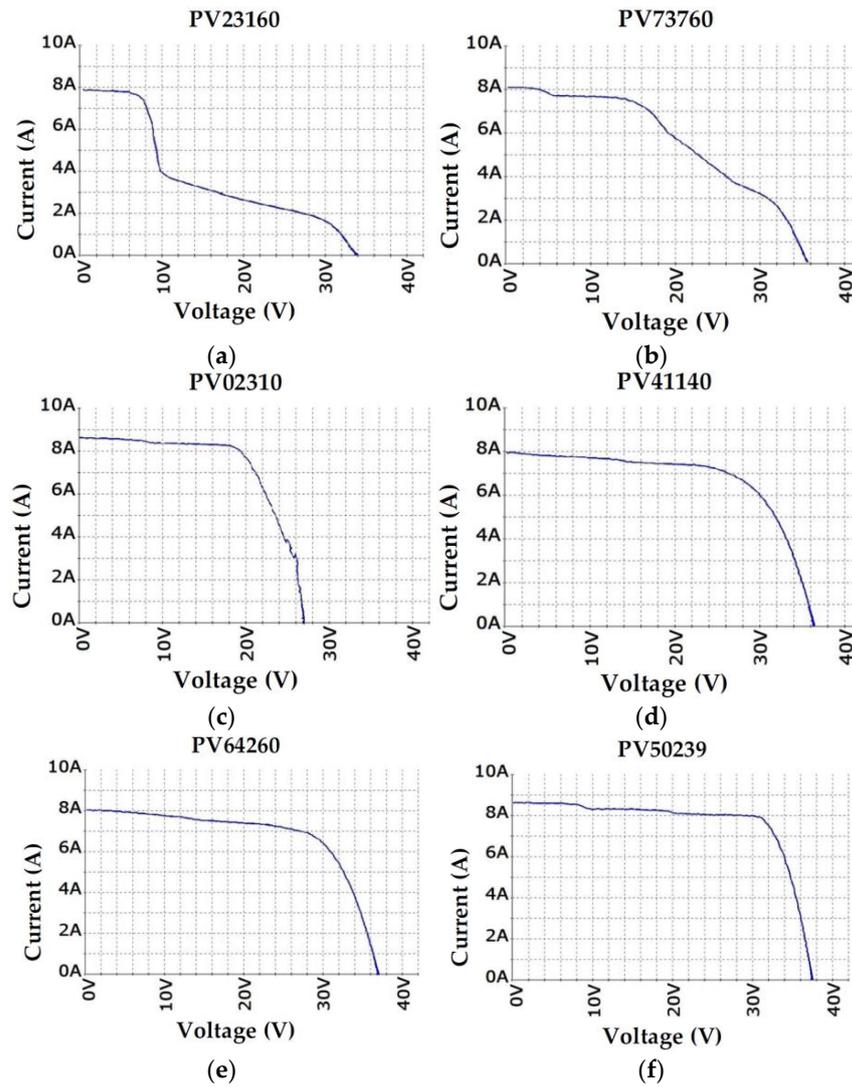
Table 1 shows the electrotechnical results and the Figure 5 shows the I–V characteristics of several flash tests. The performance of the most malfunctioning module (PV23160) was only 26.3% of the manufacturer’s data. This value is in sharp contrast with the performance guarantee, and module was virtually completely damaged. The value of the maximum operating point voltage was only one-fourths of the manufacturer’s value. However, the value of the operating point current was proportionally much better, near to the normal value. Based on the electrotechnical parameters, it can be seen that a significant decrease in the voltage of the module can cause some cell damage and their destruction. The voltage of PV73760 and PV02310 modules was low, only about one-thirds of the normal value. The maximal power of both was also low, only 55.5% and 69.4%. PV41140 and PV64260 modules were in a good condition according to the electrotechnical parameters but over the 10% limit. Their maximal power was 87.2% and 89.2%. This assumption is supported by the electroluminescence test (Figures 6–11) [12,20–24].

Figure 5. I-V characteristics of (a) PV23160 module; (b) PV73760 module; (c) PV02310 module; (d) PV41140 module; (e) PV64260 module; and (f) PV50239 module.

Figure 5 illustrates the resulting I–V characteristics obtained by six differently behaving solar modules in a flash test [12]. It is well observed that the I–V curve of PV23160 module (Figure 5a) and PV73760 module (Figure 5b) does not correspond to the characteristics of a fault-free solar module; it is far from both the ideal and the practical curve. In case of PV02310 module (Figure 5c), it can be observed the effect of the non-functioning cells in two whole rows (Figure 8). The curve of PV41140 and PV64260 module shows, that these modules operate well with a small-scale power reduction (Figure 5d–e). In Figure 5f, the practical characteristic curve of the solar module (PV50239) can already be clearly recognized [13].

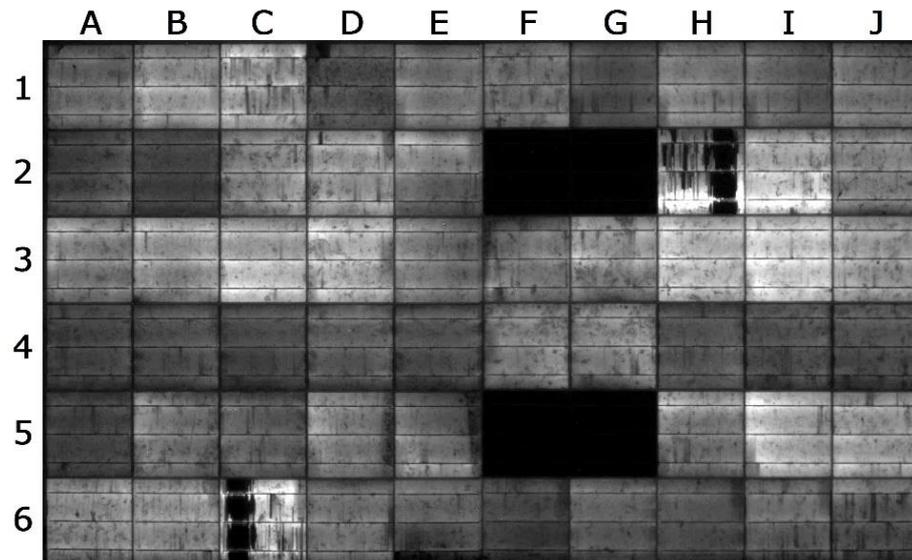
Figure 6. The electroluminescence image of PV23160 solar module that failed the flash test.

During the electroluminescence tests, all the listed types (in the Introduction chapter) of faults were detected on the solar panel. The following electroluminescent images can be well connected to the I–V curve of the modules [12]. As in Table 1, the EL images follow the order of the degree of damage. As the modules measure $1.64 \text{ m} \times 0.99 \text{ m}$ (length \times width), the aspect ratio is 1:14 in Figures 6–11. Firstly, Figure 6 shows the electroluminescence image of PV23160, which is the most malfunctioning one. There are nonfunctioning cells in the second and fifth row (F2, G2, F5 and G5). Therefore, those lines do not generate electricity. The voltage is 27.4% of the manufacturer’s data. Many cells are in good condition, but critical cracks can be observed in H2 and C6.

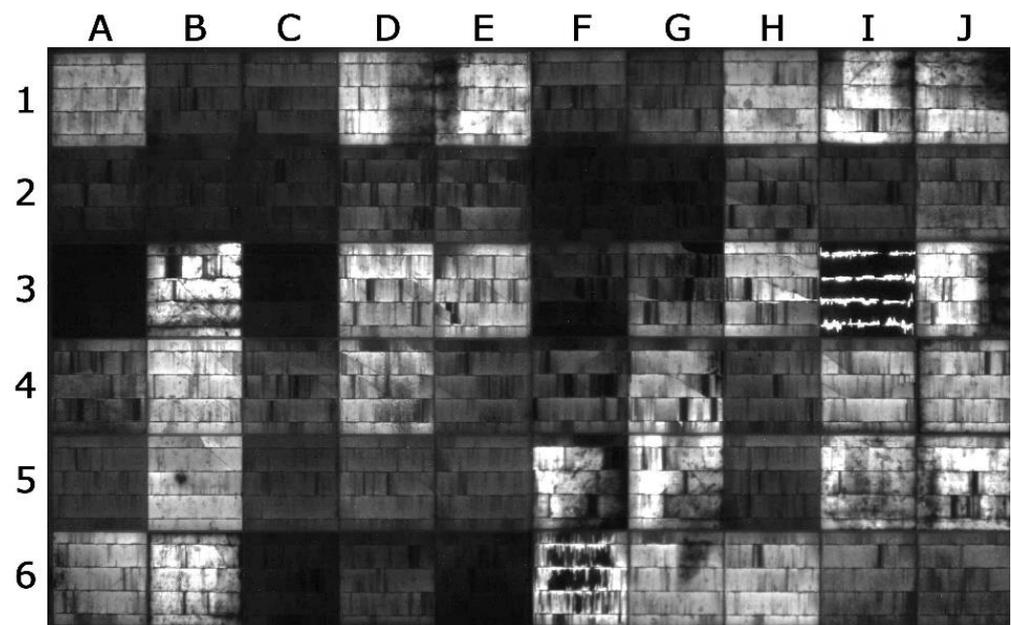
Figure 7. Electroluminescence image of a severely damaged PV73760 solar module.

Figure 7 shows the electroluminescence image of a solar module (PV73760) whose power was about the half of its rated peak power (144 Wp, 55.5%, Table 1) during the flash test. Visible full cell burnout (A3), non-critical microcracks (B4, C4), critical cracks (I3) [25], and local solder failure (B5). Several cells contain finger interruptions (e.g., A4, D3, H3) [26].

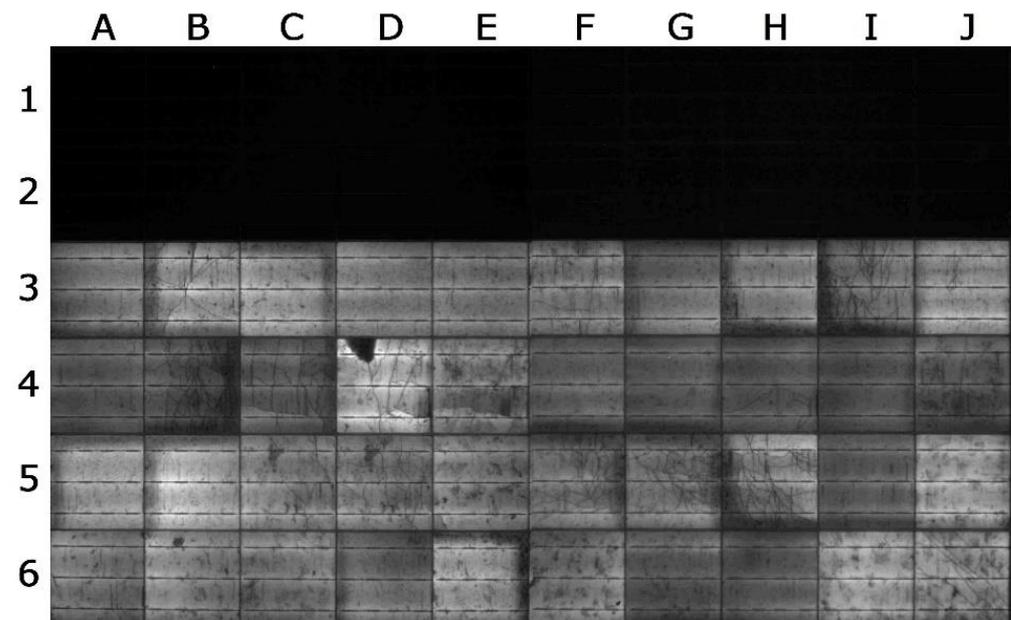
Figure 8. Electroluminescence image of PV02310 solar module with permanently shaded rows.

Figure 8 shows a panel (PV02310) that can certainly come from the bottom row of a table. Lines 1 and 2 may have been too close to the ground and shaded by the upper modules of the other table. This is the result of an installation error when the distance between the two tables was not properly determined. In addition, many cells show cracks and cobweb fractures (B3, B4, H5, I3, etc.). A cell piece detachment is observed on cell D4 and a local solder failure (B6). Due to the totally non-functioning two rows, the measured voltage is 20.91 V (60.1% of normal value, Table 1). The other four rows are still able to generate electricity.

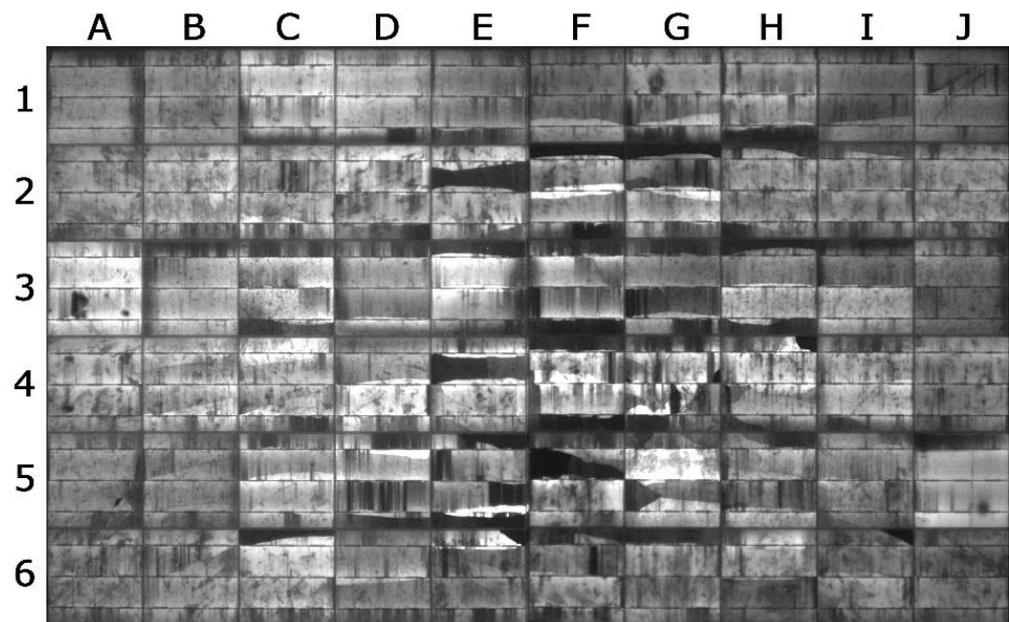
Figure 9. Electroluminescence image of an average damaged PV41140 solar module.

Figure 9 shows the electroluminescence image of a solar panel (PV41140) that failed to meet the expected power level. The power reduction of this module was over 10%. The measured maximal power was 226.7 Wp (Table 1). In Figure 9, columns E, F, and G contain “blind spots” caused by wide cracks, i.e., inoperable cell sections (e.g., C6, E4, F5) [25]. Many cells contain finger interruptions in the whole image (e.g., C2, D5, H5, etc.) [26] and also several cells contain cracks (A6, B6, C4, etc.) [25–30].

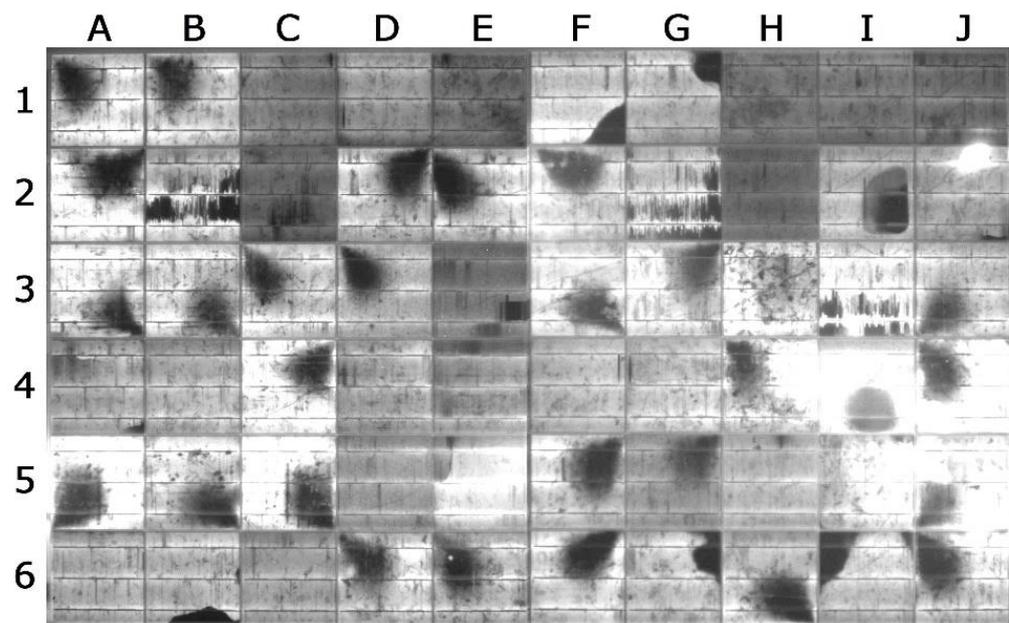
Figure 10. Electroluminescence image of PV64260 solar module.

Figure 10 shows an electroluminescence snapping of a solar panel (PV64260) showing signs of material defect due to dust deposition. These large dark spots appear to be in the form of shells or funnels (A1, B1, C3, D3, etc.) Cell breakage is observed in cells B6, F1 and I3 [25]. For five more wafers, a large, obligated cell element can be observed (B2, F1, G1, G6, and I6) [31–35].

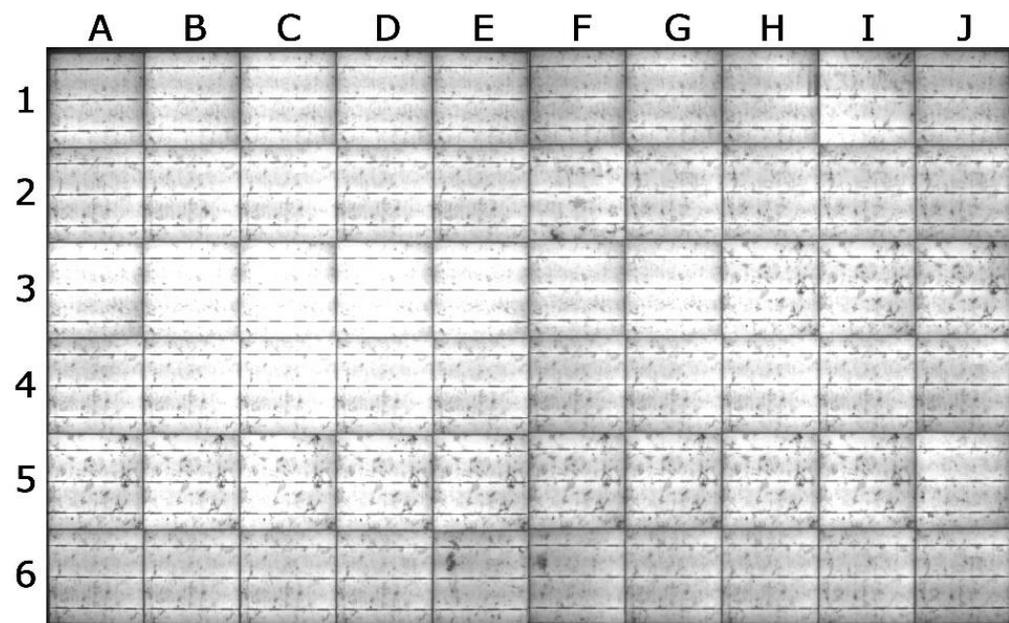
Figure 11. Electroluminescence image of a well-functioning PV50239 solar module.

Figure 11 shows the electroluminescence snapping of a solar module (PV50239) whose power was able to provide manufacturer power during the flash test. All cells are bright, with no cracks or breaks visible. Tiny dark spots may be explained by a material defect in a similar pattern on several wafers. This is not a significant manufacturing failure. These small defects do not prevent the module from working properly.

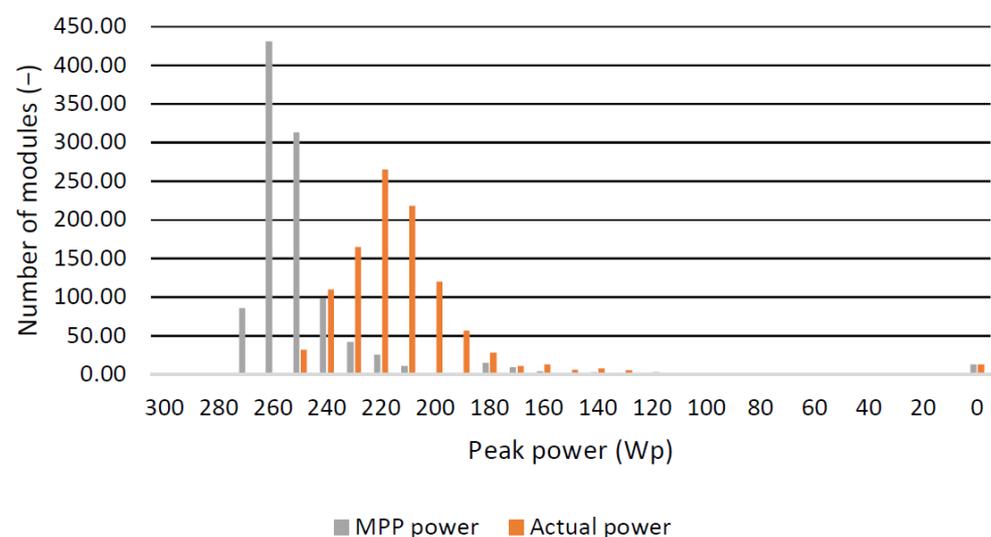
Figure 12 shows the distribution of two value types, MPP power and actual power. The MPP power values are derived directly from the flash test, whereas the actual power values are the results of the in-situ measurement. A closer look at the distribution of the MPP power series shows that the maximum performance of many panels is around 270 W. This was explained by the fact that, unlike the official data (260 Wp), many modules were already more powerful than the others at the time of installation. According to the results in the third column of Table 1, the modules have a power of 260 Wp and the value of the performance tolerance (3%) and measurement tolerance is 3%. This means that the minimum permissible power value during installation is 252.2 W, which changes to 244.63 W with the measuring tolerance. On the other hand, the maximum power is 267.8 W, with the measuring tolerance this value is 275.83 W.

Figure 12. Distribution of measured power values.

The median of MPP power series is 259.70 Wp, and the average MPP power value is 250.76 Wp. The average difference is 17.68 Wp and the standard deviation is 36.98 Wp. 29% of the values is between of 250 and 260 W (313 modules). Around 27% of MPP power values are less than 252.2 W (282 modules), and 16% were less than 244.63 W (173 modules). The panels have a 90% performance guarantee for the first 10 years and an 85% performance guarantee for the next 10–25 years. After four years, 10% of the modules (107 modules) suffered a performance reduction of more than 10%. If the actual power values are taken into account, we obtain a much worse end result after summing the data. The median of actual power series is 221.55 Wp, and the average actual power value is 215.68 Wp. The average difference of actual power series is 19.27 Wp and the standard deviation is 34.49 Wp. 3% of the values are between of 250 and 260 W (313 modules). Around 98% of MPP power values are less than 252.2 W (1043 modules) and 92% are less than 244.63 W (976 modules). Furthermore, 76% of the modules (811 modules) suffered a performance reduction of more than 10%.

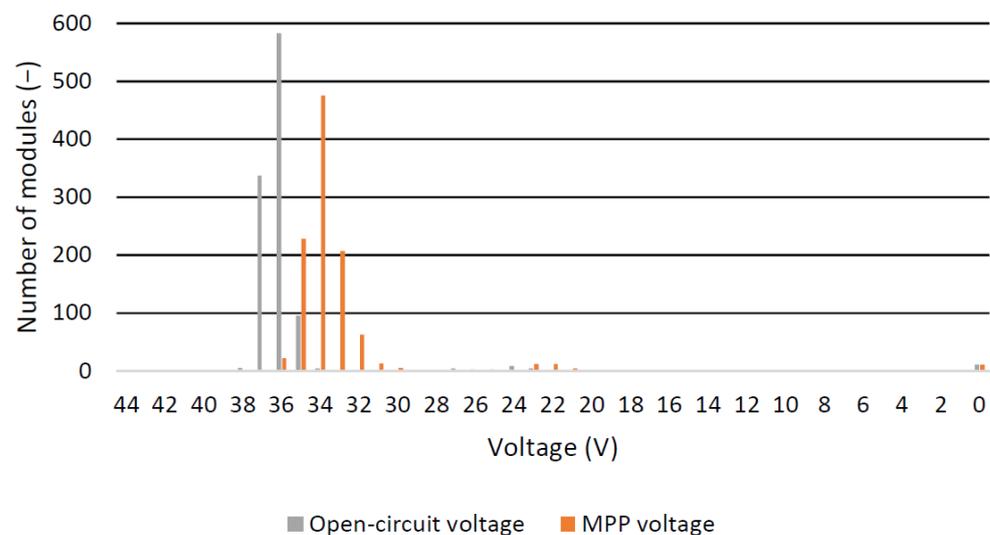
Figure 13 shows the distribution of measured voltage series. The median of MPP voltage series is 34.44 V, and the average MPP voltage value is 33.56 V. The average difference of MPP voltage series is 1.78 V and the standard deviation is 4.34 V; 45% of the values are between of 34 and 35 V (476 modules) and 51% of the values are under 34.4 V (manufacturer data from Table 1). The median of open circuit voltage series is 36.7 V, and the average open circuit voltage value is 36.01 V. The average difference of open circuit voltage series is 1.43 V and the standard deviation is 4.30 V; 55% of the values are between of 36 and 37 V (583 modules) and 61% of the values are under 36.54 V (manufacturer data from Table 1).

Figure 13. Distribution of measured voltage values.

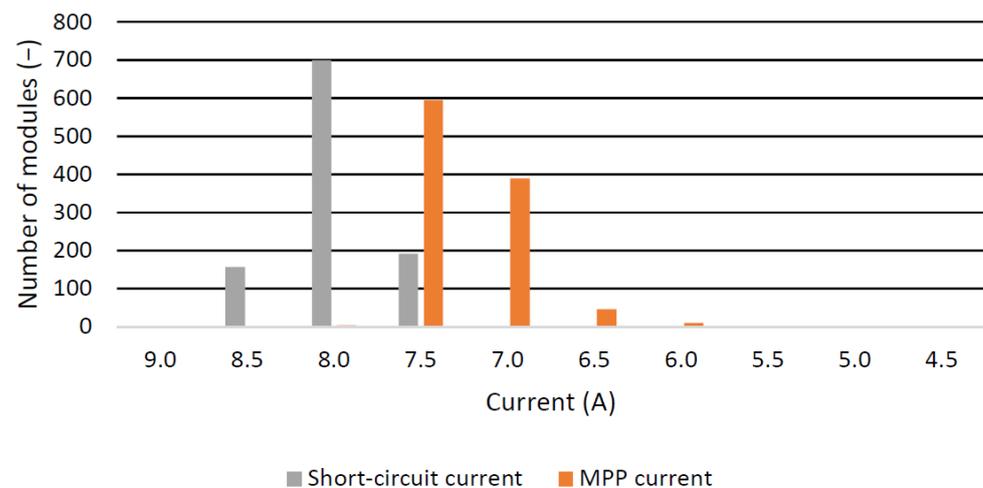
Figure 14 shows the distribution of measured current series. The median of MPP current series is 7.53 A, and the average MPP current value is 7.38 A. The average difference of MPP current series is 0.34 A and the standard deviation is 0.93 A; 56% of the values are between of 7.5 A and 8.0 A (594 modules) and 37% of the values are under 7.47 A (manufacturer data from Table 1). The median of short circuit current series is 8.24 A, and the average short circuit current value is 8.13 A. The average difference of short circuit current series is 0.33 A and the standard deviation is 0.97 A; 66% of the values are between of 8.0 A and 8.5 A (699 modules) and 11% of the values are under 7.92 A (manufacturer data from Table 1).

Figure 14. Distribution of measured current values.
