Case Report

Combination of Diagnostic Tools for the Proper Identification of Moisture Pathologies in Modern Residential Buildings

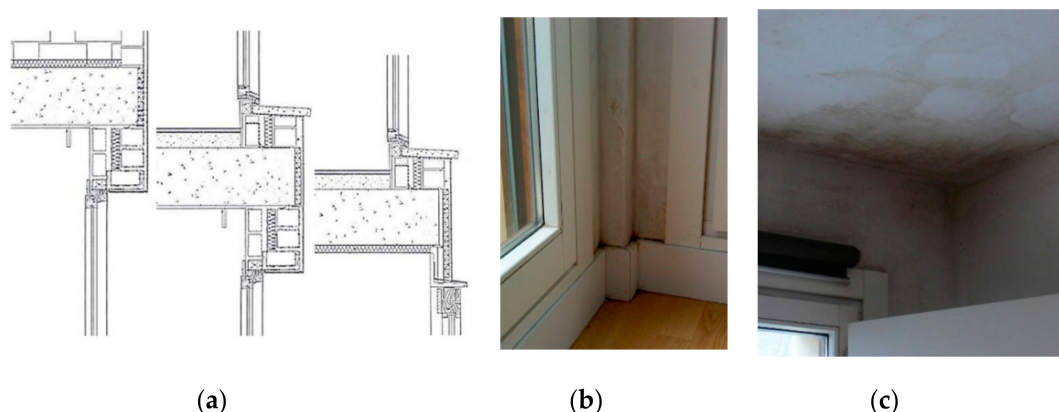
Figure 2. (a) Constructive section in detail; (b) dwelling 1A pathologies; (c) dwelling 1E pathologies.

Numerous areas with water condensation, mold, and deformed wooden elements, such as skirting boards or window frames, were detected in six out of the 14 investigated dwellings. All the problems were located in the North façades of the first and the second floors, in dwellings with letters A, D, and E, see Figure 1a. The façades of other dwellings did not have visible pathologies or moisture-related

problems. Large growths of mold and microorganisms were especially apparent in the corners of pillars, ceilings, and window perimeters. Dwellings located in the attic did not have any humidity problems and were thus excluded from the study.

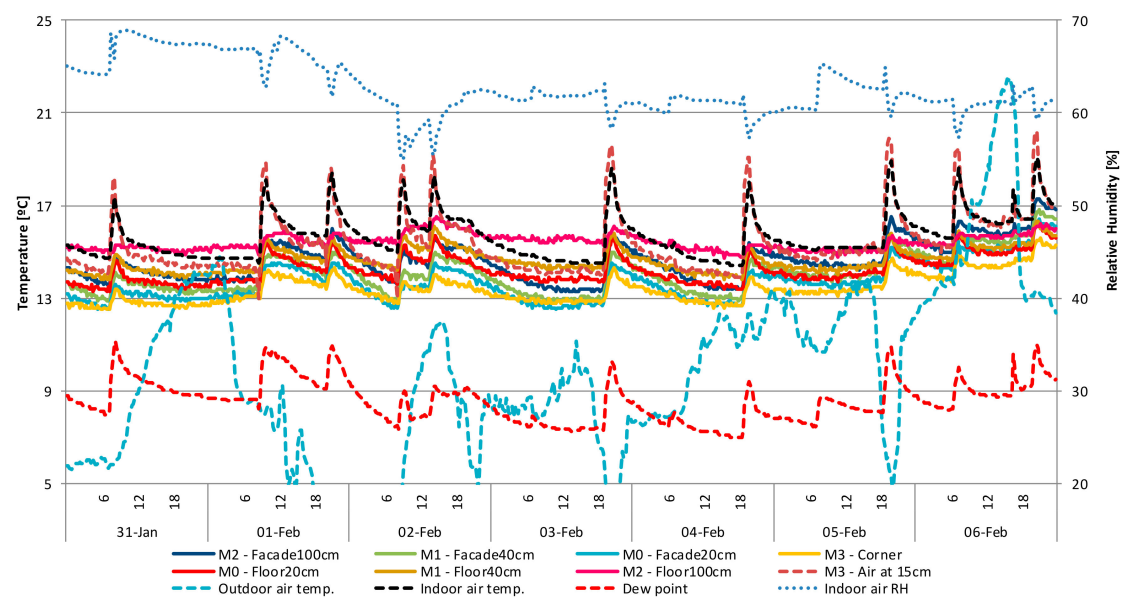
Continuous monitoring of the surface temperatures in two thermal bridges and in the adjacent opaque elements allowed assessing the likelihood of surface condensation in 40 days. Figure 6 shows a comparison between the dew point of one dwelling (calculated using the instant air temperature and RH) and the indoor surface temperatures of the sensors placed along the thermal bridge. It was observed that there is a margin of 3–4 °C between the measured air dew point and the envelope surface temperature. Therefore, according to these measurements, there was no risk of surface condensation during the 40 studied cold winter days.

Figure 6. Monitored values of the possible thermal bridge in the façade-slab connection. Dwelling 2D data from 31 January until 6 February.

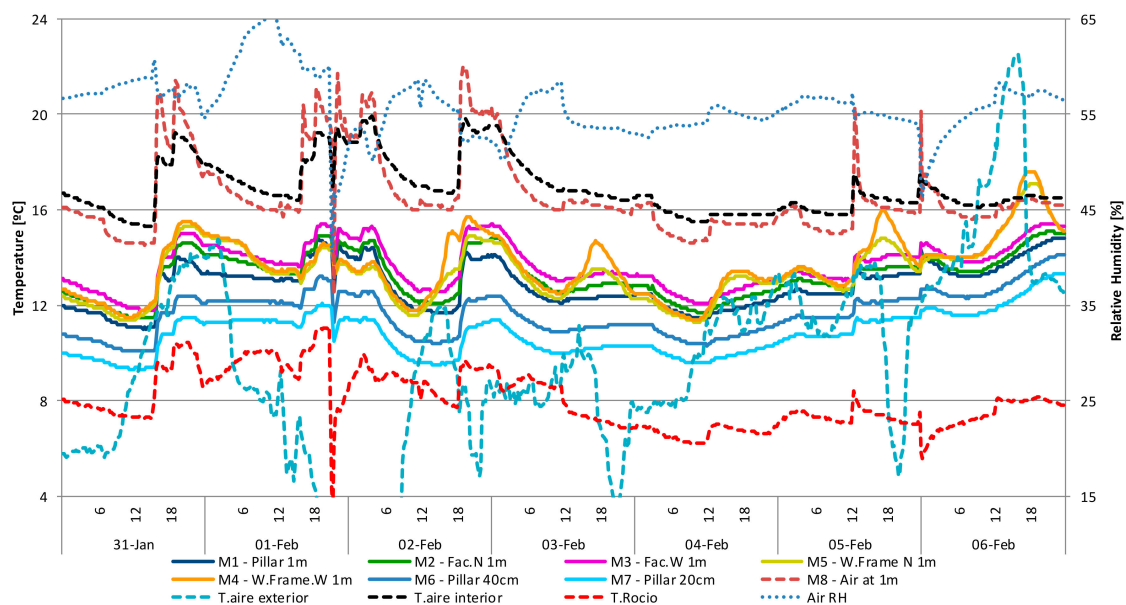
Figure 7 shows the analogous study conducted in the corner pillar thermal bridge. In this case, the margin between dew point and measured surface temperatures is smaller. The minimum gap between them was slightly below 1 °C, and during the three coldest days the difference remained small: between 1–2 °C. For this reason, there is a real condensation risk in this thermal bridge that may occur, especially when the indoor-outdoor conditions are adverse.

Figure 7. Monitored values of the possible thermal bridge in the corner pillar. Dwelling 1D data from 31 January until 6 February.

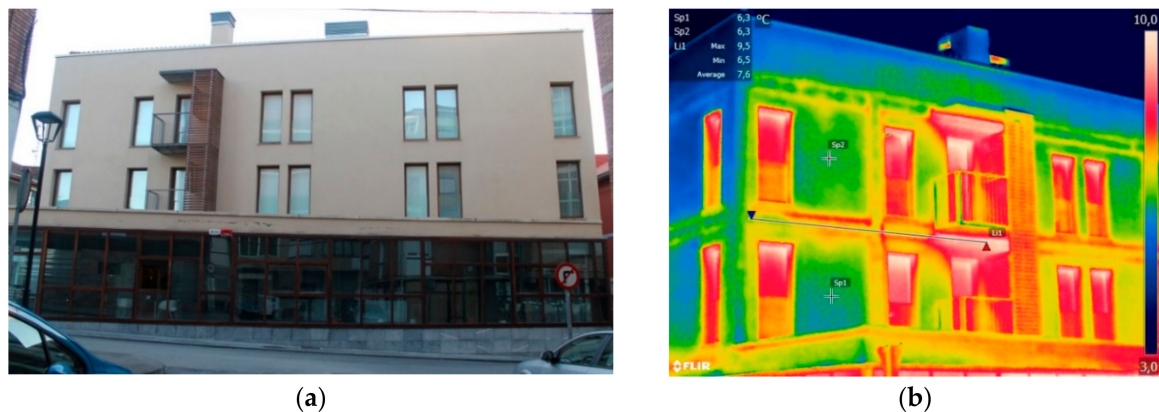
The exterior building inspection with thermal images proved that the outer surface temperatures were very similar in the four orientations of the building. Some slight differences were found between apartments, probably due to the varying indoor conditions from home to home. The outside surface temperatures indicated local increases of 1–2 °C in the front of the thermal bridges in contrast with the opaque adjacent walls. From the outside, some humid areas were found on the front of the first floor slab. On the contrary, no other evidence of humid areas was found from the outer side of the detected indoor pathologies. Examples of outdoor thermal images are given in Figures 8 and 9.

Figure 8. (a) West façade of the case study; (b) outside thermal image of dwellings 1D and 2D.

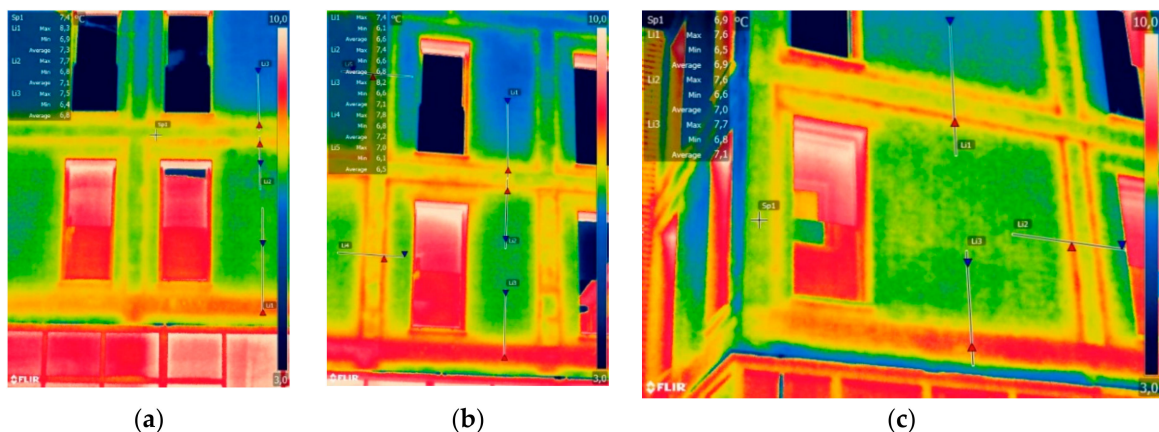
Figure 9. (a) North façade of dwellings 1A and 2A; (b) North façade of 1E and 2E; (c) North façade of dwellings 1A and 2A.

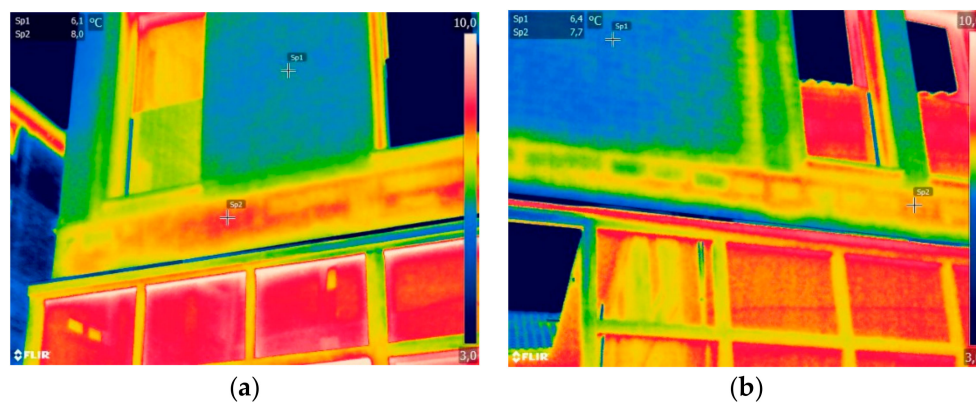
Some noticeable irregularities were found in the distribution of the cellular glass boards on the potential thermal bridges. Figure 10 shows how some boards are separated and even missing in the northeastern corner of dwelling 1C. This shows that the thermal bridging solution was not properly placed in some locations of the envelope and, consequently, that the effectiveness of minimizing the thermal bridge in these cases is seriously reduced.

Figure 10. (a) South façade area of the first floor slab of dwelling 1C; (b) South façade area of the first floor slab of dwelling 1D.

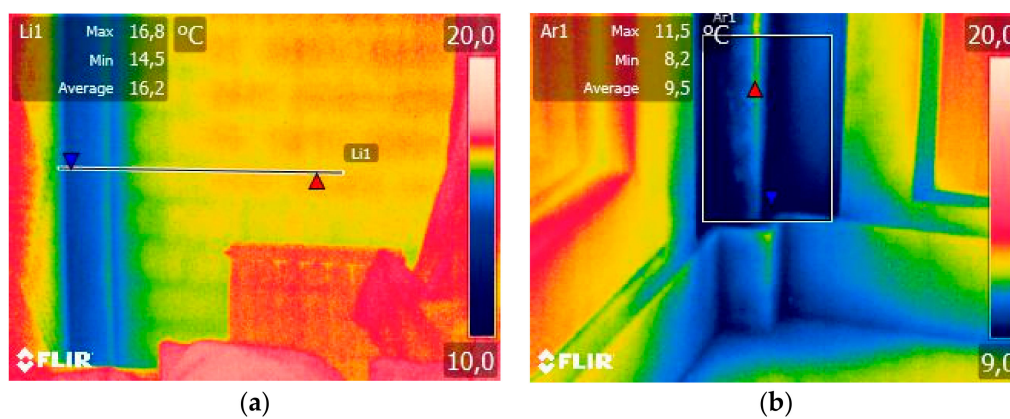
From the inside, the effect of the structural thermal bridging was observed in two ways. Some elements like a pillar, shown in Figure 11a, provoked very cold inner temperatures, but without any additional pathologies or problems. On the other hand, other areas occasioned large humid areas, such as those shown in Figure 11b. The latter were also observed during the visual inspection because of the degradation of skirting boards and window frames, with obvious expansion of the wooden pieces and bubbles in the wall paint due to evaporation.

Figure 11. (a) Dwelling 1A North façade pillar inside temperatures in detail; (b) dwelling 1A corner pillar inside temperatures in detail.

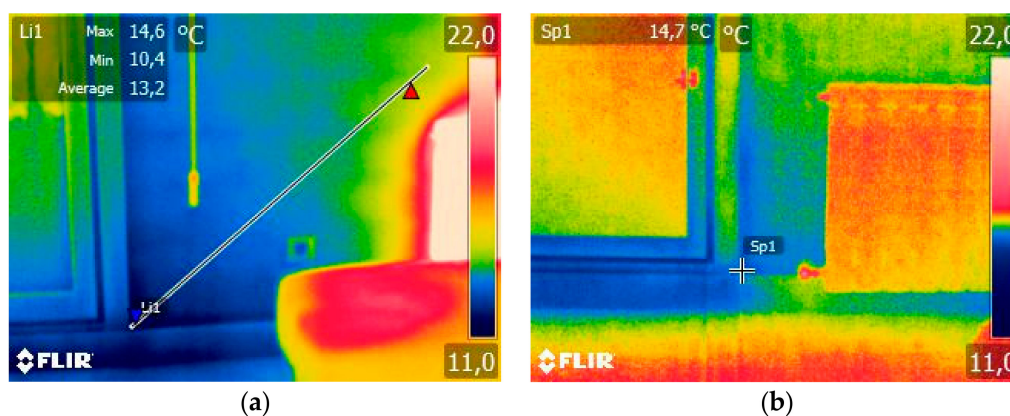
Additionally, some other minor condensation areas around the window frames were found during the inside thermographic survey. Figure 12a shows a large cold area due to evaporation in the window-wall joint, and Figure 12b shows an equivalent position, but in another apartment where there was almost no gradient of temperatures. Figure 13a reveals another case of a clear cold area due to evaporation in the window-wall joint, and Figure 13b shows a façade pillar which was fully wet at the bottom.

Figure 12. (a) Comparison of the North façade window-wall connection in dwelling 1A and (b) the West façade window-wall connection in dwelling 1D.

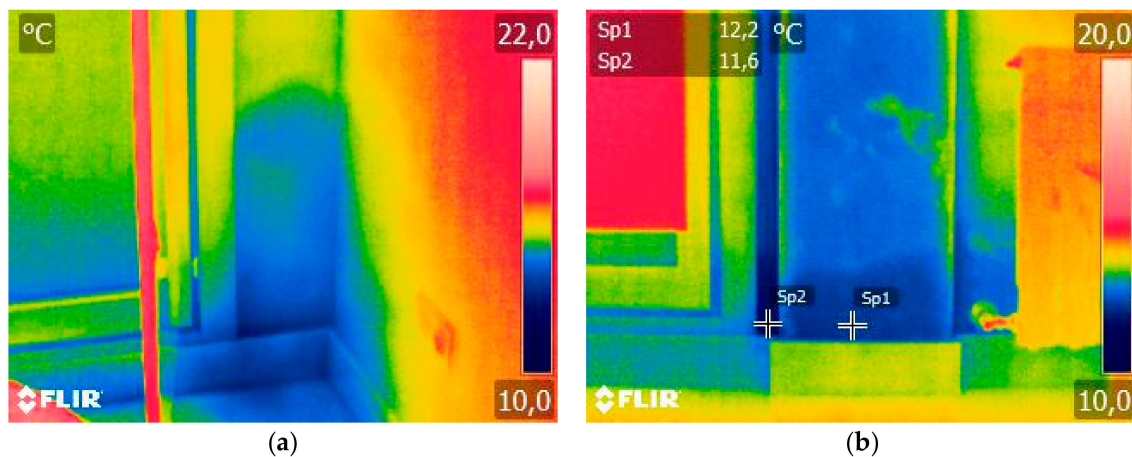
Figure 13. (a) North façade window-wall connection in dwelling 1E; (b) the lower part of the North façade pillar in dwelling 1D.

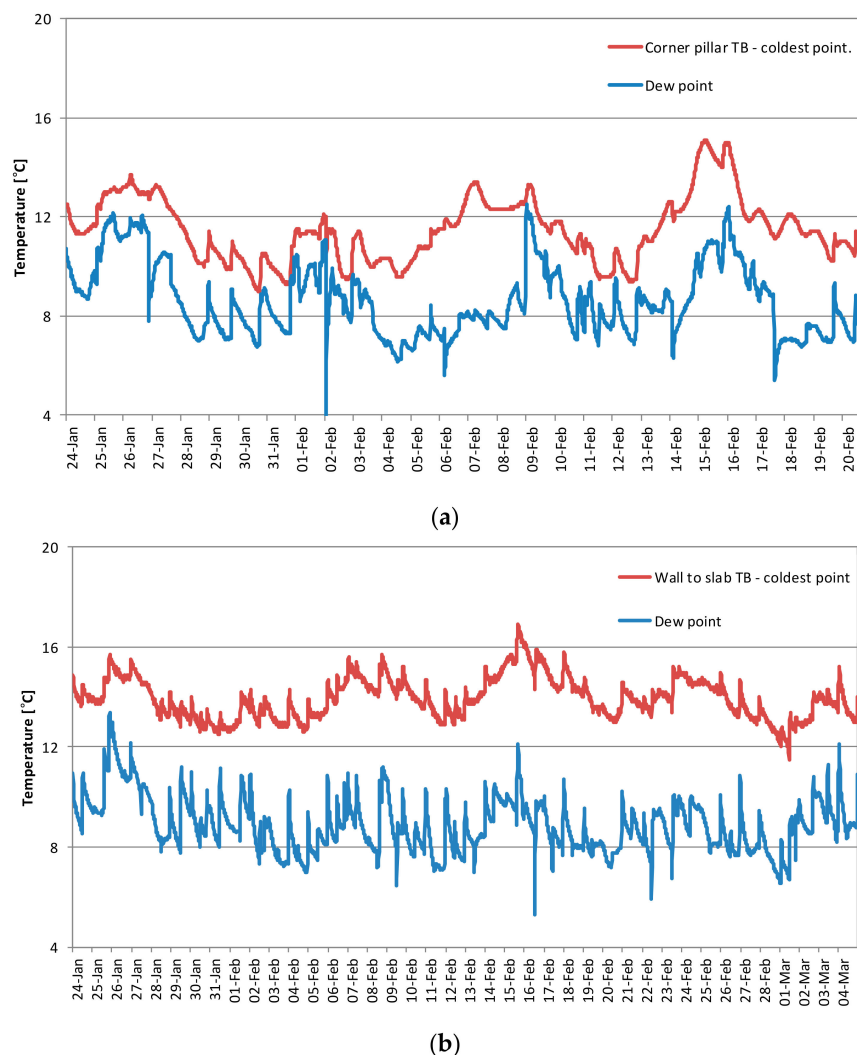
Second, the study of the surface temperature profiles in thermal bridges and the air dew point showed that the corner pillars have a measurable condensation risk. The joint of the façade-floor slab did not show any condensation risk under the monitored indoor air conditions. The pathologies around the corner pillars could be explained by this phenomenon, but other pathologies around ceilings, window frames, and walls could not, as can be seen in Figure 16.

Figure 16. (a) Dew point and thermal bridge coldest point for the corner pillar; (b) dew point and thermal bridge coldest point for the façade-floor slab joint.
