Structural Behavior of the General Archive of the Nation (AGN) Building, Mexico

Marcos M. Chávez, Fernando Peña *, Claudia Cruz and Gustavo Monroy

Instituto de Ingeniería, Universidad Nacional Autónoma de México, México City 04510, Mexico; MChavezC@iingen.unam.mx (M.M.C.); CCruzC@iingen.unam.mx (C.C.); GMonroyG@iingen.unam.mx (G.M.)
* Correspondence: fpem@pumas.iingen.unam.mx; Tel.: +52-555-623-3600

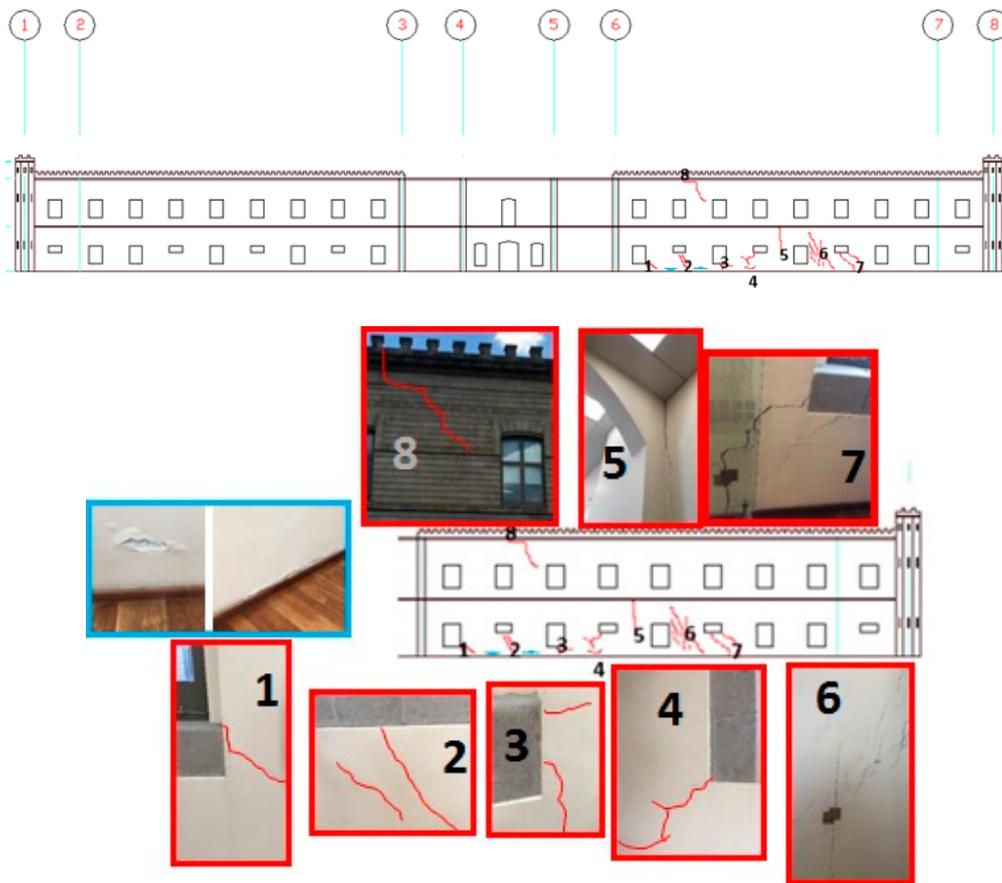
The inspection to which the building was subjected showed that it is in good condition for the most part; the south wing is the exception because it has several cracks on the walls, particularly on the ground floor. These cracks are consequence of differential settlements and some of them are major because they go along the entire height of the building (up to three meters long and five millimeters wide). However, these cracks do not jeopardize the building’s stability. There are also moisture problems on the ground floor. Figures 5 and 6 show the affected areas.

Figure 5. Layout of the damage survey on axis C [9].

Cracks in the ground floor (cracks 1 to 7 in Figure 5 and cracks a to d in Figure 6) have a similar distribution like a beam in positive flexural deformation. The cracks near the center of the building (cracks 1 to 5 in Figure 5 and cracks a to d in Figure 6) are due to tensile stresses, while cracks 6 to 7 in Figure 5 are due to shear stresses. This is due to the differential settlements being bigger at the center part and a parabolic-like deformation is presented. The bending moment due to this behavior concentrates the tensile stresses at the ground floor.

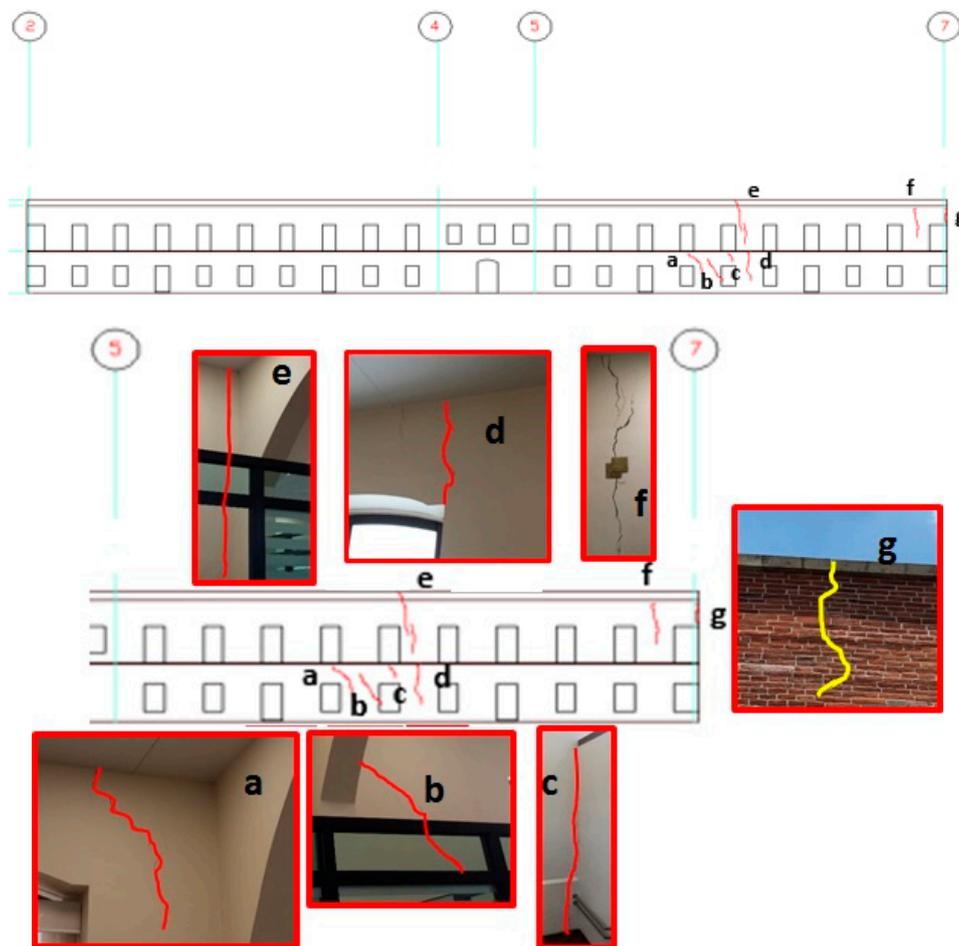
Figure 6. Layout of the damage survey on axis B [9].

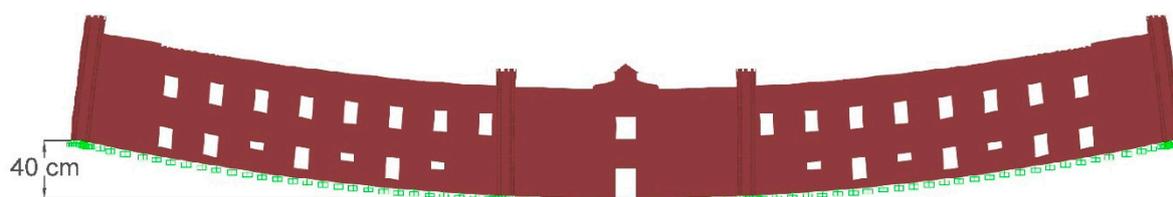
Figure 14. Model deformation resulting from a combination of loads plus the pattern of parabolic settlements (displacements scale factor 1:20).

These loads helped to create maps of vertical and horizontal axial stresses, and principal stresses. It can be observed that there is a stress concentration that exceeds the masonry's tensile strength of 0.15 MPa (Figures 15 and 16). This could be the reason for the existing cracks. However, the zones where there are concentration of stresses are not the same as the cracks in the real structure. Since the linear analysis does not allow a redistribution of stresses, a non-linear analysis becomes necessary.

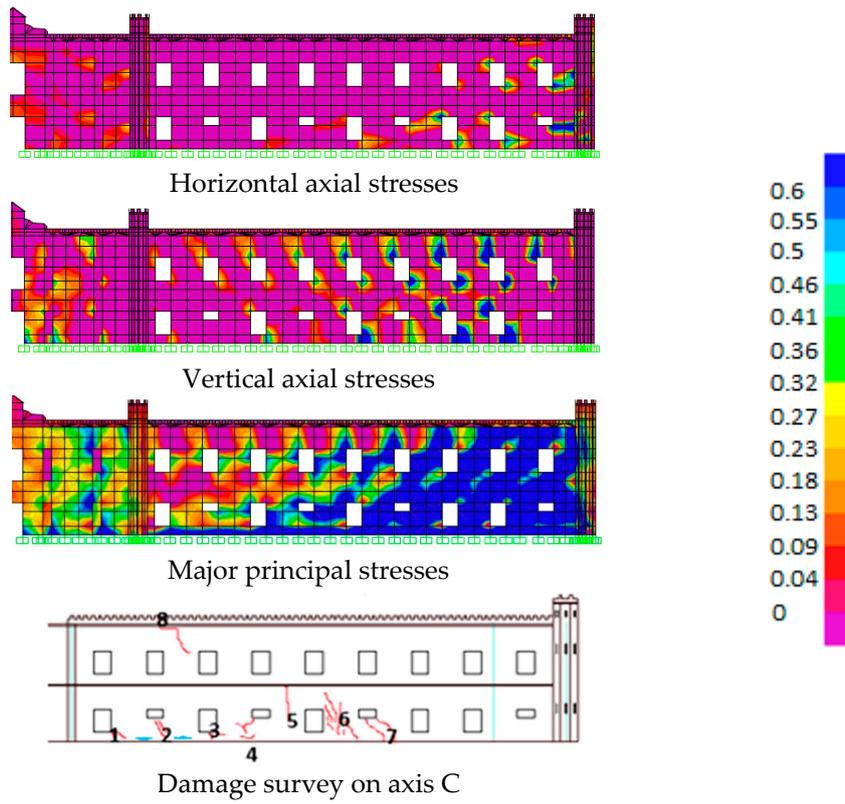
When analyzing the results of the elastic model, it was observed that a large portion of the walls present high tensile stresses values which is interpreted as damaged area; however, because the analysis is linear, a redistribution of stresses cannot be generated, so they will increase proportionally without limit. As a result, in order to generate a stress redistribution, it was decided to perform an analysis in which the elements' elasticity modules whose major principal stresses exceed the diagonal tensile resistance are reduced, so that these zones reduce their tensile stresses. This idea has already been implemented in the geometric correction analysis of the Metropolitan Cathedral [19]. Details on the implementation of linear sequential analysis can be found in [20,21]. Figure 17 shows the elements with reduced elastic modulus.

Figure 15. Comparison between stresses (MPa) at the front and existing damage.

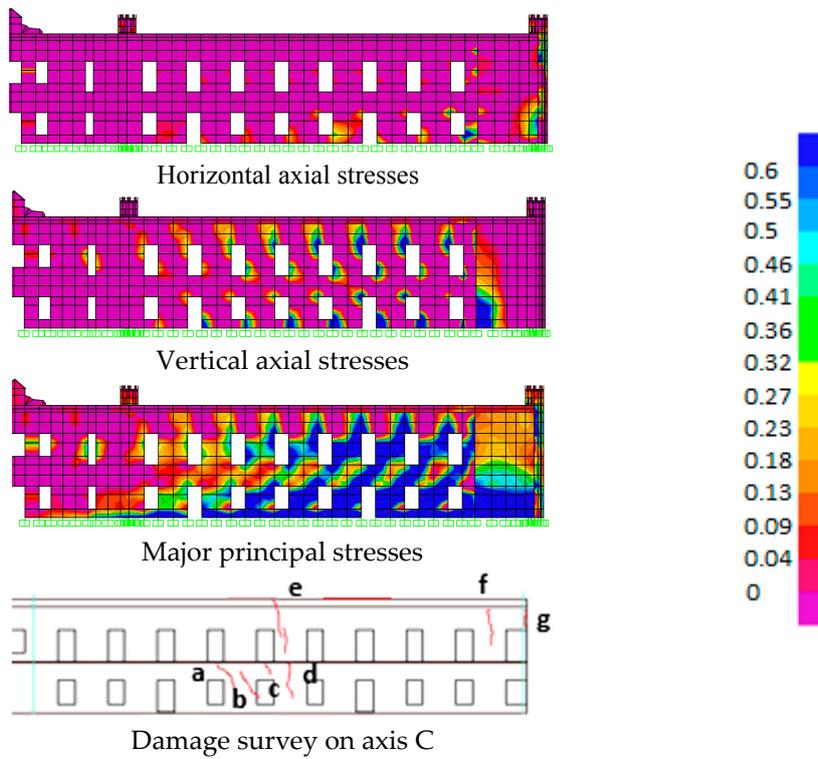
Figure 16. Comparison between rear stresses (MPa) and existing damage.

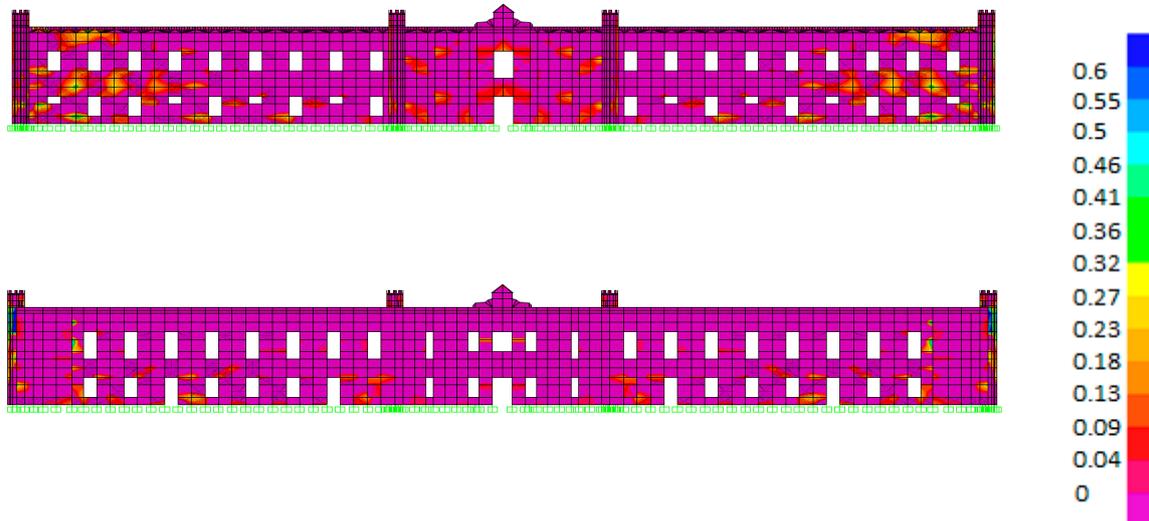
Figure 18 shows the maps of horizontal axial stresses that resulted from this analysis. These maps display tensile stress concentrations between 0.2 and 0.4 MPa at both ends of the model, at the front mainly; this contrasts with Figures 15 and 16 in which the stresses in the same areas are over 0.4 MPa.

Figure 18. Map of the horizontal axial stresses (MPa) from the linear sequential model, front and rear views.

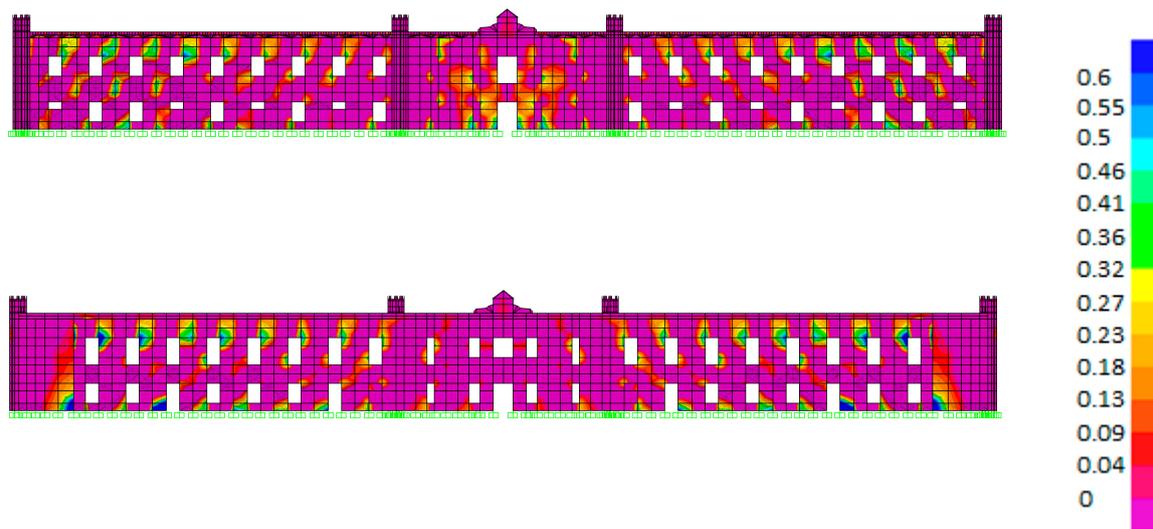
The vertical axial stresses shown in Figure 19 indicate that zones with tensile concentrations are the openings of the model, in contrast to Figures 15 and 16 in which tensions on the windows are higher than 0.6 MPa; stresses on the majority of the windows were reduced to 0.4 MPa in the linear sequential model.

Figure 19. Map of the vertical axial stresses (MPa) from the linear sequential model, front and rear views.

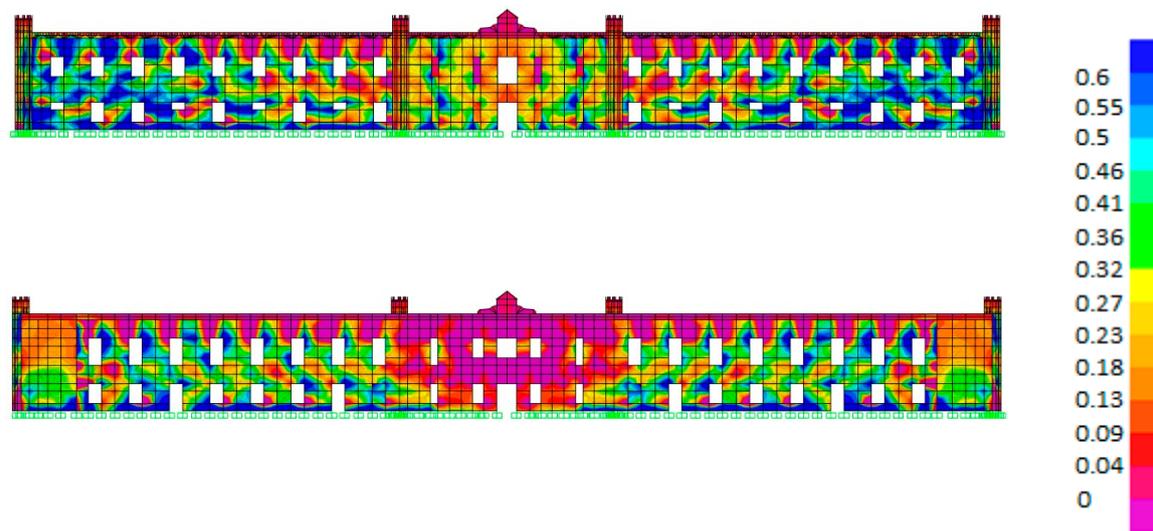
Lastly, the main principal stresses on the maps in Figure 20 show that the tensile stress concentrations are located in the door and window corners, as well as in the zones where there are supports. This differs from the elastic model, in which a large part of the walls present tensile stresses. In contrast to Figures 15 and 16, it is observed that wall stresses located between windows reduce their tensile stresses.

Figure 20. Map of the major principal stresses (MPa) from the linear sequential model, front and rear views.
