Article

Ground Penetrating Radar Investigation of Corvin Castle (Castelul Corvinilor), Hunedoara, Romania

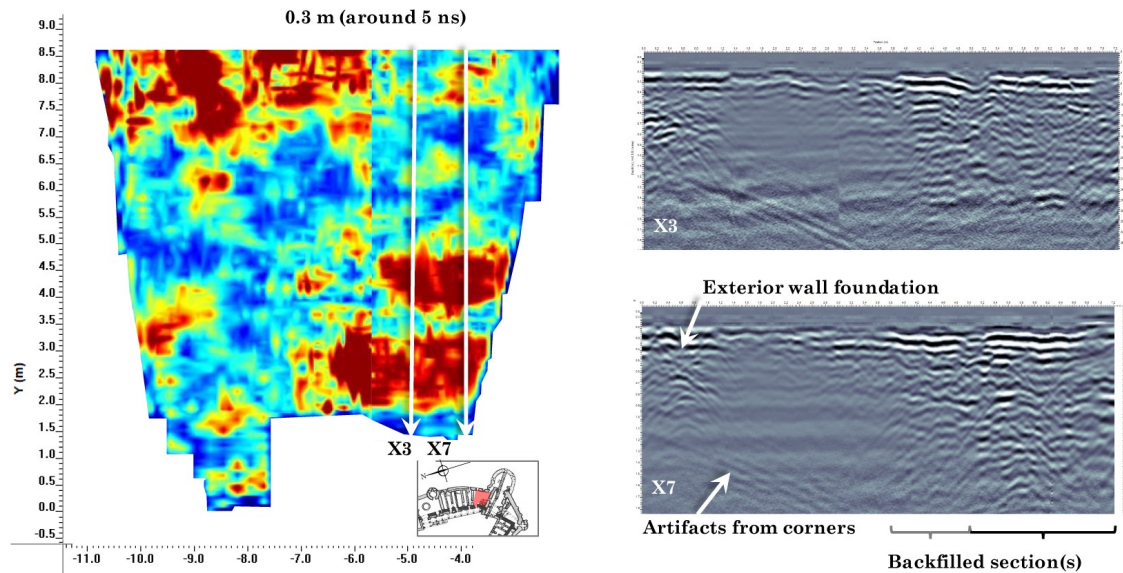
In GPR scans of the Noble's Man Kitchen, the foundations of structures implied in early maps are present (Figure 2). The highly reflective area in the SW corner is caused most likely by both the backfilled excavation trench reported in Bogdan ("caseta T," Figures 3 and 14) and foundations of structures drawn in Figure 4. Just southeast of this section, there is an area that appears similar to the backfilled trench in the corner (an area of high reflection strength), but this is not reported in Bogdan and does not appear to extend as deeply (Figure 14). In deeper slices, there also appear to be at least two more wall foundations along the southern edge that may extend into the kitchen from the entrance hall (Figure 15). The longer segment closest to the eastern wall appears to be part of an older phase of

Figure 14. Depth slices of the Noble's Man Kitchen showing the excavation backfill in the lower right-hand corner, the exterior wall across the top, and the variable depth of the backfilled trench(es) in lines X3 and X7.

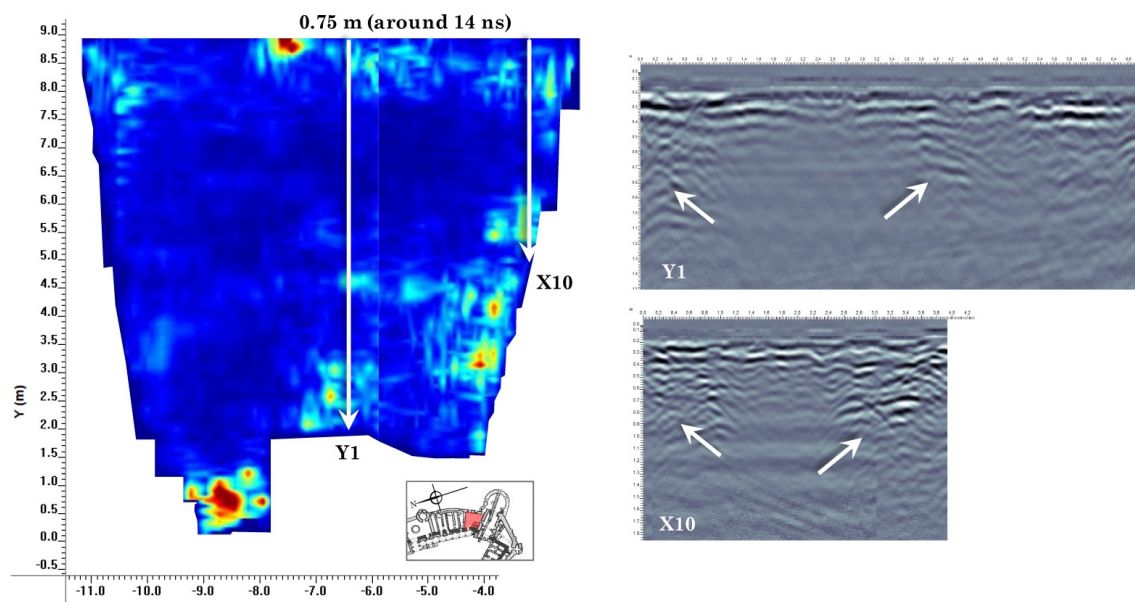
Figure 15. Deeper slice showing possible wall foundations along the exterior wall and near the 14th century fortress present in the kitchen.

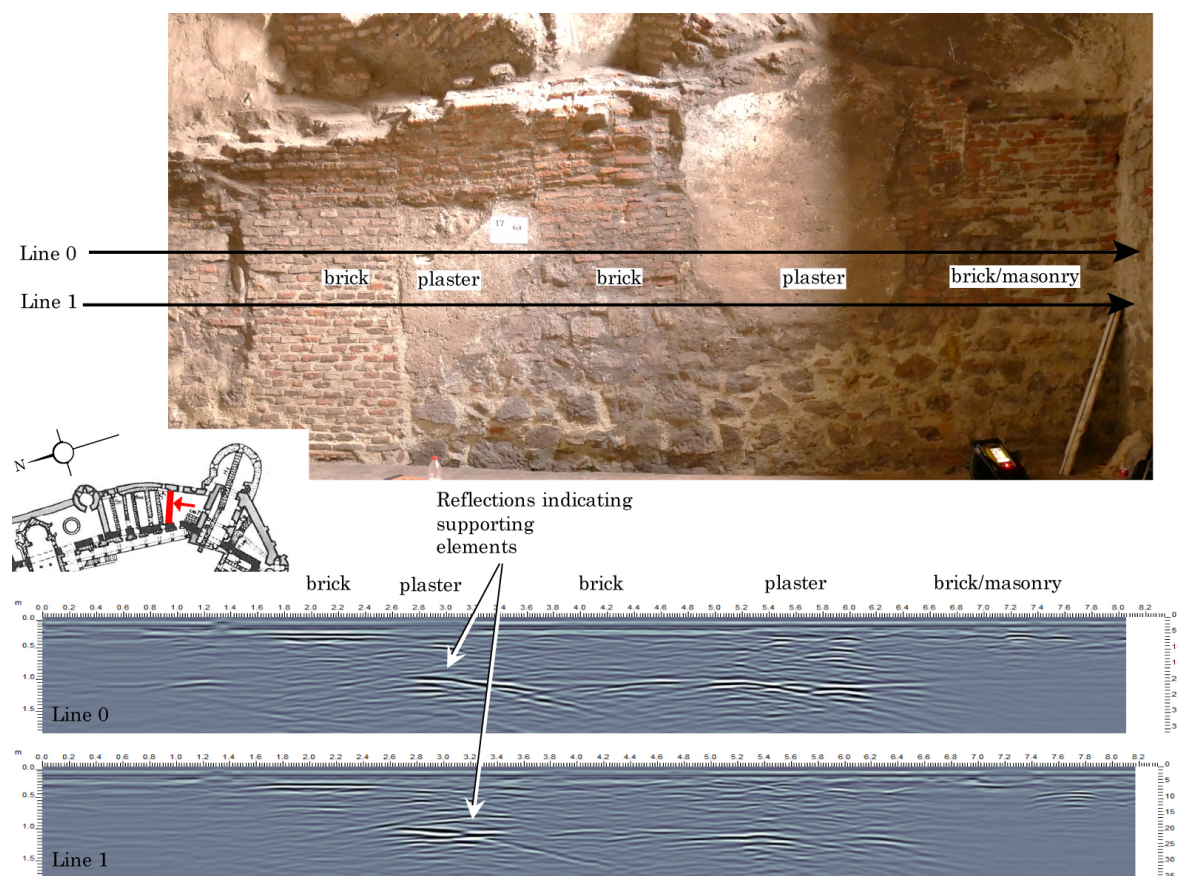
These structures line up with the springings of the second-floor vaulting that are visible higher up on the wall, indicating that they are supporting elements or columns for the now-absent structure (Figure 16). The vaulted ceiling may have been ripped off by modern restorer in the 19th or 20th century, or by Bethlen in the 17th century, as he did with the vaulting in the chapel and Knight's Hall [7].

Figure 16. GPR lines and photograph of the 1cm thick northern wall in the kitchen with different phases and wall treatments on the surface. Note the supporting elements indicated on the western (left) side.

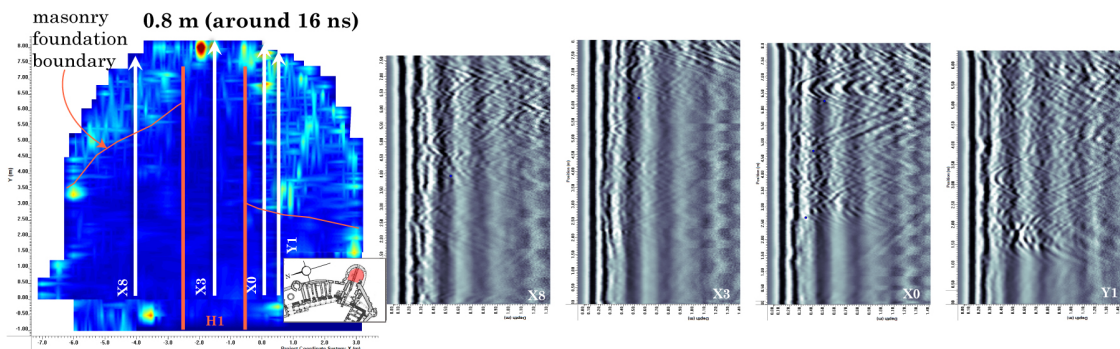
Figure 18. Depth slice at 0.8 m (16 ns) and radargrams showing the transition from bedrock foundation to built up masonry foundations in the White Tower. Note the location of the backfilled trench H1 through the center, where the foundation is homogeneous and modern. Note that the lines presented belong to two grids but are oriented in the tower as shown.

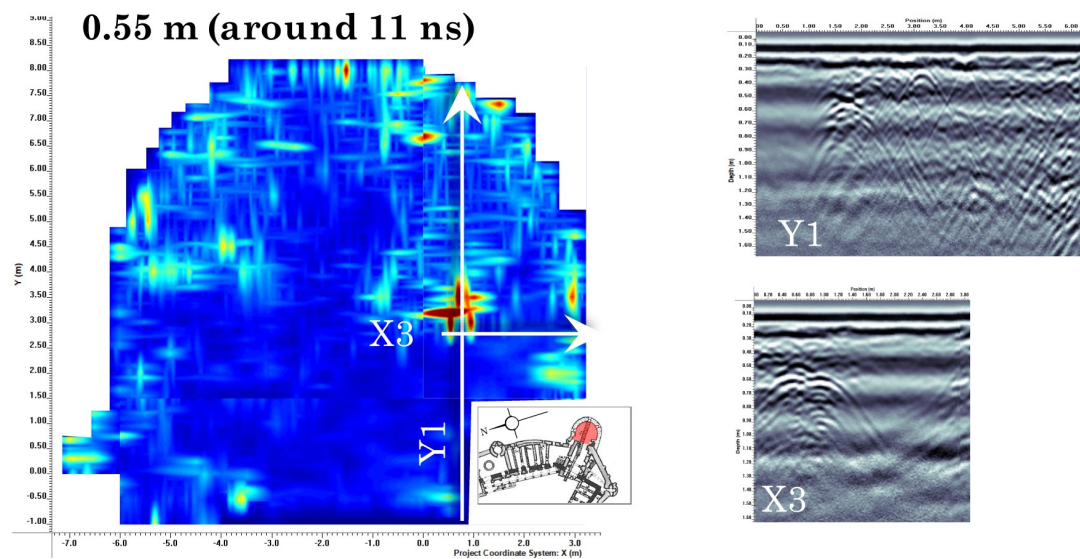
Figure 19. Shallow depth slice of tower at 55 cm (11 ns), showing feature in the central southeast half of the tower.

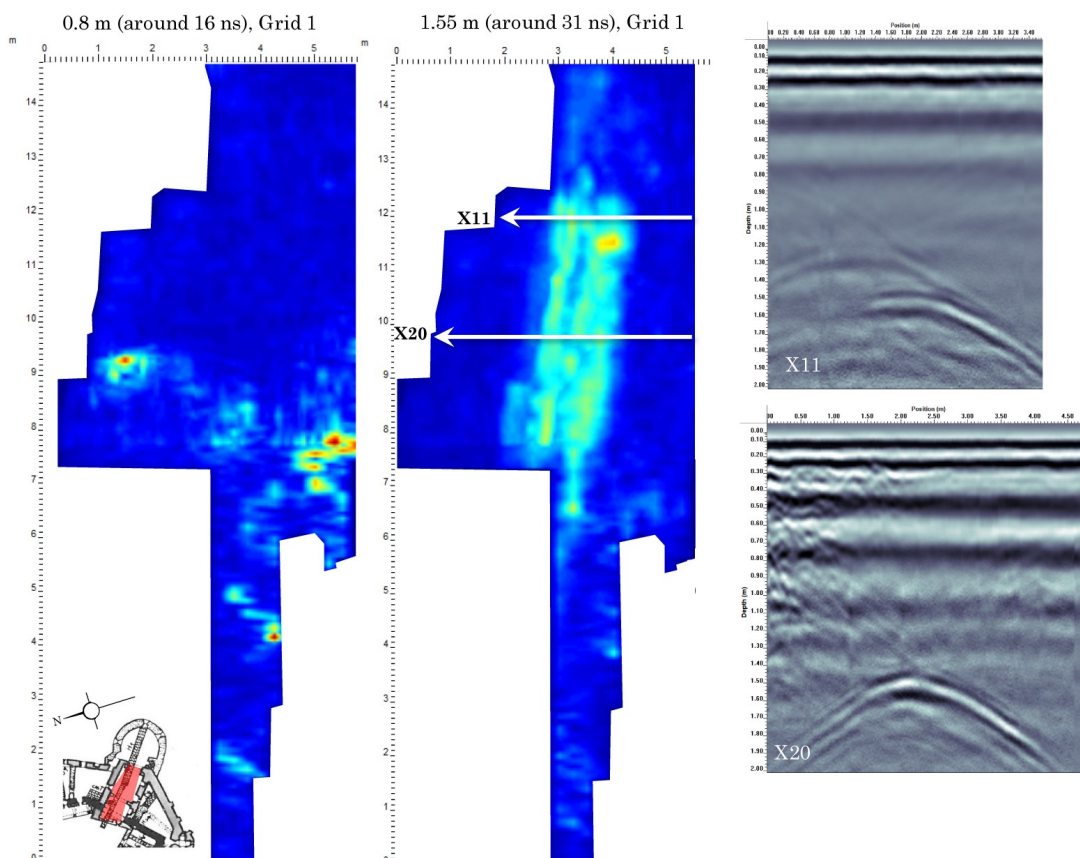
Figure 20. 0.8 m depth slice showing the cross cutting of two walls (upper half, 0.8 m) and the dipping reflector from the other figure (lower half, 0.8 m). 1.55 m depth slice and lines show the bottom of the backfilled trench H2, also shown in two representative lines (X11 and X20). NB: contrast slightly enhanced in these slices.

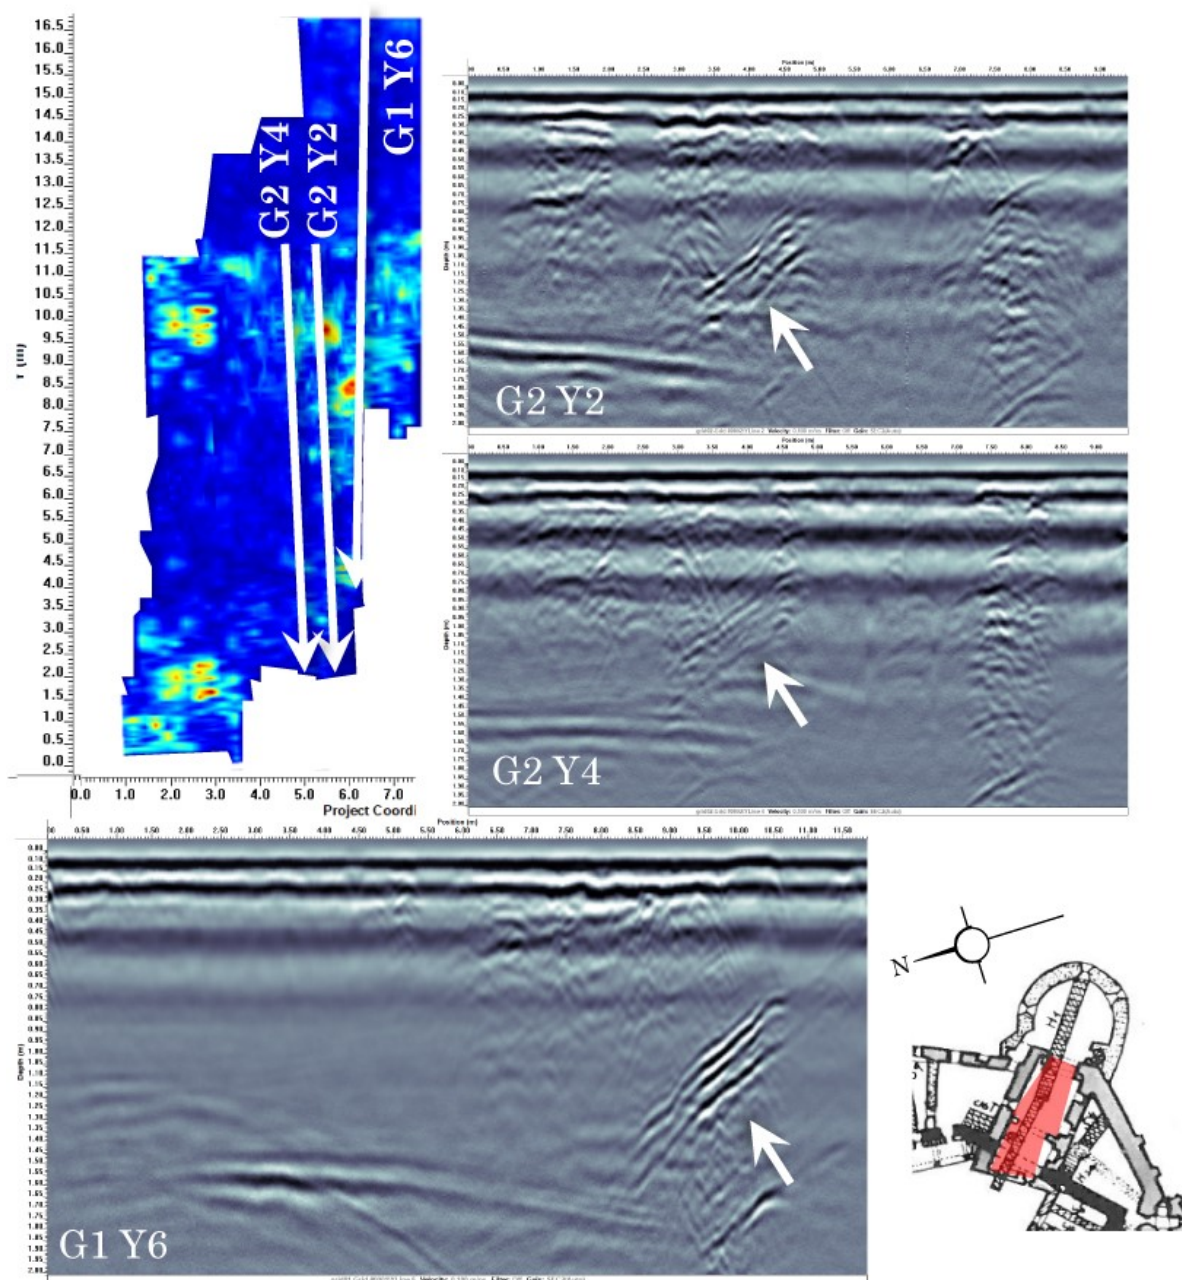
Figure 21. Radargrams showing the dipping reflector across the center of the room, possibly in line with the dotted wall noted in Bogdan’s map and an earlier boundary. Also notice the wall foundation which appears in lines in G2 and which may correspond to the original stone fortress shown in solid black on the Bogdan and Möller maps.

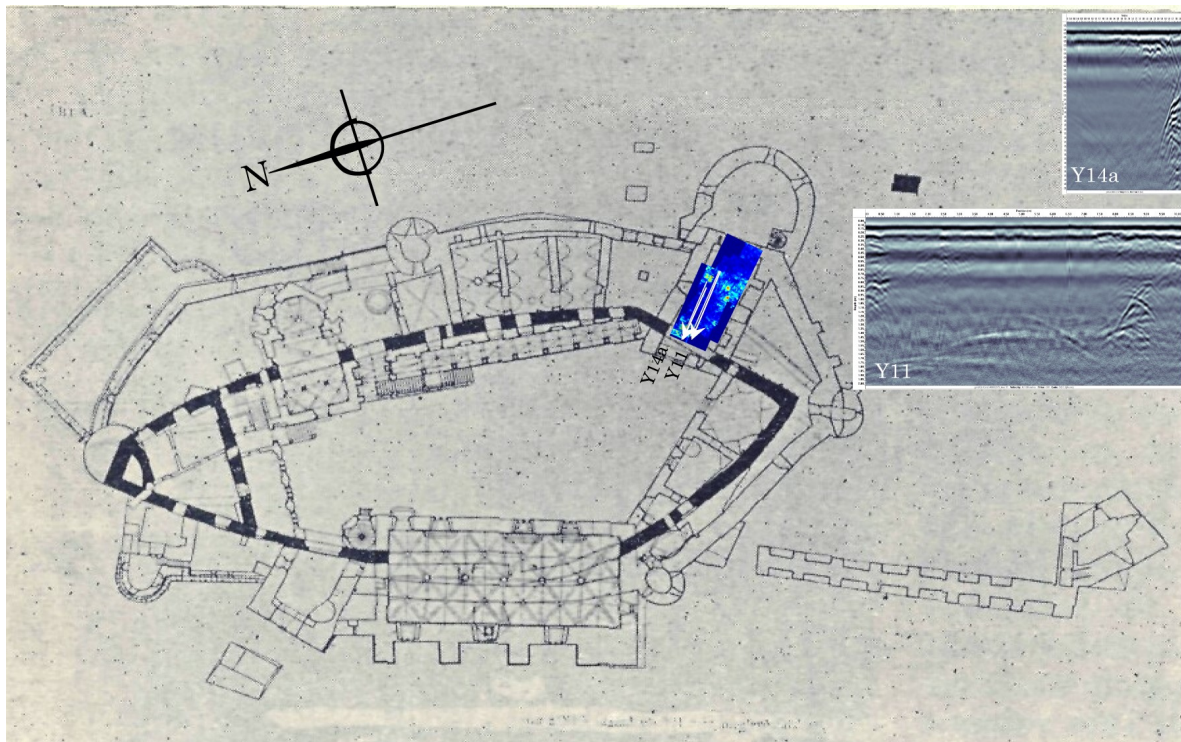
Figure 22. Possible identification of original 14th century fortress under the courtyard side of the entrance hall (shown on the right-hand side of each line) with the Möller map [7].

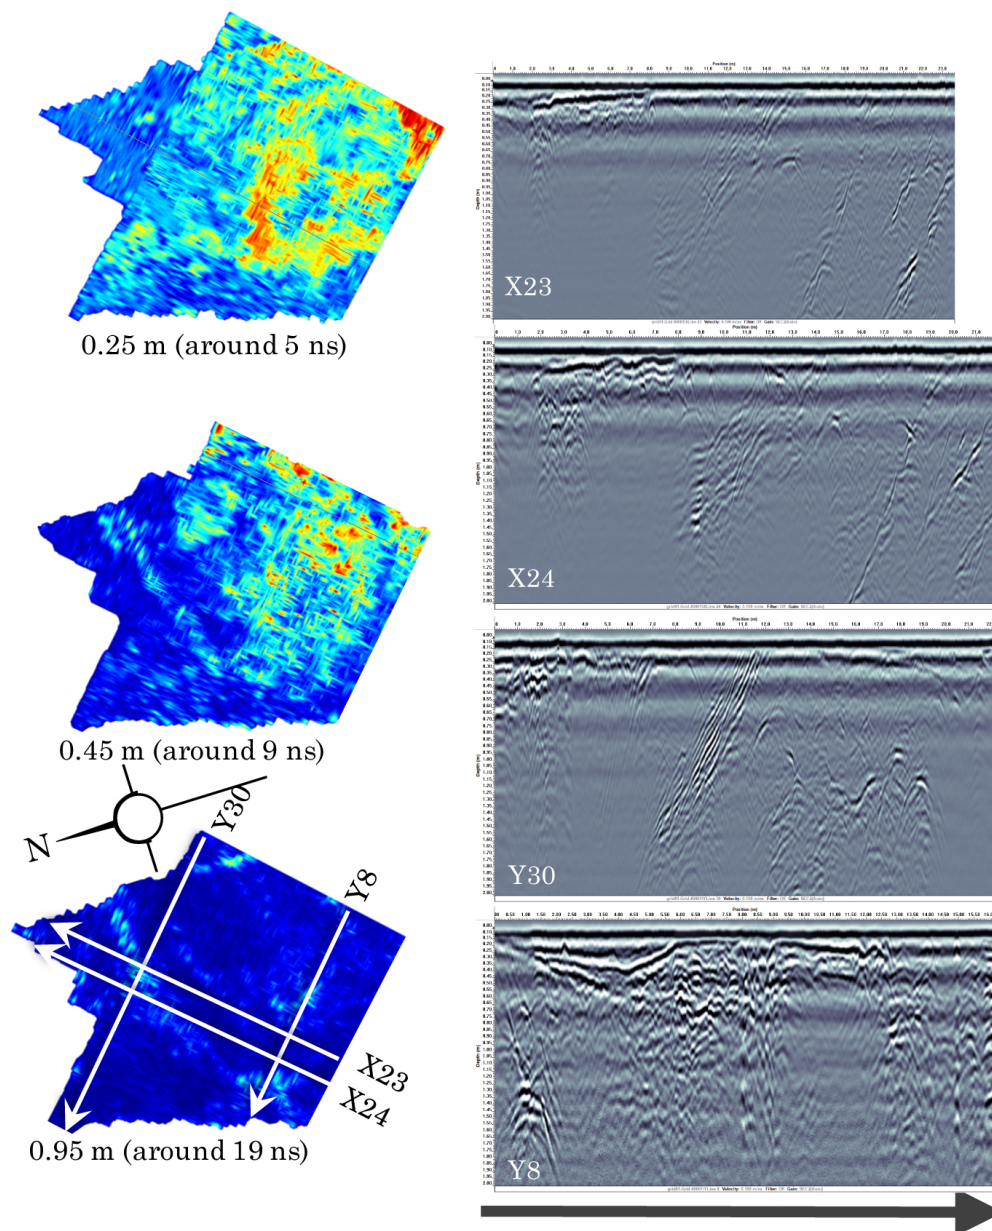
Figure 23. Depth slices and radargrams from the courtyard scans. Lines X23 and X24 show the two wall foundations (on the left); In X23, X24, and Y30, note the upward sloping reflections from underlying geology. Line Y8 is typical of the southern (left) half of the courtyard, with both geological and anthropogenic features.

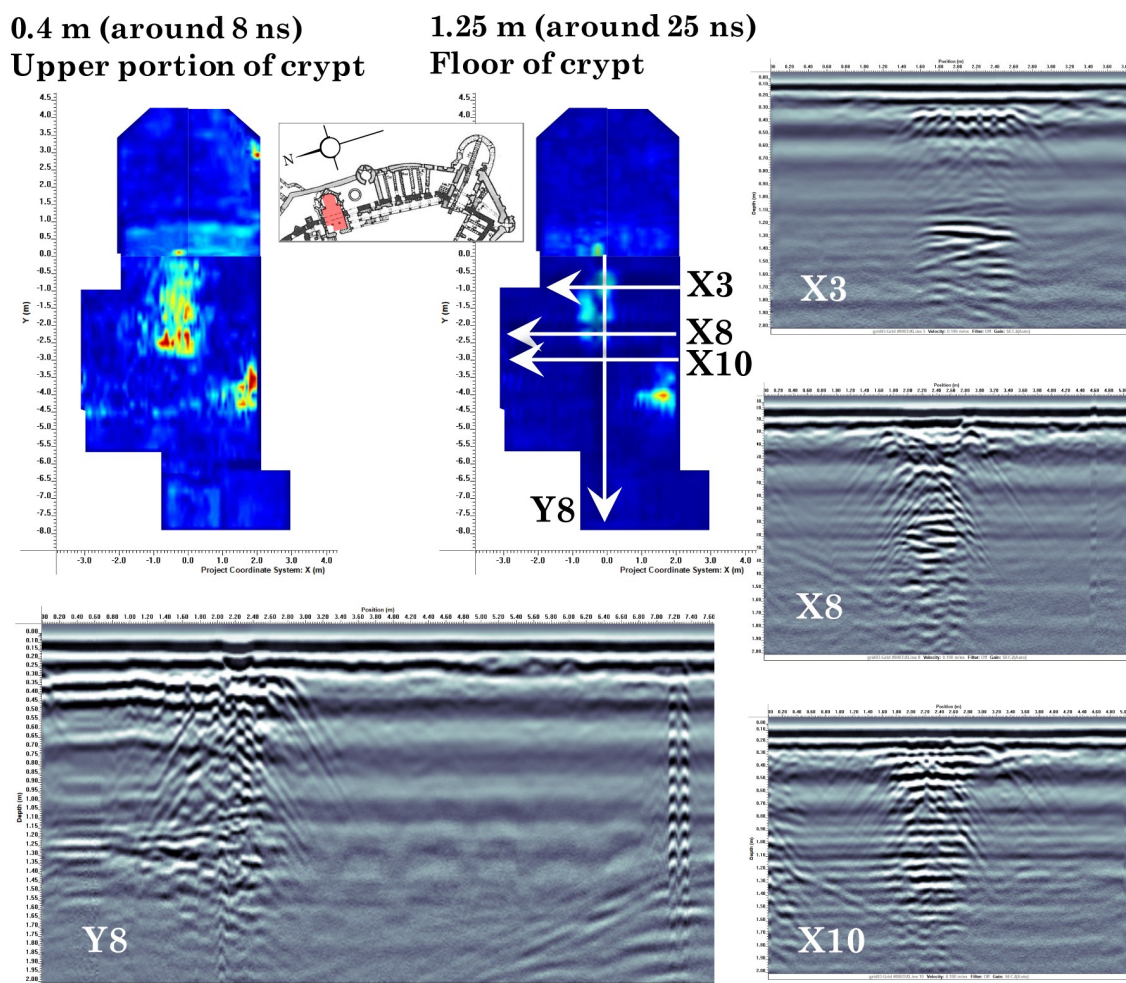
Figure 24. GPR scans of the crypt showing depth slices of the upper portion (0.4 m) and the floor (starting at 1.25 m). Note the change in fill from east to west visible in line Y8 and near X8 that likely indicates the inclusion of the 14th century fortress wall.

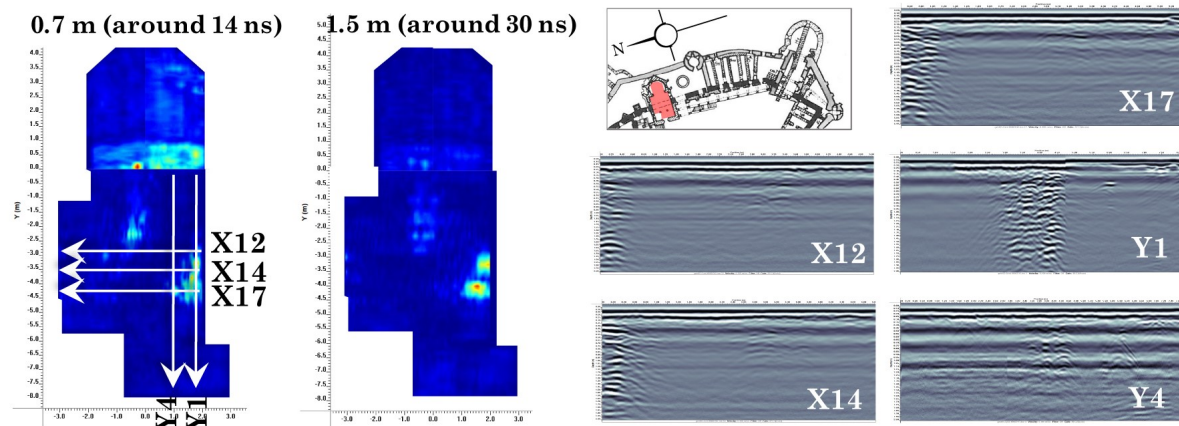
Aside from the crypt, GPR scans indicate wall foundations from earlier phases along the southern wall of the chapel (shared with the Well Courtyard). Two foundations appear in the nave of the chapel, just west of the crypt along the wall (Figure 25). These are also aligned with the original fortress boundary and should be associated with that phase. The eastern-most reflections may be related to the 1956 restoration excavations [25]. The foundations visible in the southern corner of the apse are located at the intersection of the chapel with the edge of the courtyard, where there are now stairs leading into the Bear Pit (Figure 26). This detail is included in most plans of the chapel besides those of Bogdan (Figures 2–4), and the reflection may be related to the appearance of the staircase. Also note the “ringing” effects on the radargram (localized columns of black and white stripes) from a strip of iron installed in the floor and the carpet between the apse and nave and the artifacts from corners, as in Figure 14 (Figure 24, line Y8). Deep on the west end of Y4 lies an unexplained reflection. It is not in line with the columns but some documentation could give more context. Roman and Tincu [3] look into the Floca excavations in 1956 which mentioned another brick pavement on the Western enclosure of the chapel, 18 cm below the known 15th century brick pavement. Floca believed that the older bricks might have belonged to a 14th century fortress tower that was torn down, though Roman and Tincu express hesitation about his hypothesis. Unfortunately, Floca’s notes were unclear as to whether he had left the brick in situ or dismantled the flooring. Additionally, in the year 2000, archaeologists investigated the west wall of the Sacristy (located north of the narthex) and found sandstone slabs that

Figure 25. Lines investigating features on the southern side of the chapel. In the slice at 1.5 m, it is clear that there are two separate features, likely early wall foundations. The upper foundation (in lines X12 and X14) may be part of the original 14th century fortress, which ran through the center of the chapel from North to South according to the Bogdan and Möller maps.

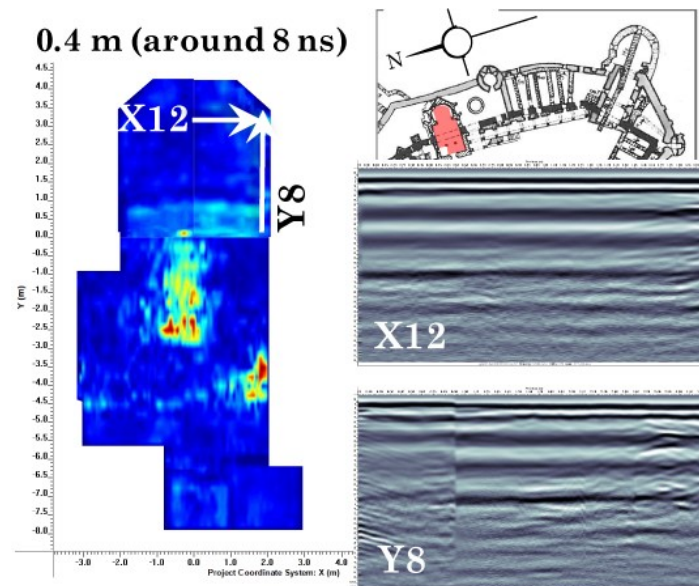
Figure 26. Lines in the apse showing foundations of walls or courtyards on the chapel's exterior, as indicated by Möller and Neumann's plan; this detail is omitted from Bogdan's map. In Y8, note the abrupt surface change from the carpet across the front of the apse (also visible in the depth slice).

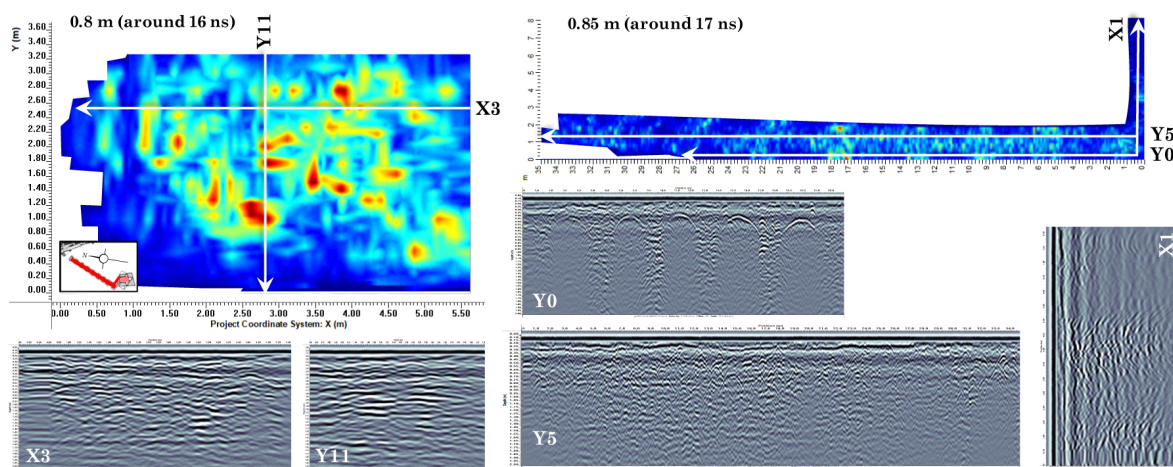
Figure 27. Representative radargrams of the Neboisa tower and gallery; note the arch reflections in the edges of the gallery (Y0), also visible in the first half of X1.

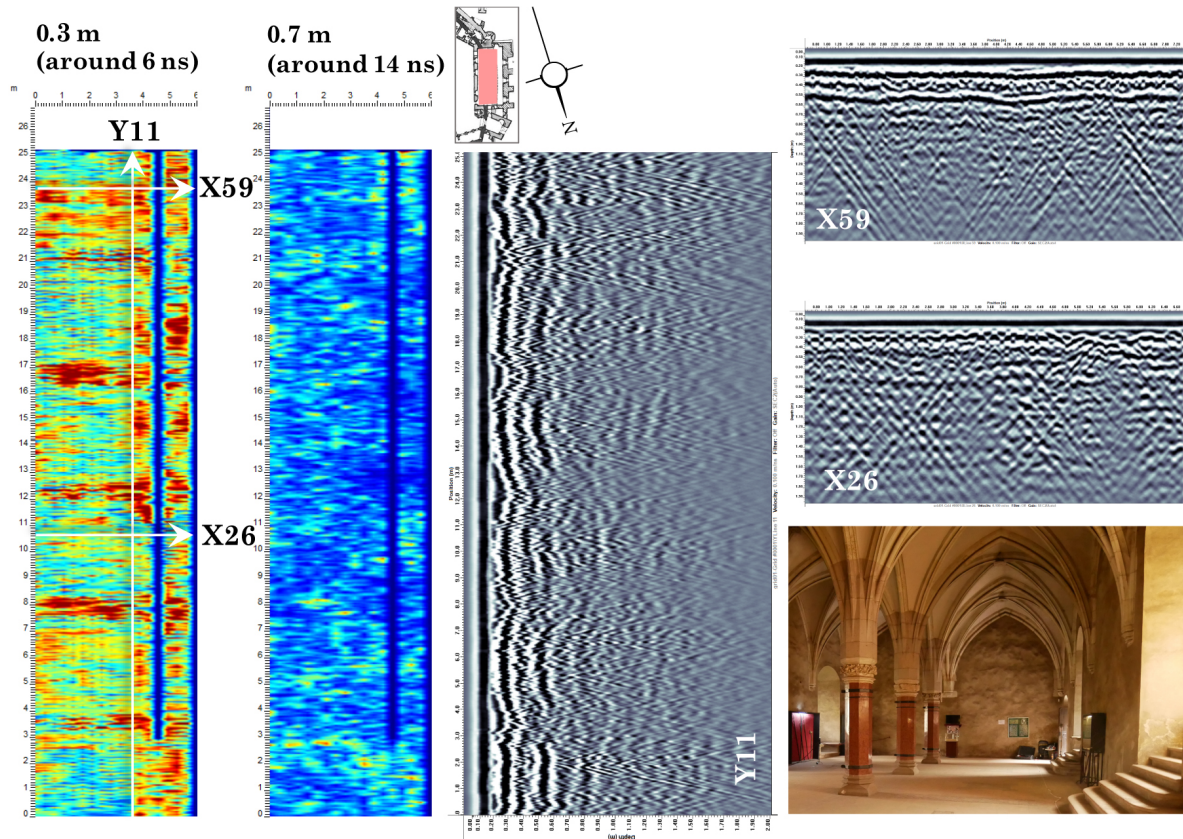
Scans of the Diet Hall clearly show the variable depth of the floor and quadripartite vaulted ceiling of the Knight's Hall below. These patterns are especially pronounced along the axes of the grid defined by the columns in the Knight's Hall (Figure 28). Note that the line of blue in the depth slices is the unscanned area between the central columns. Though the scans of this room appear markedly different from other scans of the castle, the survey parameters and collection method are the same in the Diet Hall as other rooms. The differences are primarily caused by the nature of scanning a ceiling, where there are clear reflections from a single integrated level with air on both sides. The ceiling was restored in 1874 by Schulcz and later by the Historical Monuments Directorate (1966–1969) [1,2]. The extent of the latest restoration is unclear, though the reflections indicate that the ceiling may be made (at least partially) of reinforced concrete (Figure 28, especially X26).

Figure 28. Depth slices and radargrams showing different aspects of the Knight's Hall vaulted ceiling from the floor in the Diet Hall above. Notice the curvature of the vaults in line Y11 and the rib visible in line X59.

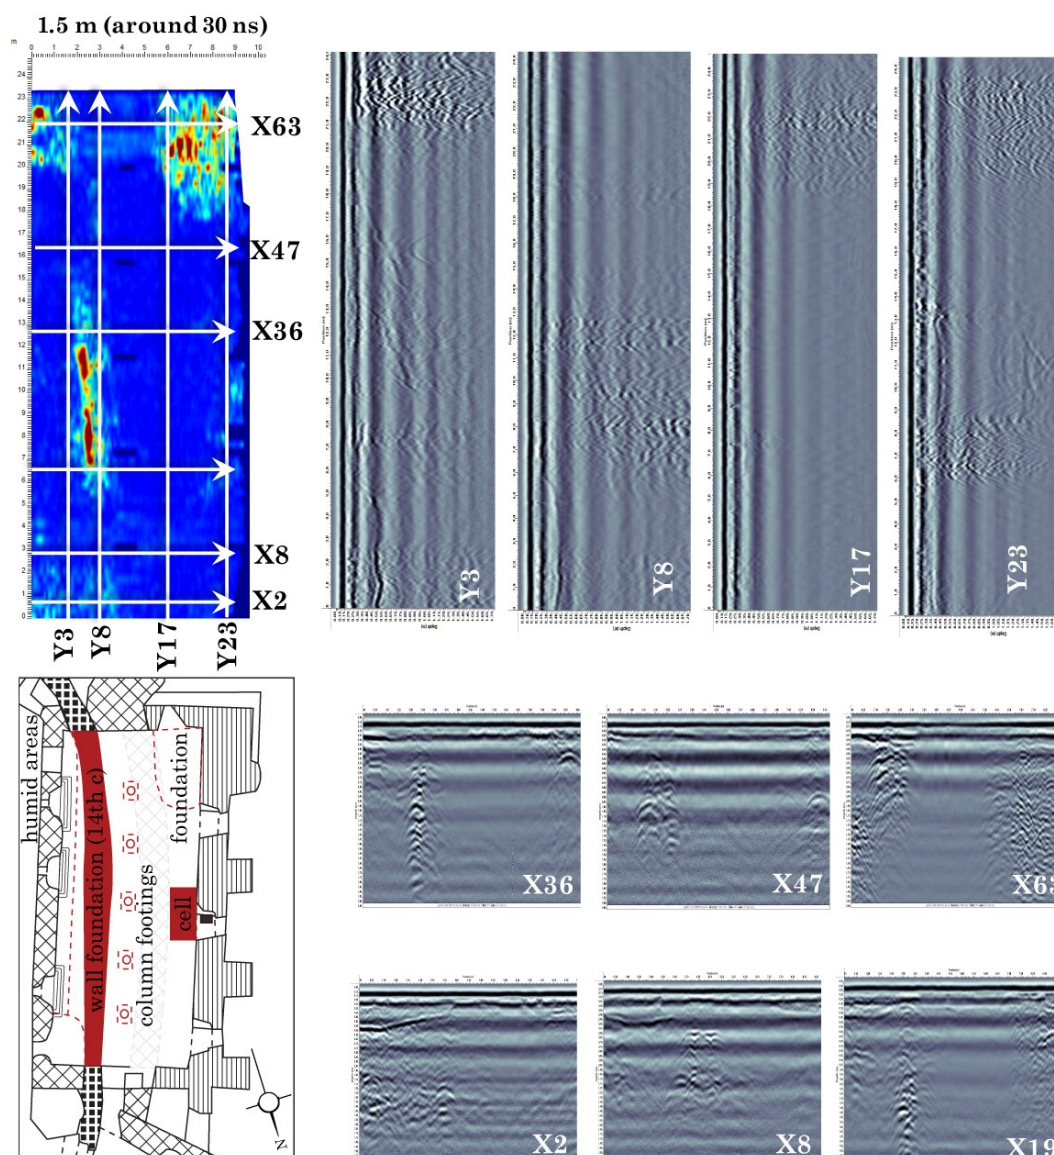
In addition to this significant wall feature, there are a number of other notable reflections in the scans. The dimensions of an empty cell (*celule*) accessible from the Knight's Hall can be seen in the center of the Hall along the western wall (Figure 29, esp. lines X36 (end) and Y23 (center, look for the faint "x" at the bottom of the scan)). The footings of the columns (X8), the foundations of a spiral staircase just outside the SE corner of the hall and next to the 14th century foundations (end of Y3), and strong early-time reflections around the alcoves and entrance on the eastern wall (beginning of most x-lines and beginning of Y3 and X2) can be seen in Figure 29. The early time reflections along the courtyard side of the room are evidence of moisture ingress in these areas, supported by visibly damp walls on this side. Water drains down the slope of the courtyard and accumulates in the shallow depression along this wall, where it soaks into the walls and foundations of the Knight's Hall. Finally, there is confirmatory GPR evidence that portions of the castle's modern foundations were built up in its exterior, which is visible in the SW corner of the hall (see the ends of lines X63, Y17, and Y23 Figure 29).

Figure 29. GPR results from the Knight's Hall. The interpreted features are included in the map, shown in the depth slice, and also visible in the linescans.

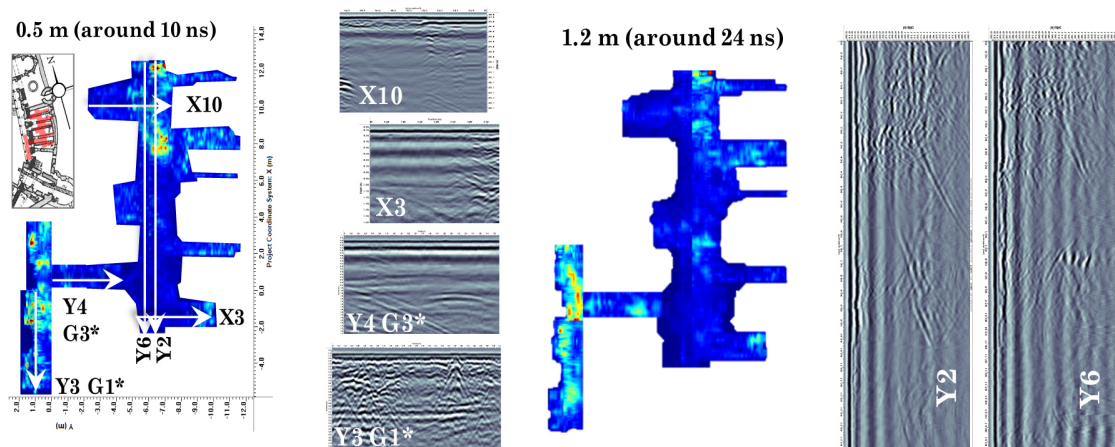
Figure 30. GPR results from the Lapidarium showing the variety of features. In the Y lines, notice the built-up foundations at the north end and the deep feature in the center; in X10, note the deep feature at the beginning of the scan; in X3, the bedrock to masonry foundation at the end of the line; the possible trench floor in Y4G3*; the built up foundations and high humidity in Y3 G4*.

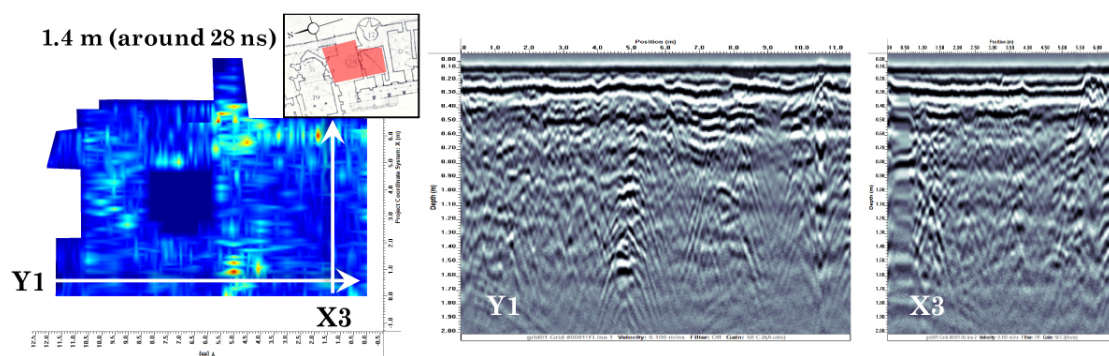
In this smaller courtyard, the wall foundation running East to West is the most significant feature, appearing directly south of the well near the center of the y-lines. The related foundations along the eastern side of this earlier room (which used to surround the tower) are also apparent in the GPR results. Also visible in the lines are the modern drainage modifications and the underlying foundations, which are likely shallow constructions on top of the bedrock slope in this area. There are no reflections from remains of the staircase or foundations on the southern side of the Möller and Viennese plans (Figure 31), though remains of the stairs are visible on the exterior of the South wall of the courtyard.

Figure 31. In the eastern courtyard with the well, the most significant feature found with the GPR is the wall foundation running east–west (near the center of Y1). This is the outer wall of an earlier room (shown in the inset) which appears on some maps of castle (such as Figures 2 and 4).

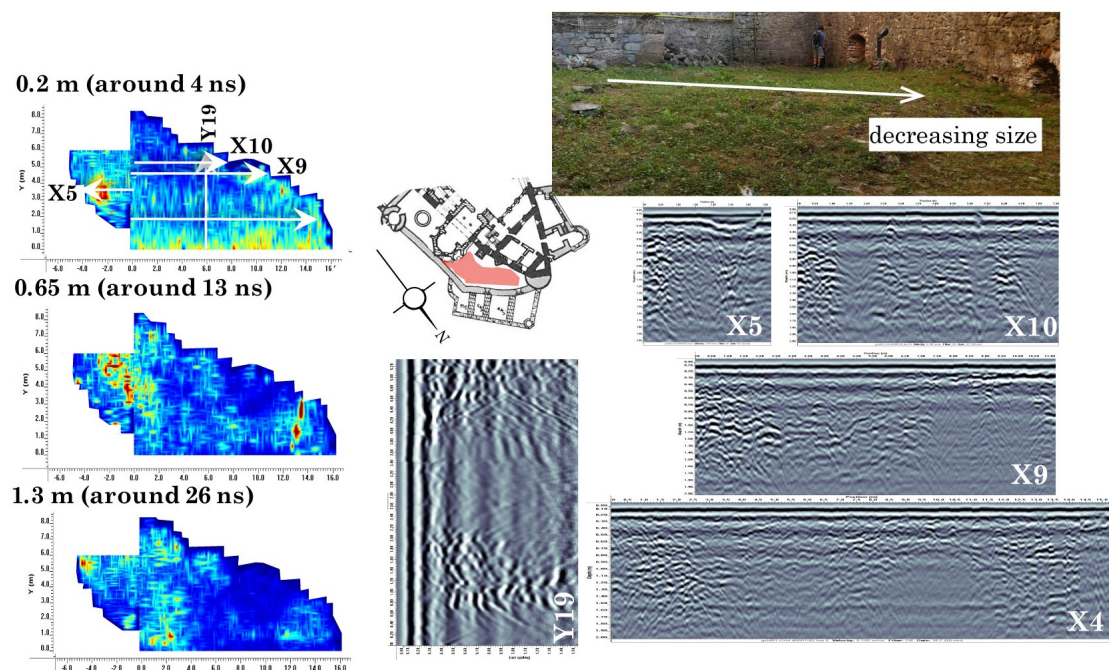
Figure 32. Selected lines and depth slices from the Bear Pit. Note the rubble piles on the southern edge (and in X5) and the predominant areas of high scatter vs. low scatter.

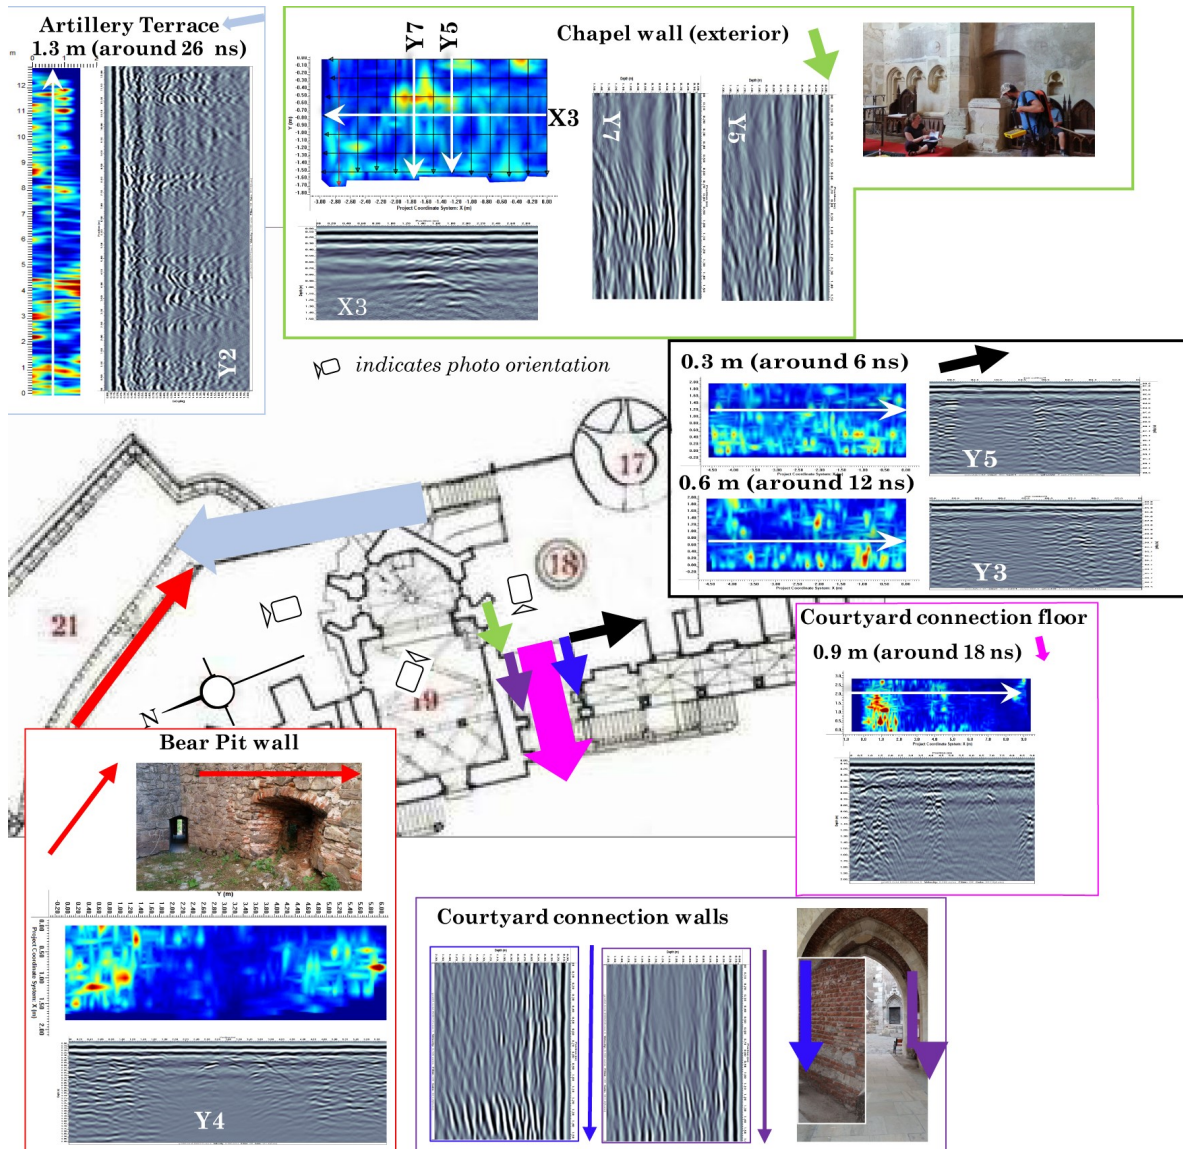
A number of wall sections and related smaller areas of the grounds were scanned, primarily in the eastern portion of the castle (including the Well Courtyard, Bear Pit, and chapel). The primary results of these scans are the presence and location of embedded elements such as portions of older phase walls. First, the outer wall of the Artillery Terrace can be seen inside the wall separating the terrace from the Bear Pit (Figure 33, esp. “Artillery Terrace”). This confirms that the dividing wall is more recent than the Artillery Terrace wall; note that this survey was only collected in one direction. Next, the wall dividing the Bear Pit from the Artillery Terrace, which has a brick archway through the base that runs all the way to the Artillery Terrace, appears to be constructed with two phases. One phase cuts through a vertical section of the wall just above this arch (pictured) and separates the left and right sides of the wall (Figure 33, “Bear Pit wall”). Moving to the connection path between the main courtyard and the Well Courtyard, the walls on each side are constructed of alternating layers of large ashlar masonry and many courses of bricks. In GPR scans, only the lowest layer of stone is easily determined. One possible explanation for this could include the exterior location of these walls and the presence of salts and moisture drawn into the masonry by capillary action (e.g., [34]), which is halted by the change in courses (Figure 33, “courtyard connection walls”). In the floor of this entryway, the abundance of crosscutting wall foundations from earlier phases places the passageway itself most likely in the Bethlen phase (Figure 33, “courtyard connection floor”; also compare to Figure 3). In the courtyard itself, the western wall is reported to contain at least the components of a frame from the original 14th century fortress (Figure 31). GPR scans confirm the embedded brick staircase present in this wall, which is visible in several locations and appears in the lines and depth section (Figure 31) as an area with weaker reflections (Figure 33, right, west wall of courtyard). North of the Well Courtyard, the exterior wall of the chapel contains reflections of the niche and former pulpit are visible (Figure 33, “Chapel wall exterior”).

Figure 33. GPR scans and results from the northeast sector.

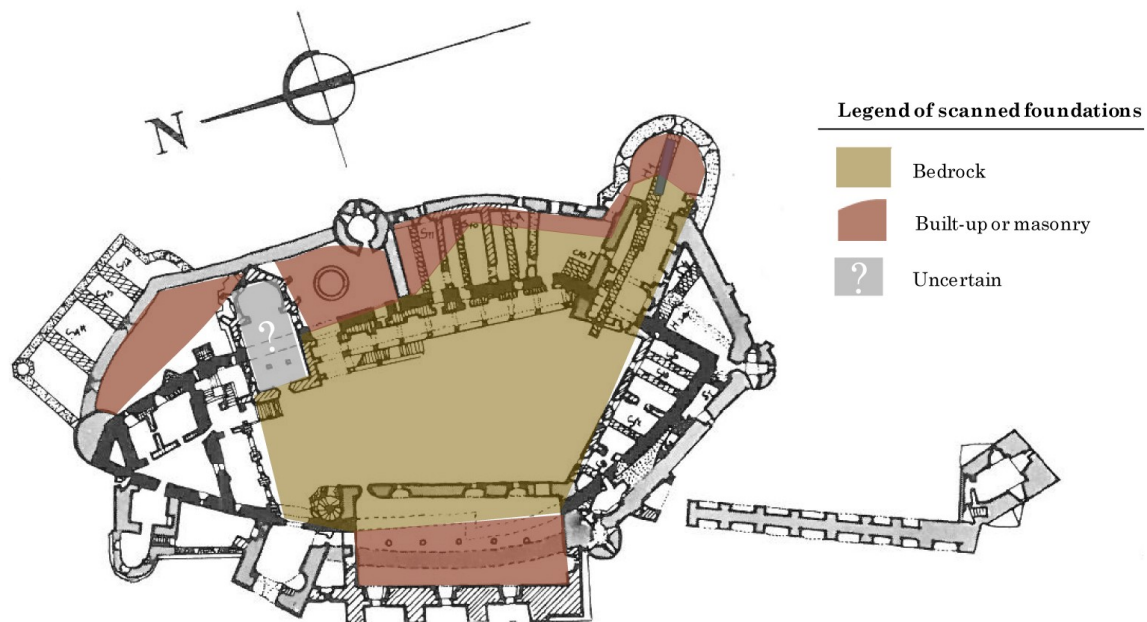
Looking at reflection patterns across scans of the whole castle, the character of the foundations apparently shifts from bedrock to built-up masonry (stone or brick) [30]. In the metamorphic bedrock, there is high attenuation and there are few reflections aside from those of the geological features of the bedrock itself (i.e., metamorphic folds, Figure 23). The built up masonry foundations, on the other hand, can be identified by the abundant reflections from the components of masonry construction. It is proposed that this represents the transition between foundation on bedrock and the foundation laid on top of bedrock using supplemental construction materials (Figure 34). This trend is seen in multiple rooms across the scanned areas of the castle (e.g., Figures 18, 29, and 30). As the castle evolved and its floor plan was expanded, it outgrew the rocky outcrop that served as the primary foundation (especially in the center and south). Additional built-up masonry foundations (either of stone, brick, or a combination of materials) served to expand the area enclosed by the castle walls and create the current footprint of the castle. As determined by GPR, the transition follows the general layout of the original 14th century fortress with the exception of the original entrance and White Tower (Figure 34). The original southeastern entrance to this phase of the castle, now enclosed in the White Tower and entrance hall, lies on the sloping bedrock outside the 14th century walls. The distinction between

Figure 34. Compilation of scanned and identified foundations. The foundation composition in the chapel is still unknown, but likely contains both built-up and bedrock foundations. Note the unscanned areas and comparison to the solid black 14th century extent walls, overlain on map from Bogdan (1970, [2].)
