Article

The Monumental UNESCO Site of Panamá Viejo: Investigation of the Masonry Mortars

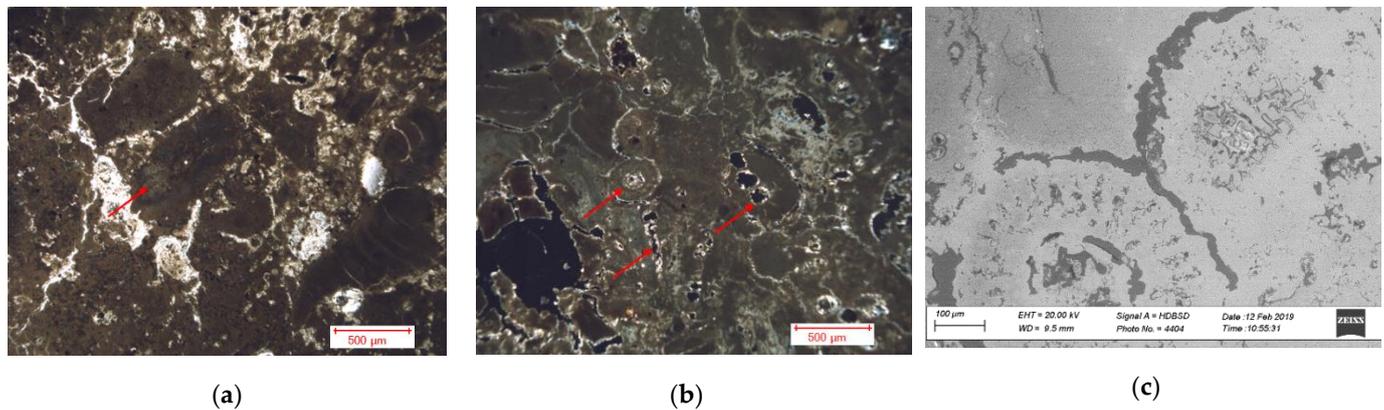
Considering the bedding and joint mortars collected from the masonries, the binder/aggregate ratio is variable; thus, from PLM observations, it is possible to highlight both fat and lean mortars [22]. In addition, two samples, PV TC 1 and PV JM 1, showed scarce and almost absent aggregate; however, they presented lumps as remnants of burnt stones (from the process for obtaining lime) and the remains of fossils/of shells (e.g., foraminifera, echinoderms, etc.—Figure 3).

Figure 3. PLM micrographs showing rests of shells/fossils (highlighted by red arrows), respectively, in sample (a) PV JM1 and (b) PV TC 1: (a) xpl, clearly shows a rest of an echinoderm; (b) xpl, shows the rest of several fossils, including echinoderms. (c) ESEM micrograph of PV TC 1 showing a detail of echinoderm fossils.

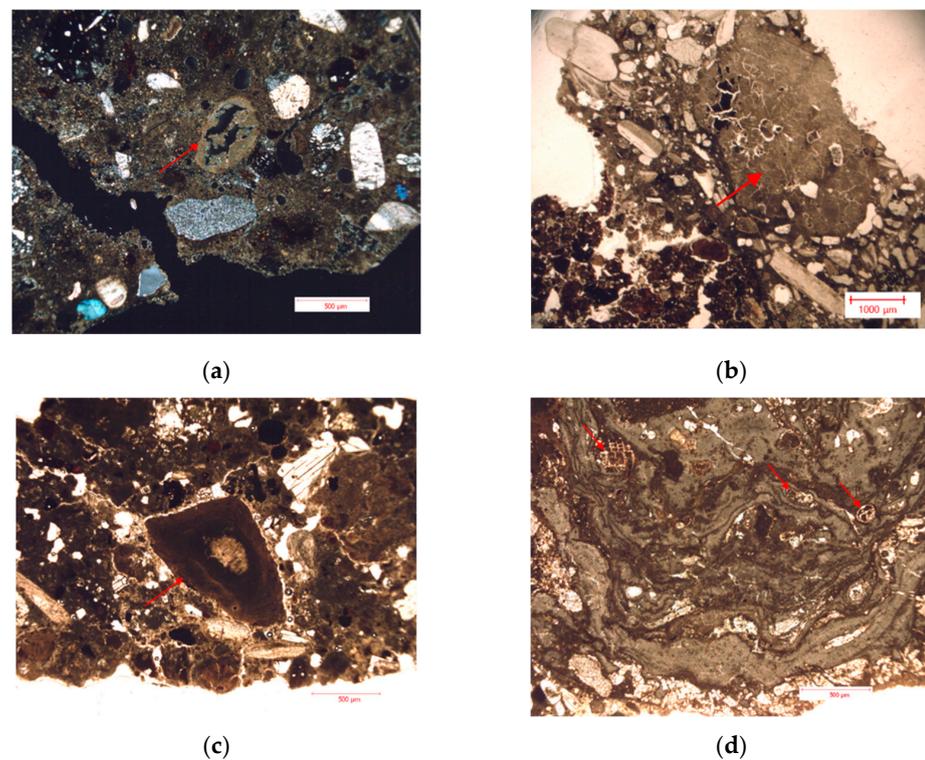
The presence of lumps, as remnants of burning and sometimes also over burnt fragments, was diffused in almost all samples, proof of a poor production technology, as inhomogeneity in the distribution of temperature within the kiln and/or due to a difficult calcination of the stone [19,22–24]. In addition, lumps often show fissuring due to shrinkage (Figure 4).

Figure 4. PLM micrographs showing lumps with dissolution and fissuring (highlighted by red arrows), respectively, in samples (a) xpl, PV JM3 and (b) ppl, PV FC 10M; (c) ppl, remnant of a rest of fossil shell fragment in sample PV JM2; (d) ppl, PV CM2 shows the rest of bio-clasts embedded in a lump of unmixed binder.

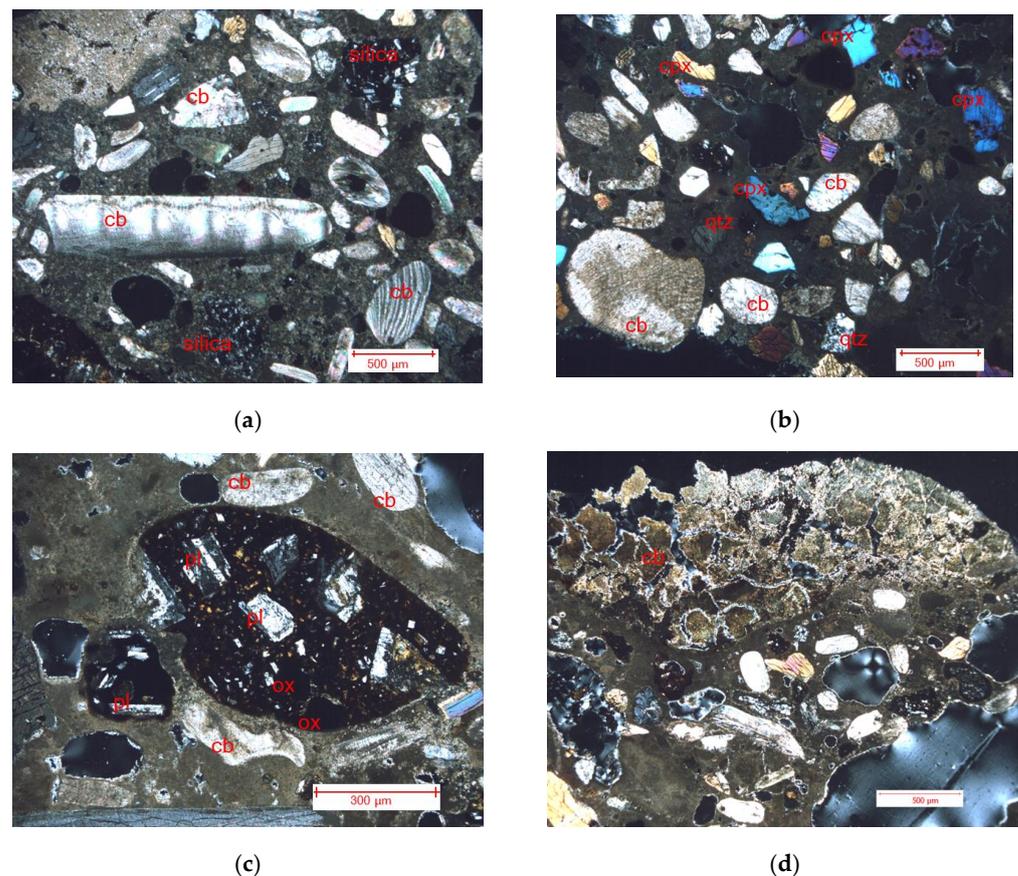
The aggregate is largely formed by both carbonate and silicate fragments (Figure 5). The first ones are represented by fragments of shells/fossils, as foraminifera, bivalves, echinoderms, etc., with rounded/subrounded shapes and dimensions varying between

Figure 5. PLM micrographs (xpl) of: (a) PV FC 10M showing the aggregate formed by carbonate (cb) and silicate fragments; (b) PV CC 2, detail of the aggregate formed by sub-rounded shell fragments (cb) and silicate fraction, mainly formed by pyroxenes (cpx); (c) PV CM 2 volcanic rock fragment rich in feldspars (pl) and iron oxides (ox); (d) PV CM 2 remnant of an under-burnt carbonate fragment, showing calcite re-crystallization within the cracks and fissures.

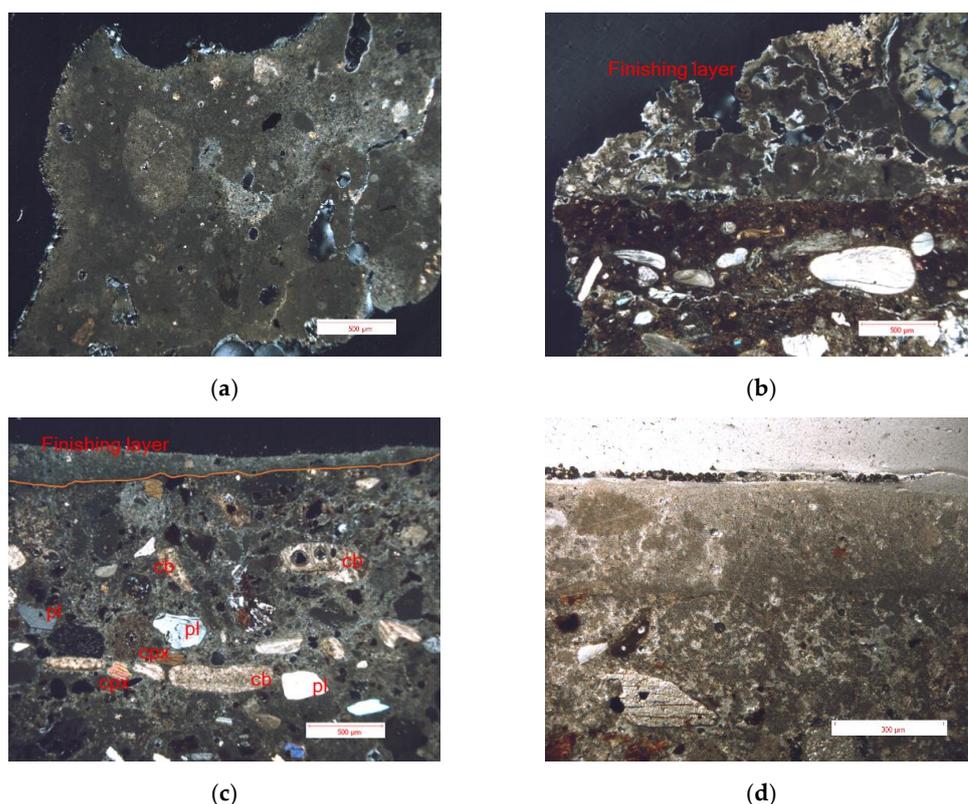
PV CR 2 was a covering/finishing layer, ascribable to a lime plaster. The aggregate was almost absent, and the binder was quite compact, with few fissures/pores but showing quite inhomogeneous color and structure. Indeed, it presented remnants of burning and unmixed lime lumps. Finally, iron oxides were detected (Figure 6a).

Figure 6. PLM micrographs (xpl) of plaster samples: (a) PV CR 2, the aggregate is almost absent, the binder shows inhomogeneity color, with the presence of lumps and pores; (b) PV AE 1 sample, the calcite finishing layer showing an irregular and porous surface, rich in dissolution and recrystallization phenomena; (c,d) PV JM 2, two main layers of mortar are clearly visible in both micrographs: the lean mortar with an aggregate constituted by bioclasts (cb), and silicate fragments (pl, cpx), whereas the thin external layer showing a homogeneous and quite regular and plane surface. In micrograph (d), the magnification of the finishing layer shows the presence of the remnant of another thin surface layer over the finishing one.

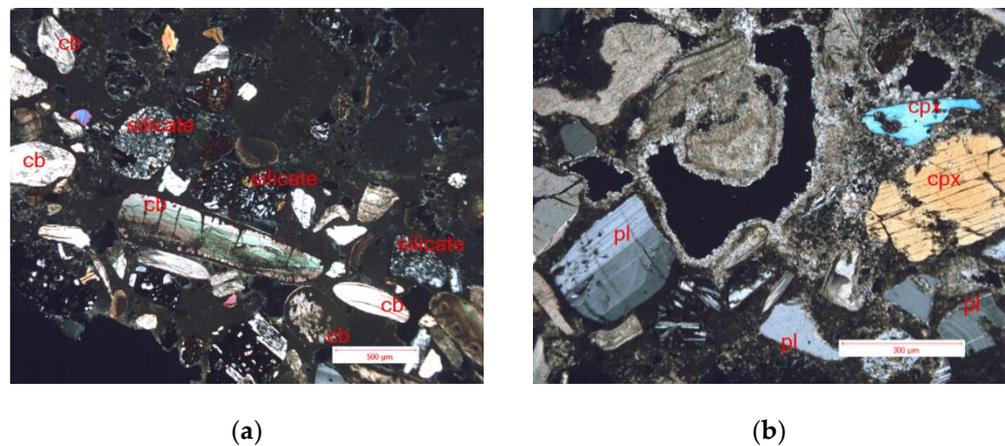
Considering the mortars from the pavements belonging to previous archaeological excavations, PV AE 2 and PV AE 3 are both lean mortars, with scarce lime binder and abundant aggregate (Figure 7a,b). This latter one is formed by a carbonate fraction (sub-rounded fragments of shells/fragments, also remnants of burning) and a silicate fraction (subangular and angular shaped crystals of quartz, pyroxenes, plagioclase, volcanic rock fragments). In addition, iron oxides and of altered zoned plagioclase are observed (Figure 7b).

Figure 7. PLM micrographs (xpl) of: (a) PV AE 2, detail of the aggregate. The traces of under-burnt of the shell (cb) are evident; (b) PV AE 3, silicate fragments of the aggregate, formed by altered pyroxenes (cpx), volcanic rocks, and plagioclases (pl—a zoned one on the right bottom). The pore rims show the crystallization of secondary calcite.

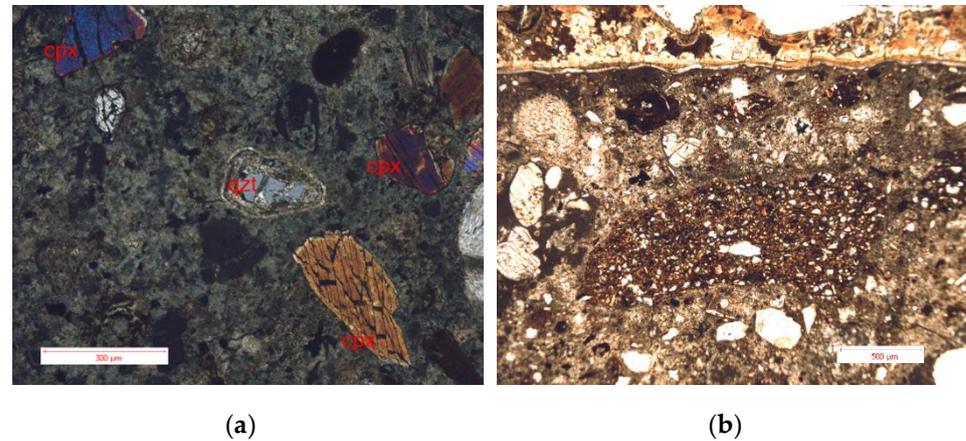
The latter one, sample PV CC 3, was sampled from a mortar described as “greyish mortar of lime and sand with small stones fragments and some shells”. Under PLM, the material presents scarce binder and an aggregate constituted by both carbonate and silicate fractions. The first ones consisting of sub-rounded fragments of shells and fossils, whereas the second ones are mainly represented by both single crystals of quartz (observed also as calcedony) and pyroxenes, and volcanic rock fragments. Among this latter one, the quartz crystals result affected by fracturing with subsequent deposition of secondary mineral phases, including calcite, within them and around the crystal rim, as represented in Figure 8a.

fragments, and pyroxenes (Figure 8b). The presence of cocchiopesto gives hydraulicity to the lime plaster, which is expected, as it is covering a wall of the cistern and thus exposed to the almost constant presence of water and moisture [26].

Figure 8. PLM micrographs of: (a) xpl PV CC 3 detail of the silicate aggregate, pyroxenes (cpx), and quartz (qtz) affected by precipitation of secondary minerals; (b) ppl PV CC 1, general view of the “mortar with cocchiopesto”, showing an external layer.

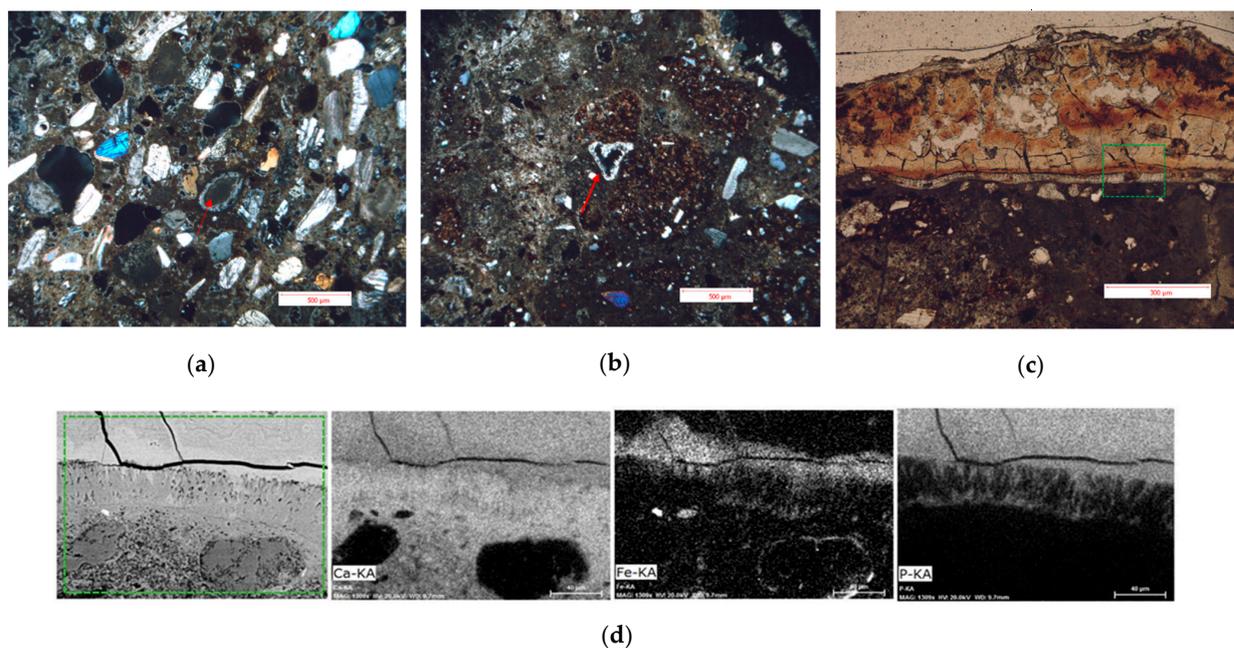
Figure 9. (a–c) PLM micrographs of, respectively: (a) xpl, PV FN 3M, presence of lump rounded shaped, showing dissolution and precipitation of calcite (red arrow); (b) xpl, PV CC1, secondary calcite re-crystallized within a pore (red arrow); (c) ppl, PV CC1 showing the external altered layer. The secondary calcite, re-crystallized within the interface between the mortar and the external layer, is more evident under the ESEM microscope (d), where also the presence of iron and phosphorus is detected by EDS maps (analyzed area is indicated by the rectangle, with dashed line, within c,d).

The majority of the observed samples showed diffused porosity (as pores and fissures/cracks), some of them with the presence of secondary mineral crystallization of calcite within pores (PV FN 3M, PV CM1, PV CM2, PV CC1, PV CR2, PV AE1, PV AE3), as shown in Figure 8a,b. In particular, in sample PV CM1 and in PV CC1, the calcite precipitation is present near the external surface, whereas in the case of PV CC1, it is located in the interface between the inner mortar and the external layer (probably due to decay phenomena, also given by the presence of iron oxides and phosphorous Figure 9c,d). Furthermore, dissolution phenomena of carbonate fragments/lumps are often detected, as in sample PV FN3M (Figure 9a).
