# Load Testing of Cultural Heritage Structures and Sculptures: Unconventional Methods for Assessing Safety

Miloš Drdácý \*

**Abstract:** The paper presents the results of static and dynamic experimental tests conducted on historical heritage structures and sculptures. In recent years, there was an increasing need to address the behaviour of these types of structures due to several reasons. Diagnosing the actual condition of a historical structure involves not only identifying the cause of a detected defect, but also determining its impact and assessing whether the structure can continue to perform safely. This article utilises unconventional loading methods to generate measurable mechanical responses. In one case, a lifting procedure is employed to study strains in a composite structure, while in another example, the mass and movement of people are used as a form of loading. Proof load tests conducted on a monumental sculpture allowed for the determination of load distribution among its heterogeneous structural components, namely a bronze shell and an iron reinforcing frame. Furthermore, the static and dynamic loading of a ceiling supported by a masonry vault demonstrated its abi

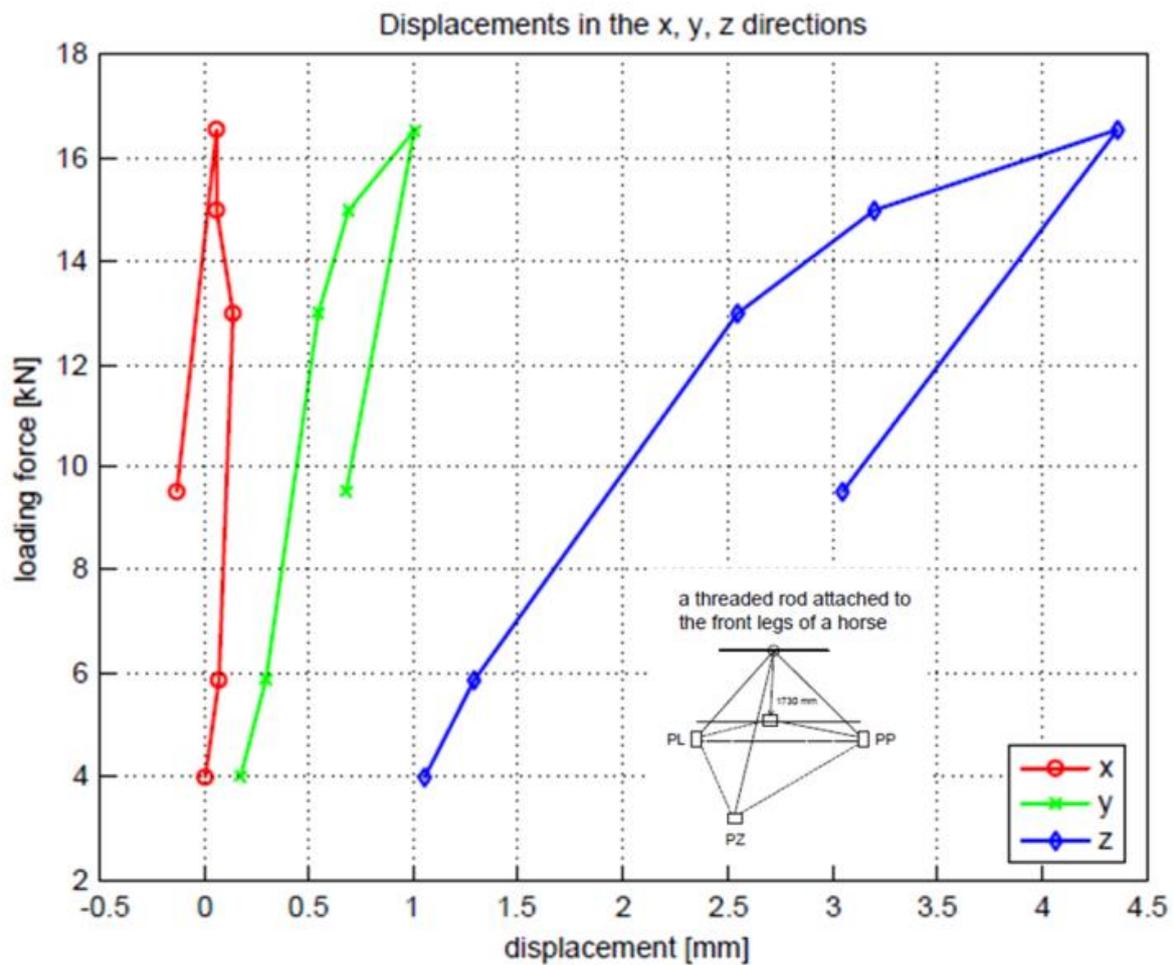
The deflection of the statue was calculated from the measured values and converted into three mutually perpendicular components: vertical deflection ( $z$ ), horizontal deflection in the direction of the horse's axis ( $y$ ), and horizontal deflection in the direction perpendicular to the horse's axis ( $x$ ). The results of the displacement values calculated in this way are shown in Figure 9. Proportional strains on the bronze shell and on the reinforcing frame were measured by electrical resistance strain gauges, and from these measurements, the stresses on the surface of the structure under the selected loading method were calculated. Result examples are shown in Figure 10.

From the measured results, it is clear that the bronze shell significantly contributes to the transfer of the statue's own weight to the support. During unloading, higher stresses were measured in the shell. The cross-sectional areas of the profiles are for the most part larger in the shell than in the steel frame, except for the profile above the hoof where the bronze tightly encircles the steel profile. Without detailed knowledge of the cross-sectional areas at a measurement point, it is difficult to infer the specific contribution of interaction. According to the behaviour of the structure, we estimate that the bronze cladding can transfer about 75% of the statue's own weight to the support in the mostly pressed and bent elements (the legs).

**Figure 9.** Translation of a fixed point between the horse's front legs (the displacements in the x, y direction are horizontal; the vertical deflection is measured in the z direction).

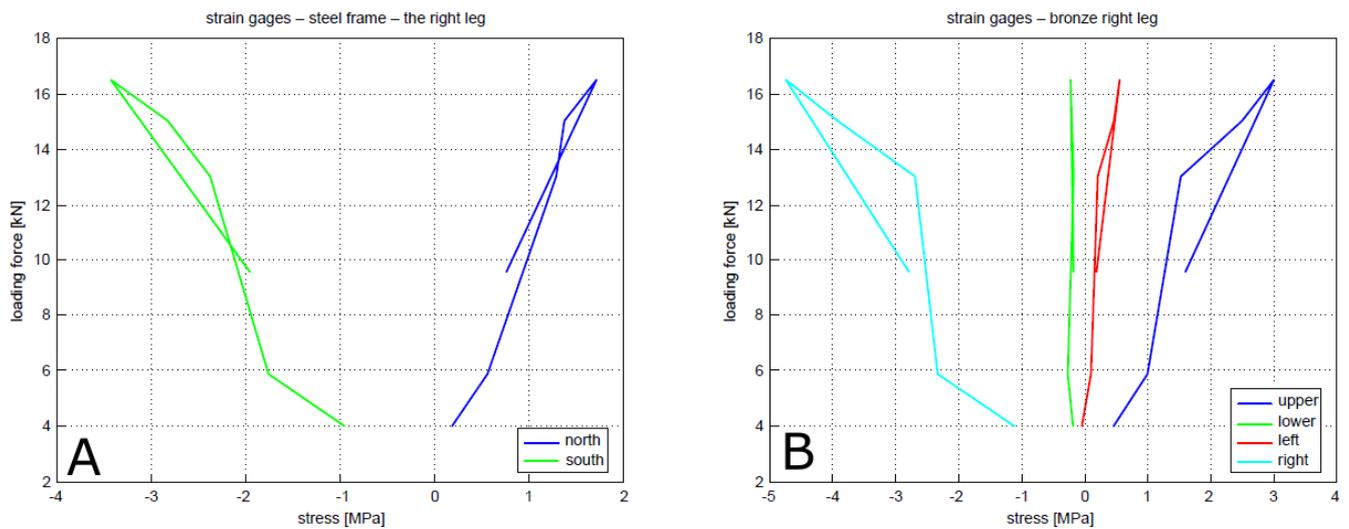
**Figure 10.** Stresses in the right-hand post of the reinforcing steel frame (A see Figure 5) and stresses in the bronze profile of the right leg above the hoof (B see Figure 6) during the lifting and the lowering of the sculpture.

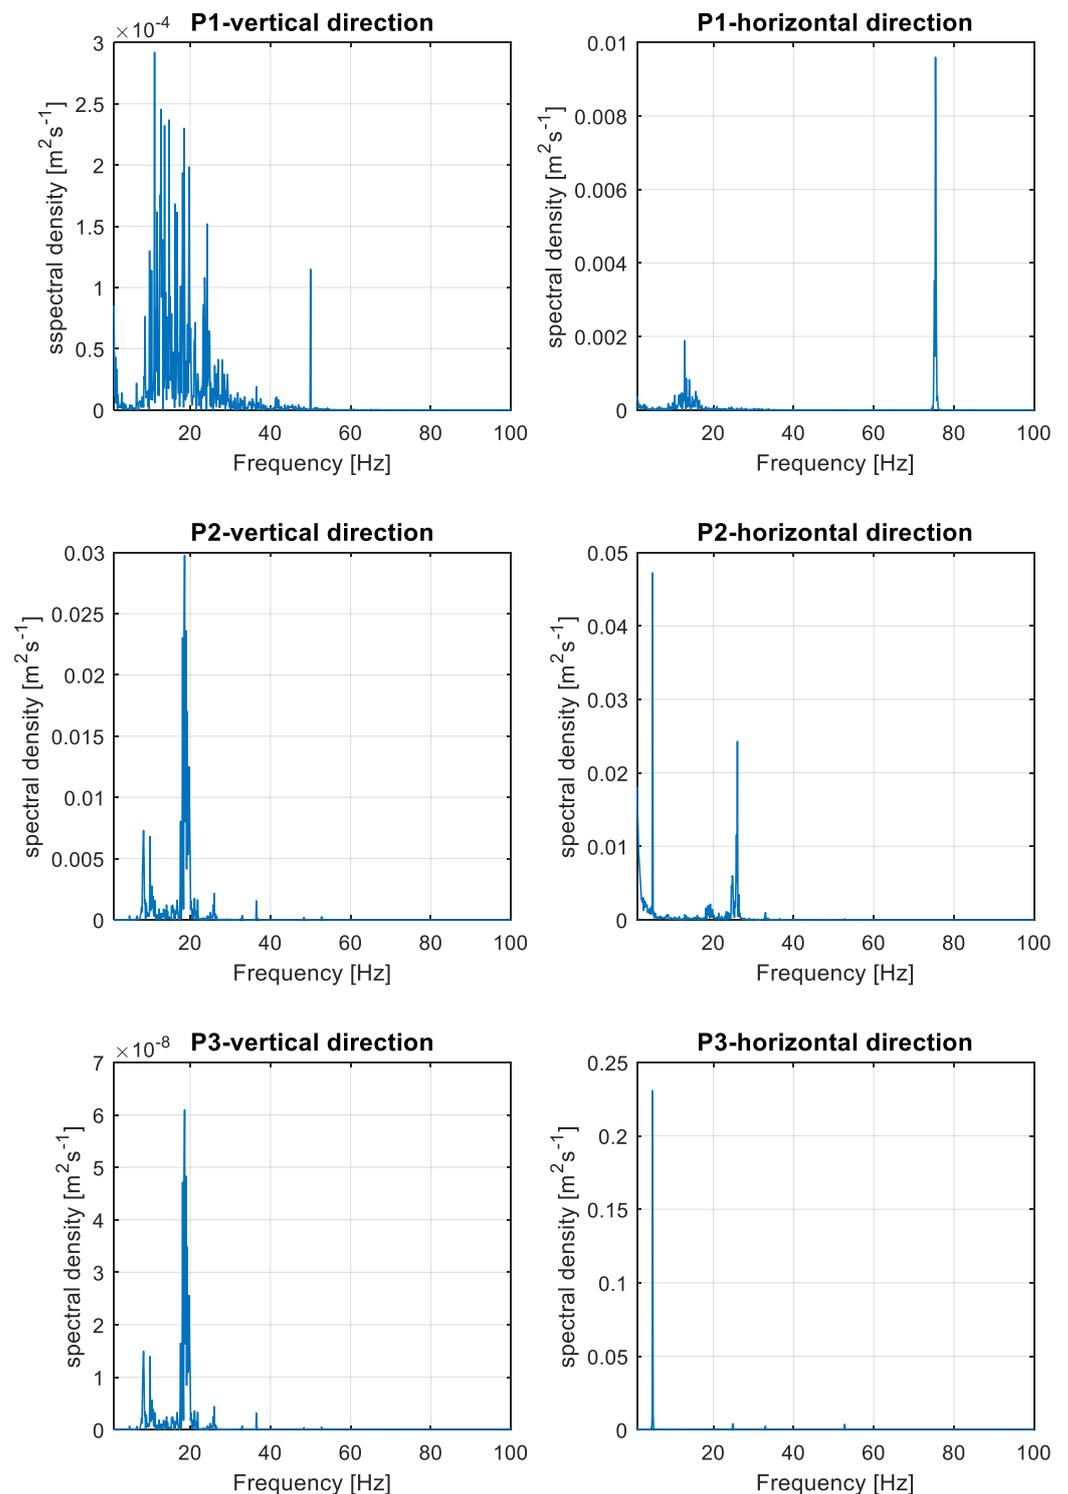
**Figure 11.** Record example for the vertical and horizontal directions at points 1, 2, and 3: a tram passes travelling east and another goes along the river moving south.

structure, the oscillation speeds may be higher. The values in Table 5 show that when excited by a tram crossing the intersection from West to East, the effective speed of oscillation on the pylon of the roof of the National Theatre building is the highest. Despite this, it is many times lower than the permissible values from the national ČSN 73 0040 standard. None of the measured values of the effective oscillation speed exceed the limit of  $1.5 \text{ mm s}^{-1}$  given by the ČSN 73 0040 standard.

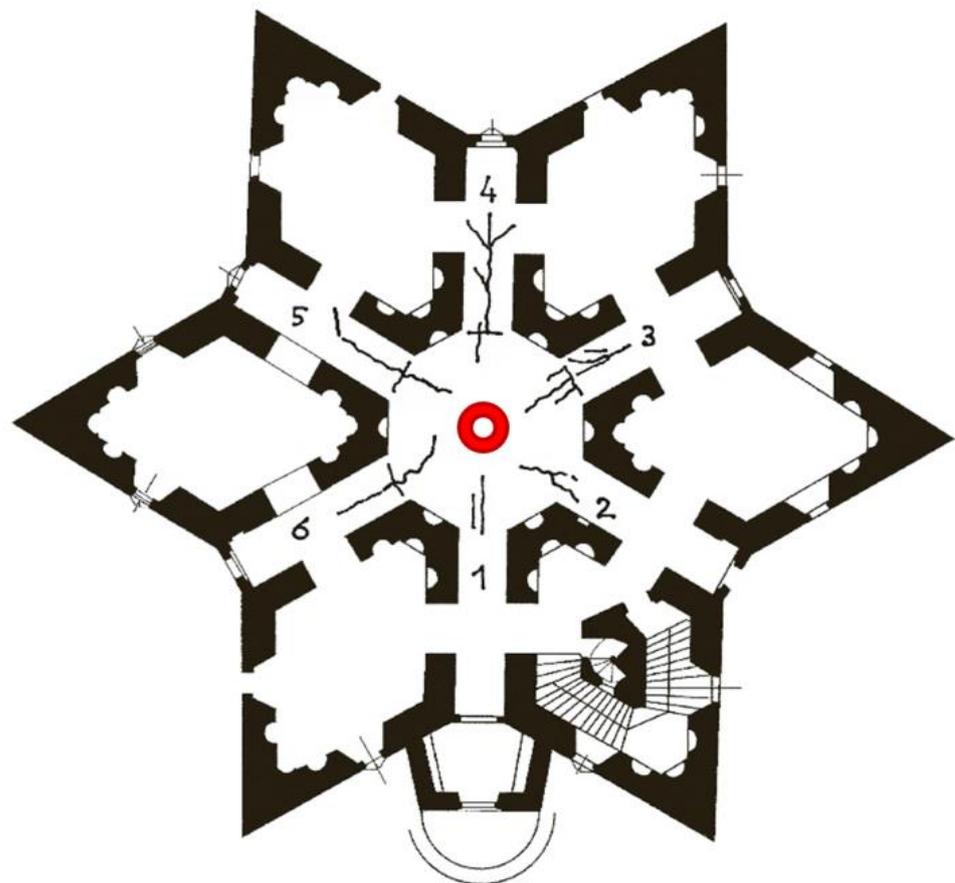
The study load test described in this paragraph was prompted by the need to know and evaluate the contribution of the load on the central part of the exhibition space of the first floor of the renaissance chateau Hvězda in Prague to the deformation of the vault above the ground floor and the possible development of cracks. A request was also made to comment on the vault damage and to formulate recommendations for further measures to prevent their progressive development and possible serious consequences. The report is based on deflection measurements and visual observations of cracks in the vaults during on-site investigations (Figure 12).

**Figure 12.** Ground plan of the Hvězda Summer chateau with marked faults in the vaults and the position of loading and deflection measurement on the central vault.

The load tests and the visual inspection yielded several results. The vault, due to its shallow nature, is very sensitive to loads in the middle of its span, approximately in the area given by a circle with a radius of the installed seat increased by about 0.5 m. Further, the growth of deflections when changing the position of the load is nonlinear and corresponds to the typical course for vaults of a similar type. Under loading, there were no visible changes in the crack system. However, the movements in the cracks are very small due to the size of the deflections, and their monitoring would require the placement of special sensors. It can be expected that the loading of the vault contributes to the cracks' propagation at the connection of the lunettes to the corridors due to a different stiffness of the connected elements. The bench installed in the middle of the room improperly loads the vault by attracting visitors to gather in the least suitable area in terms of the resulting strain on the structure. Although this condition undoubtedly contributes to the gradual deterioration of the cracks, there is no imminent accident or significantly progressive opening of the cracks.

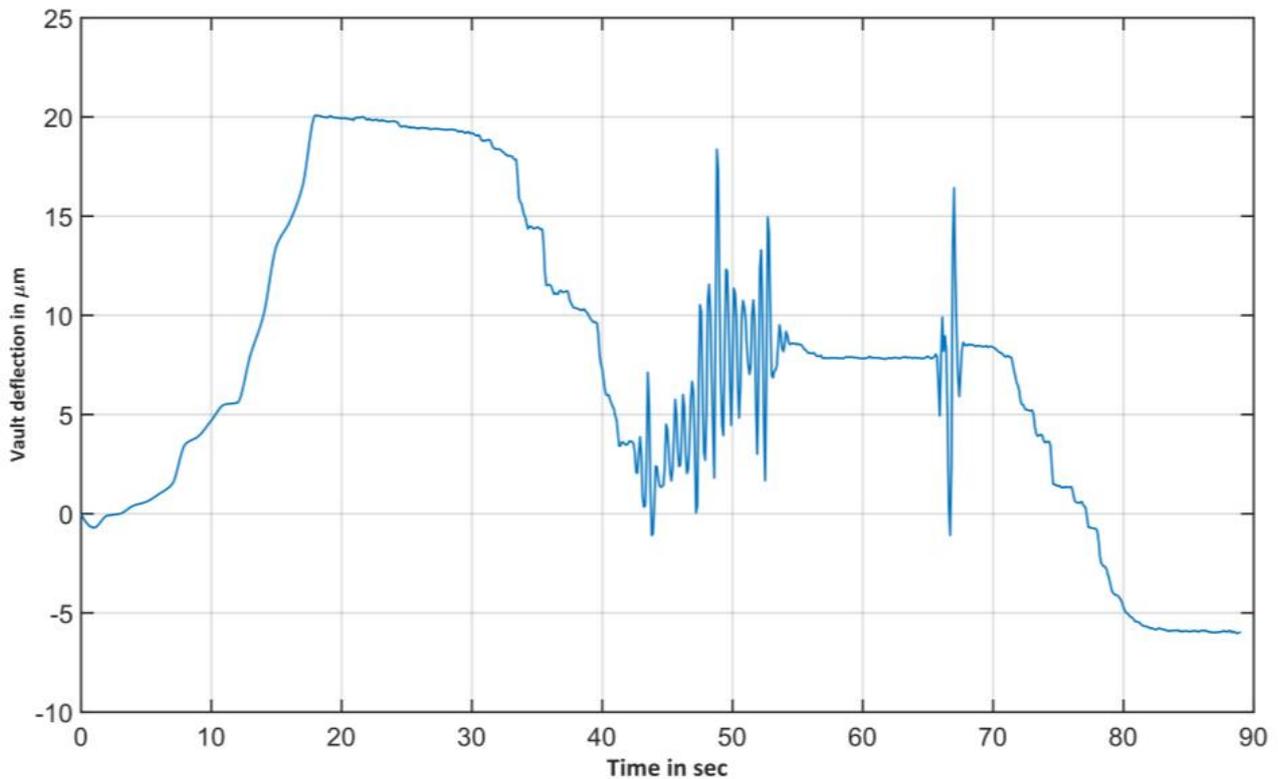
The record of the vault deflections under the various load cases is shown in Figures 15 and 16. In the first series of measurements (Figure 15), the deflection reached  $19.1 \mu\text{m}$  in the first load test and  $10.47 \mu\text{m}$  in the subsequent load test. The graph shows very well that the deflection decreases very quickly when the loading persons move away from the centre of the vault. Dynamic loads at a distance of 0.5 m from the seats produced approximately the same effects as those of the persons seated on the central seating structure.

**Figure 15.** Measured values of deflections in the centre of the vault when the load group was seated (left horizontal part of the graph) and when they moved away (right horizontal part of the graph). The central horizontal part of the graph (top left) corresponds to the load of persons standing still at a distance of about 0.5 m from the seats. The left group of oscillations in the right part of the graph corresponds to the cyclic rocking of persons in a circle 0.5 m from the seats and the right oscillation to the jump of persons in a circle 0.5 m from the seats.

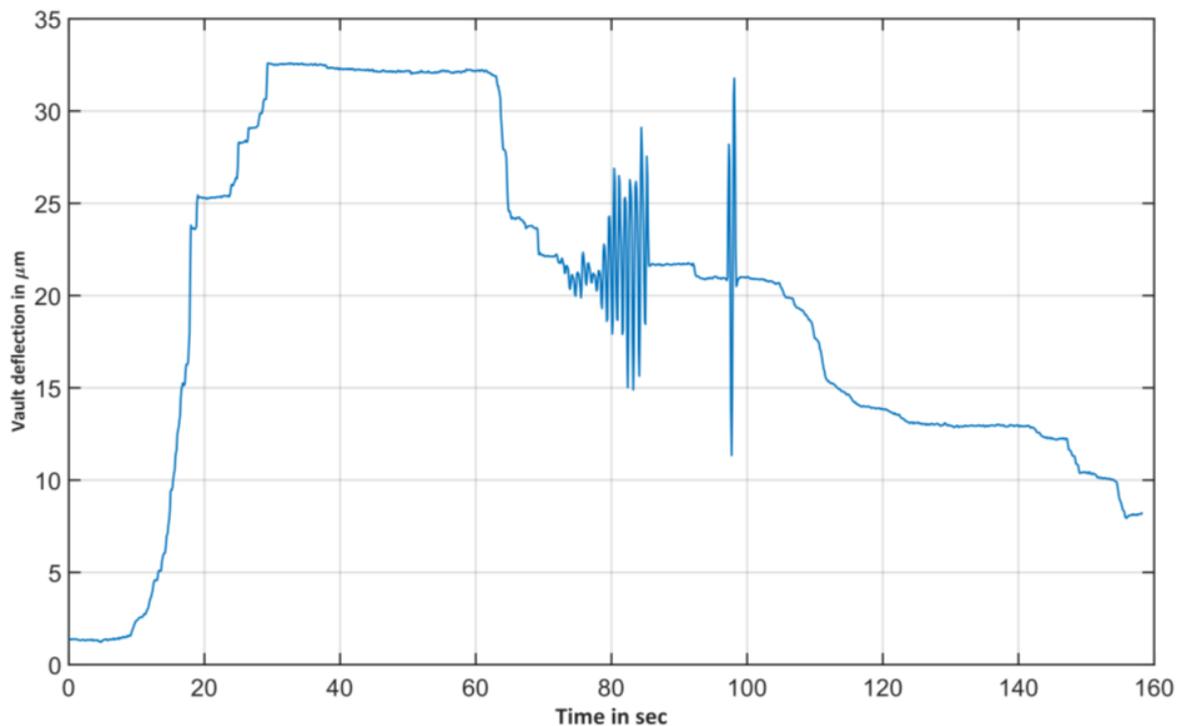
In the second series of measurements (Figure 16), the deflection in the centre of the vault reached  $31.5 \mu\text{m}$  in the first load test (persons sitting on the seats) and approximately  $19.56 \mu\text{m}$  in the subsequent load test. The ratio of static to dynamic effects is similar to that in the first series.

**Figure 16.** Measured values of deflections in the centre of the vault in the second series of measurements under the load group weighing 867 kg. The meaning of the individual parts of the graph is the same as in Figure 15, with the only difference being that there is a longer part showing the deflection of the vault completely unloaded (the left horizontal part of the graph).
