Compatibility Assessment in the Replacement of Damaged Sandstone Used in the Cathedral of Huesca (Spain)

1.1. Ebro Valley Natural Stone: Miocene Sandstone in the Cathedral of Huesca

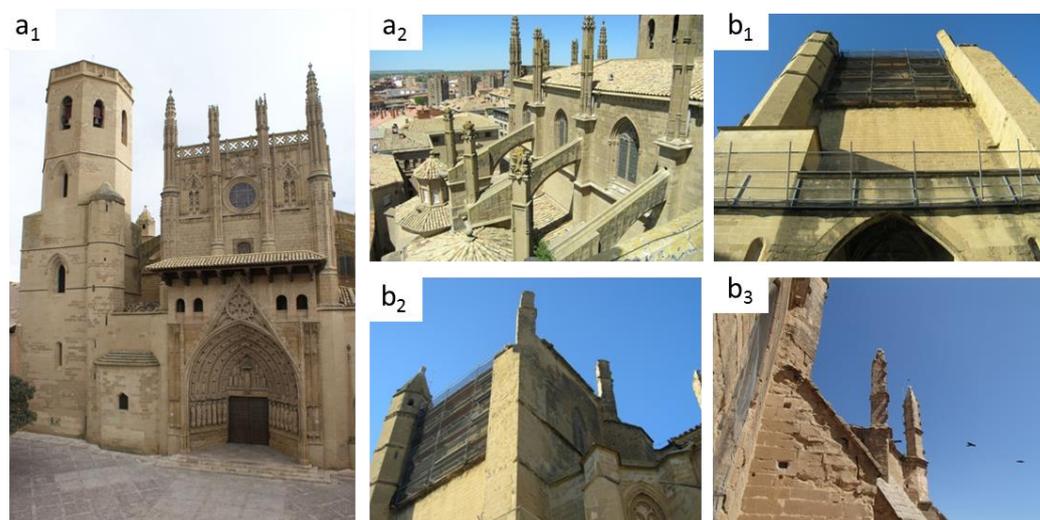
Figure 2. Different views of the outside of Huesca Cathedral. (a) Previously restored areas; (a₁): Main Façade (Courtesy of the Huesca Diocesan Museum); (a₂): Part of the southern stonework. (b) Various aspects of the southern façade under study; (b₁): View of the protective fence; (b₂): Upper-half of the façade with a scaffolding; (b₃): Partial view of the stone decay.

The main façade (Figure 2(a₁)) and part of the southern stonework (Figure 2(a₂)) were the subject of different restorative interventions during the last century. The rest of the stone masonry has been partially treated over the years but it has recently been necessary

to place a protective fence to collect the stone fragments that often fall from the pinnacles (Figure 2(b₁)). The deterioration affects the integrity of the sandstone to varying degrees, depending on its location and function in the building. After visual inspection of the upper-half of the southern external façade (Figure 2(b₂)), three different types of damage were recognized: loss of material in the dimensioned ashlars and decorative stone pieces, as well in the joint mortars; presence of fissures and cracks; and extensive biodeterioration with development of biofilms and the effects of birds nesting (Figure 2(b₃)). Their intensity and development are increased by the combination of them.

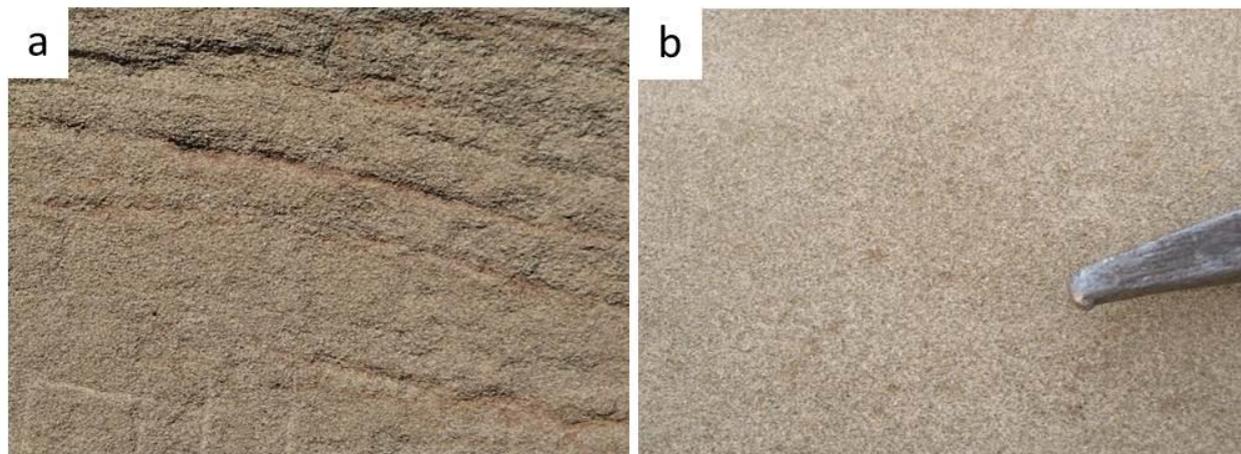
Figure 3. Natural defects in the sandstones used in the Cathedral of Huesca. (a) Presence of argillaceous laminations. (b) Scattered aggregates of clay matrix.

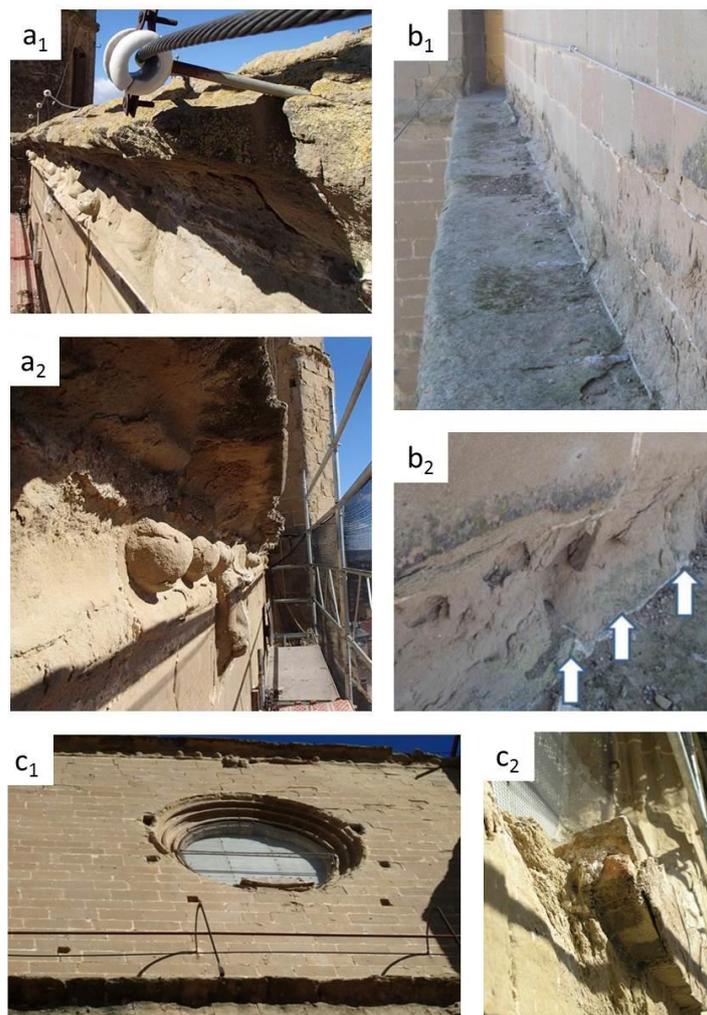
Among the zones identified with serious deterioration, the gutter of the roof was weathered by the effects of long-term rainwater/rock interaction. In general, the causes are associated with the presence and retention of water in any of its states, involving several hydric processes added to the combined effects caused by the implantation of microorganisms. Thus, the direct infiltration of rainwater through discontinuities and absorbed by the porosity of the stone produces significant damage to the pieces that make up the roof ledge, constituting the starting point of the progressive deterioration. In the lower part of this gutter, which also forms a decorative cornice, the accumulated humidity enhances the vulnerability of the rock with total loss of material, even its stony decoration (Figure 4a).

Figure 4. Different views of the deteriorated stonework in the Cathedral of Huesca. (**a₁,a₂**): Loss of material in the cornice and decorative balls below the gutter; (**b₁,b₂**): External corridor (*ámbito*): weathering on the surface and the first raw ashlars related to rainwater stagnation and capillary absorption; (**c₁,c₂**): Loss of material in the rounded pieces of the glass window (oculus) of the transept.

This problematic effect is especially visible in the inferior part of the cornices where significant loss of material, including the decorative elements, forces their complete replacement (Figure 4a). Additionally, the stagnation of rainwater on the surface of the gallery (*ándito*) causes physical damage in the first rows of wall ashlar just above this surface by capillary suction (Figure 4b). In other areas, the direct gravitational fall of rainwater collected from the roof on some pieces, such as those that make up the round glass window of the transept (*oculus*), has resulted in the loss of material in the pieces most exposed to this contact, which also need to be replaced (Figure 4c).

From the available sandstones in the local market, this study evaluates Uncastillo (U) as the most compatible stone to replace the damaged stonework pieces of Huesca Cathedral. Uncastillo sandstone (U) is highly recommended for complete replacement of the elements of the cornice that form the gutter of the roof, or the rounded pieces of the oculus. However, sandstone (U) is not recommended for baseboards or ashlar stones that might be affected by capillary suction problems.

Concerning remedial works, it is essential to check the roofs and their general condition, with special attention to the gargoyles and the evacuation of the rainwater drainage, to avoid, as far as possible, its direct discharge on the stone ashlar masonry. With regard to other solutions which seek to eliminate the cause of deterioration, the convenience of repairing the *ámbito* is indicated by giving it a certain inclination to prevent rainwater accumulation on the surface and subsequent damage by capillary suction. Regular maintenance works will lengthen the lifespan of the stone.

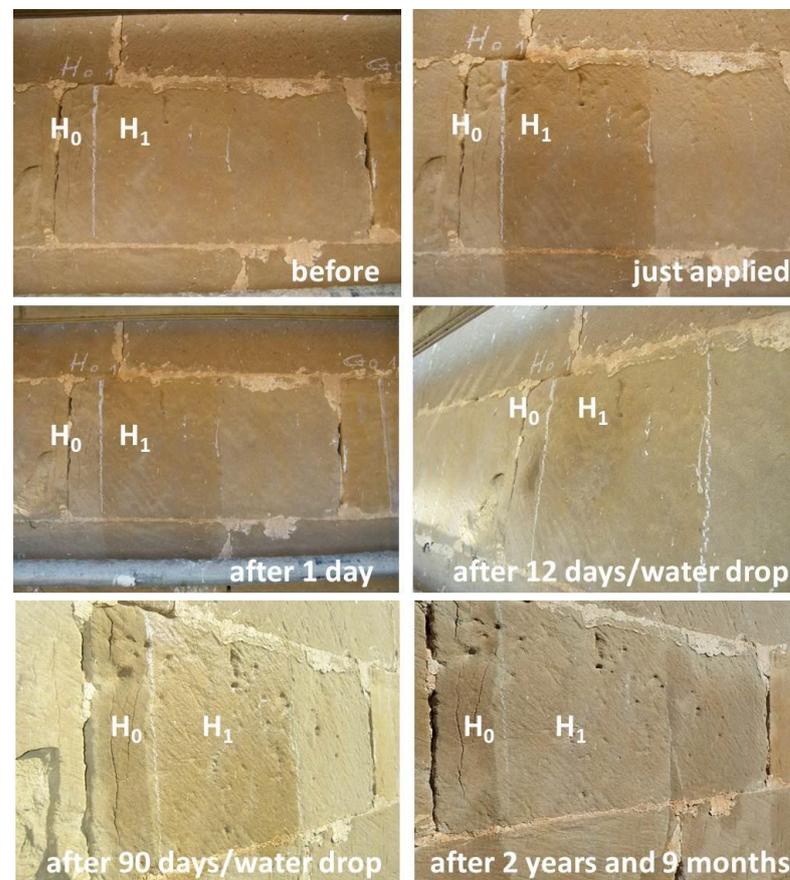
In order to check the effectiveness of each treatment (E, F, G, H) directly on the sandstone of the Cathedral, a test was carried out observing the hydro-repellent behaviour when wetted with a water spray. The experiment, documented photographically, was qualitatively evaluated observing its repellency or contact angle at 24 h and after 12 days, after 90 days, and after 2 years and 9 months. In Figure 10, the progress of one sample is shown. In all cases, untreated parts (on the left part of each ashlar) absorbed a significant amount of water, while water was repelled by the treated surface in all tests (on the right part). Sub-spherical water droplets present elevated contact angle (good hydrophobic effect) in treatments F, G, and H. At 24 h, once the products were absorbed, treatment G developed a discontinuous film or whitish patina which permanently stained the treated ashlar. After 2 years and 9 months, both F and H showed good hydrophobic effect, while the ashlar treated with E had reduced its water-repellent area. In summary, after on-site testing, F and H products were evaluated as the best possible protective treatments to be recommended.

Figure 10. Sequential images of one of the on-site water-repellent tests (treatment H). Untreated (H_0) and treated (H_1) parts before and after different times. Sub-spherical water droplets presented elevated contact angle (good hydrophobic effect) even after 2 years and 9 months.

As a preventive measure, it is recommended to protect the stone with water repellent in those parts directly in contact to rainwater. The best water-repellent product was found to be product H (Tegosivin D100), which is even very effective in slowing capillary suction problems.
