A Practical Example of GaN-LED Failure Cause Analysis by Application of Combined Electron Microscopy Techniques

Elke Meissner ^{1,*}, Maral Haeckel ² and Jochen Friedrich ¹

¹ Fraunhofer Institute for Integrated Systems and Device Technology, Schottkystr. 10, 91058 Erlangen, Germany; jochen.friedrich@iisb.fraunhofer.de

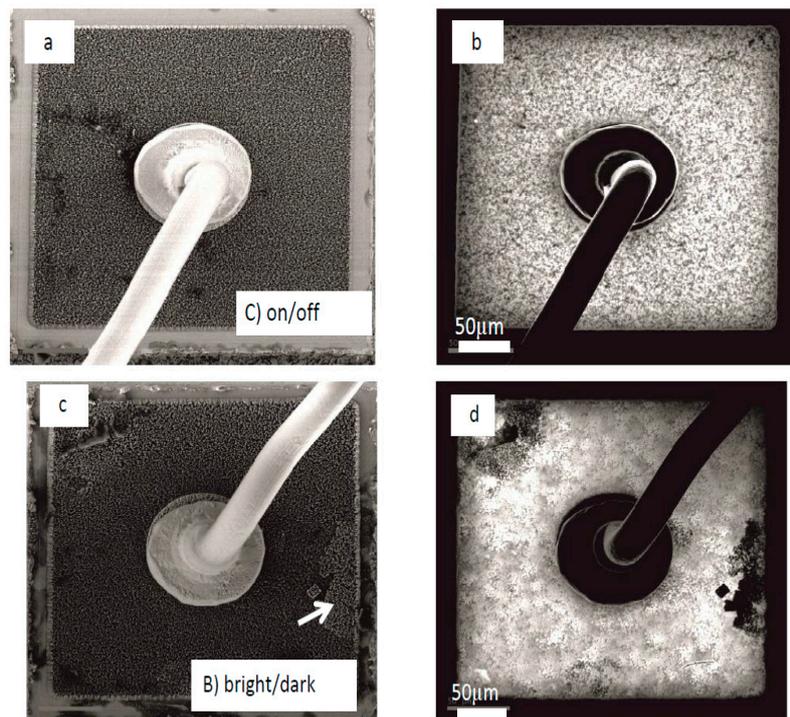
Figure 3 shows the panchromatic CL image of LED chips of the (B) (dark-bright) and (C) (on-off) cases under electron-beam irradiation. Usually, the surface of the nitride layer is roughened during the production process, so that better light extraction can be attained. For CL imaging, this causes the fine bright and darker “grainy” contrast in the picture. Aside from that, the nitride surface homogeneously emits light. The dark areas visible in Figure 3c,d are obviously residues (arrow) from surface cleaning (confirmed by corresponding regular SEM imaging), which could not be further removed.

Finally, nothing was found that could imply structural damage that could be related to ESD events for any of the failure cases described above, as can be seen from the figure. Wavelength selective imaging did not reveal any further information. This was the finding for all of the investigated devices, irrespective of failure type. In cases of discharge damage, material displacements would usually be clearly visible. However, depending on the level of impact, a chip may receive damage in the active zone, which would not be visible from the surface, but such case would presumably not correspond to the observed malfunction symptoms.

Figure 3. Cathodoluminescence imaging of case (B) and (C). On the left side, the SEM pictures are shown, illustrating that no surface defects can be found. There are only some cleaning residues visible (arrow), which could obviously not be removed during the preparation of the free chip surface. (a) SEM image of failure case (B); (b) Corresponding CL image of case (B); (c) SEM image of failure case (C); (d) Corresponding CL image of case (C).

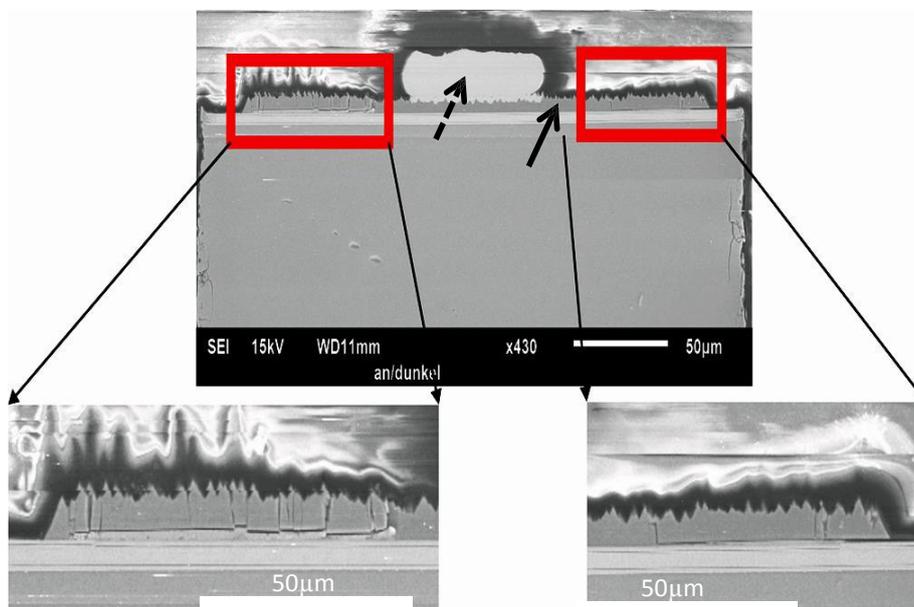
The further observation of cross-sections of the nitride layers inside revealed the reasons for the devices' malfunctions. In Figure 4, an example of a cross-section of an LED exhibiting failure type (B) (flickering dark and bright) is shown. One can see that beside the bond foot, the nitride semiconductor layer has slightly lost contact to the back side of the device and, moreover, shows tiny cracks across the layer.

Figure 4. SEM cross-section picture of an example of a device with type (B) failure case (flickering dark and bright). One can see the bond foot (dashed arrow) and the nitride layer (solid arrow). The nitride layer has lost contact to the back side, and shows partial cracks, which are visible from the enlargements.

Therefore, in that case, the failure symptoms (bright and dark) may appear because the nitride layer has only sporadic contact to the backside, and as such, functions electrically only partially. Hence, the device is not, in principle, fully broken, but the total area emitting light may change, resulting in a darker or brighter light output. This may, in the same way, also cause a LED not to flicker bright and dark, but simply to show a reduced light output due to the fact that a part of the semiconductor layer has broken off completely, and only the remaining material is emitting light. This is thought to explain the failure cases (A), (B) and (C). This suggestion is supported by the findings that were made on the field failure case type (D), LEDs which lost their functionality completely. Figure 5 depicts a SEM, as well as the corresponding EBIC image, from such a device in a cross-section picture.

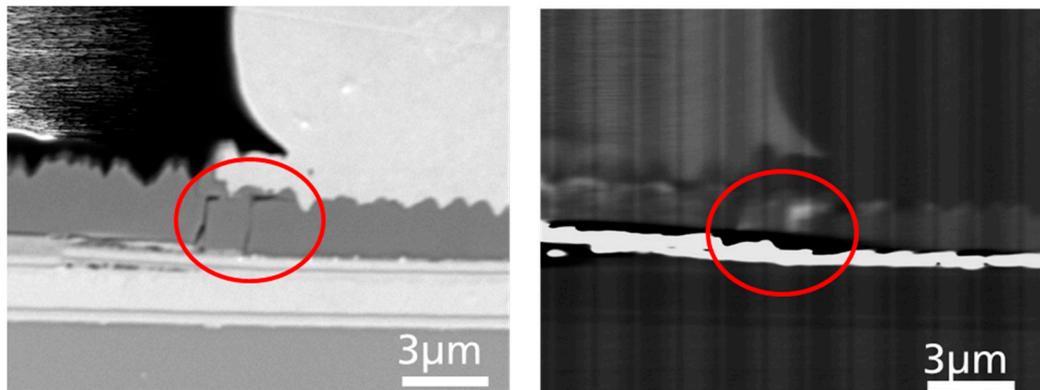
Figure 5. Left side: A crack is visible directly under the bond ball (red circle) in the SEM picture. Right side: The corresponding EBIC image shows a bright contrast at the crack position, indicating local conductivity. Such observation was associated with failure case (D).

Again, it can be seen that the nitride layer is broken, but in this case, directly underneath the bond foot. There are two cracks visible through the layer reaching from the backside to the bond. However, this may not be distinct from the above-mentioned case as long as it's just the crack.

Therefore, in this case, the LED experienced a short-circuit. In order to distinguish why this case leads to a direct shorting of the LED, rather than to one of the other failure cases, it was suspected that a conductive path was involved between the front pad and the backside. Of course, a shorting of a device could be measured directly by an I-V measurement, but that wouldn't deliver information about the physical or microscopic reasons for the short circuit. Microscopic imaging alone may show the microscopic features, but would not raise the fact of whether a particular feature was conductive or not, which could lead to misinterpretation, since the conclusions would be indirect. Therefore, EBIC imaging was applied, since that method is capable of imaging microscopic issues in parallel with its electrical properties. The EBIC current measured was thereby converted into a grayscale image. Bright contrast is related to a high EBIC current, i.e., to high conductivity. The corresponding EBIC image in Figure 5 clearly reveals that one of the cracks is highly conductive (bright contrast), vertically short-circuiting the device from the backside to the bond. The other crack does not show the same bright contrast, which means that there is no current flowing. This could be due to a different contact between that particular feature and the backside and bond, even though it may have the same properties; or, alternatively, it does not have the same conducting properties. The latter is more unlikely, from the following EDS results.

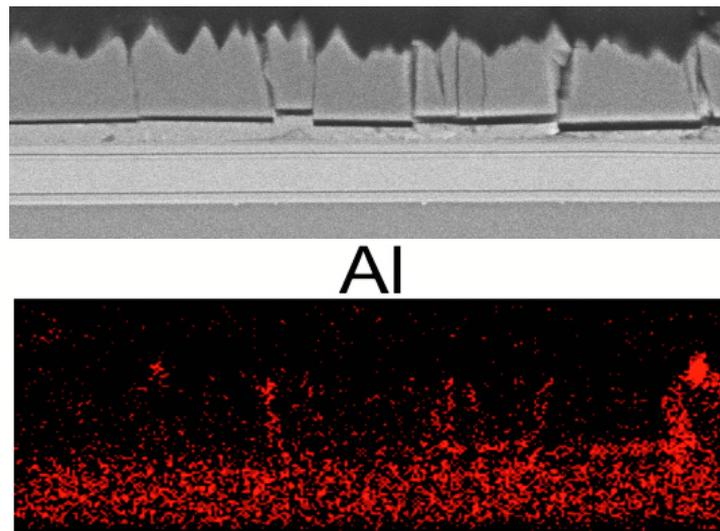
In order to clarify why this crack is conductive, in contrast to the others seen before, which were not vertically conductive and did not short-circuit the device, a subsequent EDS element mapping of an area exhibiting cracks in the semiconductor layer close to the bond was collected (Figure 6). The situation shown in Figure 6 corresponds to the case (D) depicted in Figure 5 above.

Figure 6. Top figure: SEM picture, showing a region with cracks located close near the bond. Bottom figure: EDS mapping at the same place shows the Al-EDS signal, which images the crack locations. The total width of the picture is 50 μm .

This crack could be identified as containing aluminum. The crack apparently offered a path for the metal atoms to move from the backside metallization through the cracks upon electrical operation of the device, and by this means short-circuit the device at a later point in time, which is thought to explain the failure case (D).

However, the reason for the metal moving along the cracks in this case is not obvious, as the LEDs were operated in line with the producer's specifications during their application in the modules. The phenomenon of electromigration is usually expected under large currents or elevated temperatures [7], conditions which can be excluded for the application case.
