# Comparative Analysis of Ultrasonic NDT Techniques for the Detection and Characterisation of Hydrogen-Induced Cracking

**Abstract:** The article is devoted to the investigation of ultrasonic inspection techniques suitable for detecting hydrogen-induced cracking (HIC) and a high-temperature hydrogen attack (HTHA), which are of great importance in petrochemical and refinery industries. Four techniques were investigated: total focusing method (TFM), advanced velocity ratio (AVR) measurement, advanced ultrasonic backscatter technique (AUBT) and time of flight diffraction method using ultra low angle ultrasonic transducers (TULA). The experimental investigation has been carried out on two carbon steel samples cut off from a heat exchanger of an oil refinery and potentially affected by HIC. It was shown that the AVR technique did not reveal any damage and was not effective in the case of the investigated samples due to a thin damage zone with respect to the total thickness of the samples. The AUBT method enabled us to indicate and classify the presence of the hydrogen-induced damage; however, it is complicated to use in practise due to the need perform measurements exactly at the same

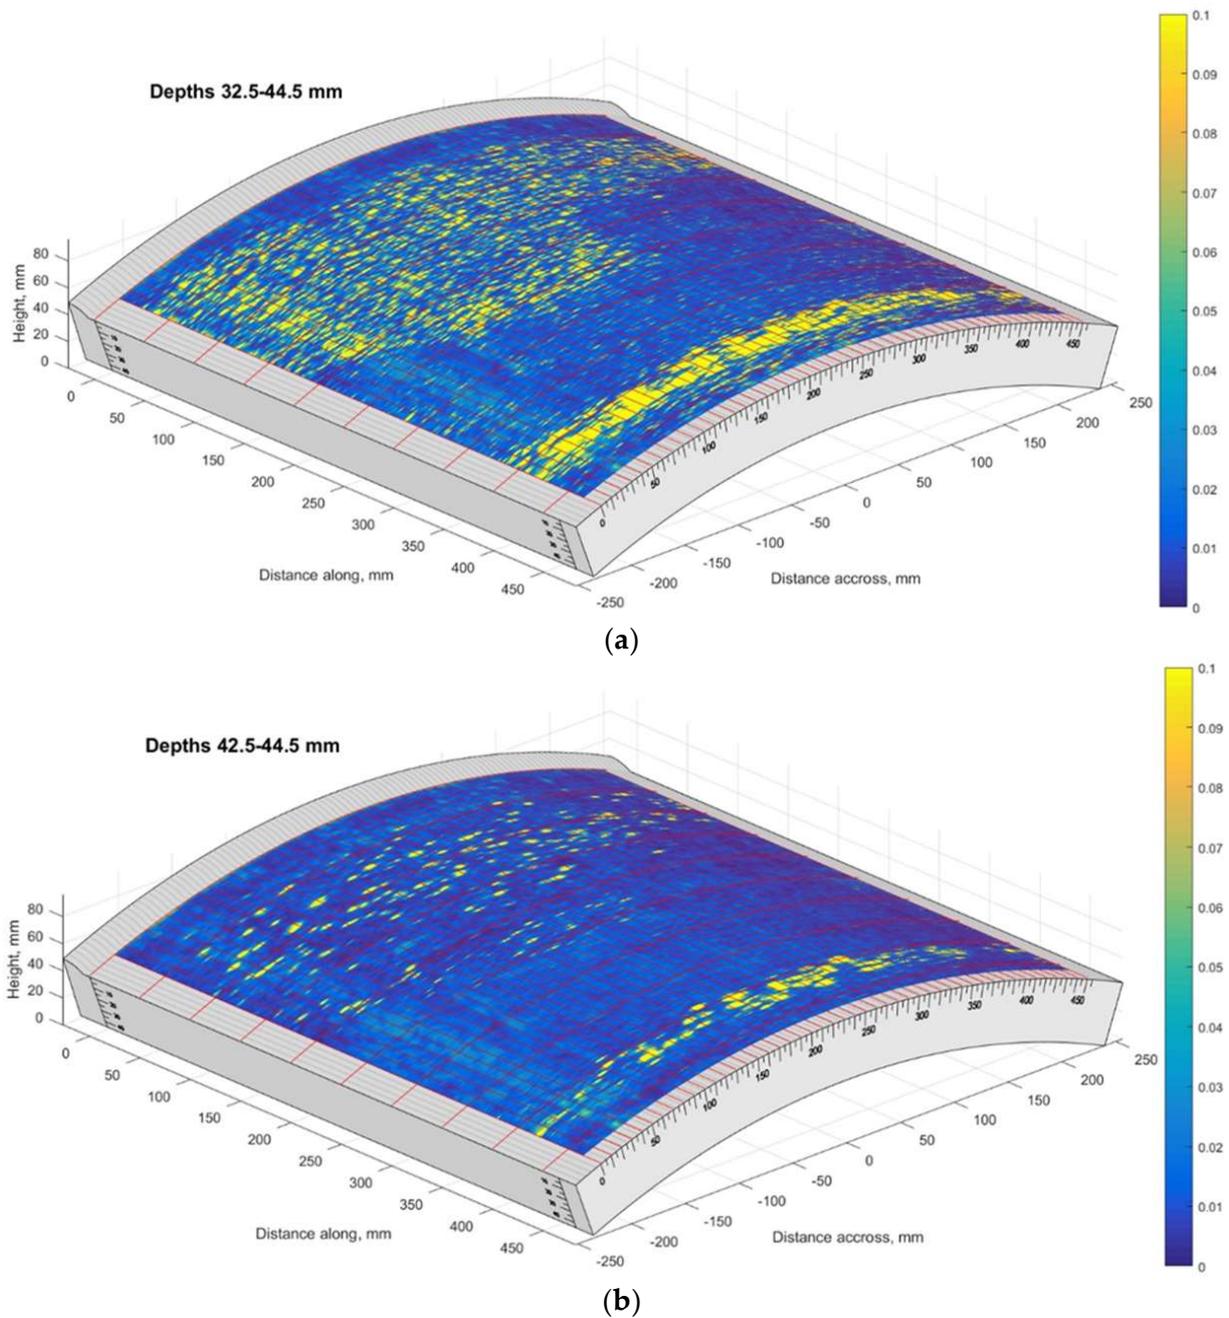
The TFM C-scan results on sample No. 4 are presented in Figure 4. The first part of the figure (Figure 4a) shows the aggregated TFM response over the depth range of 32.5–44.5 mm. The second part of the figure (Figure 4b) presents the likely indications of subsurface blisters (depth range of 42.5–44.5 mm). Here, 44.5 mm corresponds to the overall thickness of the mock-up No. 4.

The results presented above suggest that the HIC damage is distributed non-uniformly. There is a wide non-regular zone close to the weld and an extensive, concentrated region around the circumference 400 mm away from the weld. The TFM B-scan images corresponding to the first (0 mm), middle (229 mm) and the last (457 mm) circumferential scan positions are presented in Figure 5. The results clearly indicate concentrated reflectors, likely voids and cracks, that could be a result of HIC damage at approximately 40 mm depth or 5 mm above the backwall.

**Figure 4.** The TFM scan of the Sample No. 4: (a) depth range of 32.5–44.5 mm; (b) depth range of 42.5–44.5 mm. Vertical colour bar represents the peak-to-peak amplitude in arbitrary units.

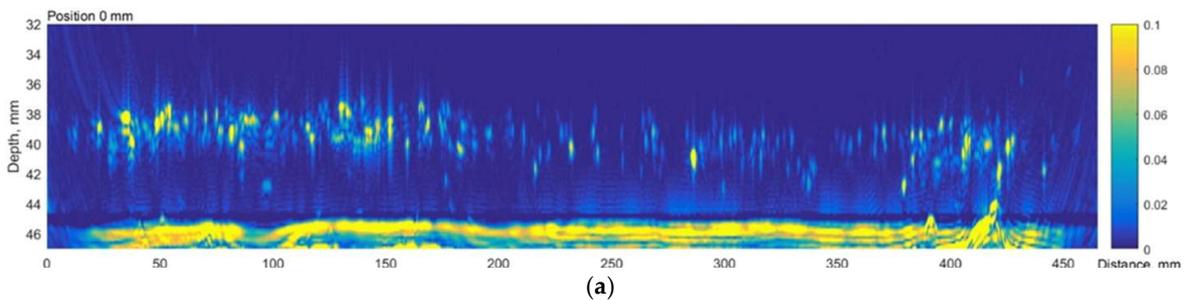
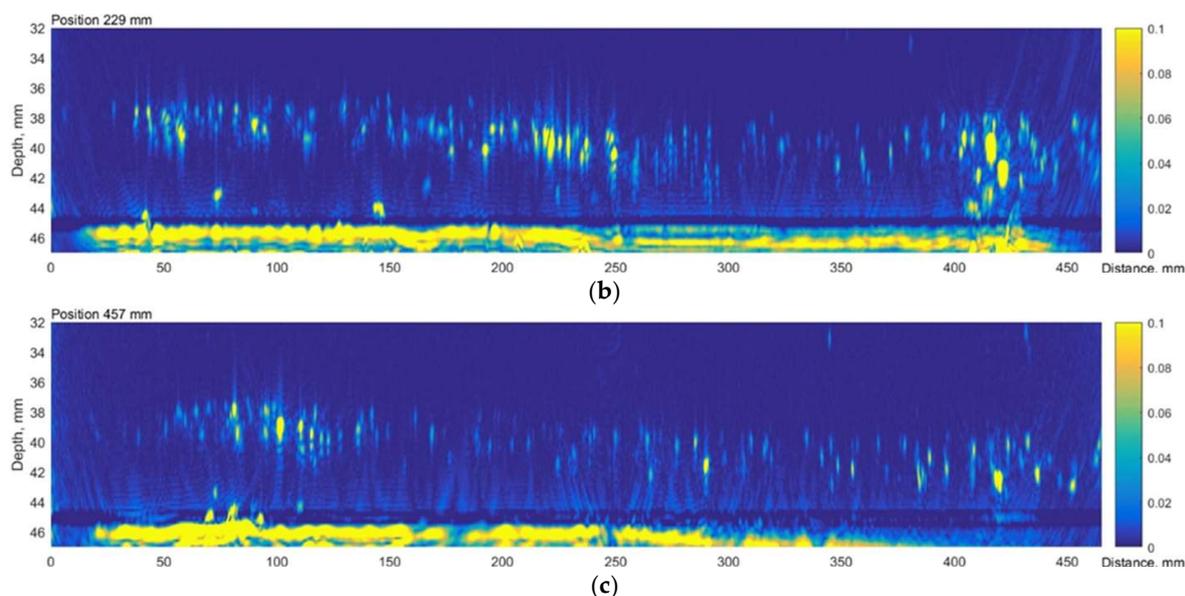
**Figure 5.** The axial scan B scan images of the TFM reconstruction: (a) at 0 mm; (b) 229 mm and (c) 457 mm circumferential locations. Vertical colour bar represents the peak-to-peak amplitude in arbitrary units.

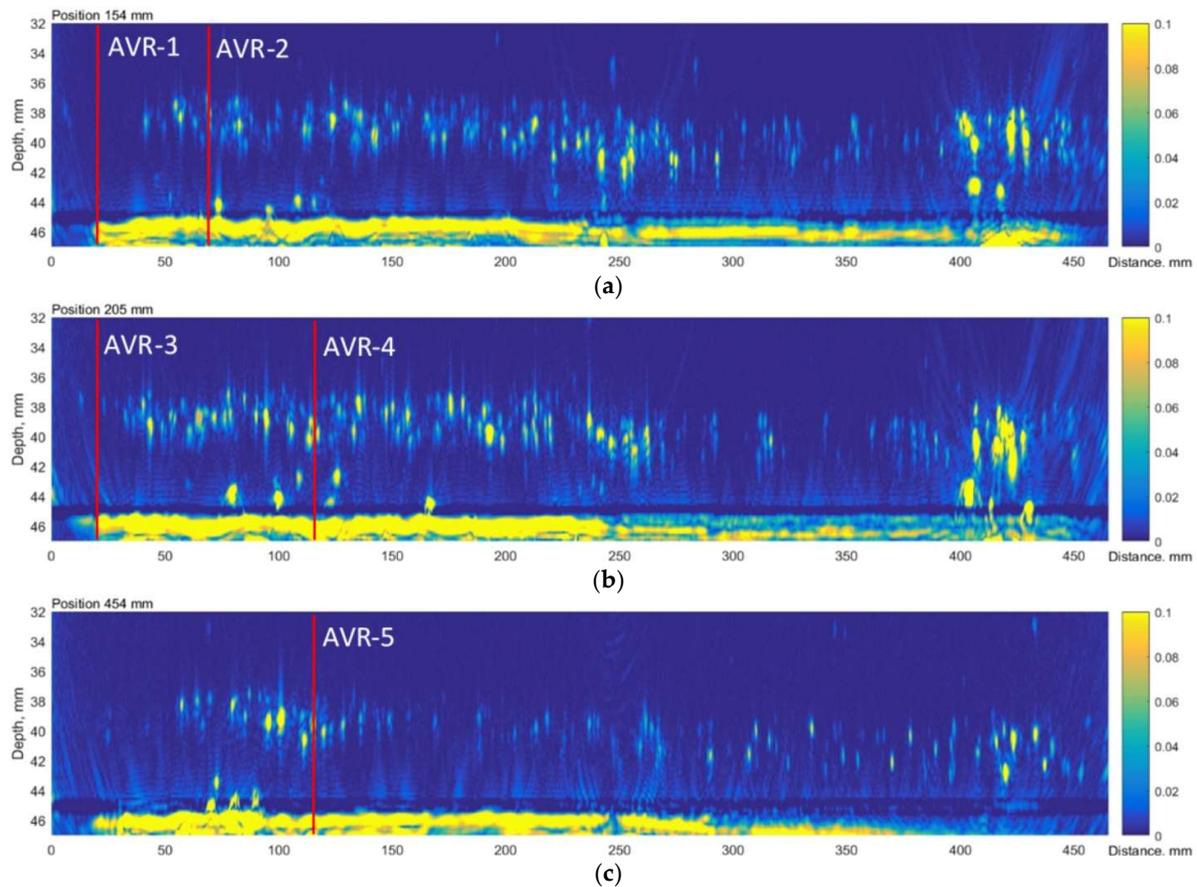
The obtained velocity ratio is equal  $0.548 \pm 0.01$  and does not depend on the measurement position, what is illustrated by TFM data at Figure 7. According to this method it is less than 0.55, thus it does not indicate the presence of HIC at these positions in the sample. However, at the second, fourth and fifth positions, some reflectors can be observed in the TFM image, likely due to HIC damage (see Figure 7). It can be stated also that indications are observed at 8mm above the back wall, so it can be assumed that the damage is present at only 18% of total thickness, so it is completely understandable that the influence of

the damage on the propagation time will be minor. So, it can be concluded that the AVR method possess poor sensitivity for the detection of HIC at a depth close to the bottom, at least in the case of thick samples.

**Figure 7.** TFM reconstructions at different circumferential locations, indicating positions of AVR measurements: (a) 1st and 2nd measurement points, (b) 3rd and 4th measurement points, (c) 5th measurement point. Vertical colour bar represents the peak-to-peak amplitude in arbitrary units.

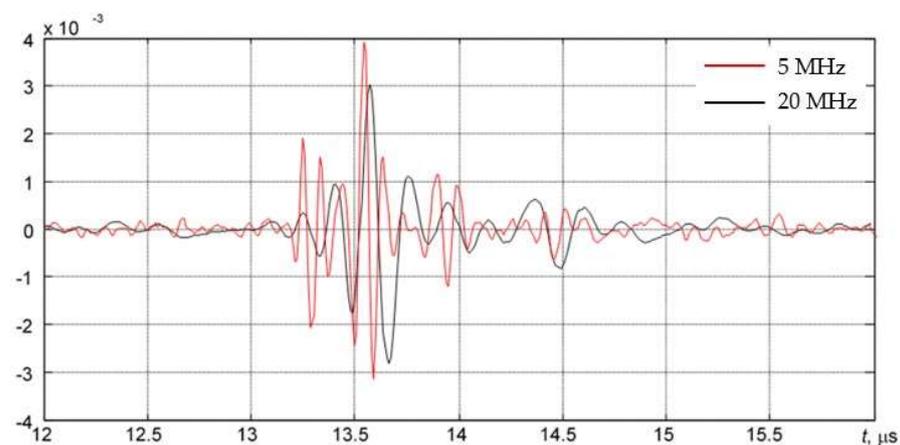
**Figure 8.** The waveforms of the received signals at the point AUBT-1 with 5 MHz (black) and 20 MHz (red) transducers.

The results presented in Figures 8–12 indicate that AUBT shows the presence of HIC at some of locations. At the AUBT-1 measurement position, which, according to the TFM image, is HIC free, the amplitudes of the noise behind the first reflection are similar, which, according to the AUBT, indicates absence of HIC. The results on other measurement positions show a big difference between 5 MHz and 20 MHz signals; the tail amplitude of the 5 MHz signals is higher with respect to the tail amplitude at 20 MHz. In contrast to AVR measurements, the AUBT technique seems to be capable of discriminating HIC defects. For example, at the coinciding measurement point (AUBT-1 and AVR-1), both AVR and AUBT were absent of HIC. In the case of the AUBT 2 and AVR-4 measurement point, HIC was detected by AUBT only.

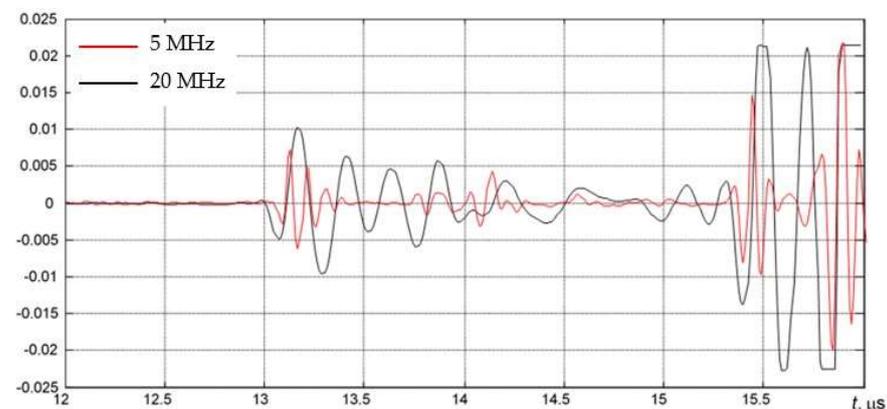
**Figure 9.** The waveforms of the received signals at the point AUBT-2 with 5 MHz (black) and 20 MHz (red) transducers.

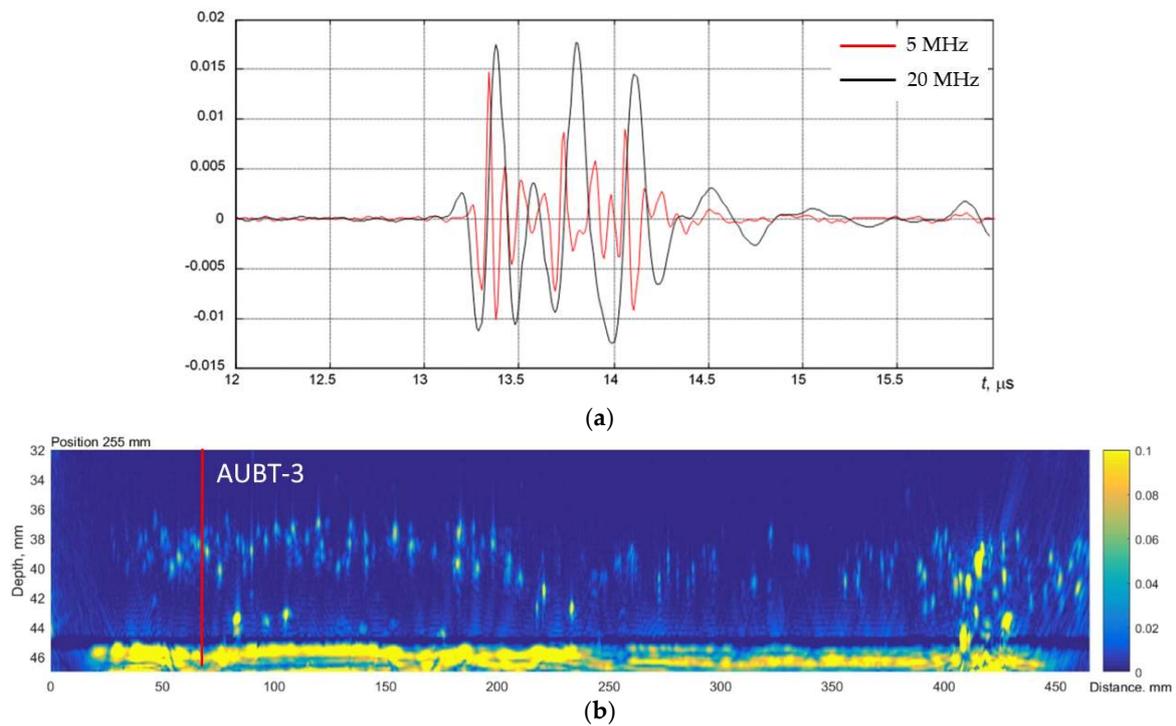
**Figure 10.** (a) The waveforms of the received signals at the point AUBT-3 with 5 MHz (black) and 20 MHz (red) transducers and (b) the corresponding TFM image, showing appropriate AUBT measurement location. Vertical colour bar represents the peak-to-peak amplitude in arbitrary units.

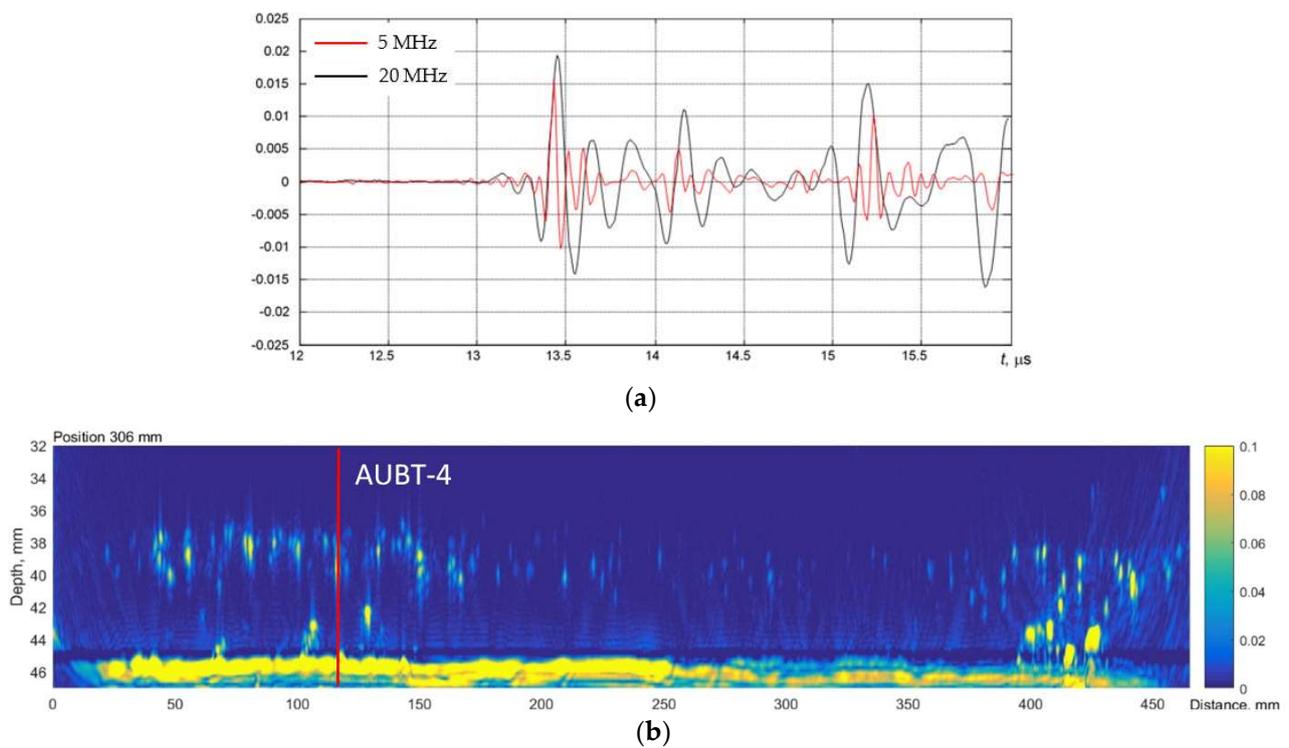
**Figure 11.** (a) The waveforms of the received signals at the point AUBT-4 with 5 MHz (black) and 20 MHz (red) transducers and (b) the corresponding TFM image, showing appropriate AUBT measurement location. Vertical colour bar represents the peak-to-peak amplitude in arbitrary units.

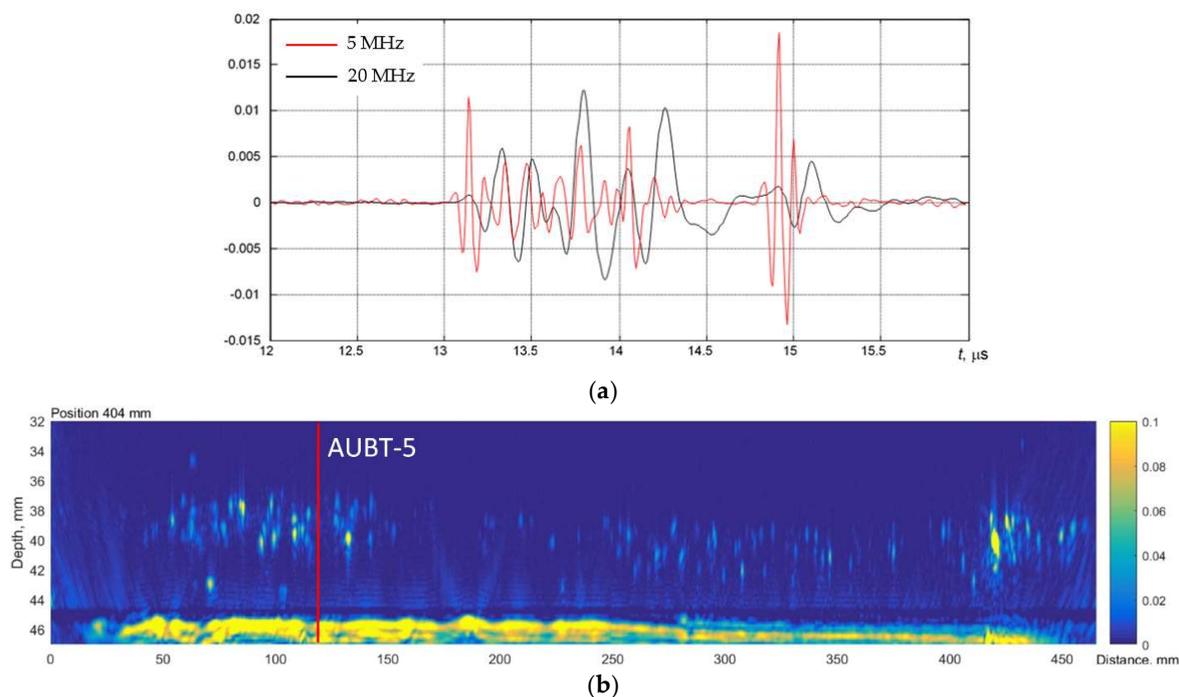
**Figure 12.** (a) The waveforms of the received signals at the point AUBT-5 with 5 MHz (black) and 20 MHz (red) transducers and (b) the corresponding TFM image, showing the appropriate AUBT measurement location. Vertical colour bar represents the peak-to-peak amplitude in arbitrary units.

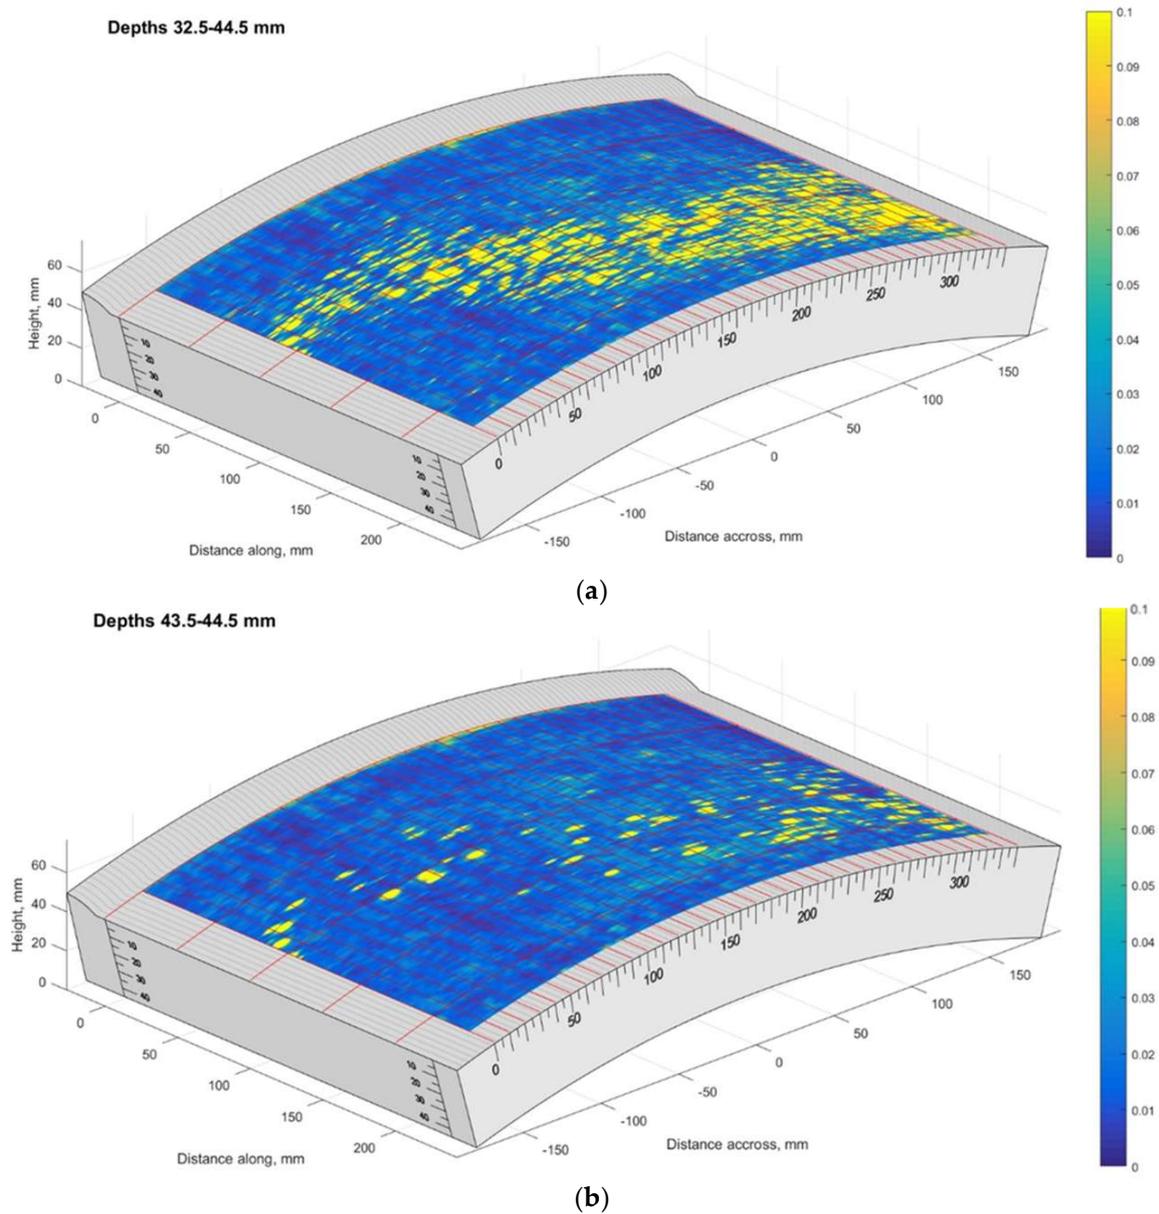
The TFM cartography of sample no. 5 is presented in Figure 18. It can be seen that regions further from the weld were more affected, while the defect distribution is non-uniform. The last TFM scan line according to the circumference of the pipe corresponded to the pipe cut line used for the metallographic analysis. The B-scan of the last circumferential scan position is presented in Figure 19.

**Figure 18.** The TFM scan of the Sample No. 5: (a) depth range of 32.5–44.5 mm, (b) depth range of 43.5–44.5 mm. Vertical colour bar represents the peak-to-peak amplitude in arbitrary units.

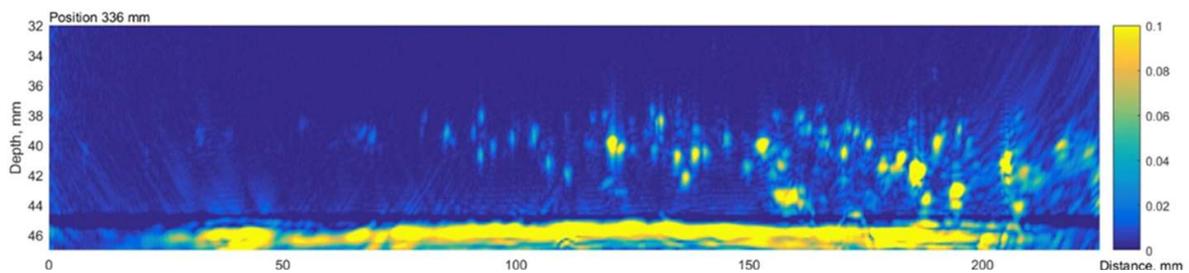
**Figure 19.** B-scan of the sample No.5 along the edge obtained by the TFM. The B scan corresponds to the section line, where the pipe was sliced before the metallographic examination. Vertical colour bar represents the peak-to-peak amplitude in arbitrary units.

The results presented above show that at a distance of 0–50 mm from the weld there are no indications at all; however, from 60 till 210 mm, the B-scan shows a significant amount of reflections located at depths from 35 mm till 44 mm.

A comparison of metallographic images (Figures 21–29) with the results obtained using TFM (Figure 19) revealed a good correlation. In the first section (distances 60–88 mm), TFM images did not show any indications. At the same time, metallographic analysis found only a minor number of small blisters with dimensions around 20 μm. Such size defects are not visible for ultrasonic inspection at frequencies used in this study. An additional problem is caused by the fact that they are situated very close to the wall of the inner surface and cannot be indicated by any of the used techniques due to strong backwall reflection.

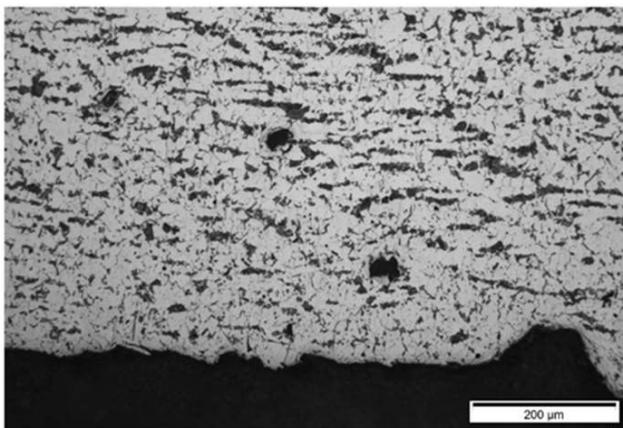
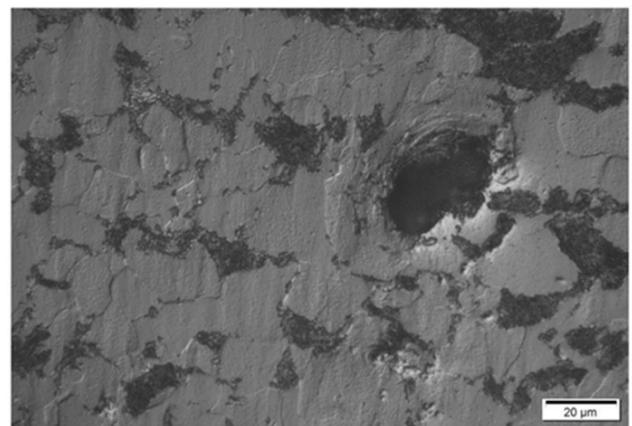
Only isolated HIC blisters were revealed at coordinates 70 mm area (see Figure 21). Discontinuities are located near the internal diameter (ID) surface (max. 0.4 mm from ID).

Figure 21. Section No1: 60–88. Coordinate 70 mm, isolated HIC blisters, micro deformation in discontinuity area, magnification 200× (a), 1000× (b).

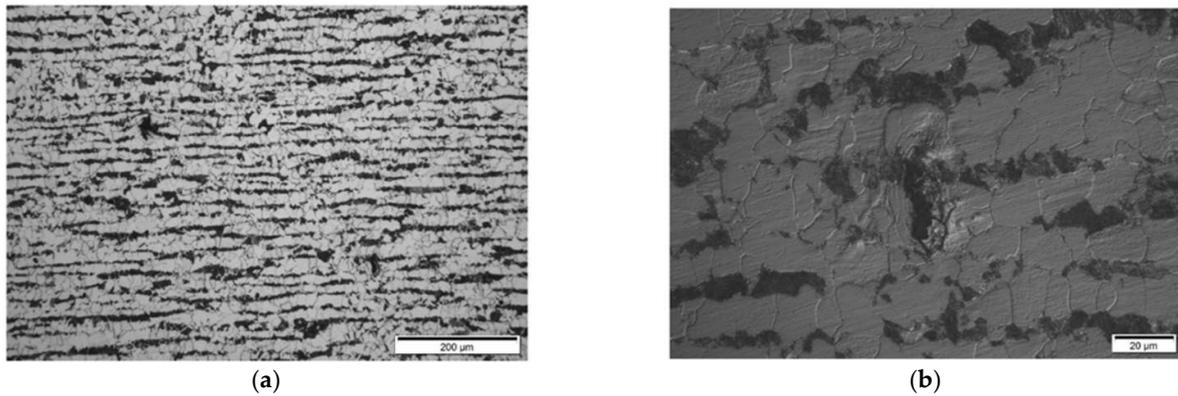
Hydrogen-induced damages such as hydrogen-induced cracking, stepwise cracking, straight cracking and blistering cracking, starting from the coordinates 120 mm onwards, were observed (Figures 22–24). The maximum depth of defects location in this section is 8.8 mm from ID (37.2 mm from the outer diameter OD, e.g., UT scanning surface). Decarbonised traces originating from the shell ID are clearly seen in the section of the steel microstructure.

**Figure 22.** Section No2: 90–140. Coordinate 120 mm, 6.2 mm from ID. Isolated HIC blister, magnification 200× (a), 1000× (b).

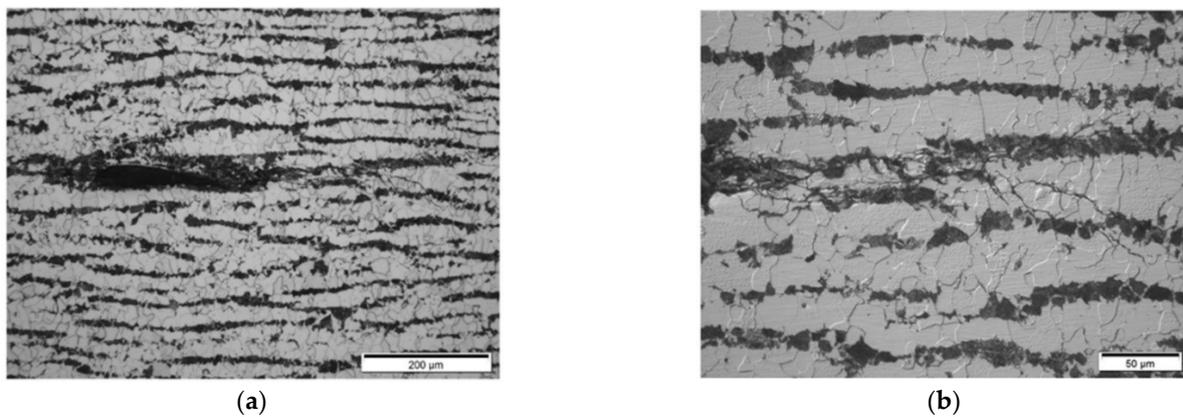
**Figure 23.** Section No2: 90–140. Coordinate 135 mm, 6.8 mm from ID, blistering cracking in pearlite band, magnification 200× (a), 500× (b).

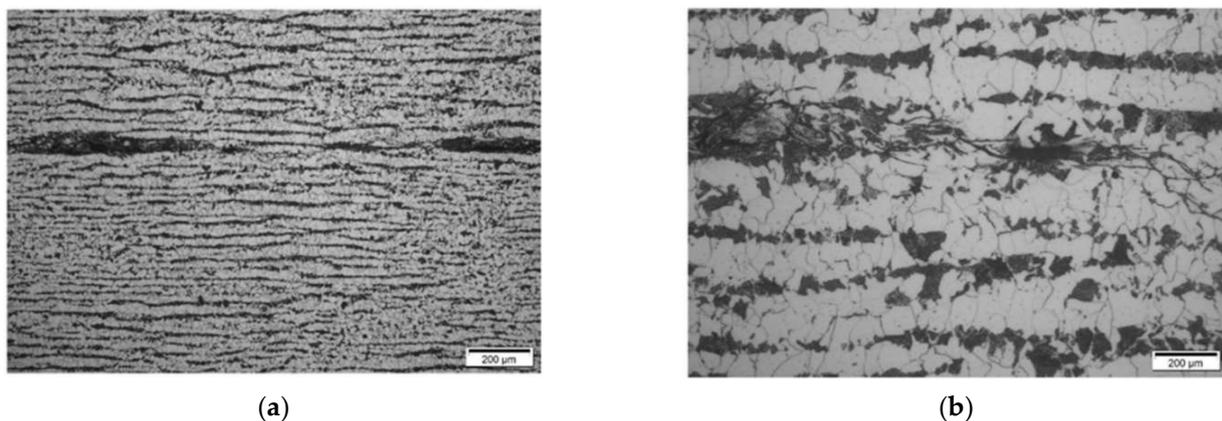
**Figure 24.** Section No2: 90–140. Coordinate 130 mm, 8.8 mm from ID, straight cracking in pearlite bands, magnification 100× (a), 500× (b).

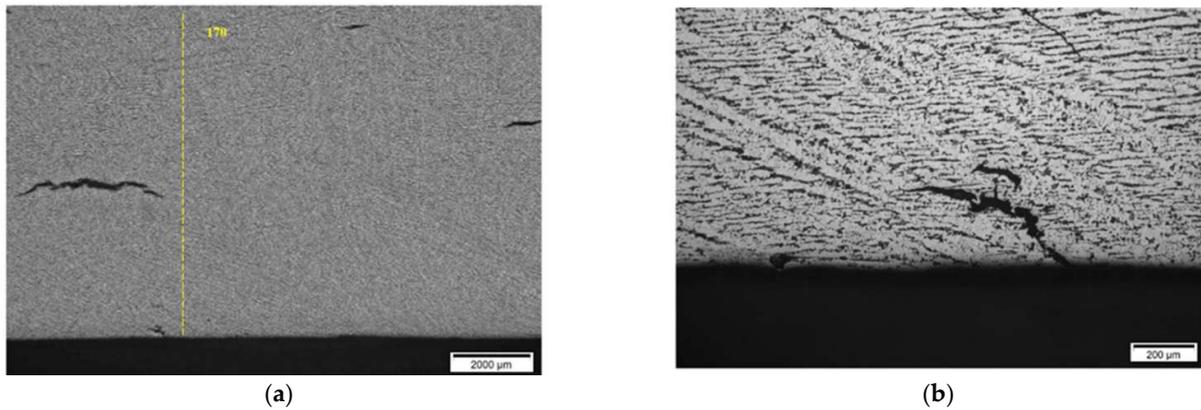
Hydrogen-induced damage such as hydrogen-induced cracking, stepwise cracking, straight cracking, blistering cracking were observed (Figures 25–27). The maximum depth of defects location in this section is 8.8 mm from ID (37.2 mm from OD). Decarbonised traces originating from shell ID are also clearly seen in the section of the steel microstructure.

**Figure 25.** Section No3: 142–198. Coordinate 170 mm. Magnification 12.5× (a), Cracking near ID surface, magnification 100× (b).

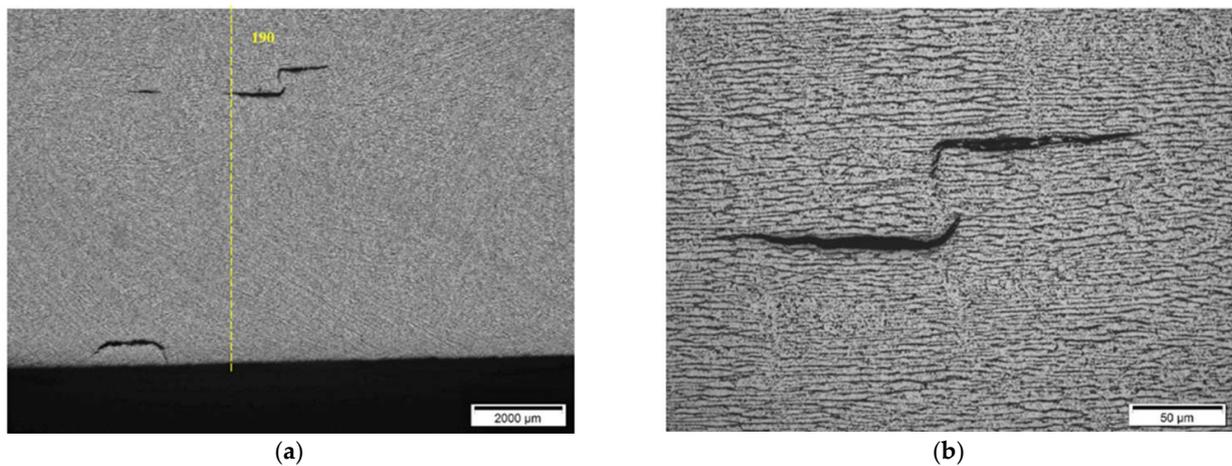
**Figure 26.** Section No3: 142–198. Coordinate 190 mm. Magnification 12.5× (a), 6.1–6.5 mm from ID, stepwise cracking magnification 50× (b).

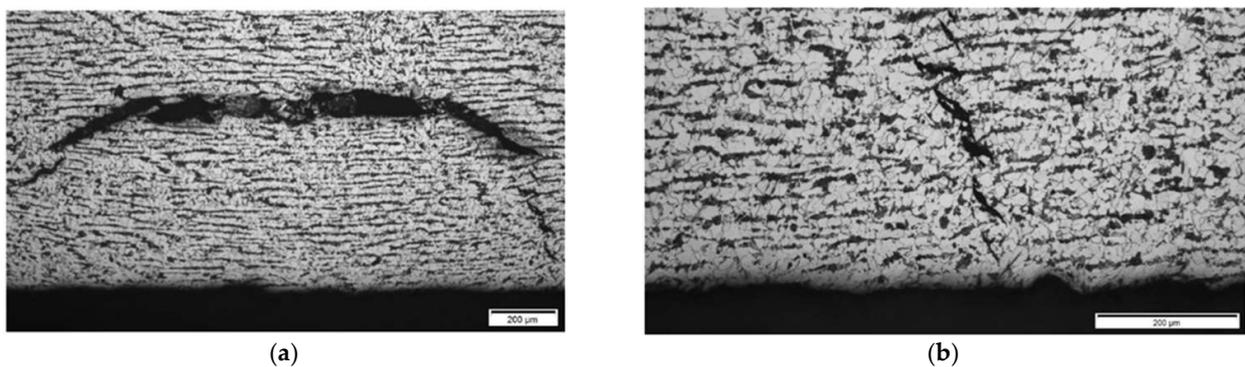
**Figure 27.** Section No3: 142–198. Coordinate 193 mm, blistering cracking magnification ×100 (a), stepwise cracking connected to ID, magnification 200× (b).

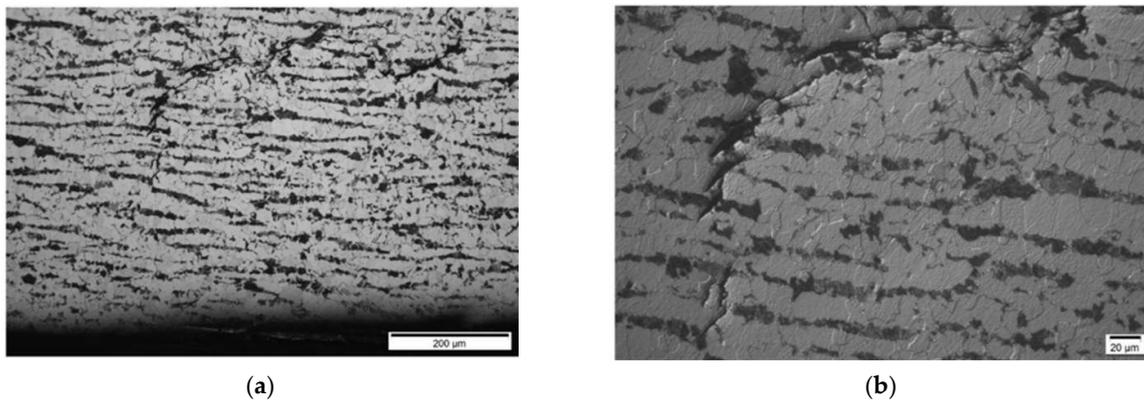
Hydrogen-induced damage, as mentioned above, such as hydrogen induced cracking, stepwise cracking, straight cracking, blistering cracking, were observed (Figures 28 and 29). The maximum depth of defects location in this section is 8.0 mm from ID (or 38.0 mm from OD (UT scanning surface)). Decarbonised traces originating from the shell ID are also clearly seen in the of the section steel microstructure.

**Figure 28.** Section No4: 142–198. Coordinate 190 mm. Magnification 12.5× (a), 6.1–6.5 mm from ID, stepwise cracking magnification 50× (b).

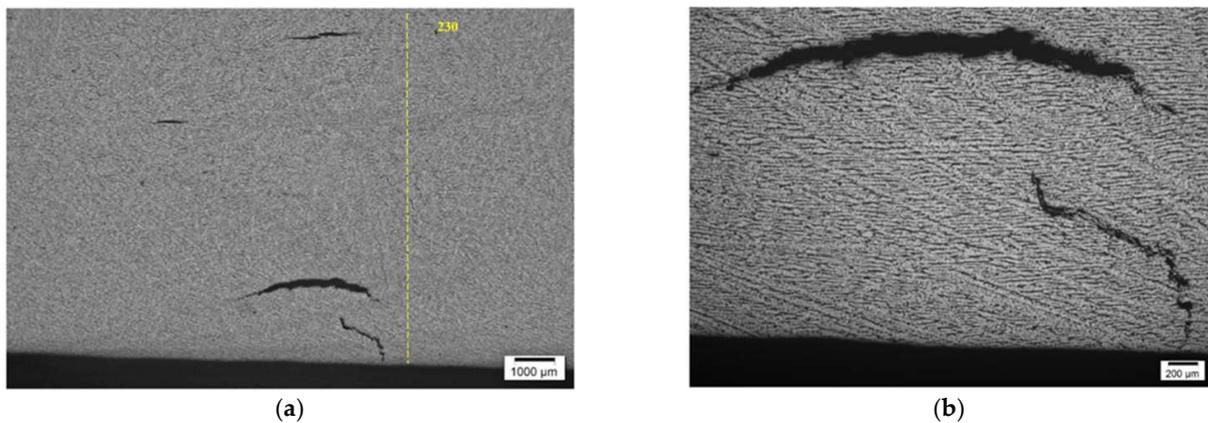
**Figure 29.** Section No4: 142–198. Coordinate 190 mm. Magnification 12.5× (a), 6.1–6.5 mm from ID, stepwise cracking magnification 50× (b).
