Brittle Fracture Behaviors of Large Die Holders Used in Hot Die Forging

Weifang Zhang, Hongxun Wang, Jingyu Zhang, Wei Dai * and Yuanxing Huang

School of Reliability and Systems Engineering, Beihang University, Beijing 100191, China; zhangweifang@buaa.edu.cn (W.Z.), wanghongxun@buaa.edu.cn (H.W.), jingyuzhang@buaa.edu.cn (J.Z.), linhaihyx@126.com (Y.H.)

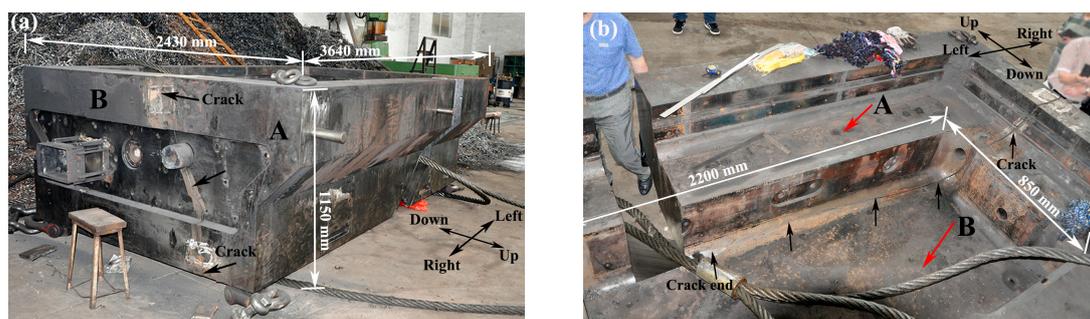
The die holder studied in this paper is used on a large screw press for hot die forging. The profile of the die holder is shown in Figure 1. The outline size of the die holder is 3640 mm (length) \times 2430 mm (width) \times 1150 mm (height) and the inner cavity size is 2200 mm (length) \times 850 mm (width). The weight of the die holder is 62.26 t. The production processes of the die holder include vacuum smelting, forging, heat treatment and machining. According to the technical requirement, the material of the die holder is set to be 55NiCrMoV7 hot-work tool steel. The initial heat treatment of the die holder is as follows. Firstly, the die holder was roughly forged. Then, it was handled by using high temperature diffusion annealing. After that, the die holder was heated up from 20 °C to 850 °C at the speed of 50 °C/h. Then, it was austenitized for 15 h at 850 °C. Thirdly, the die holder was processed by using step quenching (water-oil quenching) one time, which is first water-quenched for 30 min and then oil-quenched to room temperature. Finally, it was submitted to a double tempering treatment, first at 620 °C and then at 560 °C. After the heat treatment, the microstructure is tempered martensite.

Figure 1. The profile of the die holder: (a) the outline; (b) the inner cavity.

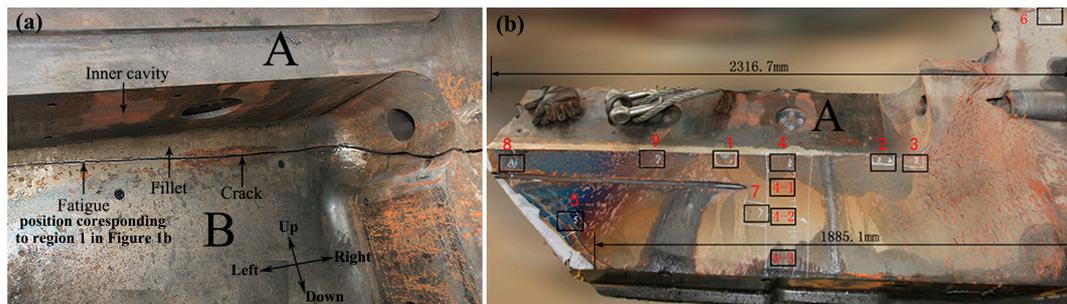
The die holder generated a large crack during the process of forging aero-engine blades. The crack penetrates the bottom and the right side of the die holder whose length extends as long as 2316.7 mm as shown in Figures 1 and 2, where the crack orientation is marked by using the arrows. Figure 2a is the crack morphology, where A represents the up side of the crack and B represents the down side, as the coordinates show in figures. Figure 2b is the numbered fracture of the A side that was cut from the die holder along the crack. On the inner bottom of the die holder, which is the top edge of the fracture, there is an obvious semicircular fatigue area (region 1). Furthermore, along the inner bottom surface, there are three surface cracking zones where the crack propagation directions are different from that of the fatigue area. The fracture characteristics of the die holder have been studied in our

previous investigation [13], and the information about the fracture characteristics are only briefly described in this section. The failure analysis of the die holder [13] has revealed that the crack initiated from the semicircular fatigue area (region 1) and the surface cracking zones (the top edges of region 2, region 4 and region 9, which are on the surface of the inner bottom as shown in Figure 2), where the fatigue is point source and the surface cracking zones are linear sources. The crack propagation region (the whole fracture except for region 1 and region 5) is rapid brittle fracture with large radial ridges. The microscopic morphology is quasi-cleavage, which is characterized by river patterns and tear ridges as shown in Figure 3.

Figure 2. The macroscopic crack and fracture morphology of the die holder: (a) macroscopic crack morphology; (b) macroscopic fracture morphology.

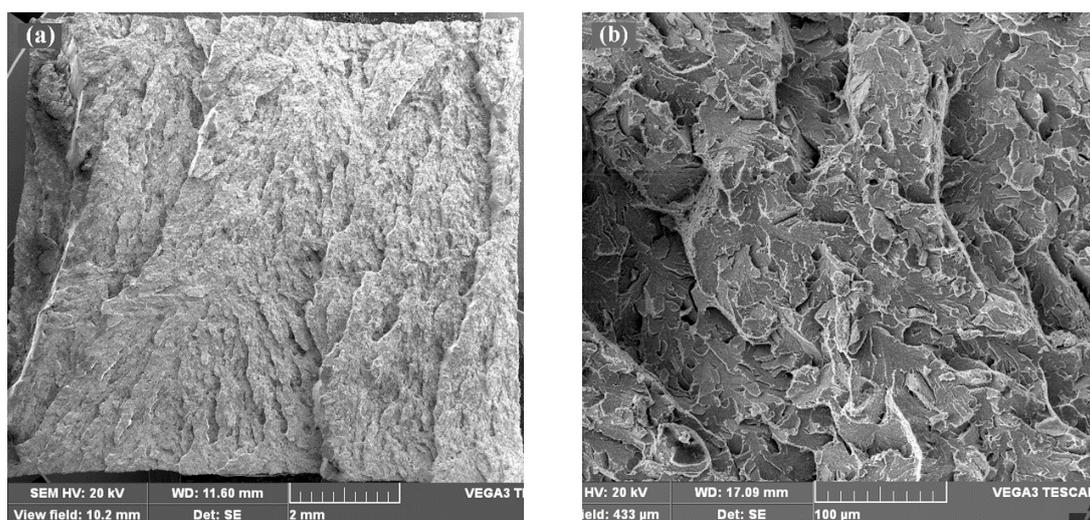
Figure 3. The low and high magnification morphology of brittle fracture region on the bottom of the die holder: (a) the low magnification morphology; (b) the high magnification morphology.

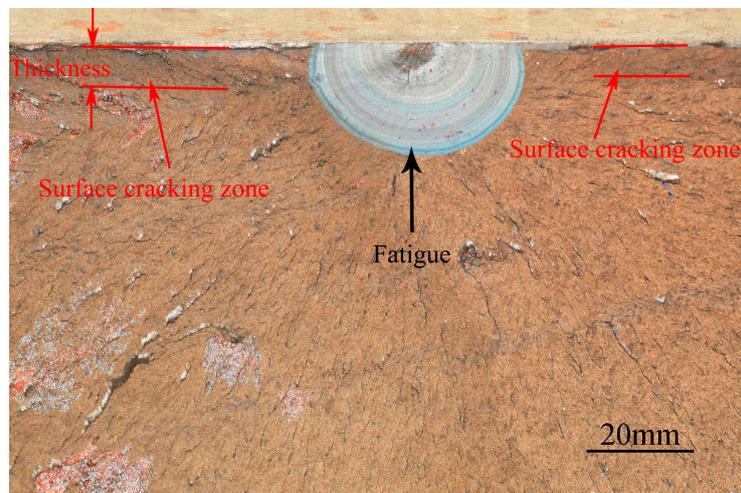
The semicircular fatigue region and surface cracking zones of the die holder are shown in Figure 4. The semicircular fatigue region is about 40 mm in diameter, and the region accounts for 0.02% of the whole fracture. The thickness of the surface cracking zones are 5–10 mm, as the red arrows show in Figure 4, which take up 0.04% of the whole fracture. The die holder had been working for two years before failure. During the working process, the die holder had forged 113,025 products made of high strength stainless steel, titanium alloy and high temperature alloy at 150 °C to 350 °C, and it had endured the impact loads 351,089 times. The impact loads are usually between 180 MN and 280 MN. The maximum and minimum loads are 350 MN and 83 MN, respectively. The bearing capacity of the die holder is 350 MN, so the service stress of the die holder does not exceed the ultimate strength of the material. Considering that the fracture sources only account for 0.06% of the total fracture, the service

stress is not large enough to explain such a large and rapid brittle fracture. Therefore, it must be other reasons that led to the brittle fracture. Thus, further study was made in this paper.

Figure 4. The semicircular fatigue and surface cracking zones.

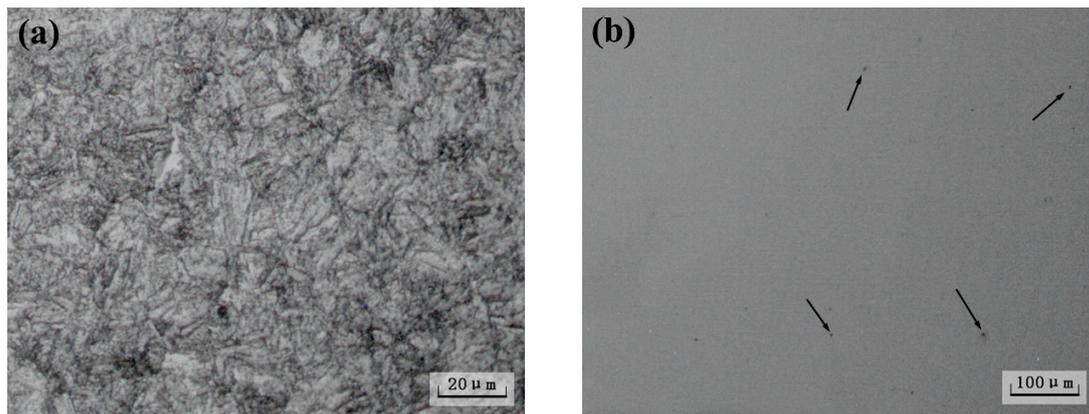
The chemical composition analysis shows that the chemical composition meets the technical requirement of the die holder as shown in Table 1. The metallographic samples removed from the broken die holder were eroded by using the 1% HNO₃ + C₂H₅OH solution. The grain size was measured by using the comparison method, which is to compare the grain size under 100× magnification with the standard grain size chart. The results show that the die holder has a fine grain size of level 7 to 8. The microstructure is homogeneous with tempered martensite and there is no oxidation and decarbonization as shown in Figure 5a. In addition, the material has dot shaped

nonmetallic inclusions. There is no large inclusion and obvious nonmetallic inclusion segregation zone as shown in Figure 5b. In conclusion, the material fits the technical requirements and there are no metallurgical defects.

Figure 5. Metallographic structure and nonmetallic inclusions of the die holder: (a) metallographic phase; (b) nonmetallic inclusions.

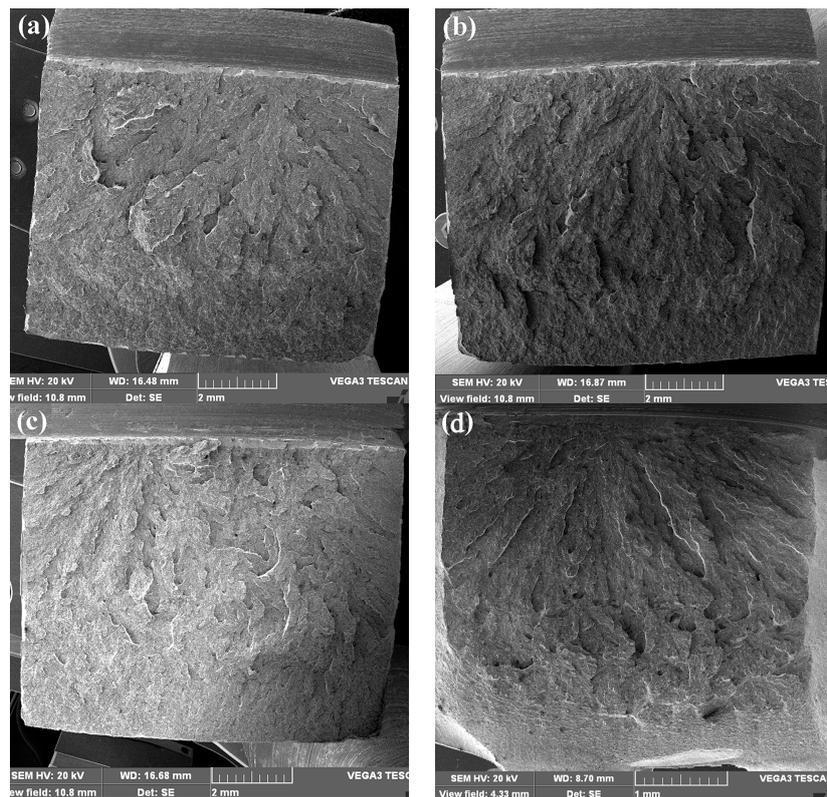
To compare the impact fracture morphology of region 4 with region 6 as well as the brittle fracture, SEM observation was carried out. The impact fractures of region 4 and region 6 are shown in Figure 6. It can be seen that there is little fiber region and shear lip on the fracture surfaces of region 4, and most of the fracture surface is the radial region with a large quantity of radial ridges, which indicates that the impact toughness of region 4 is very low. However, the impact fracture of region 6 has obvious shear lip, which is much larger than that of region 4. It indicates that the impact toughness of region 6 is much higher than that of region 4, which is consistent with the tested impact toughness.

Figure 6. The impact fracture of region 4 and region 6: (a) region 4-1; (b) region 4-2; (c) region 4-3; (d) region 6.

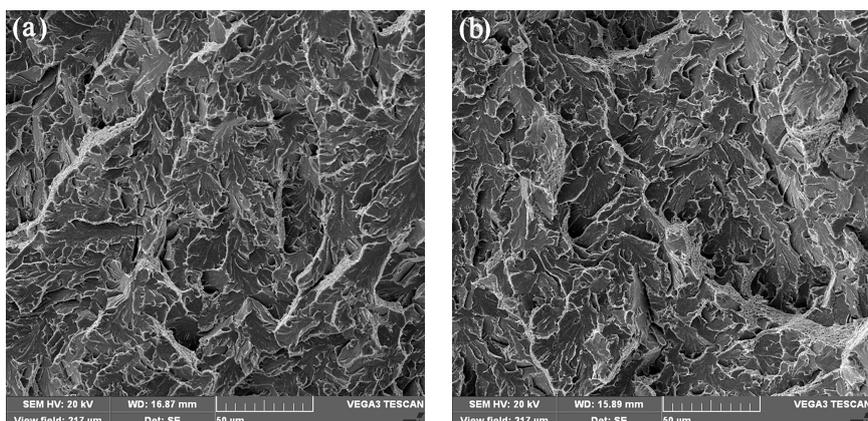
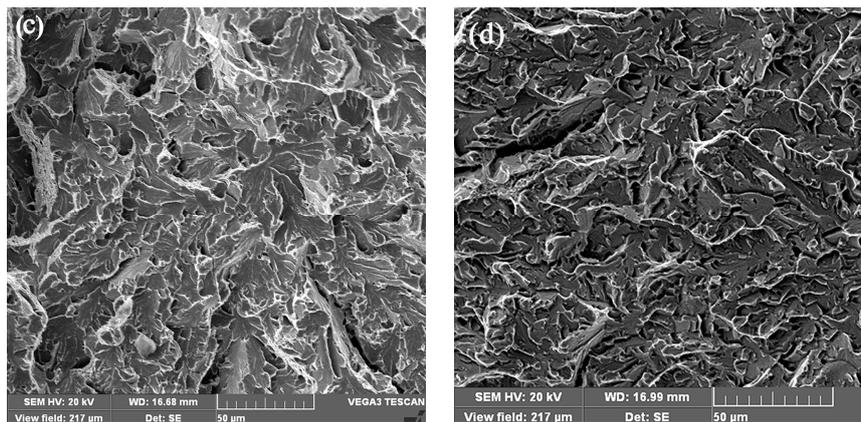
To further study the property differences of region 4 and region 6, the high magnification morphology of radial regions are shown in Figure 7. It is obvious that the microscopic morphology of the radial region on region 4 is classical quasi-cleavage with large cleavage step patterns and tear ridges. The microscopic morphology of region 6 is also quasi-cleavage, but the surface is more flat than that of region 4, and there are no obvious cleavage step patterns, which also indicates that the impact toughness of region 4 is much lower than that of region 6.

Figure 7. The radial region morphology with high magnification of region 4 and region 6 at room temperature: (a) region 4-1; (b) region 4-2; (c) region 4-3; (d) region 6.

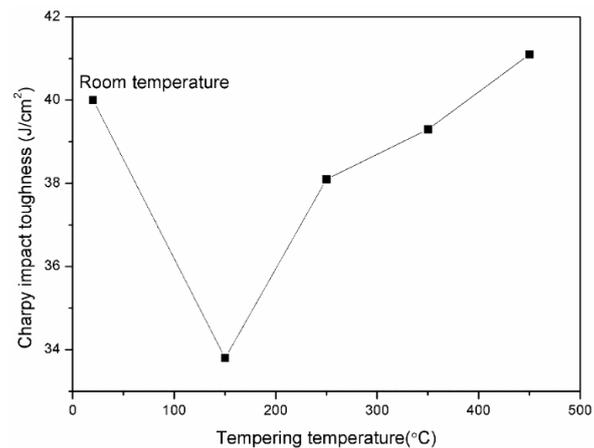
To investigate the reason for impact toughness degradation, the tempering and water-cooling experiment was used on the samples of region 6 to simulate the practical environment stress of the die holder. Each experiment has three parallel samples, and the results given are the average values. The results are shown in Figure 8. The impact toughness of region 6 is 40 J/cm^2 before tempering and water-cooling treatment, which is much higher than the minimum value of technical requirements (25 J/cm^2). The results demonstrate that region 6 is of excellent impact resistance. However, the impact toughness decreases to 33.8 J/cm^2 after tempering and water-cooling treatment at $150 \text{ }^\circ\text{C}$. The impact toughness increases with the tempering temperature rising. When the sample is tempered and water-cooled at $450 \text{ }^\circ\text{C}$, the impact toughness reaches 41.1 J/cm^2 , which is slightly above the impact toughness before tempering and water-cooling treatment. In a word, the impact toughness degradation is caused by tempering and water-cooling treatment at the temperatures between $150 \text{ }^\circ\text{C}$ and $350 \text{ }^\circ\text{C}$. During the service process of the die holder, the temperature which region 4 endured is right between $150 \text{ }^\circ\text{C}$ and $350 \text{ }^\circ\text{C}$. It means that the impact toughness degradation of region 4 is related to the tempering and water-cooling effects. It should be noticed that the minimum impact toughness after tempering and water-cooling treatment is 33.8 J/cm^2 , but the impact toughness of region 4 is much lower than 33.8 J/cm^2 . The reason is that the impact toughness is measured after tempering and water-cooling treatment once. However, the die holder has endured the tempering and water-cooling effects at $150 \text{ }^\circ\text{C}$ to $350 \text{ }^\circ\text{C}$ for 113,025 times as well as the cyclic loads for 351,089 times, which would result in much lower impact toughness as measured in region 4.

Figure 8. The impact toughness of region 6 after tempering and water-cooling experiment at different temperatures.

- The serious material embrittlement and brittle fracture of the die holder are caused by the long-term tempering and water-cooling effect as well as the cyclic mechanical loads. In addition, the operation specification must be emphasized to avoid the die holder being cooled by using water during the working process.
- The tempering and water-cooling treatment at 150 °C to 350 °C could lead to the impact toughness degradation and material embrittlement. The effect of material embrittlement declines with the tempering temperature rising.
- The material embrittlement are related to the large size $M_{23}C_6$ (M: mainly Fe and Cr) and M_3C carbides (M: mainly Fe) distributed in the martensitic lath boundaries.

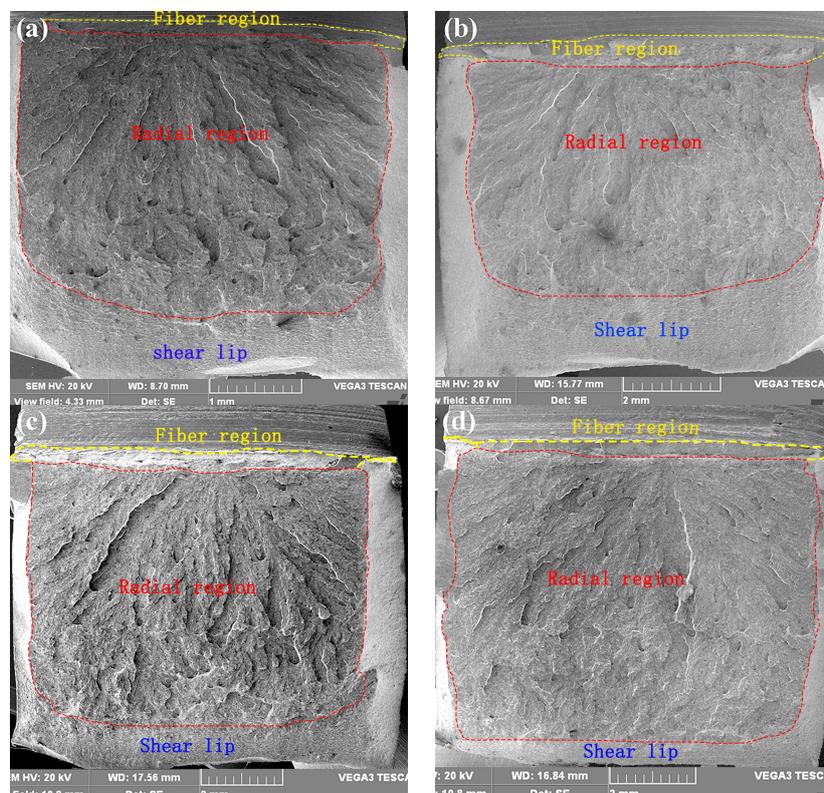
The impact fractures of region 6 after tempering and water-cooling treatment at different temperatures are shown in Figure 9. It can be seen that the fracture morphology with low magnification is similar, which includes three regions. The upper part of the fracture is the fiber region. The middle is the radial region. The lower, left and right sides of the fracture are shear lip. Moreover, the size of different regions on each fracture changes with the tempering temperature. The proportion of radial region and shear lip on two sides increase with the temperature rising, but the lower shear lip decreases. The radial region after being tempered was at 250 °C, which is the same as the fracture of region 4, as shown in Figure 3a.

Figure 9. The impact fracture of region 6 after tempering and water-cooling experiment at different temperatures: (a) room temperature; (b) 150 °C; (c) 250 °C; (d) 350 °C.

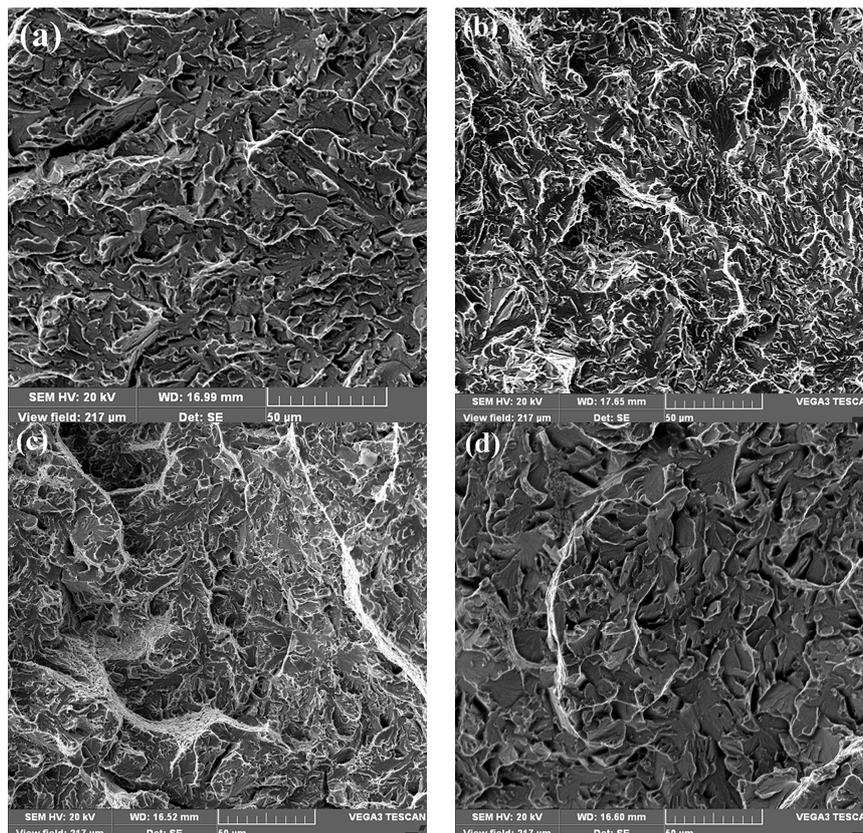
The brittle fracture morphology of the die holder is the same as the radial region of the impact fracture at low magnification. Therefore, the radial region morphology of region 6 was observed by using SEM at high magnification as shown in Figure 10. Though the samples were tempered and water-cooled at different temperatures, the microscopic morphology of radial regions are all quasi-cleavage. However, the quasi-cleavage patterns and quasi-cleavage steps are various at different tempering temperatures. The microscopic fracture of region 4 has the same quasi-cleavage morphology as that tempered at 250 °C, both of which have obvious quasi-cleavage steps as shown in Figures 3b and 10c.

Figure 10. The high magnification morphology of impact fracture in region 6 after tempering and water-cooling experiments at different temperatures: (a) room temperature; (b) 150 °C; (c) 250 °C; (d) 350 °C.

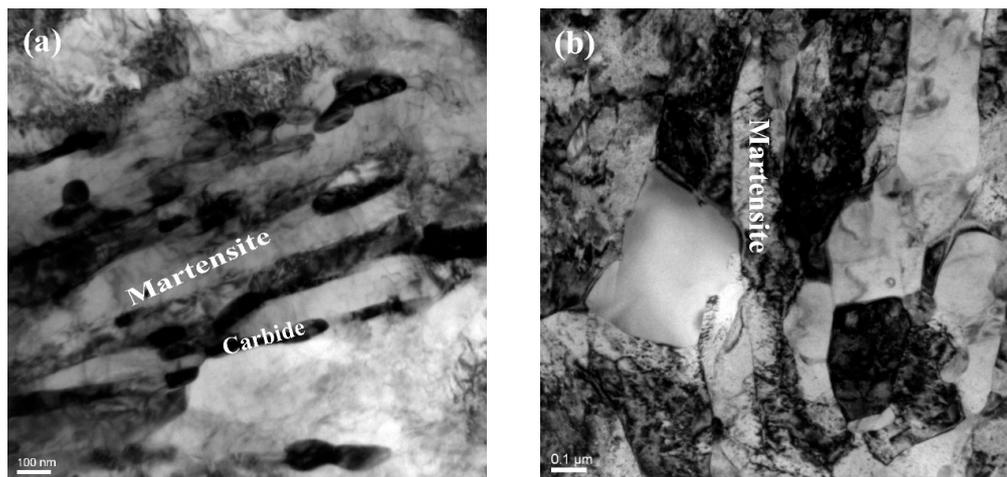
To investigate the mechanism of impact toughness degradation of region 4, the microstructures of region 4 and region 6 before tempering and water-cooling treatment were compared by using the TEM. Figure 11 is the bright-field images of region 4 and region 6. The microstructure of the two regions are both lath martensite and carbides [11].

Figure 11. Bright-field TEM images of region 4 and region 6: (a) region 4; (b) region 6.

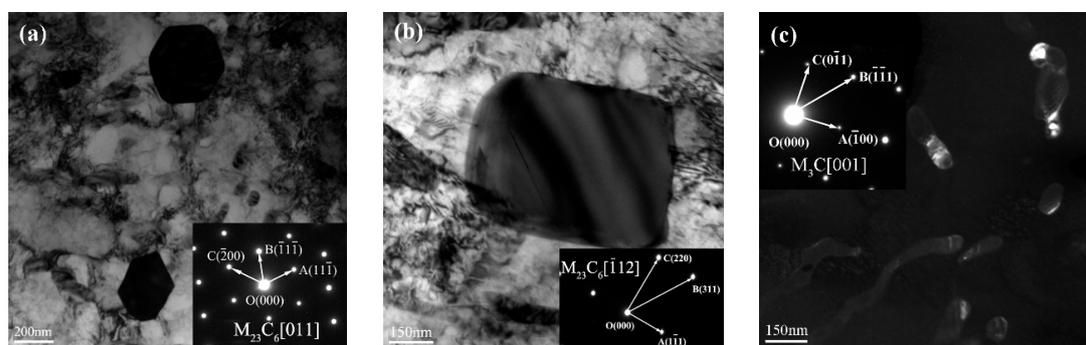
The observation of precipitate morphology results indicate that there are many precipitates with different shapes in region 4 and region 6. There are three kinds of precipitates in region 4: the hexagonal precipitates whose sizes are 200 nm to 300 nm as shown in Figure 12a. The tetragonal precipitates whose sizes are 400 nm to 640 nm as shown in Figure 12b. The elongated precipitates, most of which are between 50 nm and 1.5 μm, and a few of them are less than 50 nm as shown in Figure 12c.

In order to determine the phase of the precipitates, the SAED was utilized on precipitates. The results reveal that the SAED patterns of hexagonal precipitates and tetragonal precipitates belong to the different crystal zone axes of the same face-centered lattice as shown in Figure 12. Furthermore, they have identical chemical composition. Therefore, the hexagonal precipitates and the tetragonal precipitates are the same substance, which are collectively called the polyhedron precipitates. Compared with the standard SAED patterns data of precipitates in steel, the SAED pattern of elongated precipitates is the same as the pattern of the [001] crystal zone axis of orthorhombic lattice.

Figure 12. TEM images of the precipitates and corresponding selected area electron diffraction (SAED) patterns in region 4: (a) the bright-field image of hexagonal precipitates; (b) the bright-field image of tetragonal precipitates; (c) the dark-field image of elongated precipitates.

The precipitates were affirmed by comparing the lattice parameter of indexed patterns with the standard PDF cards, as well as by analyzing the chemical composition of precipitates (Table 5). The polyhedron precipitates are $M_{23}C_6$ carbides, where M are mainly Fe and Cr. The elongated precipitates are M_3C carbides, where M are mostly Fe. In region 4, the small size M_3C carbides are distributed mainly in lath martensite, while the large size M_3C carbides are distributed mainly along the boundaries of lath martensite as shown in Figure 12a.

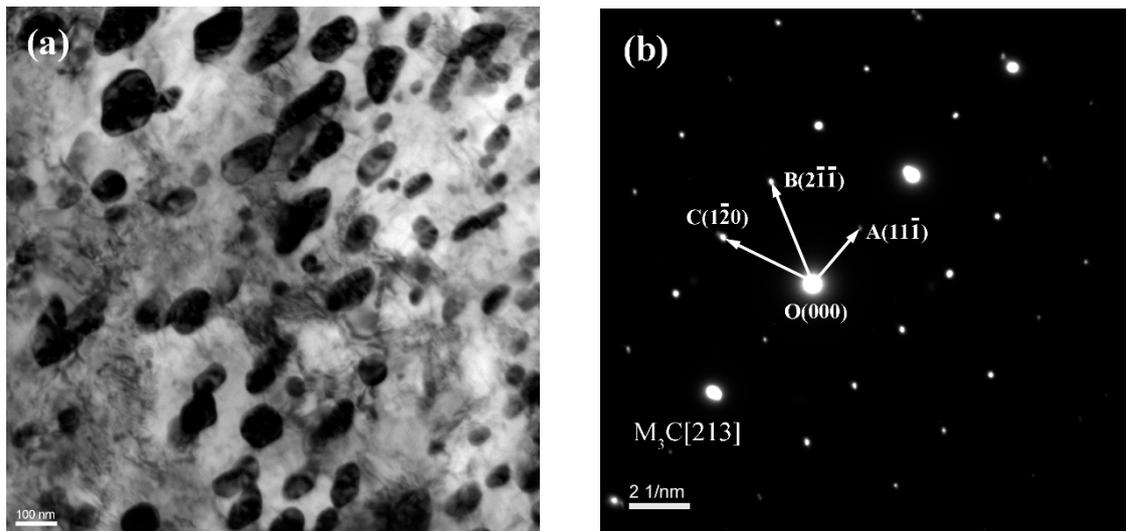
As shown in Figure 13, the precipitates of region 6 are mainly elongated precipitates whose sizes are mainly within 100 nm. Most of the precipitates are almost globular, except for a few that are elongated. Therefore, the precipitates' size in region 6 is much smaller than those of region 4. In addition, region 6 has no polyhedron precipitates. The SAED patterns of elongated precipitates were indexed, and the results are the same as that of region 4, which is shown in Figure 13. The elongated precipitates are M_3C carbides, where M are mainly Fe [15,16]. However, the M_3C carbides of region 6 are distributed mainly in lath martensite, and only a few of them are located at the martensitic lath boundaries.

Figure 13. The bright-field TEM image of region 6 and corresponding indexed SAED pattern: (a) the elongated precipitates; (b) indexed SAED pattern of elongated precipitates.
