# A Better Maintenance Strategy, a More Sustainable Hanok: Towards Korean Traditional Public Facilities

Jeong-Hyuk Jeong, Deuk-Youm Cheon and Seung-Hoon Han \*

**Abstract:** Currently, user demands for Hanok, the Korean traditional building type, are increasing in Korea, and their use as residences and accommodations are especially booming, while public facilities are rarely built in the style of Hanok these days. One of the most critical reasons for the issue is that Hanok lack usability and are difficult to maintain as a public facilities. Therefore, it is improvement of the usability of Hanok is needed for them to be accepted as public buildings and to set up the maintenance strategy for the style of the wooden structure. This research has defined public buildings in Hanok and classified them into three types according to structural standards. Then, this study analyzed the characteristics of each type, and suggested a checklist for Hanok usability, employing it to analyze the most recent exemplar Hanoks built as results in the governmental research project, monitored them in aspects of the facility management focused on the wooden structure and suggested strategies for sustain

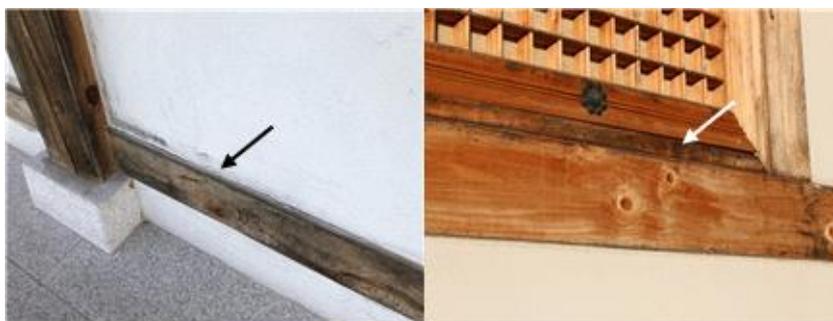
Degradation due to biological causes is closely related to the weather condition. All of the target Hanoks were surveyed, and it is confirmed that degradation and discoloration mainly occur after the rainy season and happen not only on the wood structure but also on the outer wall. In addition, due to added moisture on the ground after rainfall, it could be observed intensively on the lower parts of the building components rather than on the upper parts. Distribution tendency of the discoloration shows that a greater passage of time results in a blacker surface as shown on Figure 5. Fungi belong to incomplete microorganisms and occur on surfaces of the building. They also tend to grow on the

surface without penetrating into the wood. However, there would be a heavy risk of discoloration if left unused for a long time.

**Figure 5.** Hanok defects: fungal generation and discoloration.

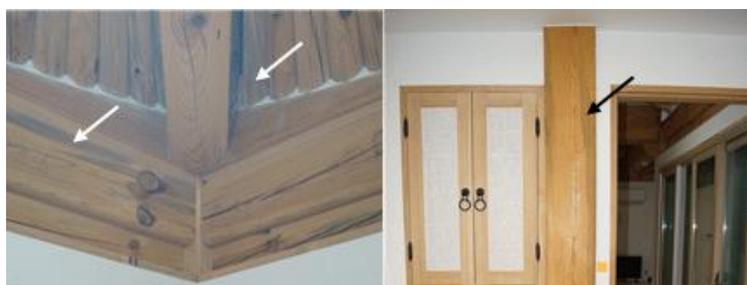
Bluish changes are the most common defect among the degradation occasions caused by microorganisms. It is caused mainly by acanthaceous fungus among known microorganisms inhabiting the wood, normally, and by this situation, various discolorations occur depending on the species of timbers. Blue color does not deteriorate the physical properties, but could contaminate the appearance of the wood mostly causing a cosmetic problem as exemplified on Figure 6. This defect is one of the biological causes repeatedly observed from all target Hanoks during the field surveys. The investigation was conducted after the completion of demonstrative Hanoks, but there have been many cases in which the bluish change is generated when producing and processing timbers as well.

**Figure 6.** Hanok defects: bluish changes.

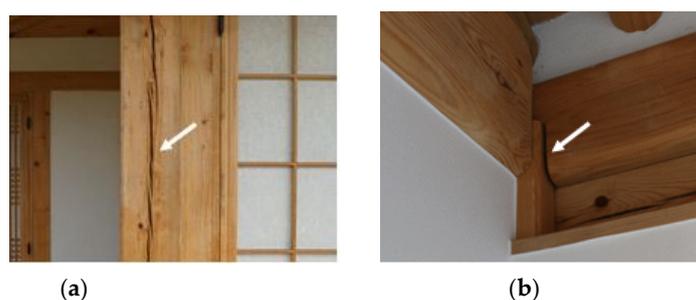
A typical wood defects observed commonly among all studied Hanoks is parallel twisting. A Hanok is a furniture-like building that supports the roof with a wooden structure, and the role of wood is very important. However, parallel twists could easily be observed on most building members using logs such as columns, girders, and beams. As described by the chapter of the timber structure in standard specifications for the cultural property repairs, the parallel twist should be controlled to be under 10% of the cross section. However, despite these standards, this type of defect becomes an element that hurts the beauty of Hanok. Particularly, the parallel twist on the end of the column for the joint is a main factor to lower the structural safety and is definitely the target of repair. In the case of target Hanok constructed with glued laminated woods, no parallel twists or ripples are generated, since the materials are provided by matching the regulated water content ratio. However, this defect was observed on horizontal materials like girders and beams using pine trees. The expansion of the margins or gaps on wooden components after construction normally occurs due to the drying

In most target Hanoks, joint fissures from drying shrinkage of the timber could be found, and there is a widening in the area where the building components made of timbers like dry walls, columns, and lining materials are connected and fit each other as shown on Figure 8. As new-Hanok or shin-Hanok are being adapted to the lifestyle of contemporary people, the air tightness is getting more important in aspects of the energy performance, while traditional Hanok emphasized spatial breathability to assist natural air flow. Therefore, this defect not only lowers the airtightness for the contemporary Hanok, but also becomes an important cause of deterioration in performance.

**Figure 8.** Hanok defects: parallel twists and joint fissures. (a) Parallel twists; (b) Joint fissures

shrinkage of the material; it is suggested to use completely-dried timbers to prevent parallel twists. Table 9 indicates sample results in the water inclusion ratio (WIR) for a target Hanok.

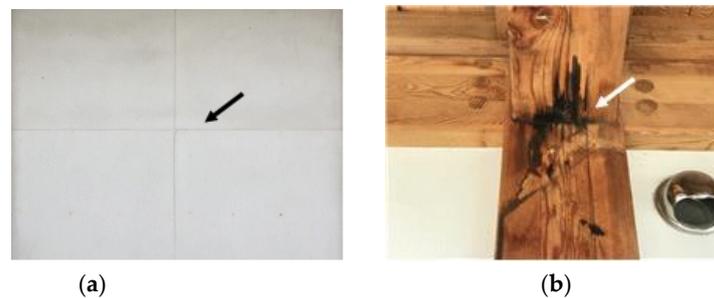
There is a big difference in the rate of deterioration of Hanok by resident existence in the space. In the case of a mock-up Hanok (A-3) that has not been occupied by residents for five years after construction, most of its drywalls have been cracked. Those of the testbed house (A-1) which is constantly used as a literature museum and an office, have not been cracked at all in the five years since it was built. On the other hand, in the case of the Maintenance Center at Gangneung Hanok Village (C-3), which has been under operation for two years after the completion of construction in 2016, as a special case, visible cracks have occurred on the drywall due to impacts and vibrations caused by the progress of the structural change for the inner wall. There is no significant effect on the performance of the drywall, but it can be improved through finishing repairs and may become better in aspects of the building aesthetics.

It is advantageous for securing rigidity and preventing parallel twists to use the nature of the glued laminated wood with attaching and cumulating cut woods. For this reason, several target Hanoks utilize that kind of wooden component unlike most traditional ones, and therefore adhesive elution could be found only from these structures as exemplified on Figure 9. The amount of glue or adhesives used for combining module timber elements was assumed to be small, but this defect

has polluted the surface of the building component with black discoloration and may be a negative aesthetic factor.

**Figure 9.** Hanok defects: parallel twists and joint fissures. (a) Wall cracks; (b) Adhesive elution

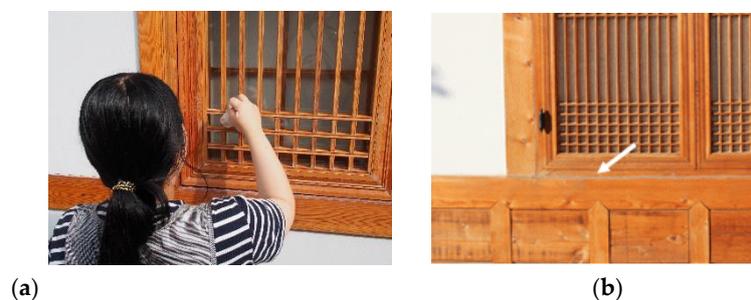
All 26 target Hanoks categorized in three different types are built by efforts with the capital of the host institution and supports from the subsidy of the government, and the ownership and management authority belong to the host institution. Figure 10 shows the current condition for Hanok maintenance performed on the site. As Hanok are based on the material of timbers, they must pay close attention to maintenance for better usability and sustainability in comparison to contemporary buildings. Interviews with the officers in host organizations and management experts also confirmed the need for a better maintenance system. Fundamental management is in progress to remove and repair defects occurred on target Hanoks, and it is based on daily management that removes surface contamination and proceeds with oil stain treatment to prevent pollution such as blue discoloration and fungi. In addition, irregular maintenance for the joint fissures or widening between the columns, the wall and/or joints have been treated with silicon. However, there was no separate official budget for regular, systematic maintenance and repairs.

**Figure 10.** Current situation for Hanok maintenance performed on the site. (a) Ordinary manual maintenance; (b) Fixing fissures using silicon.
