Article

Detection and Analysis of Aircraft Composite Material Structures Using UAV

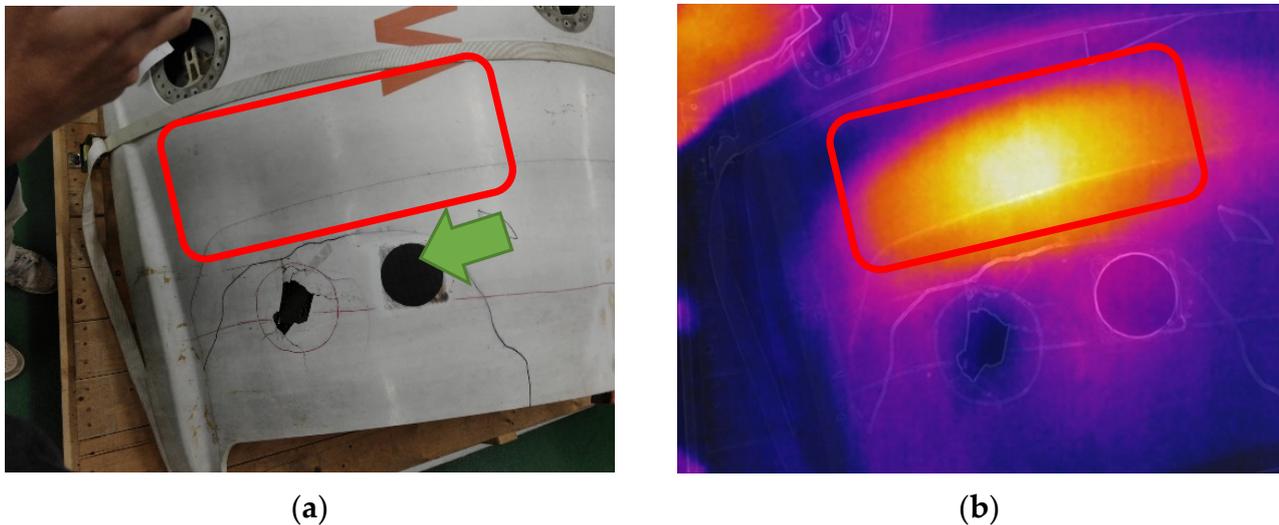
In the visible light image of the engine cowling shown in Figure 4a, the red box indicates a known defect. However, the defect's location is not discernible in the visible

light image. On the other hand, the green arrow direction in Figure 4a indicates the location of the completed repair of the defect. Although the repair area had not been repainted, the IR image in Figure 4b shows a bright yellow area within the red box, indicating that its relative temperature is higher than in other areas. At the same time, in the direction of the green arrow in Figure 4b, delamination is no longer visible at the repaired site. Additionally, manual inspection confirmed that there was no delamination in the repaired area.

Figure 4. Comparison before and after repair of engine cowling (A red box indicates a known defect; The green arrow direction is the location of the completed repair of the defect). (a) Visible light image of tested Material; (b) infrared image of tested material.

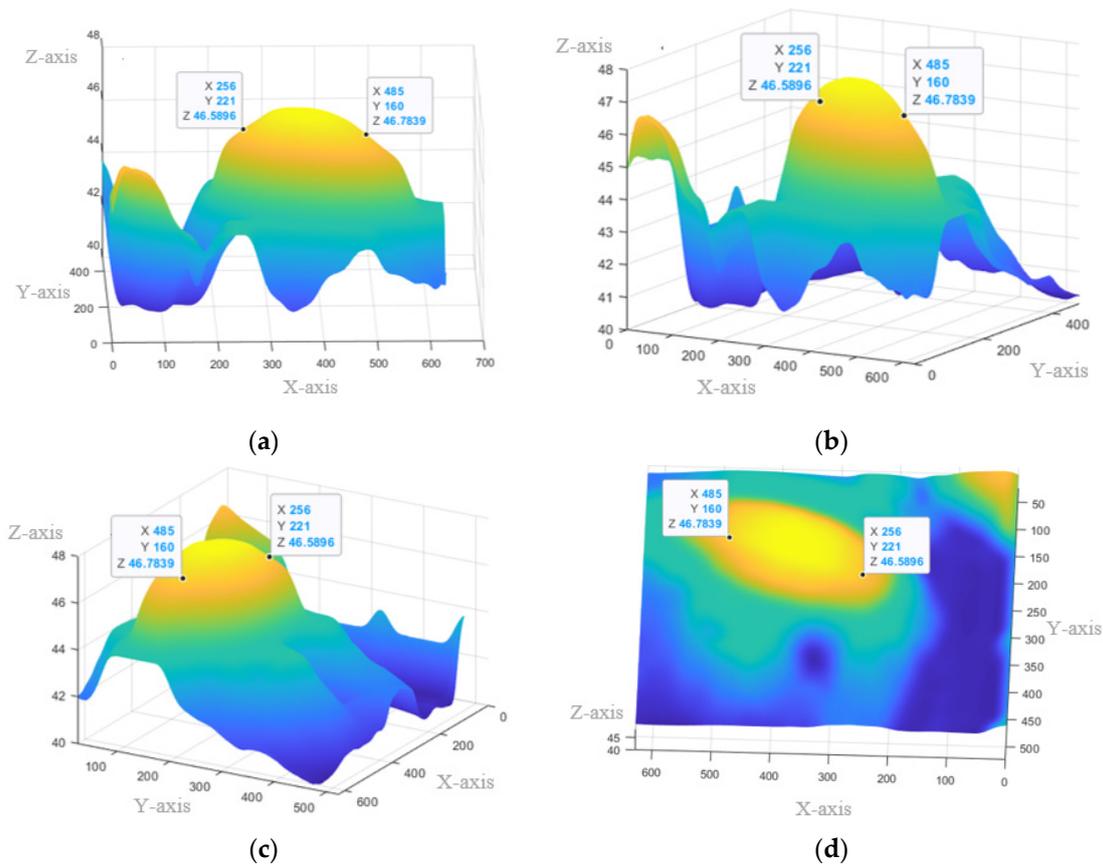
This research method uses infrared images (Figure 4b) to identify areas of delamination in composite materials that cannot be discerned in visible light images, as shown in Figure 4a. Although the red box in the IR image of Figure 4b indicates the defect region, the exact size of the delamination cannot be accurately determined. In such situations, the 3D images developed in this study can clearly label the defect location and assess the severity of delamination, as depicted in Figure 5a–d. Additionally, 3D images facilitate area transformation to determine the defect region, as shown in Figure 5a–d. The temperature settings can be obtained from the Z-values in Figure 5 before inspection, which represent temperature measurements of the aircraft exterior. Moreover, based on differences between the defect and normal areas, especially the region between the defect and normal area, the results of defect localization using the 3D images are influenced. The 3D images can also mark relatively high temperature points and coordinates to determine the defect region's size. On the other hand, after manual inspection, the temperature of the defect location in this case was $46.5\text{ }^{\circ}\text{C}$, matching the Z-values marked in Figure 5 between bright yellow and orange. Therefore, the region with Z-values above $46.5\text{ }^{\circ}\text{C}$ was designated as the defect area.

The relative temperature proportion in the histogram was used for secondary confirmation of the defect area, as illustrated in Figure 6. Finally, the defect area and size were marked and positioned using the location marks from the 3D images and the confirmed value ($46.5\text{ }^{\circ}\text{C}$, green arrow) from the histogram. These guidelines provide maintenance personnel with a clear understanding of the required material quantity for preparation, facilitating calculations during the repair process.

Figure 5. 3D analysis of the defect area size on the engine cowling: (a) front view, (b) right view, (c) left view, (d) top view.

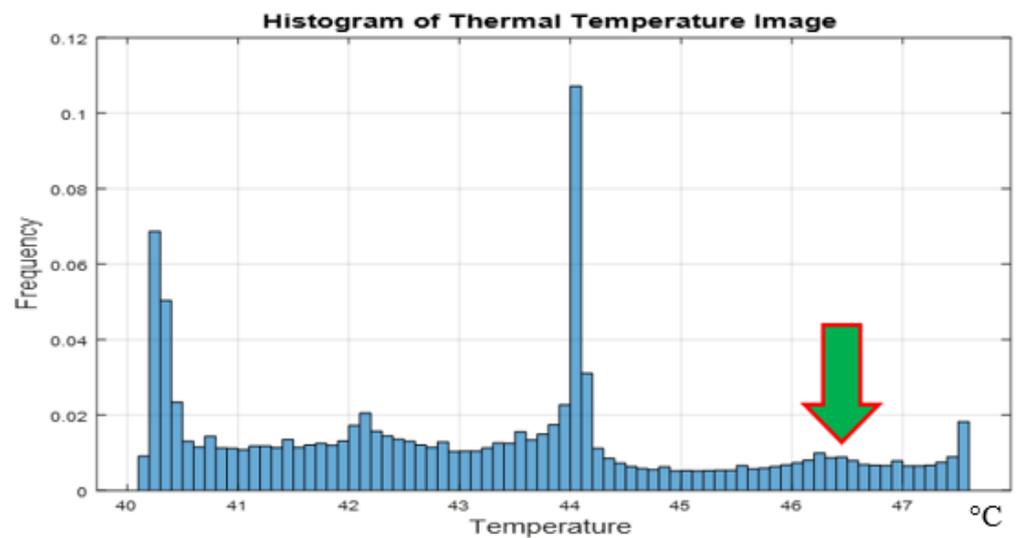
Figure 6. Histogram of temperature distribution on the engine cowling.

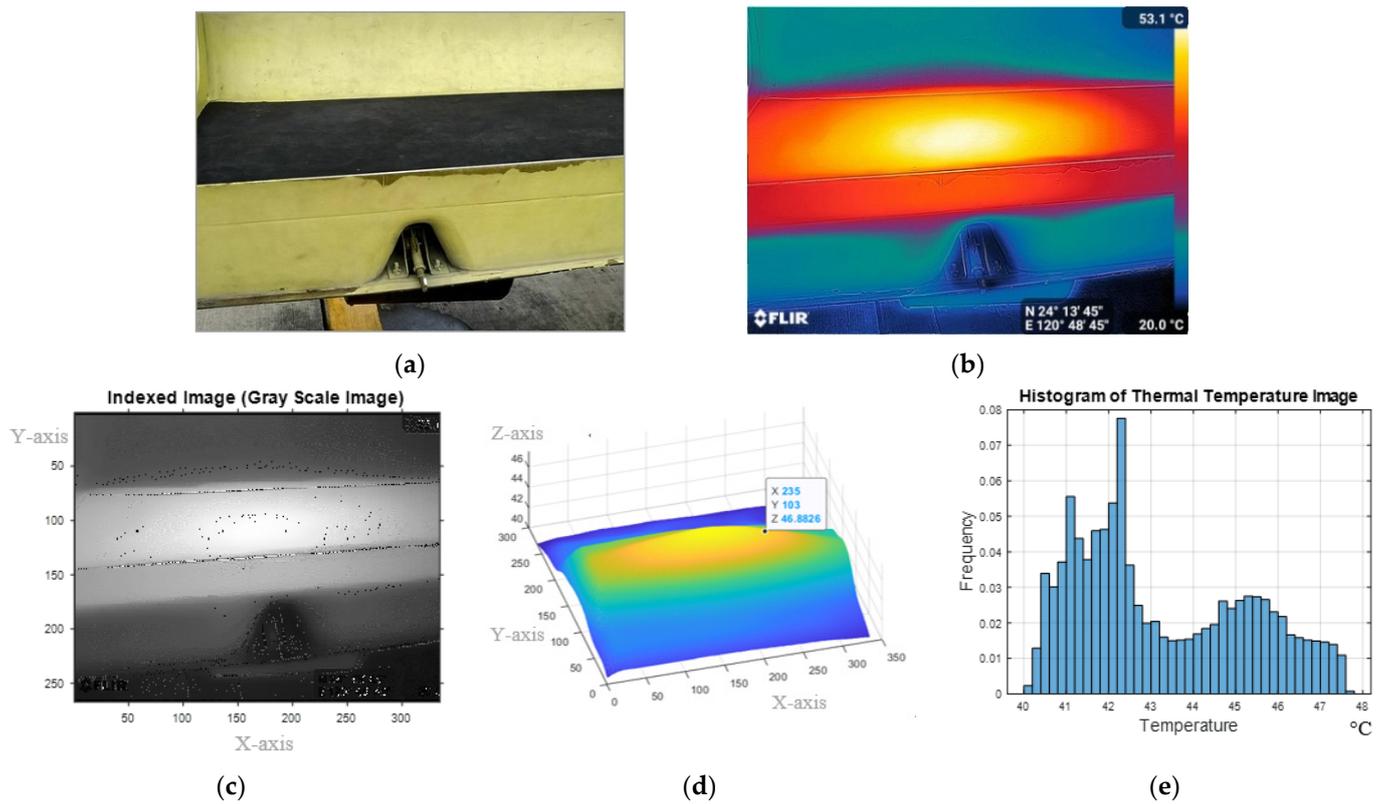
The visible light image in Figure 8a shows no visible defects in the external condition. However, the IR image in Figure 8b shows that the middle yellow and brighter areas of the engine inspection pedal are defective but the severity of the defect cannot be determined at present. After applying advanced analysis of this research, a binarization analysis was performed, as shown in Figure 8c. The noise was removed using a Gaussian filter and, finally, a 3D image was constructed, as shown in Figure 8d. Three-dimensional images were created to confirm the severity and location of the defect. In this case, the manually inspected temperature of the defect was 46.8 °C. Simultaneously, temperature differentials were used to establish a histogram, as shown in Figure 8e. Using the values confirmed by the 3D image's position markers and the histogram (46.8 °C), the defect range and size were identified. From the temperature proportion in the histogram, the amount of material required for the defect can be calculated. The innovative aspect of this research lies in determining the size of the repair material needed for the defect location and predicting the acceptable degree of the defect using combined information from the 3D image and histogram. This method can be used to schedule maintenance times for effective manpower and reduces material preparation time.

In Figure 8b, the latitude and longitude of the acquired image are displayed in the bottom right corner. The brand name of the thermal imager is shown in the bottom left corner and a color bar is located on the right side. This information, except for the color bar, may potentially affect the interpretation of the image and will be cropped before analysis. Therefore, before conducting 3D image analysis, a binarization analysis was performed in this study, as shown in Figure 8c. Additionally, any potentially influential information was converted to black to reduce errors.

Figure 8. 3D analysis of the engine inspection pedal of the AH-1W helicopter: (a) visible light image, (b) IR image, (c) indexed image, (d) 3D analysis image, (e) temperature analysis histogram.

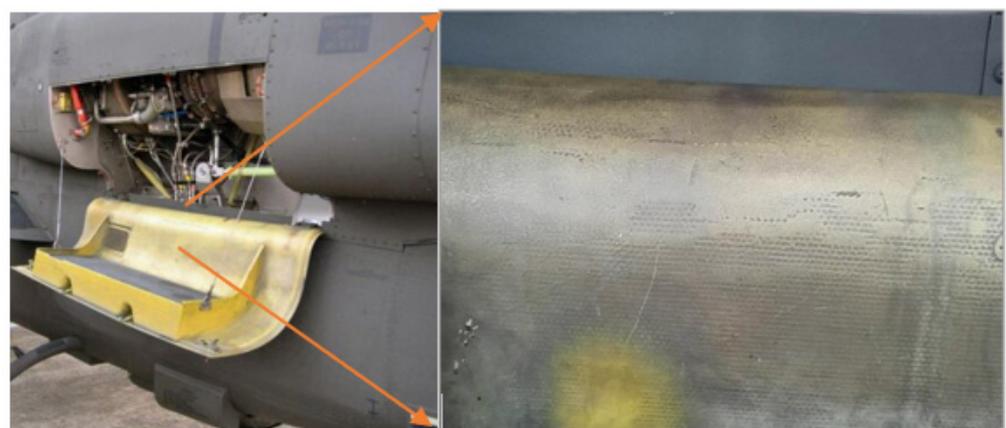
Case 2 involves the engine cowling in the non-pedal section, as shown in Figure 9. It is also manufactured from composite materials, but unlike the pedal, it is constructed using carbon fiber layers. This design meets lightweight and heat-resistant requirements. However, composite materials manufactured with resin bonding may experience delamination issues due to their proximity to high-temperature areas.

Figure 9. AH-1W helicopter aircraft engine cowling (non-pedal section).

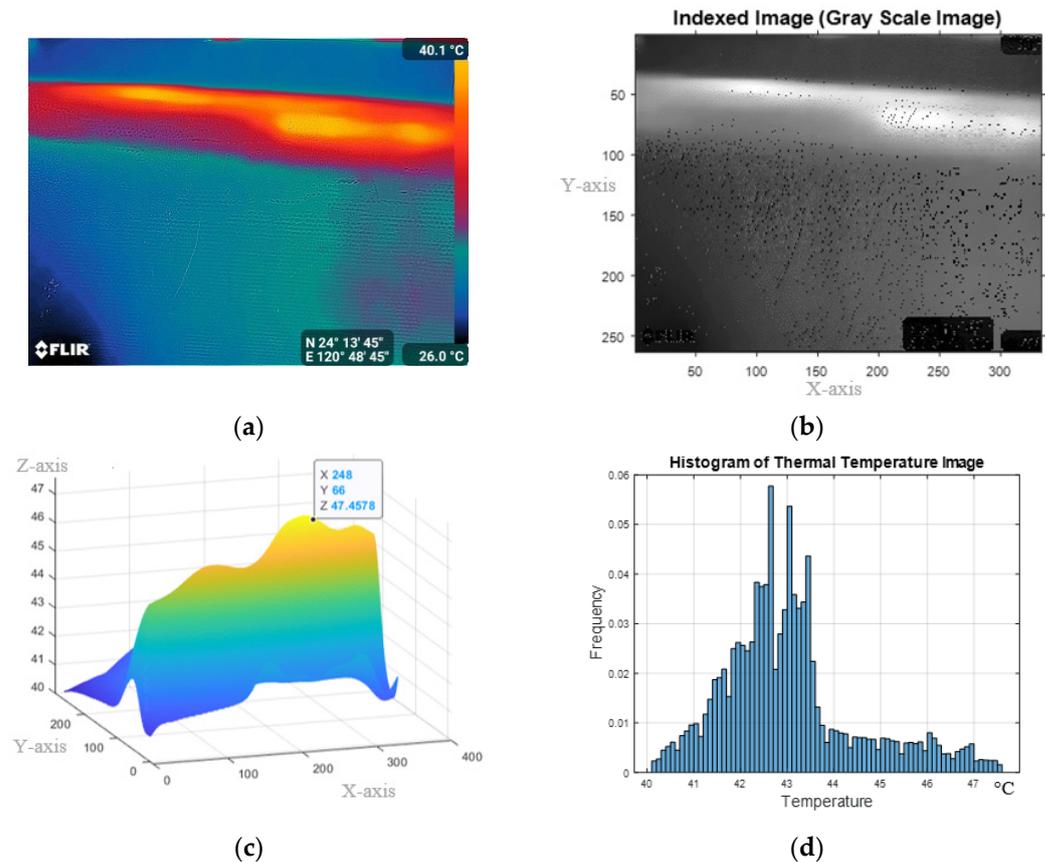
The helicopter aircraft engine cowling (non-pedal section) analysis was conducted using the same steps and methods. Similarly, in the IR image shown in Figure 10a, delamination areas can be roughly identified, but their severity cannot be confirmed. The image was then binarized, as shown in Figure 10b. A 3D image was also constructed, as depicted in Figure 10c. After manual inspection, the temperature at the location of

the defect was 47.4 °C. Histograms were created based on temperature differences, as illustrated in Figure 10d. The defect area and size were marked and positioned using the values confirmed by the 3D image and histogram (47.4 °C). The temperature proportions from the histogram were used to calculate the extent of the defect, providing a reference for maintenance personnel.

Figure 10. Analysis of AH-1W helicopter aircraft engine cowling (non-pedal section): (a) IR image, (b) indexed image, (c) 3D analysis image, (d) temperature analysis histogram.

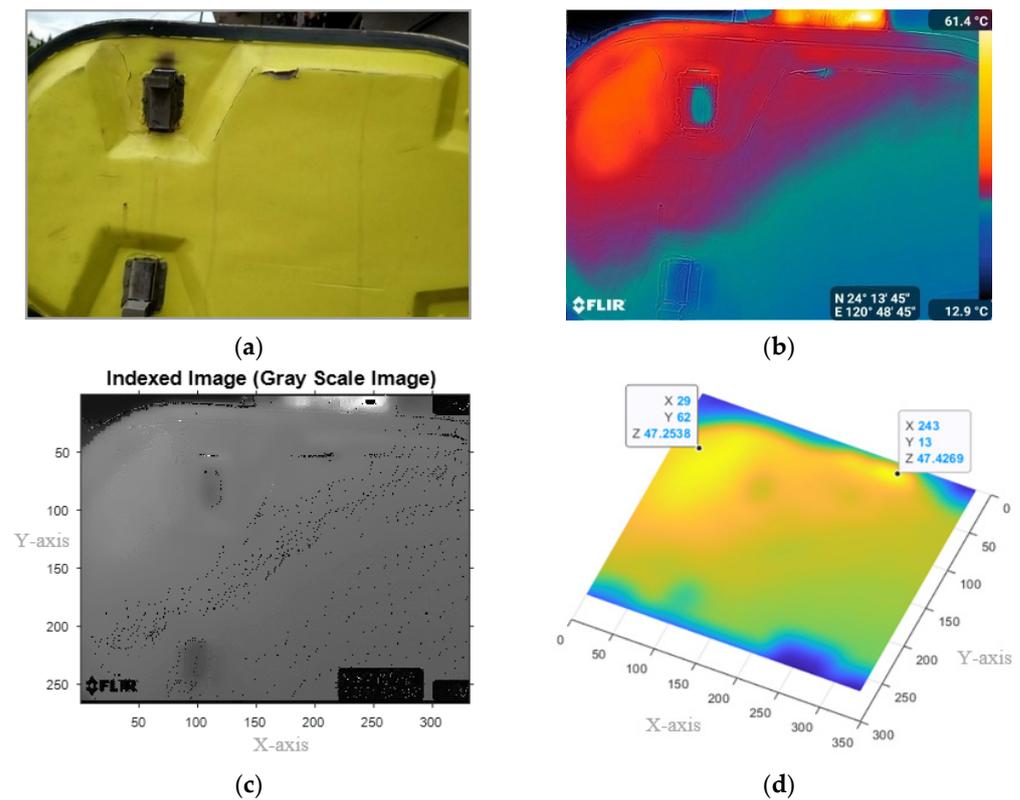
Case 3 involves an equipment compartment door manufactured from honeycomb composite material, as shown in Figure 11a. Located in the tail boom section, the equipment compartment door is positioned near the engine exhaust port. Therefore, it must meet lightweight and heat-resistant requirements. On the other hand, honeycomb composite materials are prone to delamination due to their proximity to high-temperature areas.

This case focuses primarily on the analytical approach developed in this study. In the IR image in Figure 11b, areas with suspected delamination are observed in the upper-left region, but the severity level cannot be confirmed. The image is binarized, as shown in Figure 11c. A constructed 3D image is also shown in Figure 11d. Different orientations of the 3D image were used to verify delamination severity and location. However, it is important to note that this 3D image has two bright yellow areas. The first is in the upper-left region, which corresponds to a defective area. The second area is directly above the image, corresponding to the engine exhaust port. These observations indicate that the image analysis in this study has certain limitations. When conducting image analyses, it is necessary to exclude high-temperature zones that may affect the IR image to ensure accuracy. Therefore, this case employed histograms based on different temperature differentials. Exercising caution when using such images for analysis is essential, as they may lead to potential misjudgments by maintenance personnel.

Figure 11. Analysis of AH-1W helicopter equipment compartment door: (a) visible light image, (b) IR image, (c) indexed image, (d) 3D analysis image.
