Case Report

# Inflatable Penile Prosthesis Complication in the Emergency Department

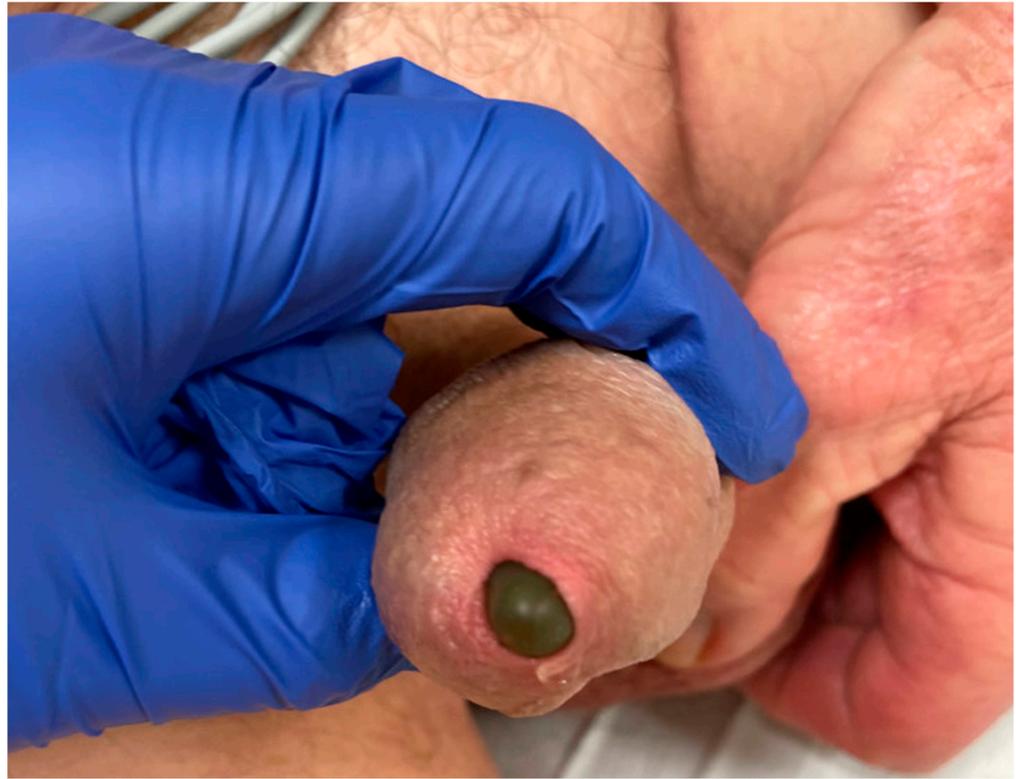
The patient's symptoms started a month before presentation, shortly after a large dog jumped on his groin. Since then, he noticed pain and feeling of the prosthesis more superficially. This was followed by noticing spraying of his urine stream. The patient did not seek medical care at this point; however, one day before presenting to our emergency department, the patient noticed the device protruding from his urethra and saw his outpatient urologist, who advised him to go to the emergency department.

**Figure 1.** A picture demonstrating the perforating cylinder protruding through the urethral meatus.

In our case, the perforation occurred 7 years after the prosthesis implantation in a patient with risk factors including Peyronie's disease and DM. Notably, the precipitating insult may have been the traumatic injury described by the patient, when his heavy dog jumped on his lap, causing a minor urethral injury that progressed to a cavernourethral fistula over the monthlong period.

The patient was administered antibiotics and underwent complete device extraction 2 days after presentation to the emergency department. No large urethral defect was cystoscopically apparent following device removal. A Foley catheter was then placed for 2 days to allow the urethral defect to heal. After its removal, the patient experienced no difficulty voiding and was discharged without complication. The patient was seen for a follow-up several months later and was in his usual state of health. He inquired regarding options for ED, and was advised that he would be at high risk for repeat erosion and infection; moreover, they may be dissatisfied with the IPP, as corporal excavation could be required, leading to reduced girth. Given these risks, the patient deferred repeat IPP placement.

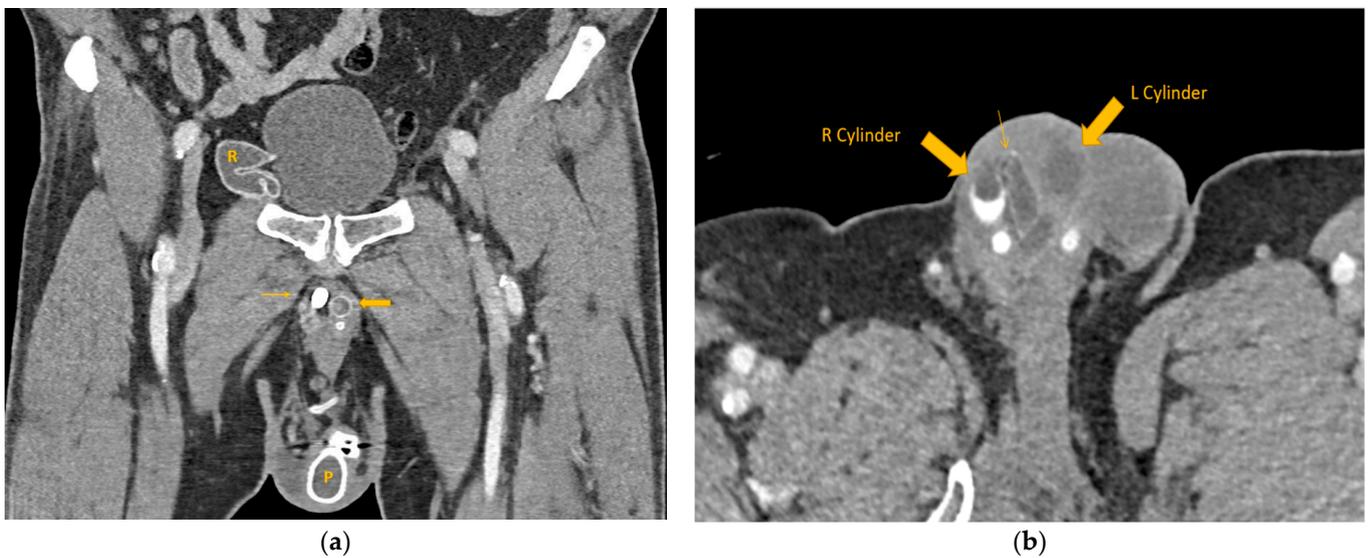
**Figure 2.** Contrast-enhanced CT of the abdomen and pelvis. (a) Coronal reformation demonstrating the decompressed reservoir in the right hemipelvis adjacent to the bladder, and the pump noted in the left scrotum. The left fluid-filled cylinder (broad arrow) is appropriately positioned in the left corpus cavernosum. At the same level, the metallic rear tip extender is seen in the right corpus cavernosum (thin arrow) due to anterior migration of the right cylinder. (b) Axial image focused on the proximal penis, demonstrating the right and left cylinders with focal kinking of the proximal right cylinder (thin arrow) and central inferior extension of the cylinder, at the site of suspected urethral erosion. R: reservoir, P: pump.

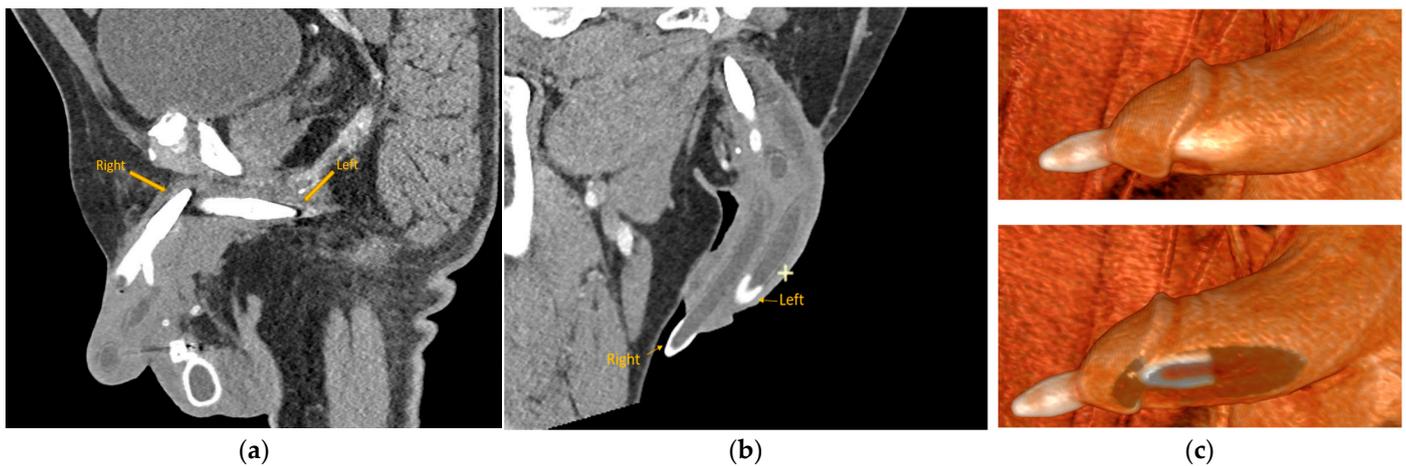
**Figure 3.** Contrast-enhanced CT of the abdomen and pelvis. (a) Sagittal reformation demonstrating the anterior displacement of the right metallic rear tip extender and the normal position of the left rear tip extender. (b) Oblique reformation of the penis demonstrating the transurethral extension of the right penile cylinder. (c) Volumetric 3D rendering of the penile prosthesis demonstrating the abnormal protrusion of the right penile prosthesis cylinder through the meatus, and left cylinder in the expected location.

CT with intravenous contrast correlated well with the operative findings and was sufficient for preoperative assessment and planning, with high-fidelity 3D reconstructions obviating the need for MRI. To the best of our knowledge, this is the first published case of penile prosthesis perforation demonstrated by contrast-enhanced CT.
