## Article

# Tensile Fracture Behavior and Failure Mechanism of Additively-Manufactured AISI 4140 Low Alloy Steel by Laser Engineered Net Shaping

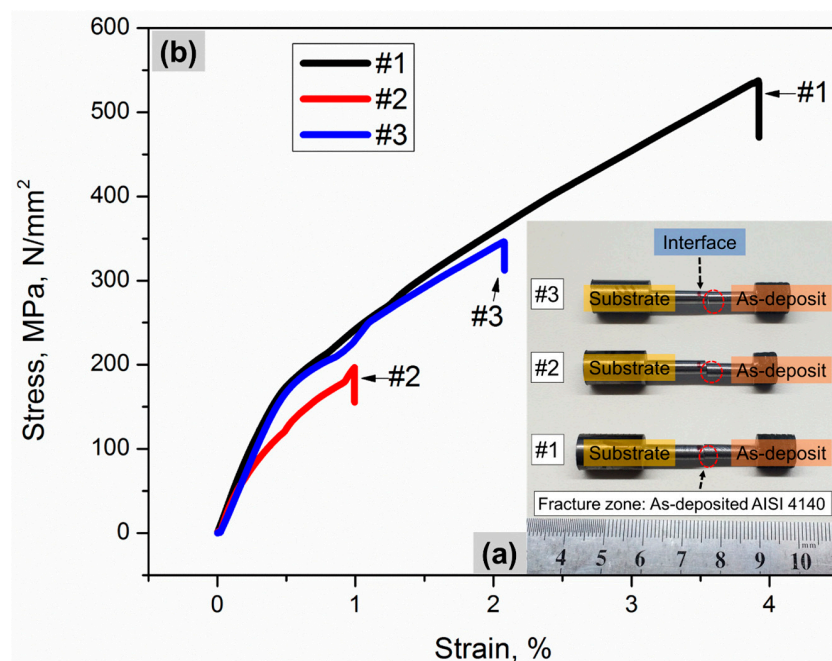
Figure 3 shows each fractured specimen after the room-temperature tensile test and a corresponding stress-strain curve. The substrate accounts for the left side of the specimen, and the as-deposited AISI 4140 occupies the right side of it. As seen in Figure 3a, all the specimens fractured at the as-deposited region. No indication of fracture failure was observed at the substrate and the interface, which implies that the substrate and the interface is stronger than the as-deposited part in the hybrid specimen. Therefore, it can be deduced that the strength of the interface bond between the as-deposited part and the substrate is higher than that of the interlayer bond within the as-deposited section.

**Figure 3.** (a) Hybrid specimens that fractured at as-deposited zone indicated by dotted circles after tensile testing and (b) the corresponding stress-strain curves.

As observed in Figure 3b, the tensile behaviors were highly varied among the specimens, which is attributed to the metallurgical defects, such as partially-melted powder and lack-of-bonding porosity [33,34]. No prominent necking behavior was presented from the fractured AISI 4140 parts (Figure 3a). Furthermore, the cross-sectional morphology of the fractured specimens indicated flat and smooth surfaces, indicating a brittle fracture mode.

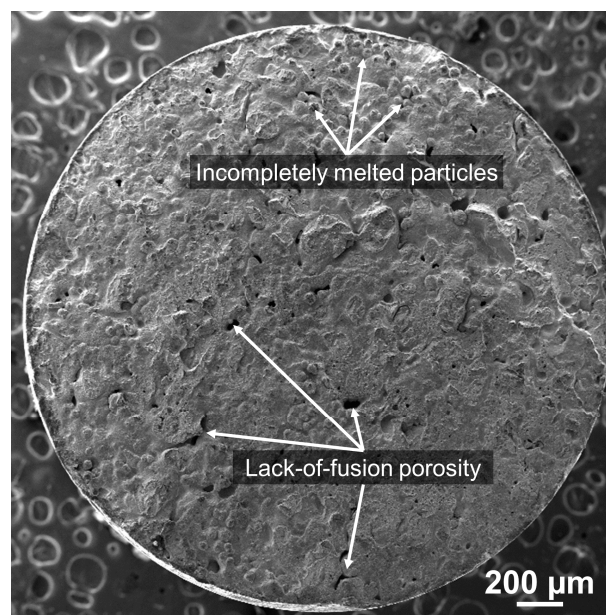
In Figure 4, the overall fracture surface of specimen #3 with the intermediate tensile properties (Figure 3b) predominantly presented a smooth brittle fracture mode. During the tensile test, the brittle fracture occurred suddenly with little plastic deformation. Additionally, the fracture angle between the applied tensile loading axis and the fracture surface was nearly perpendicular and exhibited a relatively flat fracture surface, indicating that the crack propagates parallel to the macroscale plane of the maximum normal stress by continuously breaking the atomic bonds along specific cleavage planes [35].

**Figure 4.** Overall fracture morphology of specimen #3 with insufficiently melted powder particles and porosity.

A cluster of spherical particles was largely distributed on the fracture surface as marked in Figure 4, which was regarded as partially melted powder during LENS process. As a result, voids were formed between the unmelted or partially-melted powder particles due to excessively blown powder into the molten pool [29], misalignment of the deposition head [36,37], or insufficient energy density [38,39].

Moreover, relatively larger and irregular pores were clearly seen throughout the fracture surface owing to a localized lack of fusion during deposition, which resulted in the existence of gaps between deposited tracks as indicated by arrows in Figure 4. This is most likely attributable to locally insufficient energy density absorbed by the powder particles since porosity has an inverse relationship with absorbed energy per unit length of a deposited track [36,40].

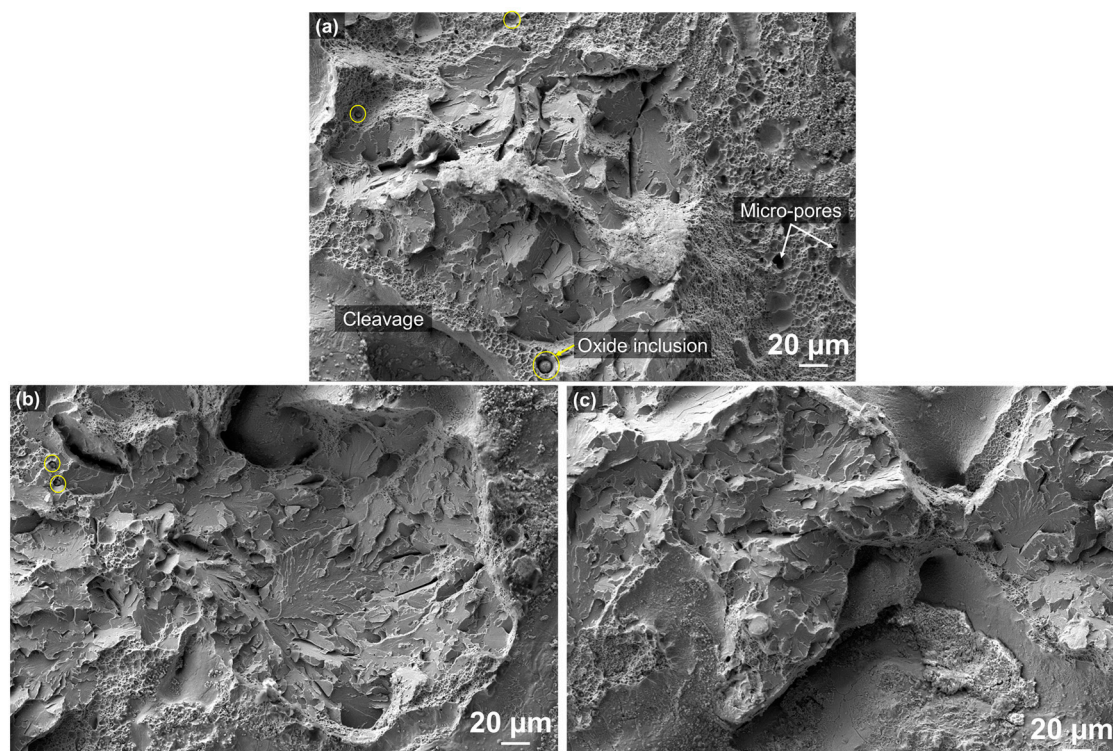
From the high-magnification views on the fracture surface, more details of fracture morphology and defects were revealed, as seen in Figure 5a–c. The brittle cleavage was predominant with a very small amount of a localized dimpled zone, which shows a quasi-cleavage fracture mode (Figure 5a). The locally-dimpled microvoids that coalesce represent a ductile fracture, whereas the tearing cleavage deformation indicates a brittle fracture, which is commonly found in steels as observed in other studies [46–50]. The microscopic mechanism of the cleavage fracture is specified as follows: (i) crack nucleation at cementite particle; (ii) propagation of the microcrack nucleus across the particle/matrix interface along a cleavage plane of the neighboring grain; and (iii) propagation of the grain-sized crack to neighboring grains across the grain boundaries leading to final failure [35,51,52]. The cleavage-type morphology mostly appeared to be smooth and flat, suggesting a lack of bonding between adjoining layers or tracks.

**Figure 5.** (a–c) High magnification views of the fracture surface after tensile testing showing a transgranular quasi-cleavage fracture mode.

Spherical-shaped micro-pores were also identified in the dimpled rupture zone as indicated by arrows in Figure 5a, which was on account of the entrapped gas inside the gas-atomized (GA) hollow powders [30,36,37,53,54]. The trapped gas inside the powders could not come out of the melt pool because of the fast cooling nature caused by the LENS process, which ended up forming the micropores in the as-deposited part. Furthermore, spherical oxide inclusions were observed in the dimple fracture area as indicated by circles in Figure 5a. The details on chemical element analysis using EDS for the inclusions will be discussed in Section 3.2.3.

Figure 5b,c also represent the typical transgranular crack morphology with the river patterns which indicate the direction of localized crack propagation [45,55,56]. It was observed that the presence of this transgranular cleavage fracture mechanism in steel is related to iron carbides (cementite) [57,58]. During the deposition process, the first layer undergoes rapid cooling (quenching) due to steep temperature gradients close to the interface on top of the substrate resulting in a very fine martensite structure with some retained austenite. However, the first layer experiences phase transformation subject to reheating (tempering) phenomenon caused by subsequent layers [59]. It is known that the transgranular quasi-cleavage fracture mode is associated with the tempered martensite embrittlement (TME) mechanism, which occurs at the tempering temperature, ranging from 200 to 380 °C, in low/medium carbon and alloy steels due to the transformation of retained austenite at lath martensite boundaries [60,61]. This interlath austenite transforms to coarse cementite crystals, and cementite nucleates on the martensite boundaries, which induces large lattice distortions and a high density of dislocations that can act as crack nucleation sites and, therefore, reduces impact toughness and ductility [62,63].

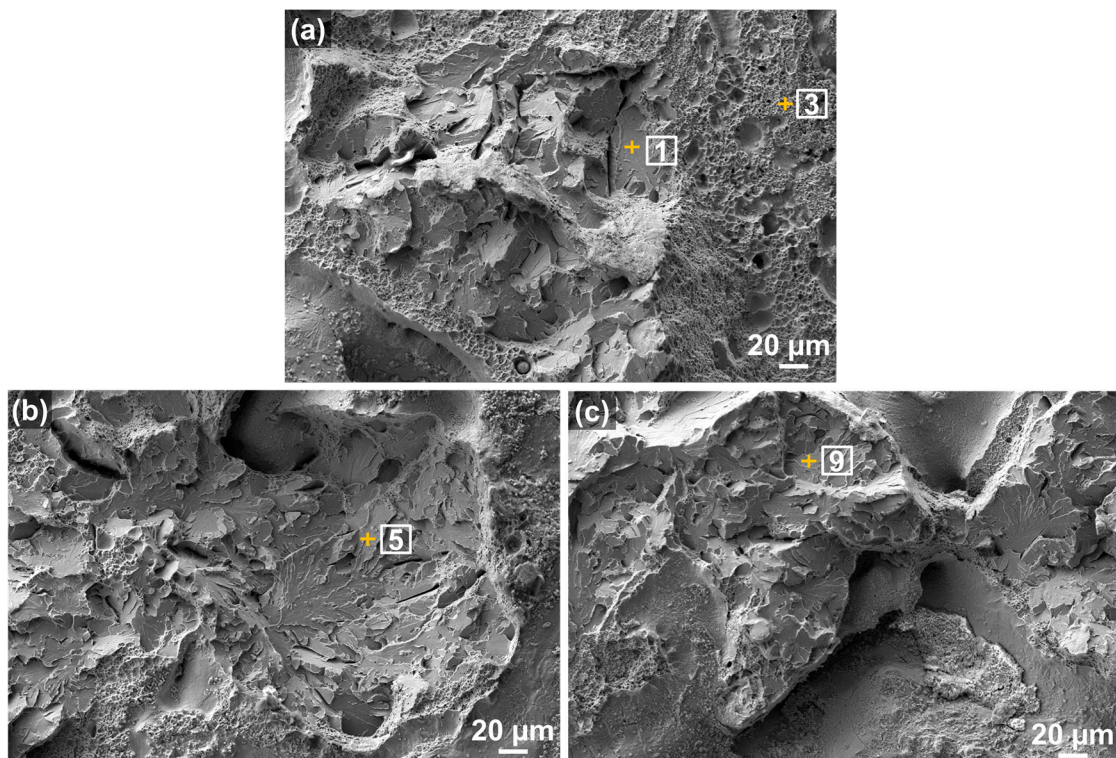
EDS spot analyses were further performed on the transgranular cleavage areas, as shown in Figure 6a–c, to confirm iron carbide phase formation quantitatively as discussed in the previous section. As seen in Table 2, the wt % of C was evidently higher in the transgranular cleavage areas than the nominal composition of AISI 4140, which was confirmed as a cementite phase. Other researchers also found a similar C composition (5.72 in wt % or 22.16 in at %) and identified as cementite in similar alloy steels [64]. Darwish et al. [58] observed that cementite contained a high concentration of carbon peak values ranging from 10 to 24 at % in quasi-cleavage fracture of alloy steels. The current study also confirmed in Table 3 that C concentration ranged from 16 to 21 at %, indicating a high enrichment of carbon and carbide formation in the corresponding areas marked in Figure 6.

**Figure 6.** (a–c) SEM micrographs of the fracture surface (transgranular cleavage areas) for the EDS spot analyses.

From the EDS composition analyses, a highly-enriched carbon content was detected on the fracture surface, indicating that the carbide precipitation was the main reason behind the brittle fracture mode [58]. Thus, the quasi-cleavage fracture and transgranular cracking are attributed to carbide precipitation in highly carbon enriched regions.

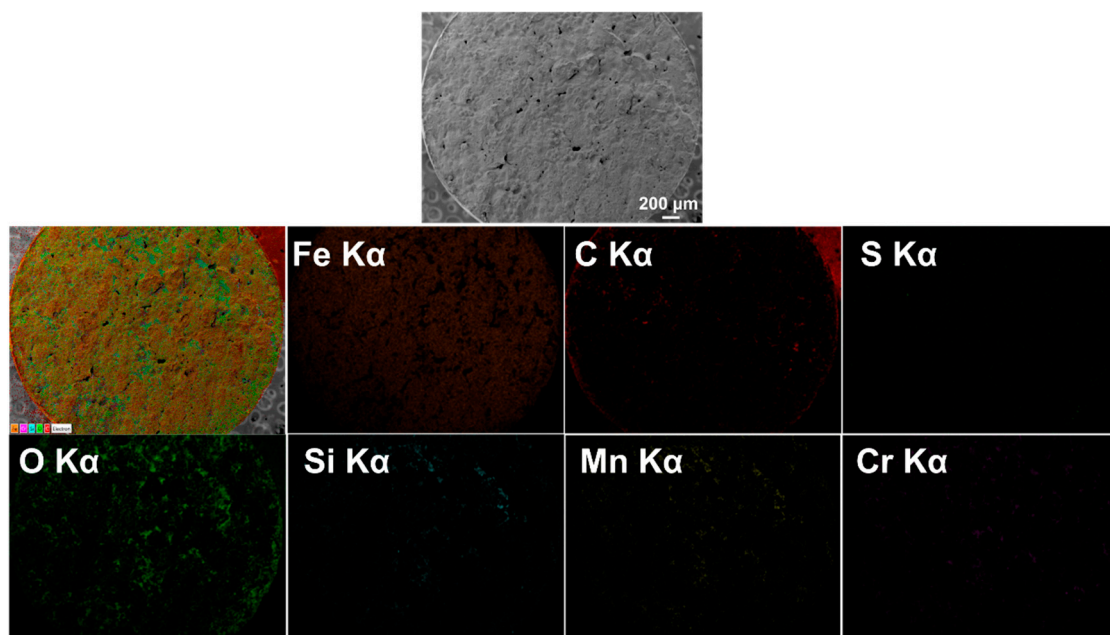
Figure 7 shows EDS element mapping on the entire fracture surface, illustrating that Fe was the primary elemental constituent since it accounted for more than 96% of AISI 4140 (please

refer to Table 2). However, it was observed that evident presence of O was largely distributed throughout the fracture surface along with Si, Mn, and Cr. It was considered that oxide inclusions were formed during the deposition process. To detect the elemental composition of the inclusions identified on the fracture surface, EDS spot analyses were conducted on the selected areas as shown in Figures 8 and 9, respectively. As mentioned in Section 3.2.1, spherical oxide inclusions were observed in the dimple fracture area, as indicated by circles in Figure 8a. Figure 8b shows EDS spot spectrum detected on the inclusion marked by an arrow in Figure 8a, indicating that the highest peak of O, followed by Si, Mn, and Cr. The quantitative chemical composition on this inclusion was also obtained in Tables 4 (in wt %) and 5 (in at %), which gives further evidence of higher O, Si, Mn, and Cr concentrations compared to the nominal compositions.

Figure 7. EDS element mapping on the fracture surface of specimen #3 from Figure 4.

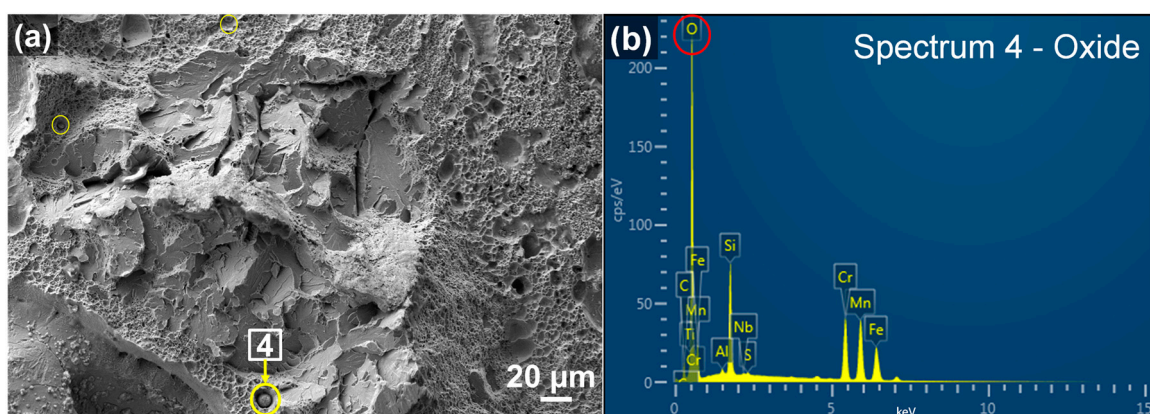
Figure 8. (a) SEM micrograph showing oxide inclusions marked by circles; and (b) the EDS spot spectrum of the inclusion marked by an arrow from (a).

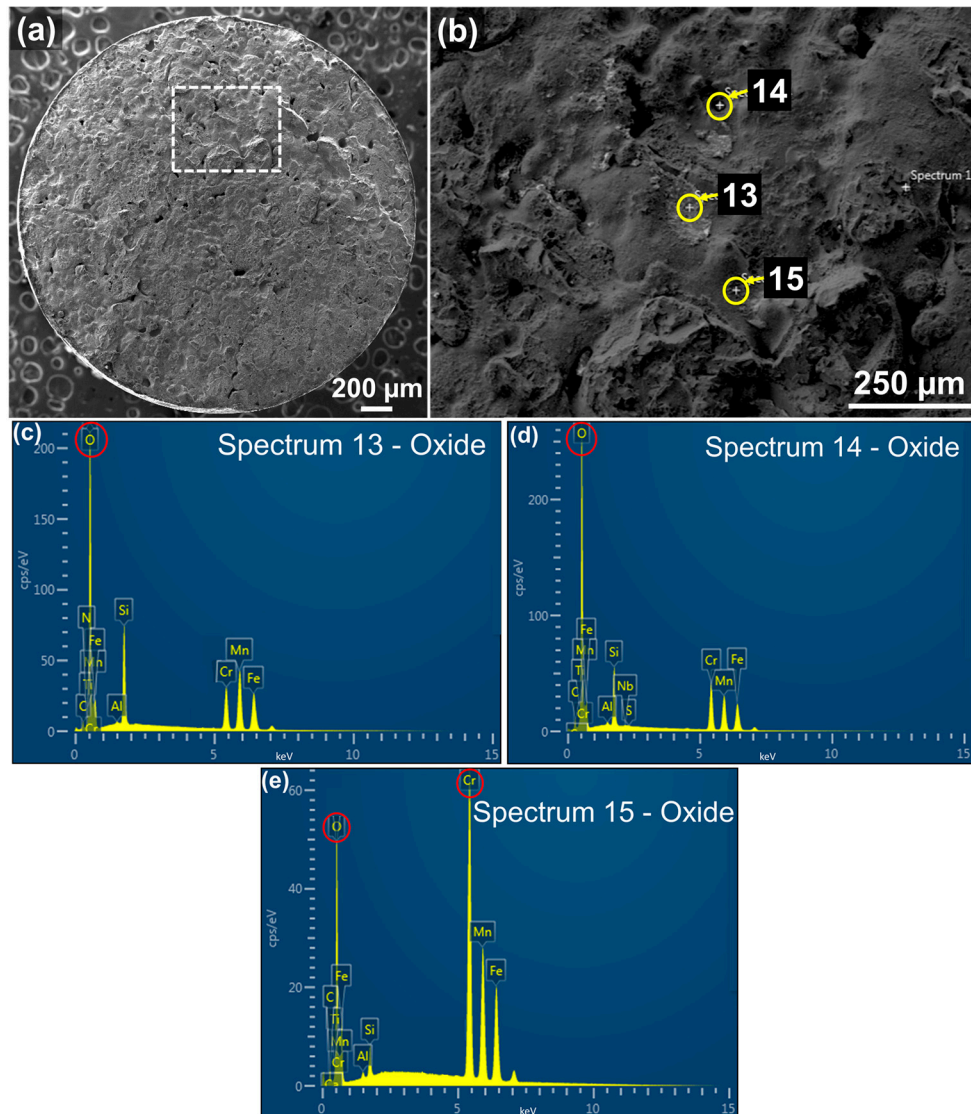
Figure 9b shows the high magnification of another selected area marked by a dashed box from the entire fracture surface in Figure 9a. Spherical oxide inclusions whose morphology was similar to that of the oxide from Figure 8a were also observed as marked by circles. Figure 9c–e show EDS spot spectra detected on the inclusions marked by arrows in Figure 9b, indicating that the highest peak

of O, followed by Si, Mn, and Cr. The quantitative chemical composition on this inclusion was also obtained in Tables 4 (in wt %) and 5 (in at %), which gives further evidence of the higher concentration of O, Si, Mn, and Cr contents compared to the nominal compositions.

**Figure 9.** SEM micrographs showing oxide inclusions (a) overall fracture surface; (b) high magnification of a selected area from (a) marked by a dashed box showing oxide inclusions; and (c–e) EDS spot spectra detected on the corresponding spots marked by circles in (b).
