Fatigue Behavior of Non-Optimized Laser-Cut Medical Grade Ti-6Al-4V-ELI Sheets and the Effects of Mechanical Post-Processing

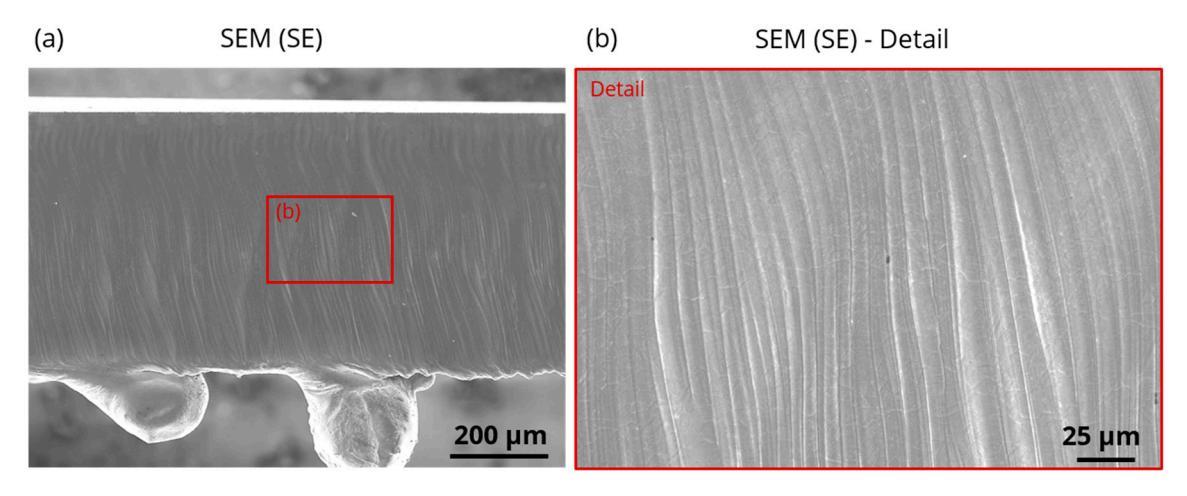
The surface quality achieved due to the laser-cutting process with the particular cutting parameters applied (see Material and Methods section) is depicted in Figures 2 and 3. The Ti-6Al-4V-ELI alloy shows a distinctive surface relief with recognizable additional melting drops on the lower cutting edge. On the upper cutting edge, an irregular distributed terrace-like surface structure can also be identified (Figure 3a). Both observed features can be traced back to the influence of the laser-cutting parameters applied. The melting drops are caused by an insufficient pressure of the inert argon gas atmosphere. Whereas on the upper cutting edge, the occurring melting drops could be sufficiently removed, the lower cutting edge is less accessible, demanding a higher pressurized air stream to successfully remove all residual melting drops. As a consequence, the necessary argon pressure has to be well over 6 bar to homogeneously remove melting drops on the whole cutting edge.

The irregular terrace-like structure can be assigned to an influence throughout the interaction of the laser and Ti-6Al-4V-ELI but not directly explained till now. Further evaluation is, therefore, necessary. However, optimized laser-cutting parameters will improve the surface quality to a great extent, and therefore, also has a positive effect on the resulting fatigue strength of the Ti-6Al-4V-ELI alloy. The average height parameters of the laser-cut surface relief are measured according to ISO 25178 by means of confocal microscopy. Several µm in distance between the relief hills and valleys (Figure 2a) are identified, which concludes a significant surface roughness. Since fatigue failure in the LCF (< 1×10^3 – 10^4 cycles) and HCF (up to 1×10^7 cycles) regime is mostly triggered by the stress concentration at distinct surface flaws leading to early crack initiation and propagation, pronounced surface roughness is detrimental for the expected fatigue strength and endurable cycles [10–12]. The Ti-6Al_LC samples with a surface quality as depicted in Figure 2 could, therefore, be expected to cause a dominant concentration of cyclic stress in the relief valleys during fatigue. In addition, Ti-6Al-4V is known for its high notch sensitivity, which was the subject of detailed studies in the past [3,10,14,19], demonstrating a strong decrease of fatigue strength correlating with higher surface roughness and

Figure 2. Obtained quality of the laser-cut surfaces of Ti-6Al-4V-ELI with non-optimized laser cutting conditions: (**a**) Overview SEM-image of the cutting edge with residual melting drops at the lower part; (**b**) Detailed SEM-image showing a wavy, irregular surface structure after the laser-cutting process.

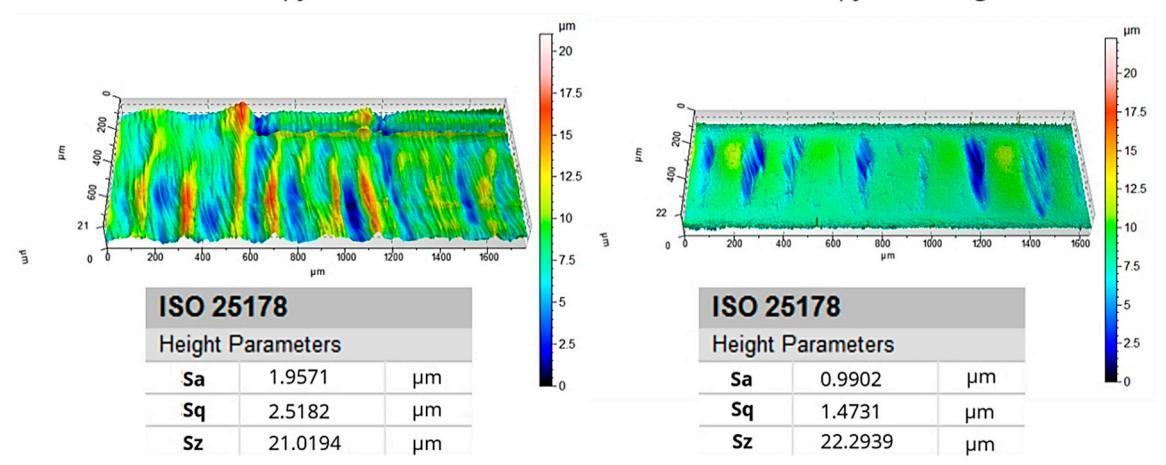
Figure 3. Typical representative surface reliefs by means of confocal microscopy (normalized) of Ti-6Al-4V-ELI with average height parameters: (a) Surface after laser-cutting; (b) Surface after barrel-grinding—Improvement of surface quality.

Barrel-grinded surfaces, on the other hand, show a strong improvement in surface quality and less roughness, but retained micro-notches are visible in the center area of the cutting edges (Figure 3b). These micro-notches could act as possible crack initiation sites in the application, which was already shown in detail in one of the authors previous studies of laser-cut β -titanium, as well as α -titanium for fatigue samples and osteosynthesis plates [12]. This leads to the conclusion that the barrel-grinding process is an effective tool to reduce detrimental laser-cutting effects, but only under the prerequisite of already optimized laser-cutting parameters for a specific material. Without the improvement of the original laser-cut surface quality, micro-notches seem to remain in the center area of the laser-cutting edges playing a decisive role for achievable fatigue strength in the application.

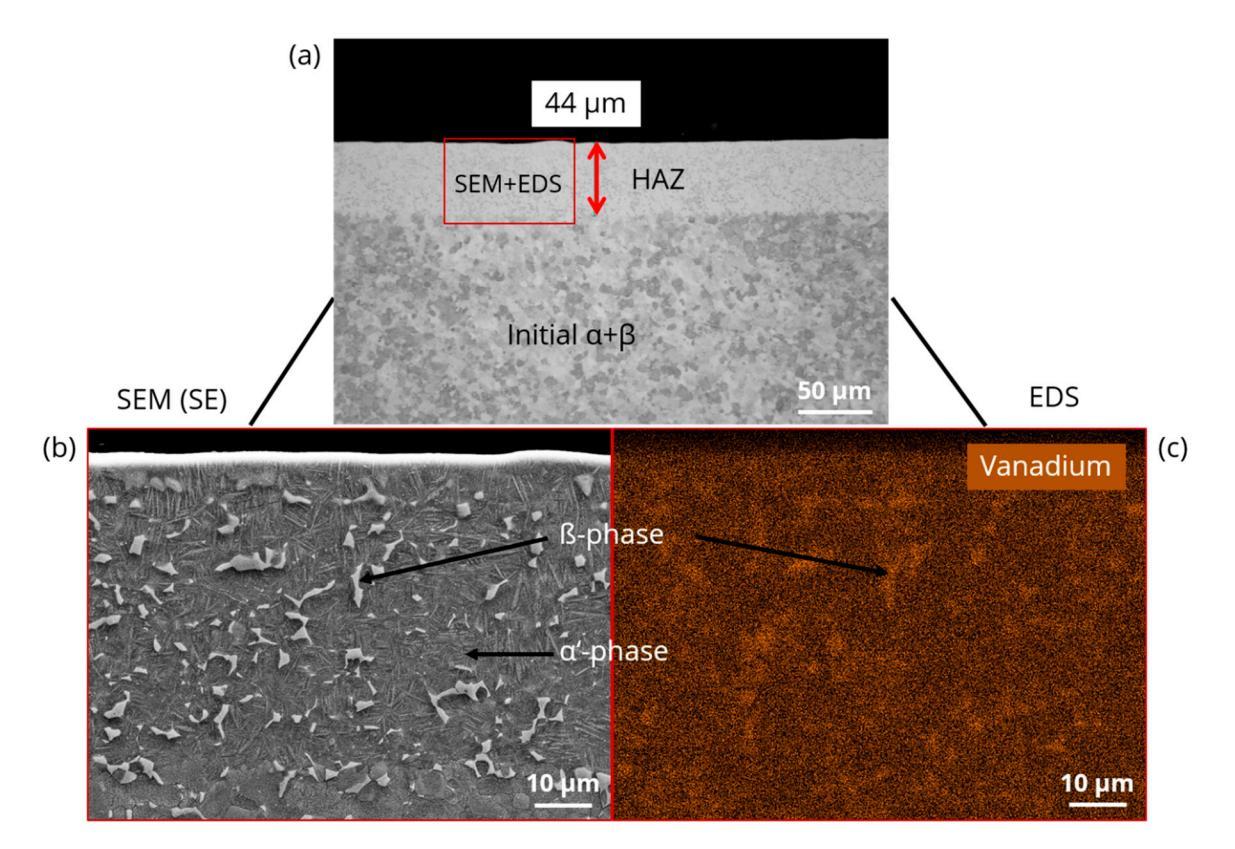
The HAZ in a cross-sectional view at the upper cutting edge depicted in Figure 4 clearly demonstrates the change in microstructure from equiaxial $\alpha+\beta$ into acicular martensitic α' with retained β , the latter being proven by the EDS-analysis showing a higher V-content as a strong β -phase stabilizer. The transformation into martensitic α' is, thereby, associated with the self-quenching process, which is fast enough to transform the initial equiaxial α -phase (5–10 μ m in grain size) to fine acicular α' martensite. The retained β -phase can be explained by the very fast processing time and holding over β -transus not allowing the β -phase also to transform into α' martensite. The lower cutting edge with residual melting drops (Figure 2a) shows, by contrast, two distinctive zones (Figure 5-Cross-sectional view). A small surface layer (average thickness $10-15 \,\mu$ m) consists solely of acicular α' without β -phase. The second zone, which develops with growing distance to the free surface, consists of α' and β -phase, comparable to the upper cutting edge, followed by the initial $(\alpha+\beta)$ -microstructure. The development of the different microstructural zones could be explained with the self-quenching gradient from the laser-cutting temperature, which causes different quenching speeds towards the sample interior and, therefore, possible zone formation. However, in order to explain the pronounced microstructural difference of upper and lower cutting edges, more detailed information of the temperature distribution related to the process parameters would be necessary.

Figure 4. Typical HAZ at the upper cutting edge developed during the laser cutting process (Ti-6Al_LC sample): (**a**) Light microscopic image representing an overview; (**b**) SEM-image (SE cross-section) of the HAZ microstructure with α' -martensite; (**c**) Element analysis (EDS) showing the higher vanadium content (β -stabilizer) in the β -phase of the HAZ.

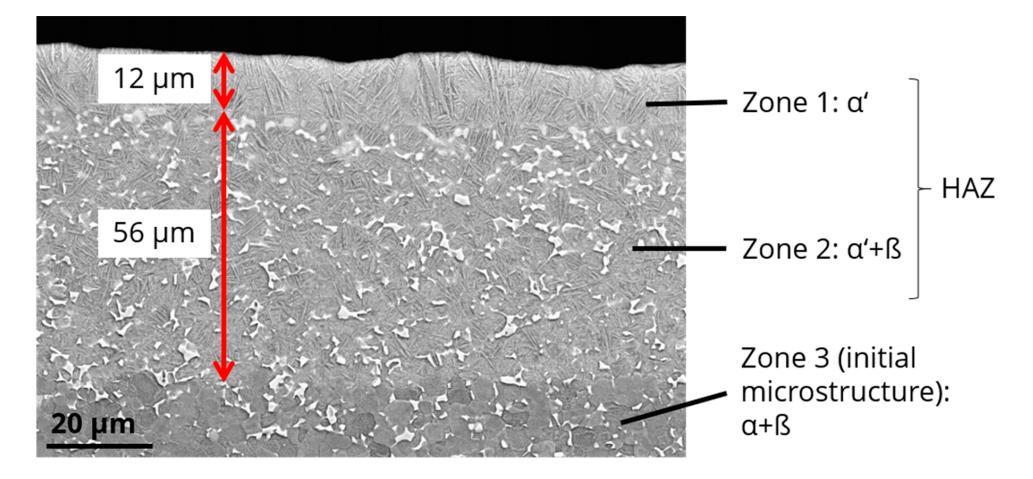
Figure 5. SEM image (BSE cross-section) of the HAZ at the lower cutting edge of a Ti-6Al_LC sample showing three distinctive microstructural zones after laser-cutting consisting of martensitic α' -phase and retained β -phase.

The measured thickness of the HAZ (\approx 40–70 µm) depends on the occurrence of the different zones and is more pronounced at the lower cutting edge with the additional α' -zone. The optimized laser-cutting parameters, such as speed and power would contribute to a significant less pronounced HAZ. Furthermore, the application of a pulsed laser is expected to have a positive effect on the local microstructural changes due to the very short processing window and heating over the β -transus temperature [36].

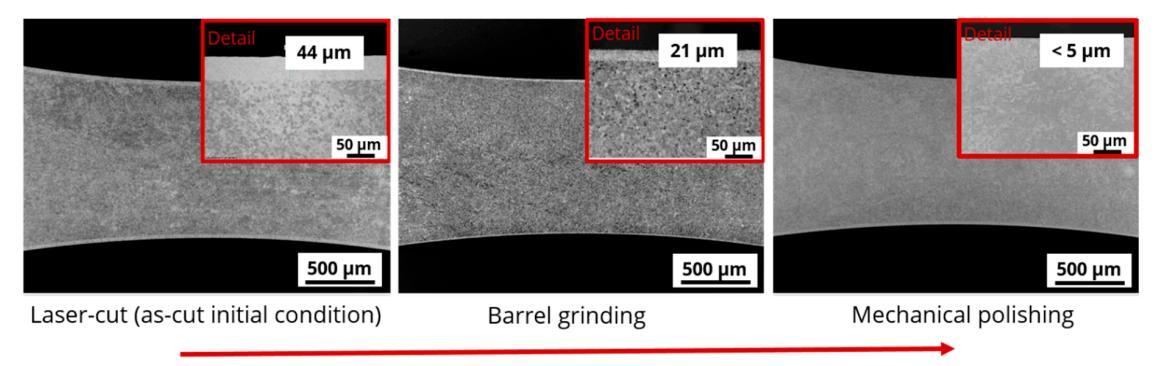
Figure 6. Thickness of the HAZ dependent on the mechanical post-processing showing a significant decrease in measured HAZ-thickness at the upper cutting edge.

The results of mechanical polishing are also depicted in Figure 6. An almost complete removal of the HAZ is observed. However, it has to be pointed out that in the study presented, the mechanical polishing was executed hand-made, leading to slight variations regarding the extent of removal of the HAZ for the overall number of samples.

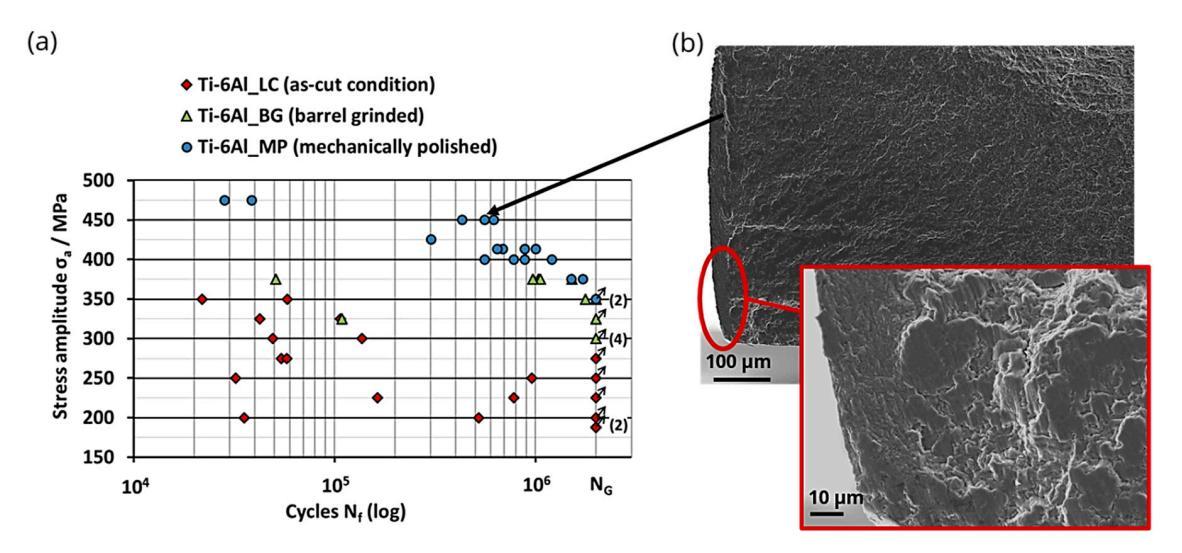
The fatigue test results for all the three sample series are shown in Figure 7a. Remarkable differences are recognizable between the samples with the as-cut surface (Ti-6Al_LC) and the sample series with additional post-processing of the surface (Ti-6Al_BG and Ti-6Al_MP). The results for the as-cut samples show a significant scatter and the lowest fatigue strength ($\sigma_{aD,50\%}$ = 235 MPa) for a fatigue life limit of $N_G = 2 \times 10^6$. A superior fatigue strength was reached for the series with barrel-grinded surface (351 MPa) and mechanically polished surface (363 MPa). These values represent an increase of around 50% compared to the original laser-cut surface condition. However, while comparing the fatigue strengths obtained for the different sample conditions, it has to be considered that the as-cut condition represents a more or less "worst-case" condition since the process parameters were chosen on the basis of practical knowledge and were not yet optimized. The optimized laser-cutting parameters result in strongly decreased surface roughness and improved fatigue strength. The scattering of the results is less distinctive with mechanical post-processing of the surface and can be attributed to a higher surface quality with less surface roughness, and therefore, less possible notches acting as stress concentrators during fatigue loading. For the barrel grinded surface condition; however, micro-notches remain in the center area of the laser-cut edges, which was exemplarily shown in Figure 3. In comparison to the process of mechanical polishing, which displays the best overall fatigue behavior, barrel grinding of the Ti-6Al-4V-ELI alloy must be optimized, especially in case of homogeneity and removal of all surface notches.

Figure 7. Fatigue results of the Ti-6Al-4V-ELI alloy: (a) S-N diagram for all three tested sample series; (b) Fracture surface analysis for a Ti-6Al_MP sample with mechanically polished surface conditions including the crack initiation site on the laser-cut edge directly near the sample corner after fatigue failure at 450 MPa and 6.2×10^5 cycles.

Fatigue crack initiation sites for all Ti-6Al-4V-ELI samples are located at the sample edges and corners. There are distinct differences between the three tested series, which are depicted in Figures 7b, 8 and 9. For the mechanically polished surface condition (Figure 7b), fatigue cracks initiate at the laser-cut edges or the flat sample edges, but primarily at or directly near the sample corners. The reason for this behavior is the overall good surface quality and comparable surface roughness of all sample edges with no distinctive micro-notches. In this case, the sample corners act normally as the

highest stress concentrator under fatigue loading for flat sample geometries [39]. The consequence is a preferred fatigue crack initiation at these sites for the Ti-6A1_MP samples.

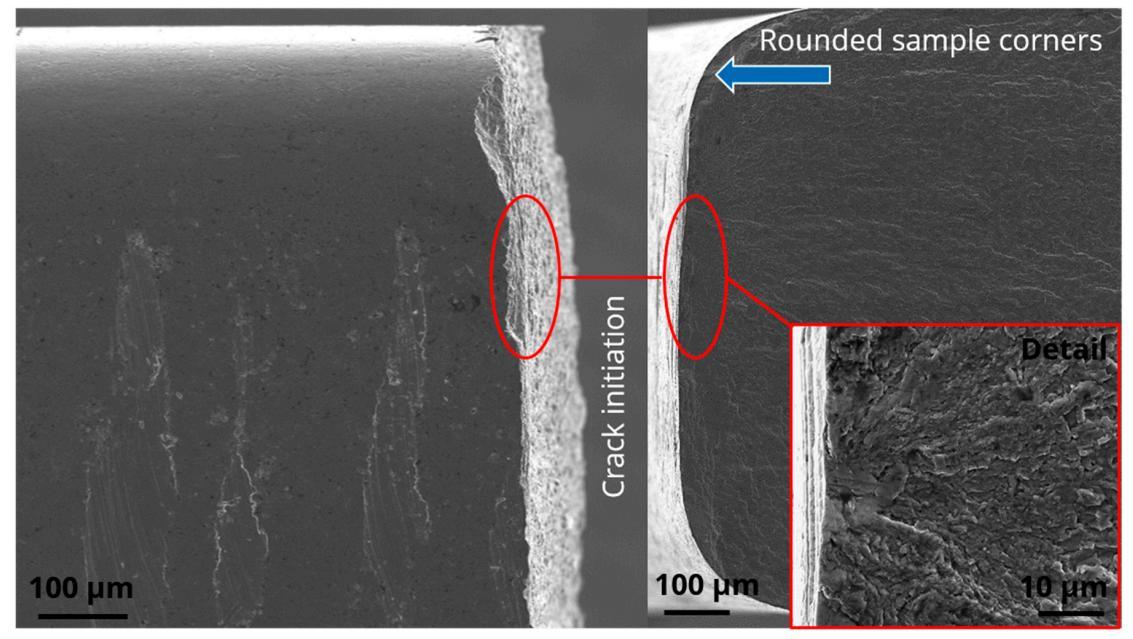
Figure 8. Fractography of a Ti-6Al_BG sample with barrel-grinded surface condition failed at 375 MPa and 5.1×10^4 cycles: (a) SEM (SE) analysis of the laser-cut edge with detectable notches; (b) The corresponding fracture surface with detailed view on fatigue crack initiation.

The sample series with the barrel-grinded surface condition (Ti-6Al_BG) showed, on the contrary, fatigue crack initiation always on the laser-cut edges, which is exemplarily depicted in Figure 8. Furthermore, the crack initiation sites are not always located at the smallest loaded cross-section but rather in the radius section. The cause for this behavior can be assigned to the remaining and detected surface notches after the barrel-grinding process in the middle of the laser-cut edges (Figures 3 and 8a). The irregular size and distribution of these remaining notches leads consequently to stress concentration, crack initiation, and failure at the biggest notches, and these can be located outside the smallest loaded cross-section. Associated with the effective lower overall surface roughness of

the laser-cut edges and the observed, particularly rounded, sample corners (Figure 8b—lower stress concentration sites), all Ti-6Al_BG samples are expected to fail at one of the remaining notches.
