# Article Case Study—An Extreme Example of Soil–Structure Interaction and the Damage Caused by Works on Foundation Strengthening

Abstract: This paper describes the works on foundation strengthening of the towers of the Cathedral of St. Theresa of Avila in Subotica and the damages caused by these works. Strengthening was performed by means of jacked-in piles and deep soil injection. The construction of the Cathedral began in 1773 and it lasted for several decades with frequent interruptions and changes to the project. The present appearance of the facade was created in 1912. According to historic data, several years after construction, the cracks appeared on the front facade. With time, these cracks became more pronounced, and in 2015, when the remediation project started, the total width of major cracks reached about 15 cm. The first contemporary attempt to repair the towers was made in 2017 by inserting piles beneath the foundations. These works were interrupted due to increased settlements and the appearance of new cracks. In the second attempt, the strengthening was performed by deep injection of soil with expansive resins. During these works, settlements and damages intensifie

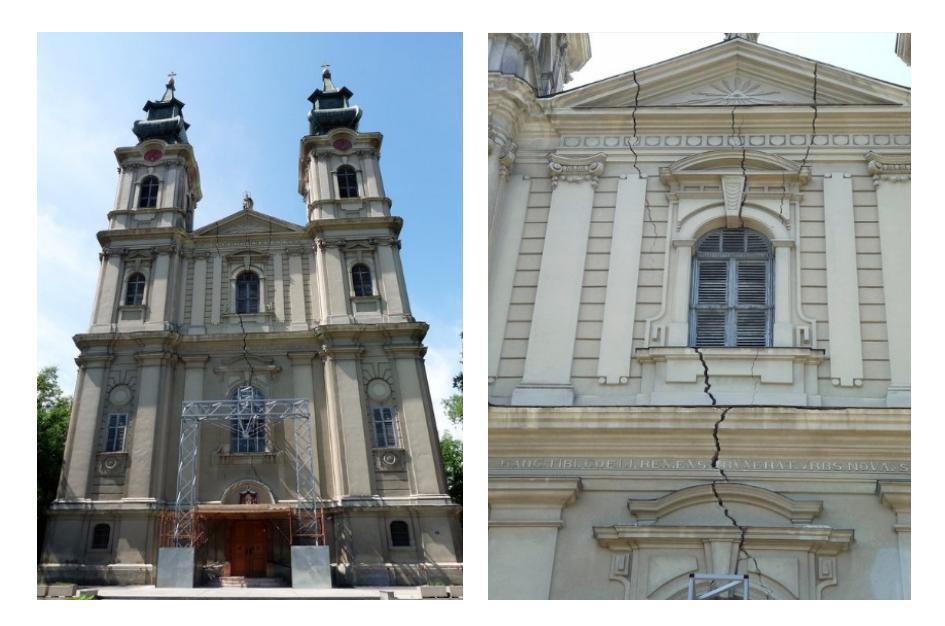
Figure 2. (Left) Cracks in the front facade wall; (Right) Crack details on the upper window.

Figure 2 shows the large cracks that developed on the frontal facade. At present, these cracks have a maximum width of approximately 19 cm, and they spread over the full thickness of the wall, over the whole crack lengths.

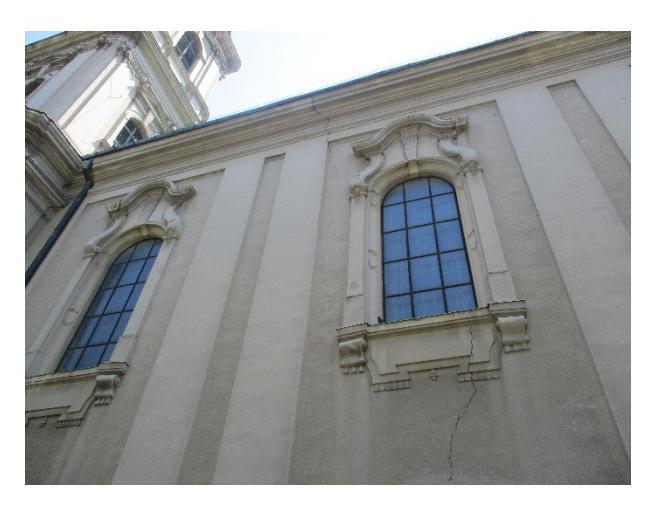
Figure 3. Cracks in the longitudinal wall—north facade.

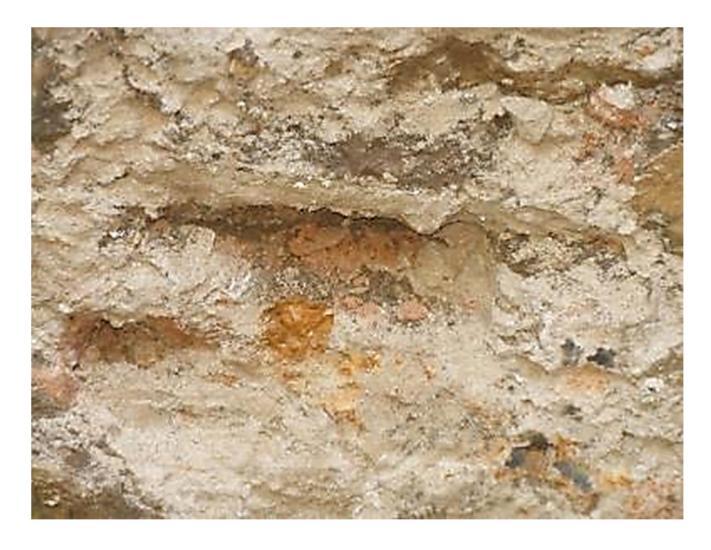
Figure 7. Appearance of the cleaned side surface of the lime concrete foundation.

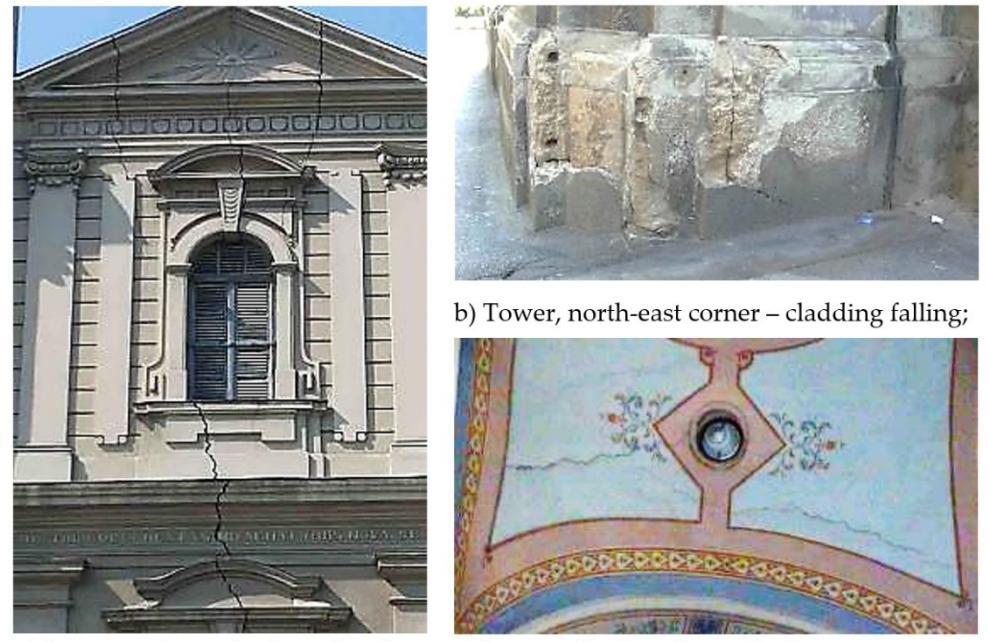
It is interesting to note that, despite the significant damage to the Cathedral (Figure 8) caused by long-lasting and uneven settlements, there are no written traces that geodetic measurements were ever performed in the previous 100 to 150 years. Except for the state markers in the front wall of the south tower, there was no other geodetic markers on the building. Therefore, for the purpose settlements monitoring of the Cathedral, about 30 new geodetic markers were installed in the outer walls and two adjacent ones on old buildings nearby. These geodetic markers form a stable and highly accurate levelling network. In order to analyse the inclination of the towers, in 2016, a geodetic measurement of the verticality of the south wall edges of the south tower and the north wall edges of the north tower was performed (Figure 9), between elevation H = 131 to 136 m. The + *X* axis is in the south direction, and the + *Y* is in the west direction. I1 and I4 are the edges of the south tower, while I2 and I3 are of the north tower [9,10].

a) Large cracks on the front facade;

c) Longitudinal cracks on the first nave vault.

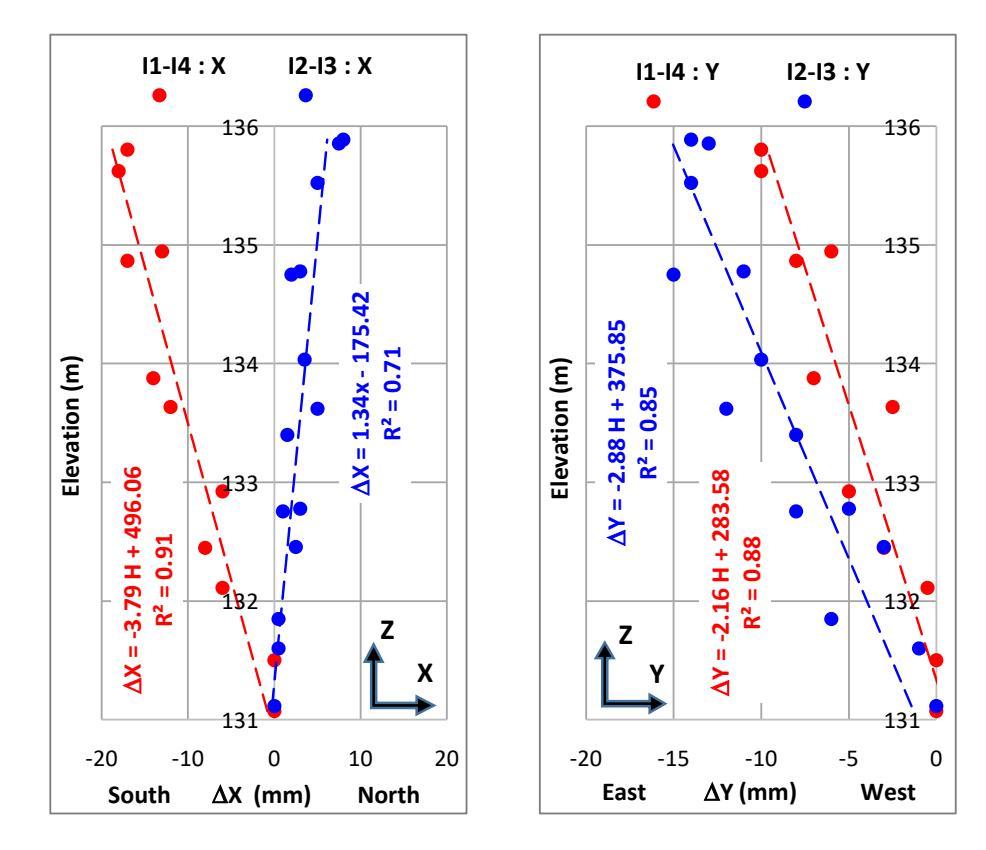
Figure 9. Linear interpolation of observed points on tower lining [9].

Linear interpolation of observed points on the tower edges show the inclination, namely the lining I1–I4 of the south tower to the south by  $\theta_X = 3.79 \text{ mm/m}$ , and the lining I2–I3 of the north tower to the north by  $\theta_X = 1.33 \text{ mm/m}$ , or divergence of 5.12 mm/m. At the same time, both towers lean to the east about  $\theta_Y = 2.16-2.88 \text{ mm/m}$ . At the height of the crown of the frontage wall at 27.0 m (elevation 137.5 m), the spacing of the towers is

about  $\Delta X = 27 \times 0.512 = 13.8$  cm, which is slightly less than 15 cm, which is approximately the sum of the measured cracks width at the crown of the frontage wall.

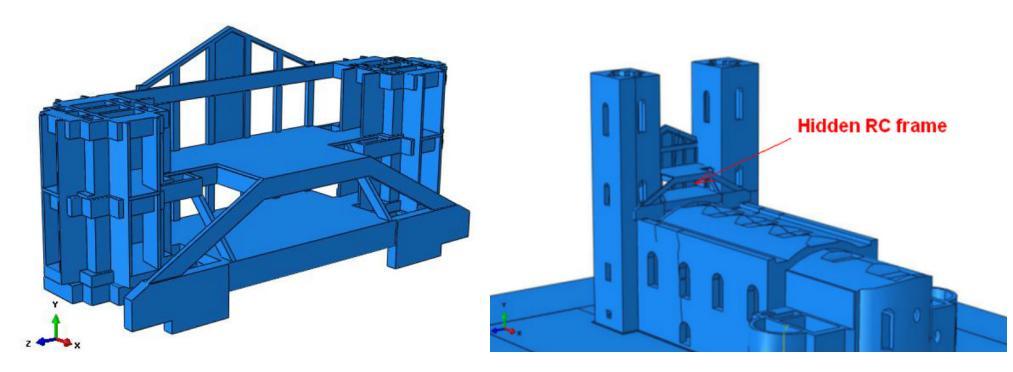
(a) Proposed hidden RC frame-detail;

(b) Location of the proposed RC frame

Figure 18. Proposed RC frame.

The additional (hidden) RC frame was supposed to be joined with the existing masonry by installing a series of anchors. The size of the RC frame, and the dimensions of interaction surfaces, combined with the anchors, was expected to ensure the joint work of the old and the new structure. With additional structural elements, this RC frame can be joined with the nave, therefore utilizing its mass to counteract the eastward tilting of the towers. On the downside, this strategy raises the issue of increased additional weight and increased pressure on the ground. Hawing in mind all the above, it was concluded that this type of tightening must be combined with partial soil reinforcement, to exclude

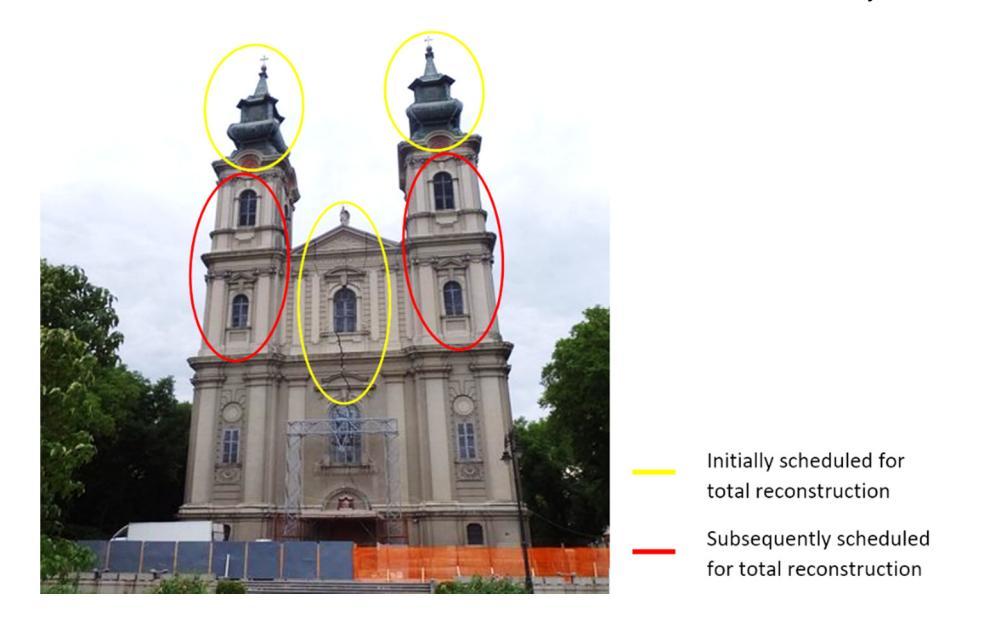
Figure 19. Upper sections of the towers and front façade—proposed total reconstructions.

Following the detail analysis of all the above-mentioned aspects of this problem, an additional proposal was formed that would lead to reduced pressure on the ground, while increasing the overall structural strength. This would have to include a partial dismantling of the upper sections of the towers, which would then be reconstructed with all the necessary strengthening elements and reduced weight—see Figure 19. The initial calculations showed that the pressure reduction would be approximatively 15 to 20%. This solution is also supported by the fact that several large structural elements of the front facade were planned for total reconstruction even before the increased settlements raised the question of the structural stability of the towers, such as: the dilapidated roof structure of the tower and the middle section of the facade wall that currently has extremely large cracks and damages. Additionally, new bell carriers, platforms and internal tower stairways need to be built. The major advantage of this strategy is that it allows for the possibility of unhindered construction of the powerful reinforced concrete frame that would connect the towers themselves, and the towers with the nave of the Cathedral. From a structural point of view, this solution is clean, simple, and durable, it does not require soil reinforcement or the installation of steel ties and anchor blocks, and lastly, it is affordable.

Partial dismantling of the towers, their interconnection and connection to the nave of the Cathedral by means of a powerful reinforced concrete frame, followed by their rebuilding with lighter materials, preserving the current appearance, can solve the problem of cracks in the long run with a radical extension of the service life.

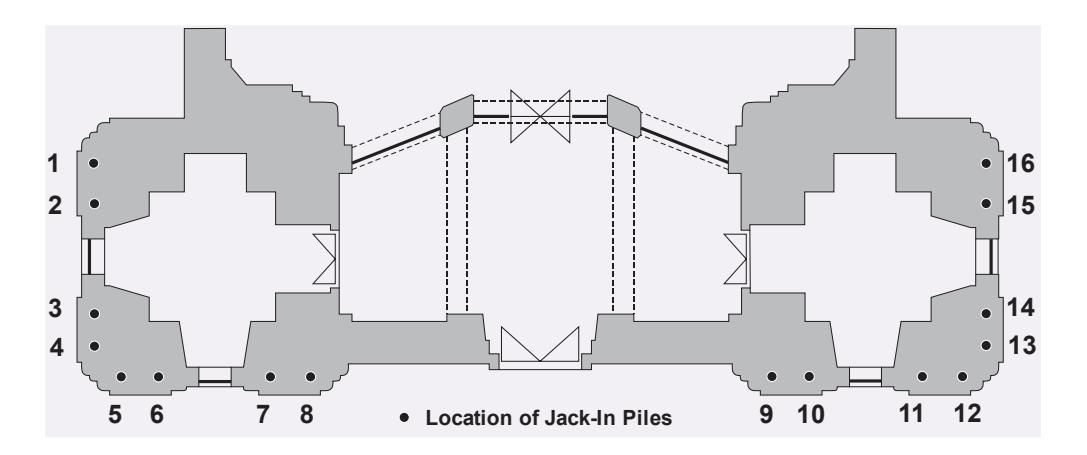
The underlaying idea of strengthening the soil with jacked-in piles was based on improving the bearing capacity of the soil beneath the two outer edges of the tower foundations. The calculation showed that in this way, with a relatively small force in the piles, the angular pressure on the ground could be reduced and thus stop the further tilting of the towers. There were four piles planned along the outer edges of the tower foundation, i.e., a total of eight piles under each tower (Figure 20).

Figure 20. Layout of the piles below the foundations of the towers.

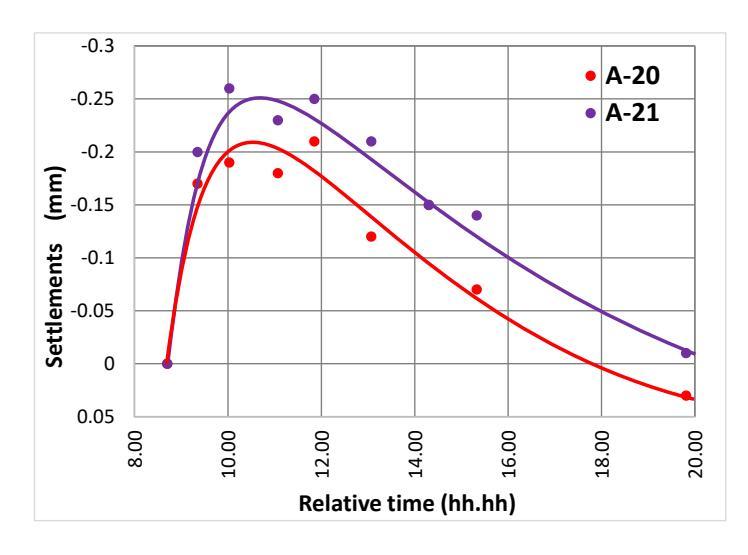
Figure 25. Movements of geodetic markers A-20 and A-21 during and after injection.

The geodetic markers were measured eight times during working hours, and the ninth measurement was on the next day, shortly before the next injection session continued. According to the diagram, the markers showed upward movement that had a peak during the injection of 0.21 to 0.25 mm, but after injection ceased, the markers began to move downward. After 24 h, out of 0.25 mm rise, only 0.01 mm remained on the marker A-21. The marker A-20 showed a downward movement of 0.03 mm, after reaching 0.21 mm of upward movement. Based on the shape of the displacement curve, it can be concluded that, despite the initial rise during injection, both markers eventually have some settlement. Although the individual settlements are very small, when superimposed for each injection point ( $2 \times 92$  points), settlements of 8 to 10 mm were observed. In other words, during and

after polyurethane resins injection, soil with reduced permeability, instead of increasing the soil volume around the injection zone, showed a permanent reduction [15].

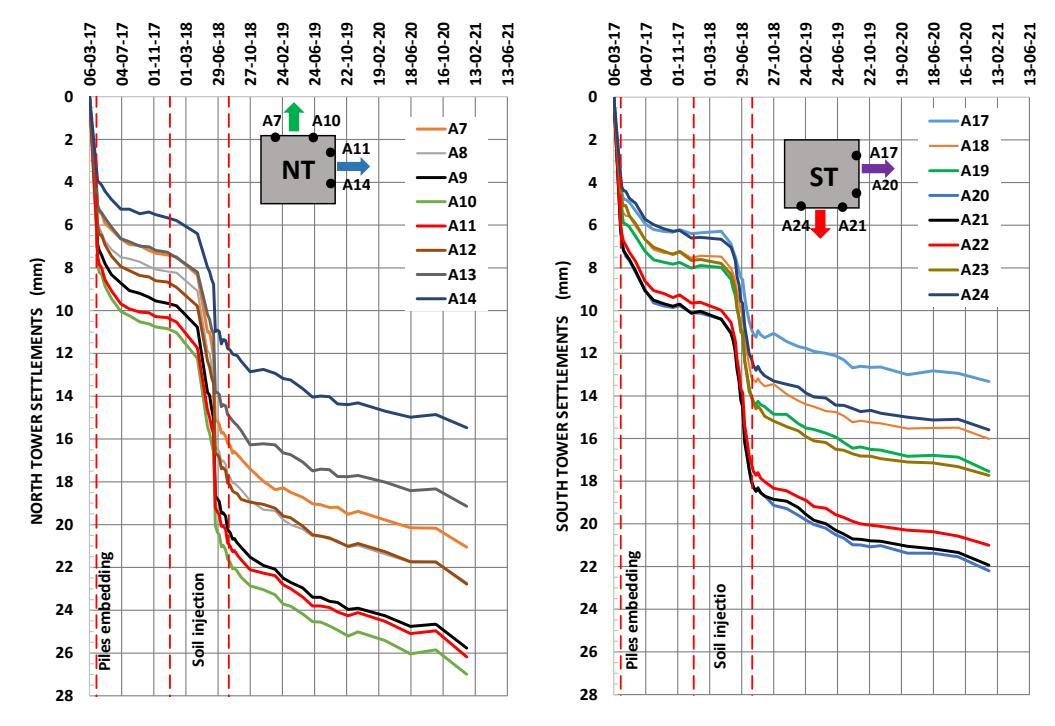
Figure 26. Diagrams of geodetic markers settlement during and after remediation works.

During the installation of the jacked-in piles, the geodetic markers on both towers showed approximately the same level of settlement, 6 to 11 mm. After the soil injection with polyurethane expanding resin was completed, these settlements increased to 11 to 22 mm for the northern, and to 11 to 19 mm for the southern tower. Approximatively 2.5 years after injection, settlements increased by an average of an additional 4 mm for the north tower and 3 mm for the south tower, meaning that neither piles nor grouting stopped the settlements.

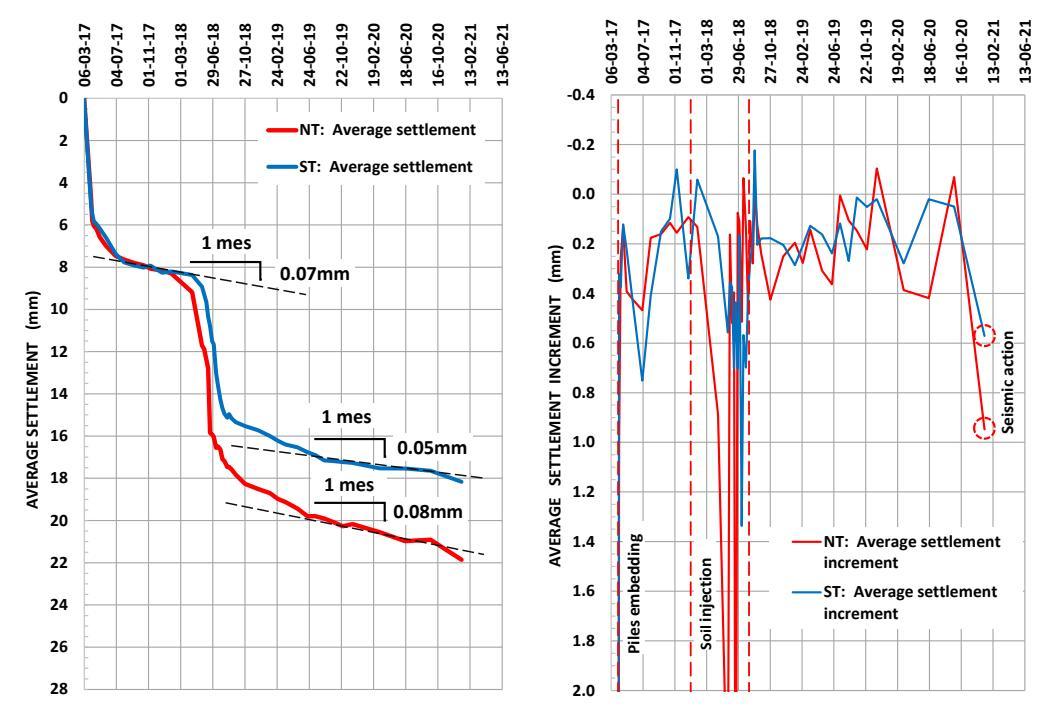
Figure 27 shows the average settlement and the average settlement increment of the geodetic markers. It is evident that, as with the settlements (Figure 26), the average settlements of the northern tower, which was founded at a depth of 2.5 m, are about 4 mm larger than the ones of the southern tower, which is founded at a depth of 3.0 m from the surface around the Cathedral.

Figure 27. Diagrams of average settlement and average increment of settlement.

In order to explain the measured monthly settlement of towers of 0.05 to 0.08 mm/month (Figure 27), it should be noted that the settlement on clay consists of three components: instantaneous settlement, settlement due to primary consolidation and settlement due to secondary compression (creep). Having in mind the construction time, the first two components were completed, so only the settlement due to creep remained. Based on the time required to complete settlement due to primary consolidation of about  $t_{100} = 6.0$  years and the secondary compression index  $C_{\alpha}$  which can be estimated by compressibility index Cc = 0.18, from the oedometric test (Mesri and Godlewski, 1977), the settlement due to creep from 1912 to 2017, or for about 105 years, is:
