Article Measuring Displacement before and after Repair on Korean Wooden Built Heritage: Records for Authenticity and Sustainability

In this study, the displacement of the Sungryeoljeon Shrine in Namhansanseong, the object of this study, was measured before and after its repair from 2017 to 2019. Subsequently, the displacements were measured again in 2023 to determine what changes had occurred since the repair. Accordingly, Section 2 examined the value of the Sungryeoljeon Shrine in Namhansanseong, a site inscribed on the UNESCO World Heritage List, and described how the displacement could be measured using a 3D scanner. Section 3 considered the Shrine Dismantling and Repair Report as a record of the repair of the Sungryeoljeon Shrine. Section 4 analyzed and interpreted the displacement measurement data using 3D scanning from 2017 to 2023.

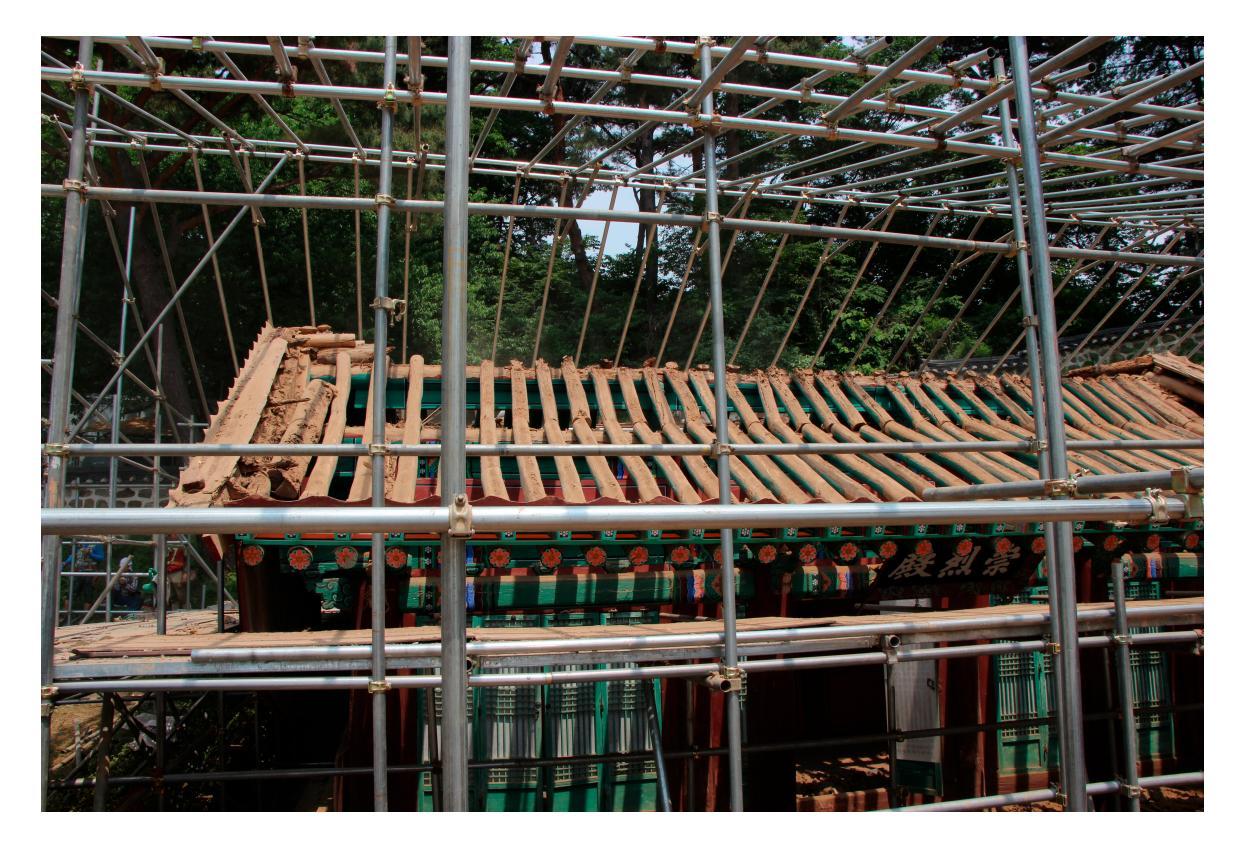
Figure 5. Sungryeoljeon roof dismantling work. Source: authors.

During the repair, the damaged members were replaced with the same type of wood, pine, while attempting to preserve the existing members as much as possible. As the replaced members were new, attempts were made to ensure that they were recognized naturally. Additionally, we tried to use traditional methods as much as possible by trimming the members in the same way. Details were created by trimming the members by hand to more precisely combine the old and new members without damaging the existing ones. Consequently, it can be stated that the construction process implemented the concepts of

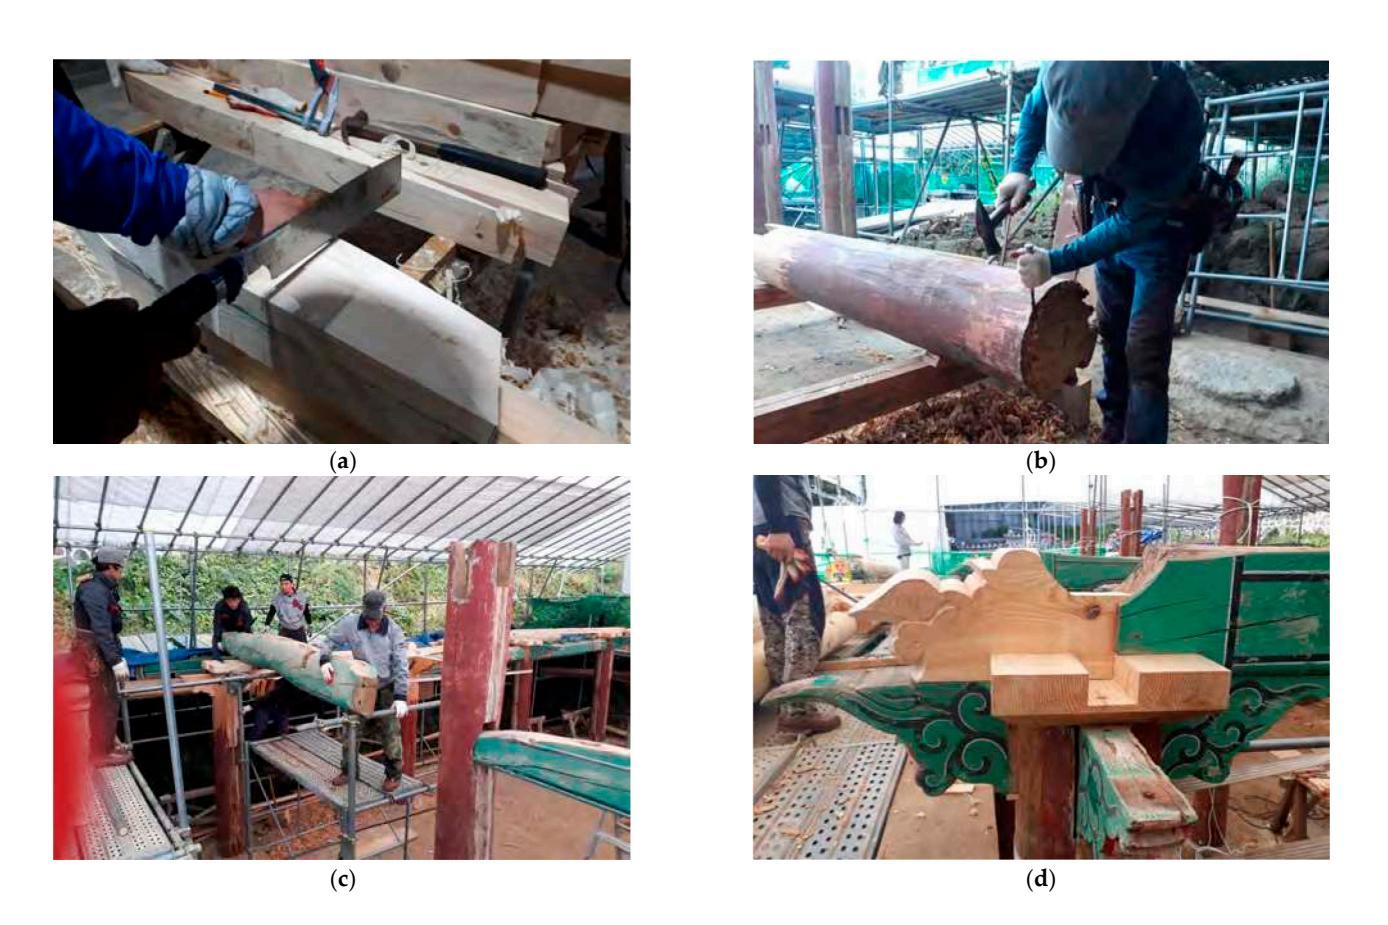
Figure 6. Repair work process using traditional methods; (a) Cutting wooden member; (b) Trimming the bottom of the column; (c) Assembling of wooden member; (d) Assembling of new and old members Source: repair report (open source).

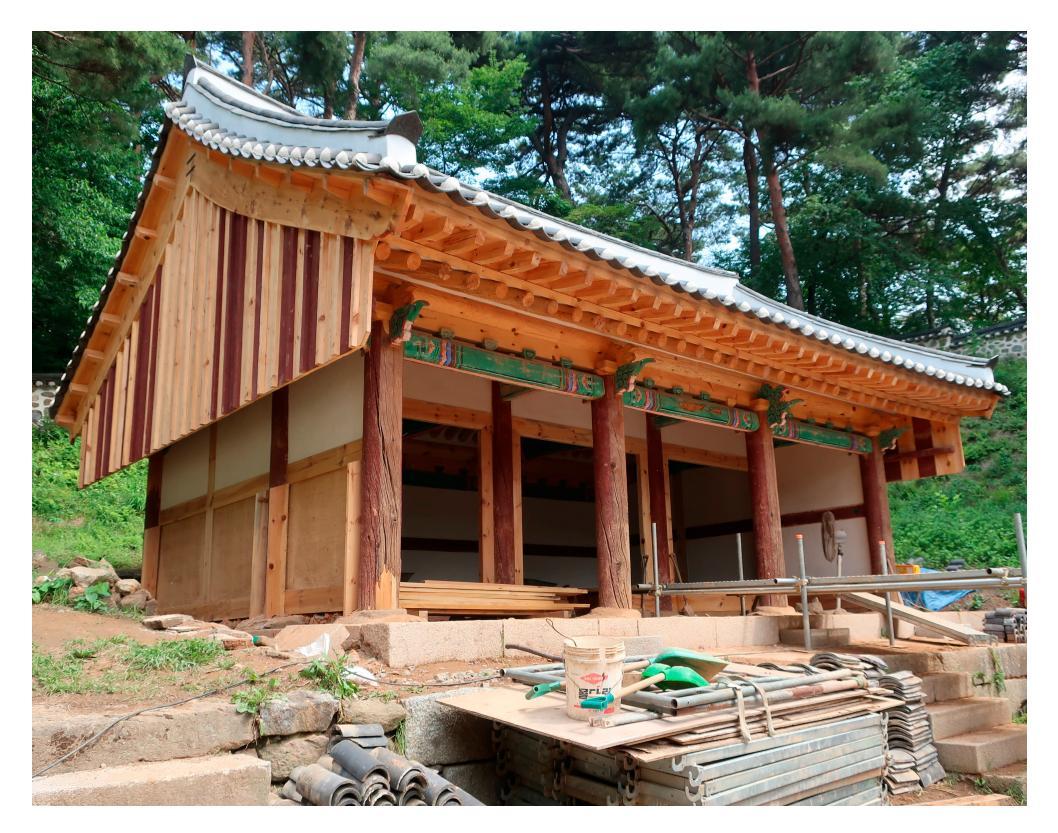
Figure 7. Sungryeoljeon assembly work. Source: authors.

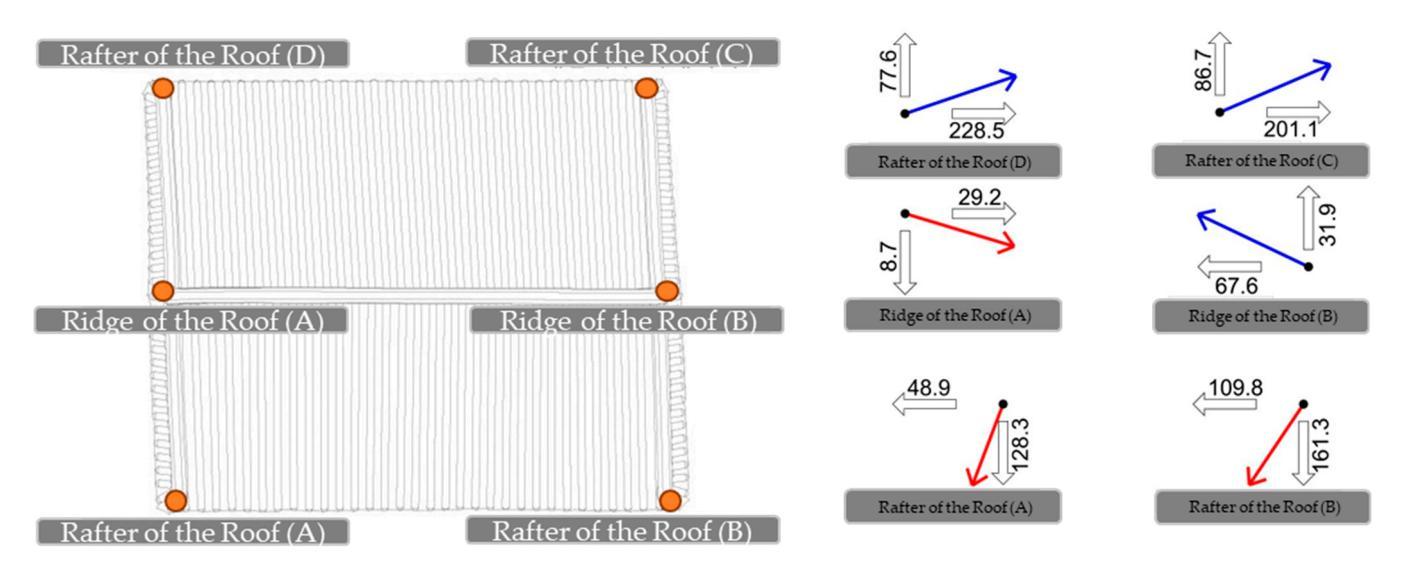
Table 5 presents displacement after and before repair and Figure 10 presents detailed view Maksae roof tile displacement after and before repair. The Maksae roof tile along ridge A exhibited a displacement of plus value on the X-axis and minus value on the Y-axis. Conversely, the Maksae roof tile along ridge B exhibited a displacement of minus value on the X-axis and plus value on the Y-axis. This indicated that the entire ridge of the roof had undergone warping and had been repaired. Along the Z-axis, it was evident that the Maksae roof tile along ridge A had been elevated by 334.2 mm and the Maksae roof tile along ridge B had been raised by 252.8 mm, resulting in an overall increase in roof height. Both Maksae roof tiles along ridges A and B displayed relatively large displacement values.

By observing the Maksae roof tiles along the rafters, it was evident that Maksae roof tiles along rafters A and B had minus values in both the X- and Y-axes. Conversely, Maksae roof tiles along rafters C and D had plus values in both the X- and Y-axes. Notably, the variation values were large, reaching up to 228.5 mm. It could be concluded that the rafters of the roof had been repaired where warping had occurred. This, combined with the change in the Maksae roof tile along the ridge, suggested that the entire warp of the roof had been addressed and repaired. The Z-values of the Maksae roof tiles along the rafters indicated that the end of the Maksae roof tile along rafter B, which was particularly low, was raised by 219.5 mm. The Z-values of the remaining rafters of the roof had displacement values ranging from -17.4 mm to 69.2 mm, indicating that the Maksae roof tile along rafter B had settled down and had been repaired.

However, the Z-value of the Maksae roof tile along the ridge was significantly smaller than the rise or had a minus value, indicating a partial change in the shape of the roof, implying that the roof had grown in length.

As a result, the displacement of the Maksae roof tiles along the ridge and rafter indicated that the previously warped section had been repaired and the roof had been installed larger than it was before the repair.

Figure 10. Detailed view of Sungryeoljeon Maksae roof tile displacement (after and before repair). Note \rightarrow : South (front), \leftarrow : North (back) Blue and red arrows indicated the overall direction of displacement. Source: authors.

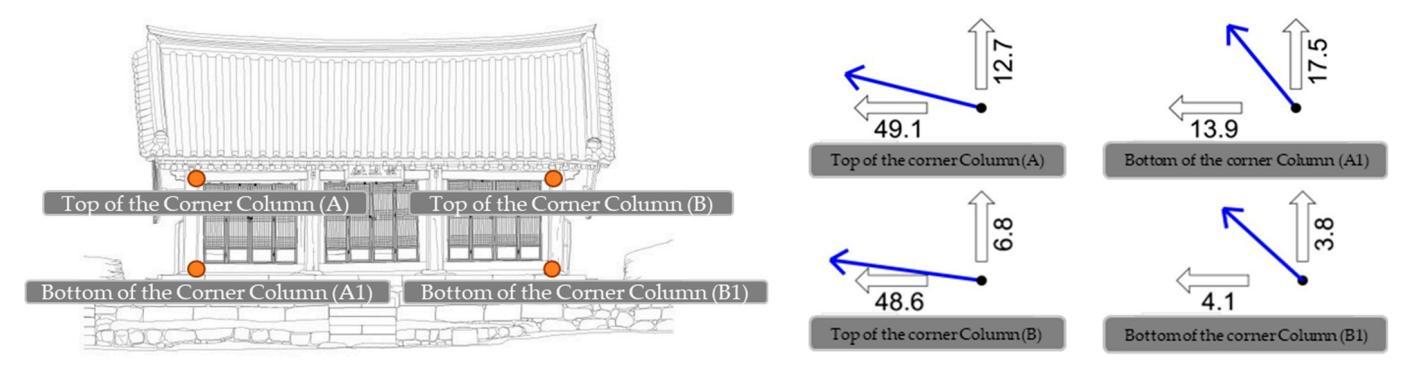
Figures 11–13 present detail displacement of corner column after and before repair. The examination of the corner columns' displacement values provided several insights by analyzing the top and bottom of a single member. First, the change in the X- and Y-axes values at the bottom of the column indicated that the position of the column had changed, suggesting that the column row had been repaired. The corner column C was shifted 93.1 mm on the X-axis and 13.2 mm on the Y-axis, which was the most significant change in the position of the column. Second, the upper part of the column was adjusted to compensate for the tilt of the lower part. Therefore, corner columns A and B were considered tilted due to the large change in position between the top and bottom, indicating that they had been repaired. Conversely, corner columns C and D exhibited similar position changes at the top and bottom, indicating that they had undergone lateral movement rather than tilting. Third, examining the height change of the corner columns revealed that corner column C was 76.9 mm lower, while corner column D was 90.3 mm higher. This indicated that the height of the columns was adjusted during the repair. Regarding the length of the columns, corner columns C and D were shorter, while corner columns A and B were nearly identical. In summary, corner column C exhibited the largest displacement, followed by corner column D.

Figure 11. Front corner column displacement detail of Sungryeoljeon (after and before repair). Blue and red arrows indicated the overall direction of displacement. Source: authors.

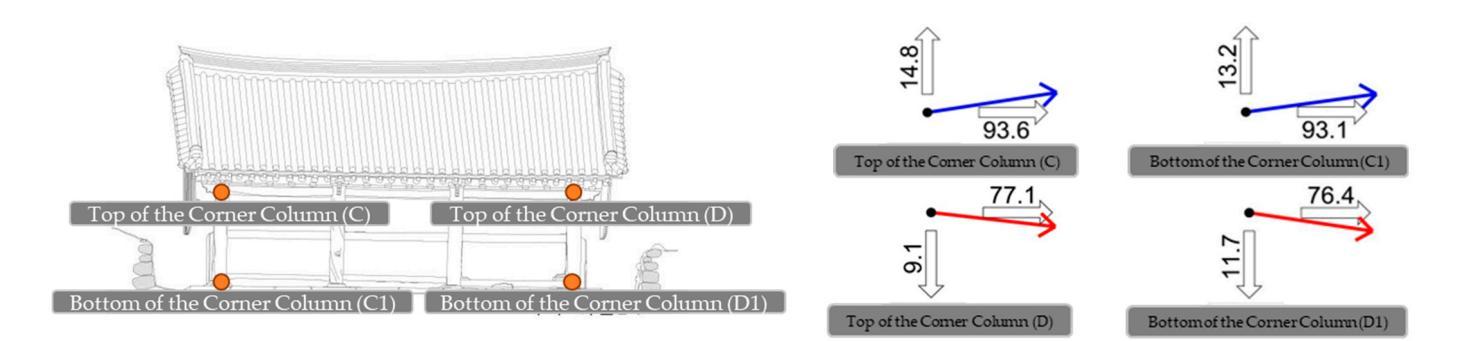
Figure 12. Rear corner column displacement detail of Sungryeoljeon (after and before repair). Blue and red arrows indicated the overall direction of displacement. Source: authors.

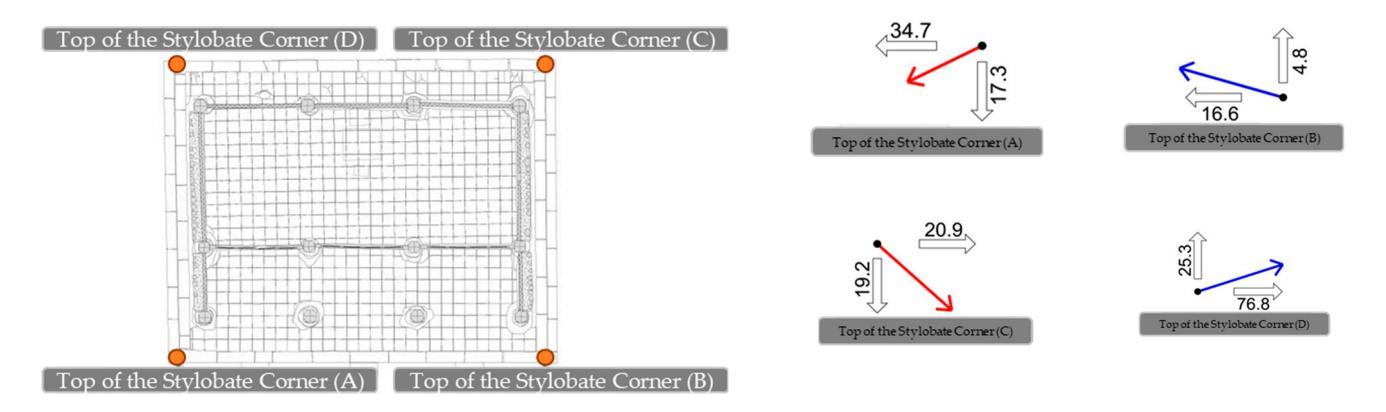
Figure 13. Detailed view of Sungryeoljeon top of the Stylobate corner displacement (displacement before and after repair) Blue and red arrows indicated the overall direction of displacement. Source: authors.

The top of the stylobate corner showed a significant change in corner D at 84.8 mm, while the remaining upper stylobate corners exhibited similar changes of approximately 60 mm. Notably, an overall decrease in the height of the top of the stylobate corner was observed (Figure 13).

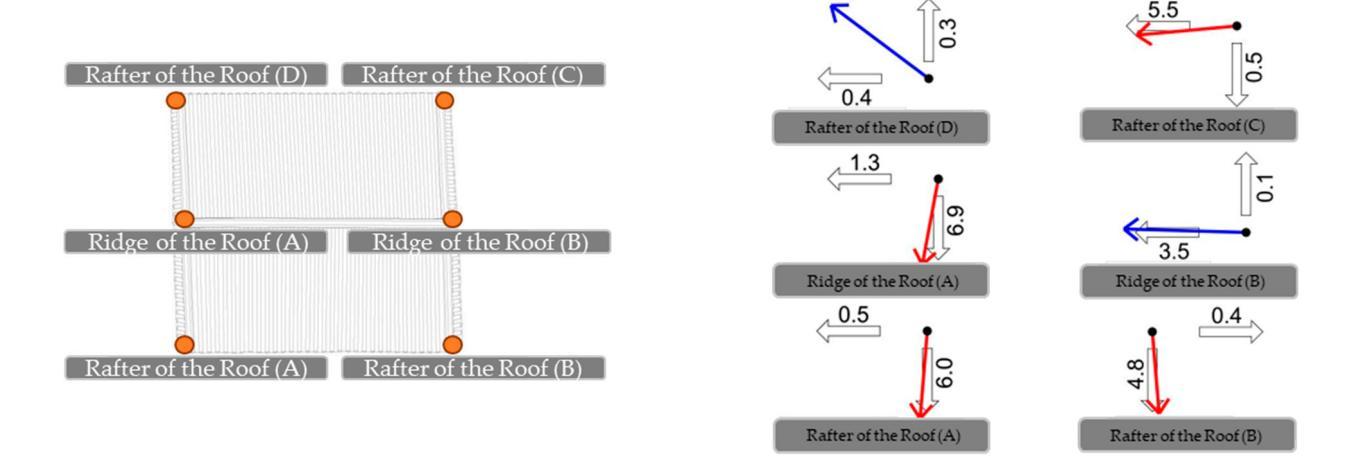
Figure 14. Detailed view of Sungryeoljeon Maksae roof tile displacement (displacement before and after repair) Blue and red arrows indicated the overall direction of displacement. Source: authors.

Upon closer examination, the most significant displacement was observed at the edge of the Maksae roof tile along the ridge and along the rafter, the outermost components of Korean wooden built cultural properties. Displacements in this area ranged from 2.6 mm to 9.6 mm. Considering that these are the outermost parts of the structure, the notable displacement was within an expected range. In contrast, the stylobate exhibited the smallest displacement. This pattern of smaller displacement in the stylobate compared to the outermost sections was consistent with a predictable change trend.

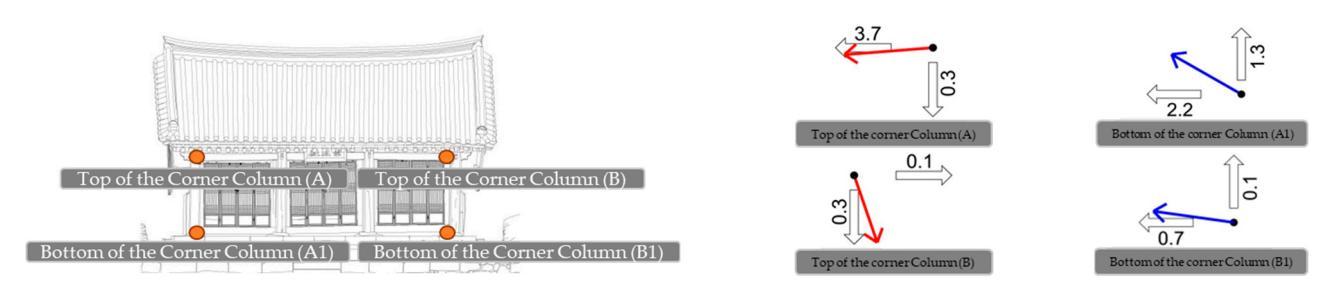
Figure 15. Detailed view of Sungryeoljeon front corner column displacement (current displacement and after repair) Blue and red arrows indicated the overall direction of displacement. Source: authors.

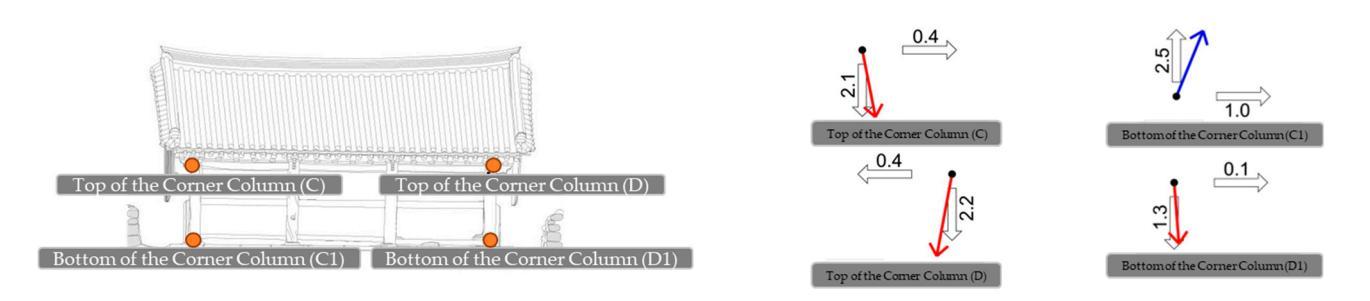
Figure 16. Detailed view of Sungryeoljeon rear corner column displacement (current displacement and after repair) Blue and red arrows indicated the overall direction of displacement. Source: authors.

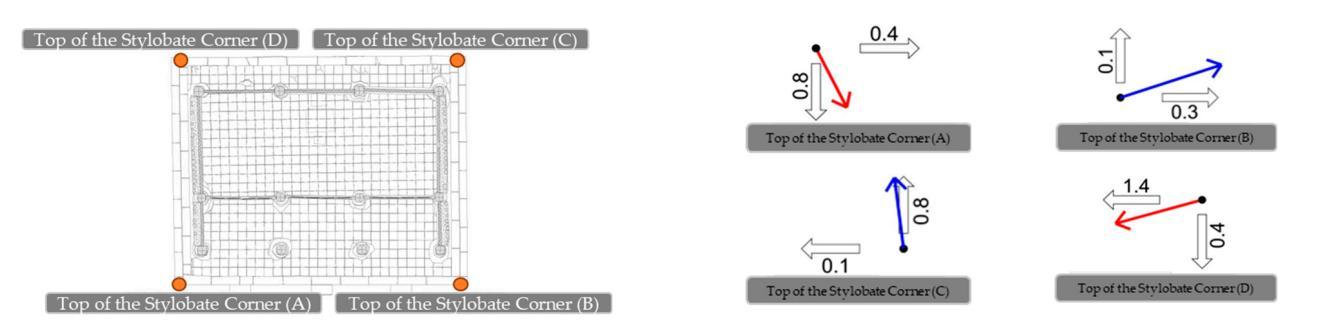
Figure 17. Detailed view of Sungryeoljeon top of the stylobate corner displacement (current displacement and after repair) Blue and red arrows indicated the overall direction of displacement. Source: authors.
