Article

Hydraulic Structures as a Key Component of Sustainable Water Management at the Catchment Scale—Case Study of the Rgilewka River (Central Poland)

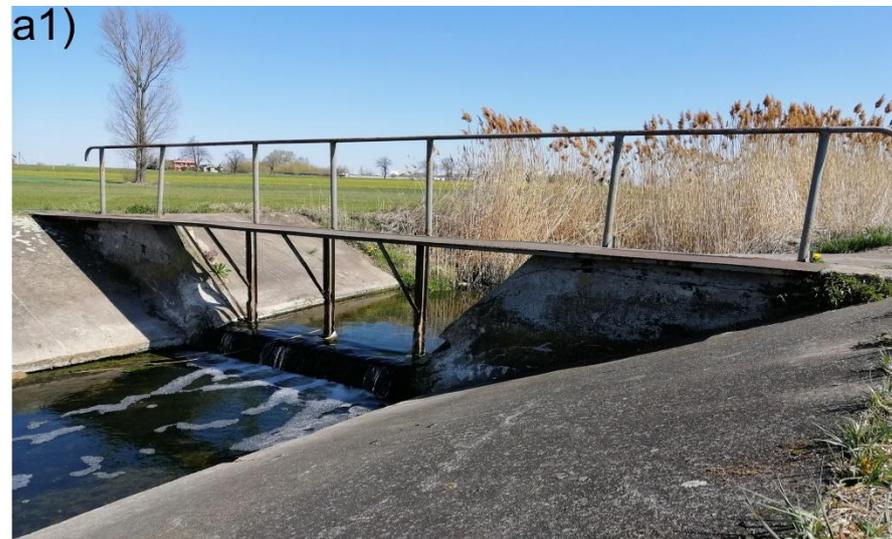
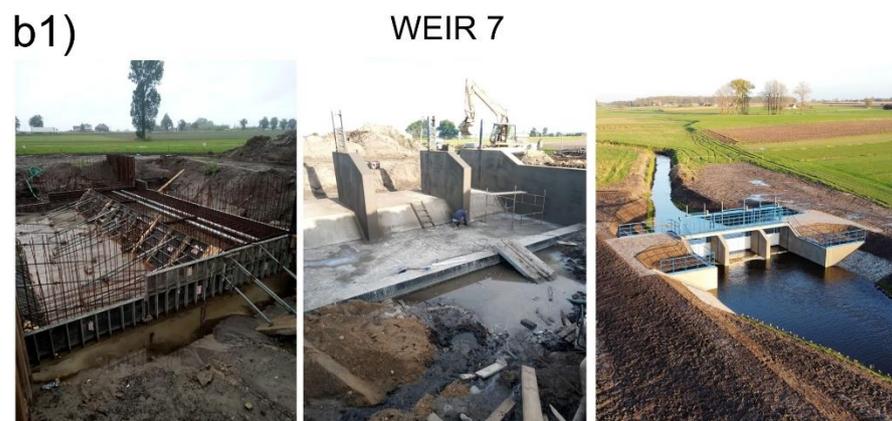
Figure 3. Example reconstruction of weirs (weir No. 7 and weir No. 9) on the Rgilewka River: (a1,a2) original state, (b1,b2) present state, and (c1,c3) longitudinal cross-section (source: [20]—changed).

In the second decade of the 21st century, the hydrotechnical infrastructure of the Rgilewka River was largely rebuilt. It involved modernisation of seven old weirs, and construction of two new ones. All of them took shape of reinforced concrete gate weirs with locks in the form of a two-part steel gate valve driven by a manual lifting mechanism. Depending on the width of the river bed and the amount of water that the river can carry, the weirs feature 3-, 4- or 5-span structures with a total clearance of 10–12 m. Each weir has concrete abutments and pillars, a concrete sill, and a bottom plate of the profiled basin.

A reinforced concrete footbridge with a thickness of $T = 20$ cm and a width of $W = 120$ cm was set on the pillars and bridgeheads. For the safety of users, steel barriers made of pipes were installed on the abutments, wings, and the working footbridge. The underground surfaces of the structures were covered with an insulating preparation based on bituminous masses. The air-vent and drain surfaces were protected with a two-component hydro-insulating mortar based on cement and polymer dispersion. The wings of the weirs are caps on steel sheet piles from profiles (sheet piles) for protection against filtration from the upper and lower waterside. The crown of the wings abutments and pillars was designed on an ordinate elevated above the natural banks of the Rgilewka River by more than 1 m. To enable the control of water stages/levels and subsidence of the structure, water level gauges and benchmarks were installed on each structure. Additionally, markers indicating damming levels were installed on the weirs. Weir closures are equipped with manual lifting mechanisms with a mandrel suitable for mounting both a river wheel for manual operation and an electric key.

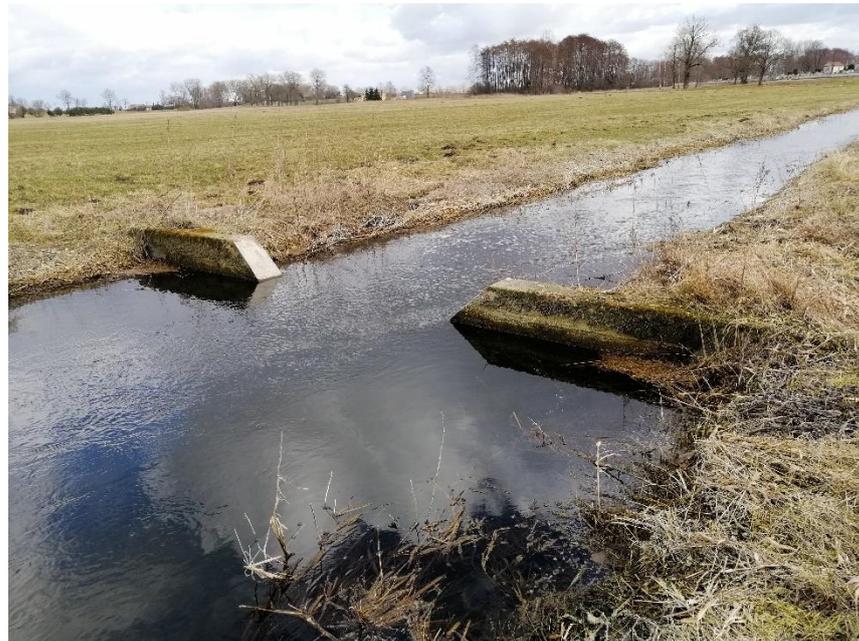
Figure 4. Concrete threshold No. D on the Rgilewka River at km 31 + 118 (author of the photo: Bartosz Rygas).
