Investigation of Disc Cutter Wear in Tunnel-Boring Machines (TBMs): Integration of Photogrammetry, Measurement with a Caliper, Weighing, and Macroscopic Visual Inspection

Blaž Janc, Goran Vižintin *

Citation: Janc, B.; Vižintin, G.; Pal, A. Investigation of Disc Cutter Wear in Tunnel-Boring Machines (TBMs): Integration of Photogrammetry, Measurement with a Caliper, Weighing, and Macroscopic Visual Inspection. *Appl. Sci.* **2024**, *14*, 2443. <https://doi.org/10.3390/app14062443>

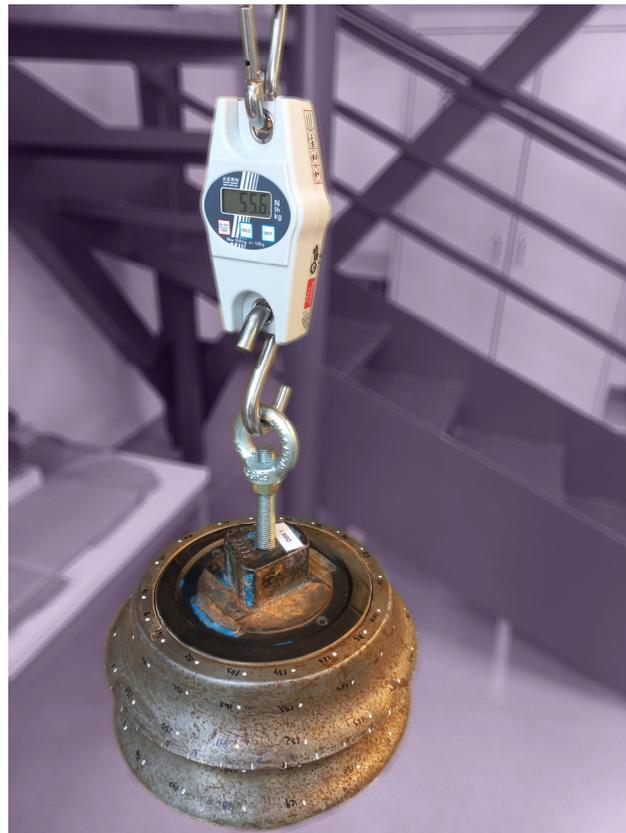
Figure 6. Weighing the worn disc cutter using a digital hanging scale.

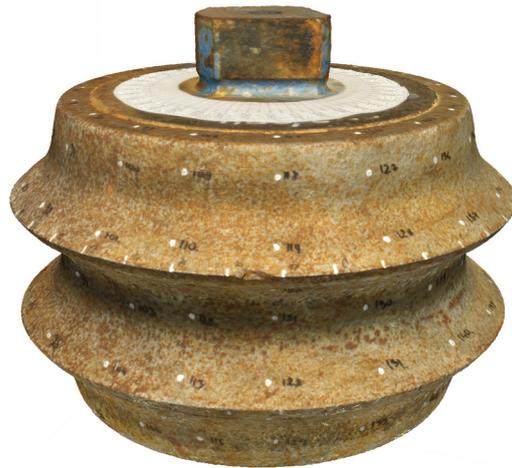
Figure 13. A 3D model of a worn disc cutter, created in Agisoft Metashape 1.6.3 software.

A dense point cloud with 47,742,682 points was created by processing 396 photos, 16 selected reference points (visible in all camera positions), and 129 control points. The resulting 3D model consisted of a mesh with 9,548,536 faces and 4,775,132 vertices, as shown in Figure 13. The calculated RMS (Root Mean Square) reprojection error of 0.0802754 (0.538642 pixels) shows a precise alignment between the reconstructed 3D points and their corresponding 2D positions in the images and confirms the high quality and accuracy of the reconstruction.
