UAV Monitoring of Stream Restorations

Jakub Langhammer

Abstract: This study examines the potential and limits of the unmanned aerial vehicles (UAVs) applicability for the monitoring of stream restoration in an urban environment. UAV imaging was used for long-term post-restoration monitoring of an urban stream. The monitoring was aimed to track the stream changes significant for the assessment of the restoration success, such as the compliance of the restoration to the plan, stability and evolution of the stream channel, or changes in stream and riparian habitats. The recurrent imaging campaigns in the restored segment of Hostavický brook in Prague, The Czech Republic, were undertaken for three years since the restoration using the DJI Inspire 1 Pro platform. The UAV monitoring revealed that the new stream pattern substantially differs from the proposed restoration plan. Despite this, the new channel has proved stability, supported by intense grassing of the floodplain, resulting in only marginal evolution of the restored channel. The new channel proved the ability to mitigate the course of a significant flood event without significant flood spills outside the riparian zone. The U

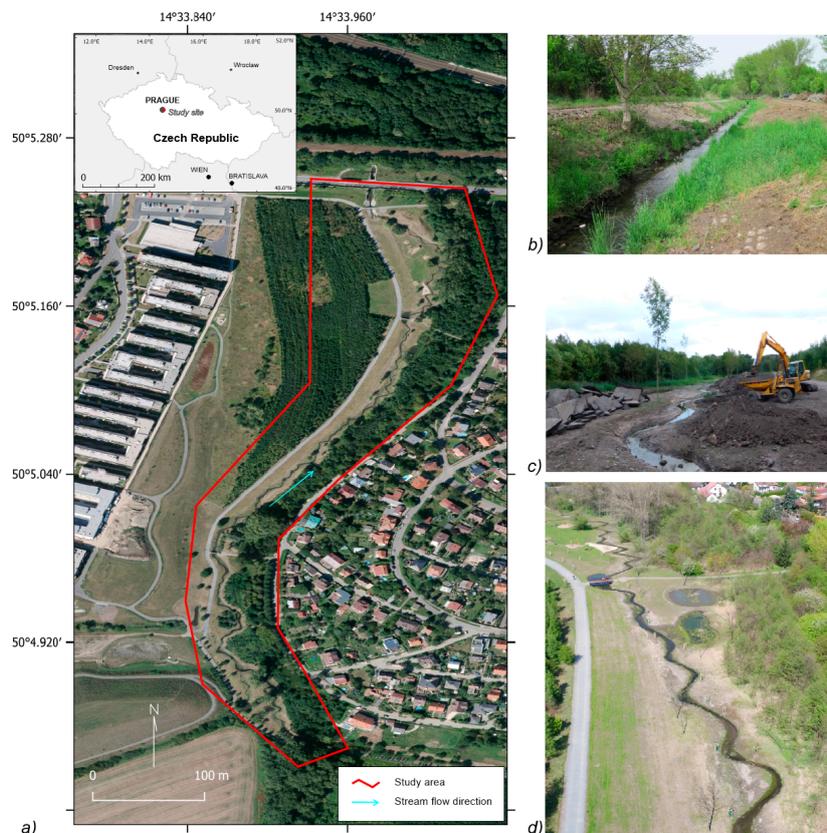
Figure 1. Study area of Hostavický brook, Prague. (a) Map of the study area, (b) stream channel prior to restoration, (c) stream restoration works on the channel, (d) aerial view of the stream one year after restoration. Photo by J. Langhammer.

The study area of Hostavický brook in Prague is a 1 km long segment of the stream in an urbanized area that underwent a complex restoration in 2015 (Figure 1). The assessed stream is located in the north-eastern boundary of the Prague metropolitan area, in a zone between the old housing and new development area. The stream was channelized in the 1980s during construction of the new road and highway infrastructure in the area. For three decades, the study area was an abandoned zone of the sub-urban “new wilderness” [30,31], featuring a spontaneous succession of vegetation over the former agricultural land without management. In consequence of development of new residential complexes, the City of Prague in 2015 realized a project of a complex revitalization of the area, aimed not only to the restoration of the meandering system of the stream, but also to build the recreational infrastructure for the public, including the cycle route, playgrounds, and park [32]. The key elements of the restoration of Hostavický brook, the stream corridor, and ponds were finished in November 2015. The whole complex of restoration works, including the grassing of the riparian zone and planting of trees stabilizing the newly built channel, was opened in spring 2016.

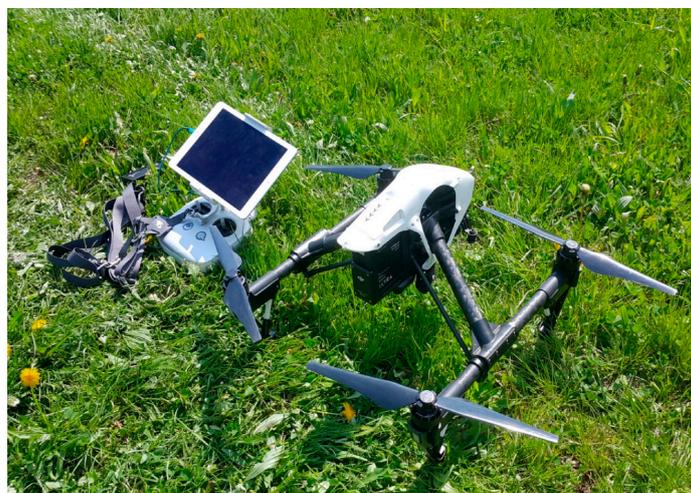
Figure 2. UAV platform DJI Inspire 1 Pro, used for monitoring campaigns. Photo by J. Langhammer.

The Inspire 1 Pro platform (Figure 2), used for the imaging since November 2015, is driven by four propellers, enabling a flight of a length of 15–22 min, according to the payload. The maximum distance of the control system is 2 km, the physical maximum altitude of 1 km [34] is, in practice, limited by the legislation regulations, limiting drone traffic at a level under 300 m above ground. The control system of the drone also allows, besides the manual control, the flying of pre-programmed routes, which was used for the recurrent imaging campaigns. The platform was equipped with the DJI Zenmuse X5 camera (cDJI, Shenzhen, China) with interchangeable lenses, equipped for this study with the 12 mm Zuiko prime lens (Olympus, Tokyo, Japan) with 84° field of view (FOV), 24 mm equivalent in 35 mm system, and with a Zenmuse X3 camera (DJI, Shenzhen, China), featuring a fixed lens with focal length 3.6 mm (94° FOV, 20 mm equivalent in 35 mm system). The X5 camera has a 17.3 × 13.0 mm CMOS sensor of micro 4/3 standard, featuring a resolution of 4608 × 3456 pixels (16 Mpix), capturing in Red, Green and Blue (RGB) spectral bands. The X3 camera features a Sony EXMOR 1/2.3" CMOS chip (Sony, Tokyo, Japan) with a resolution of 4000 × 3000 pixels [34]. The DJI Phantom Vision plus, used for the first two campaigns, is a multirotor platform, equipped with a 14 Mpx panchromatic camera with a resolution of 4384 × 3288 pixels and a fixed lens with 5 mm of focal length and 110° FOV, equivalent to 18 mm for 35 mm system [35].

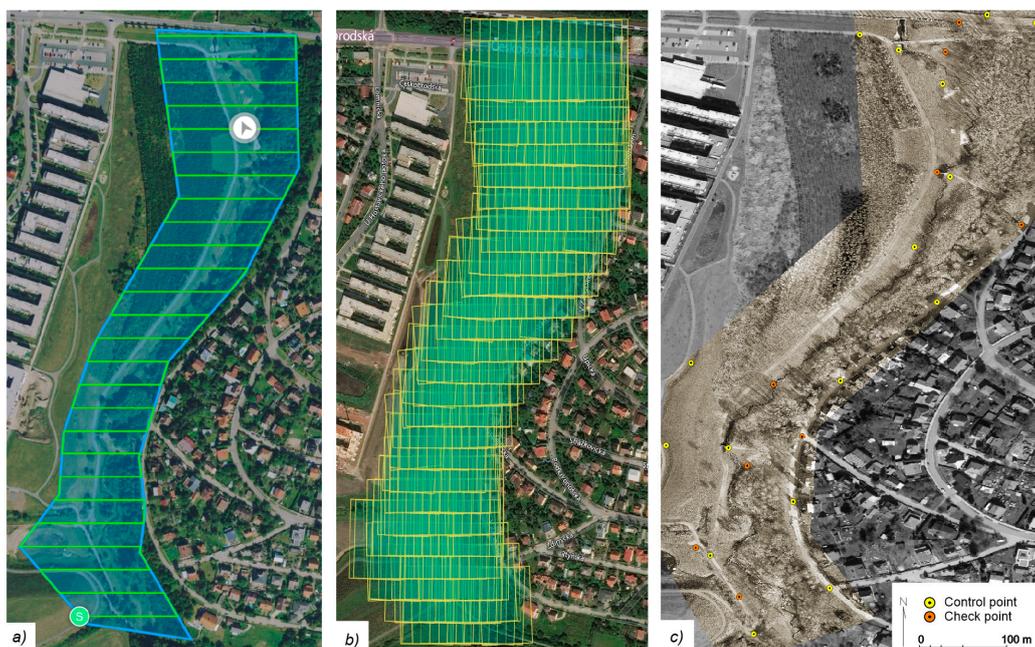
Figure 3. UAV imaging campaign. (a) Flight route planning. Screenshot from GroundStation Pro software. The green mark represents the start-point of imaging; at the upper end of the stream segment, the green line represents the flight track and the grey arrow mark indicates the take-off position of the drone. (b) Location, coverage, and overlaps of the 292 images, resulting from the flight track, used for the photogrammetric analysis. (c) Distribution of control and check points in the study area.

For georeferencing, 26 ground control points (GCPs) were used. The control points were defined at the stable structures of the urban environment, which are apparent in the imagery and have geodetically surveyed position available from the digital city plans, such as sewer lids, edges of buildings, or concrete structures (Figure 3c). From the total of 26 GCPs, 15 were used as control points for georeferencing and 9 as checkpoints to validate the accuracy of photogrammetric processing. Mean differences in x and y coordinates at the checkpoints typically reached 1.5–3.5 cm, while the maximum differences, observed at the outer parts of the scene, did not exceed 10 cm.

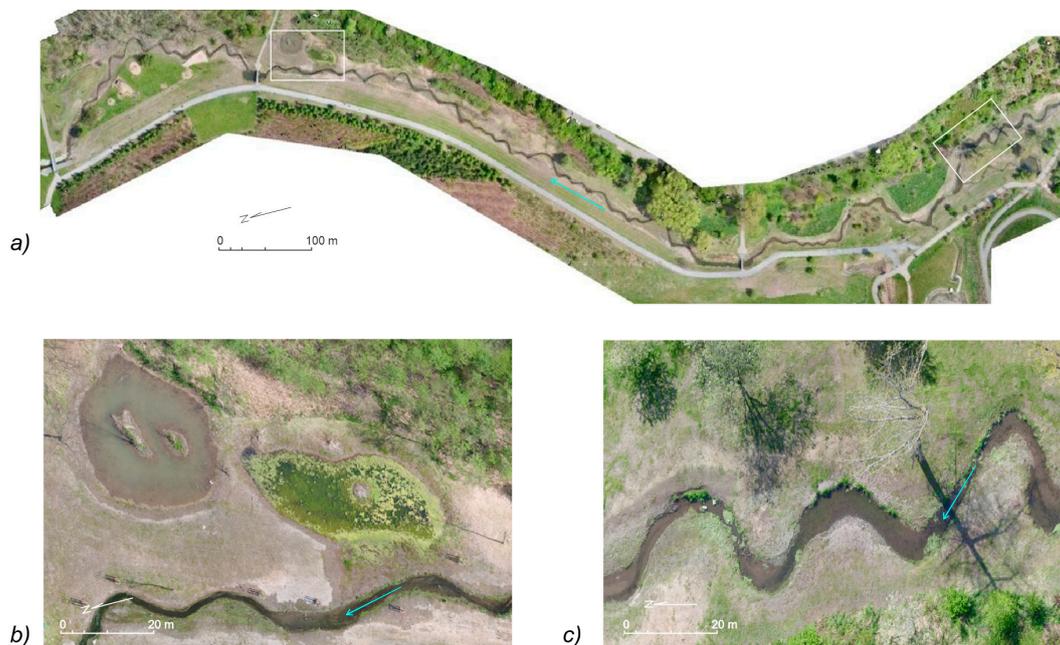
Figure 4. Orthoimagery of Hostavicky brook from June 2016. (a) Overview of the study site, (b) detailed view of the newly built ponds, (c) detailed view of the newly designed meanders of the stream.

All indices were calculated for three states of the stream system—prior restoration, restoration plan, and realized restoration. The status prior stream restoration and of the restoration plan were acquired as vector geodatabase [32] and the status of realized restoration was derived by the vectorization of the UAV orthoimagery. As the reference post-restoration status, the imaging campaign from April 2017 was selected, reflecting the stabilized channel after cca 1.5 years since the restoration completion. The spring imagery was selected as suitable for capturing the stream properties in the off-vegetation season, enabling the display of the possible maximum of the stream and floodplain features (Figure 4).

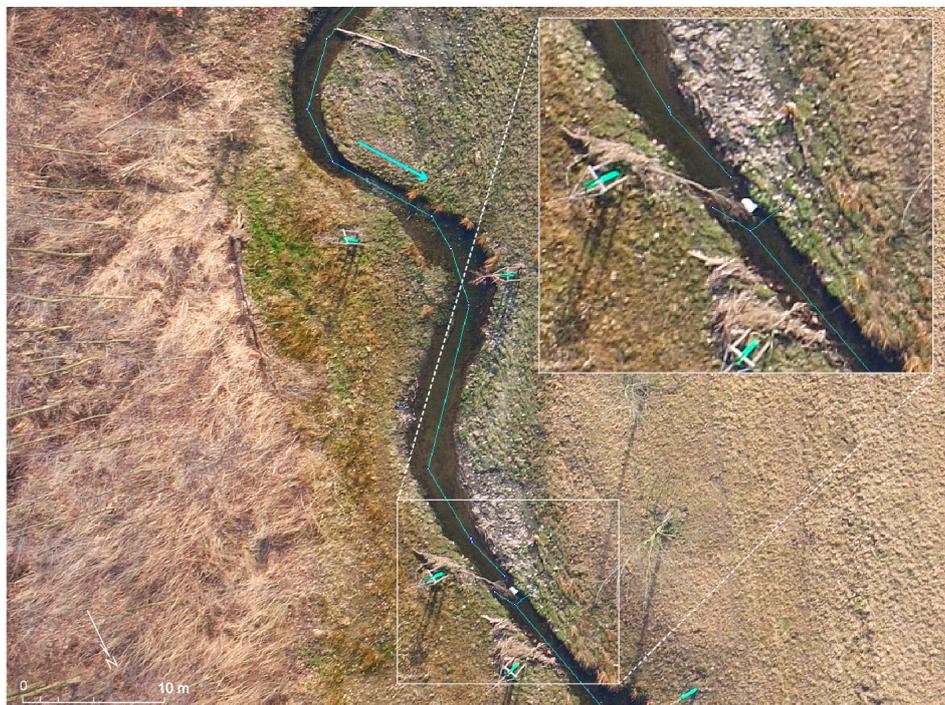
Figure 5. Automated delineation of the stream centerline using Vextractor tool with a detail of the interruption of the line at the location of in-stream obstacle.

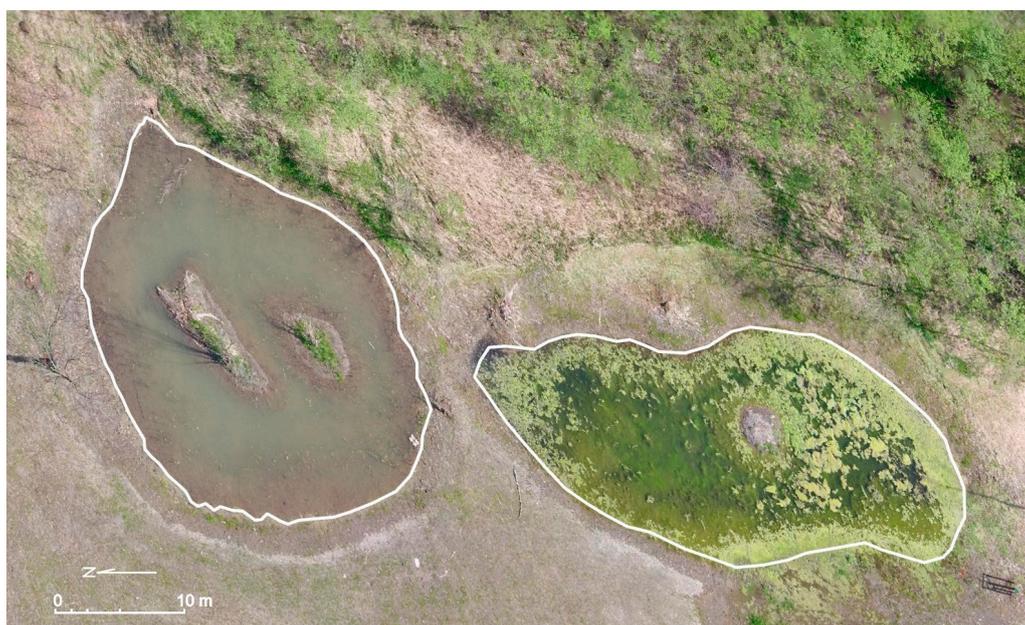
Figure 6. The newly created ponds in riparian zone, left without hydrological connection, featuring eutrophication. Orthoimage from 30 April 2016.

In this study site, the progress of overgrowing and eutrophication in the newly created ponds was tracked based on the UAV imagery. The newly built ponds in the floodplain of Hostavický brook became subject to spontaneous overgrowing and eutrophication processes since the restoration completion (Figure 6).

maximum, mean, and quartile values were calculated for the area under the mask of the extent newly built ponds (Figure 6). Calculation of indices as well as the grid statistics was done using the SAGA GIS grid calculator and grid statistics tools.

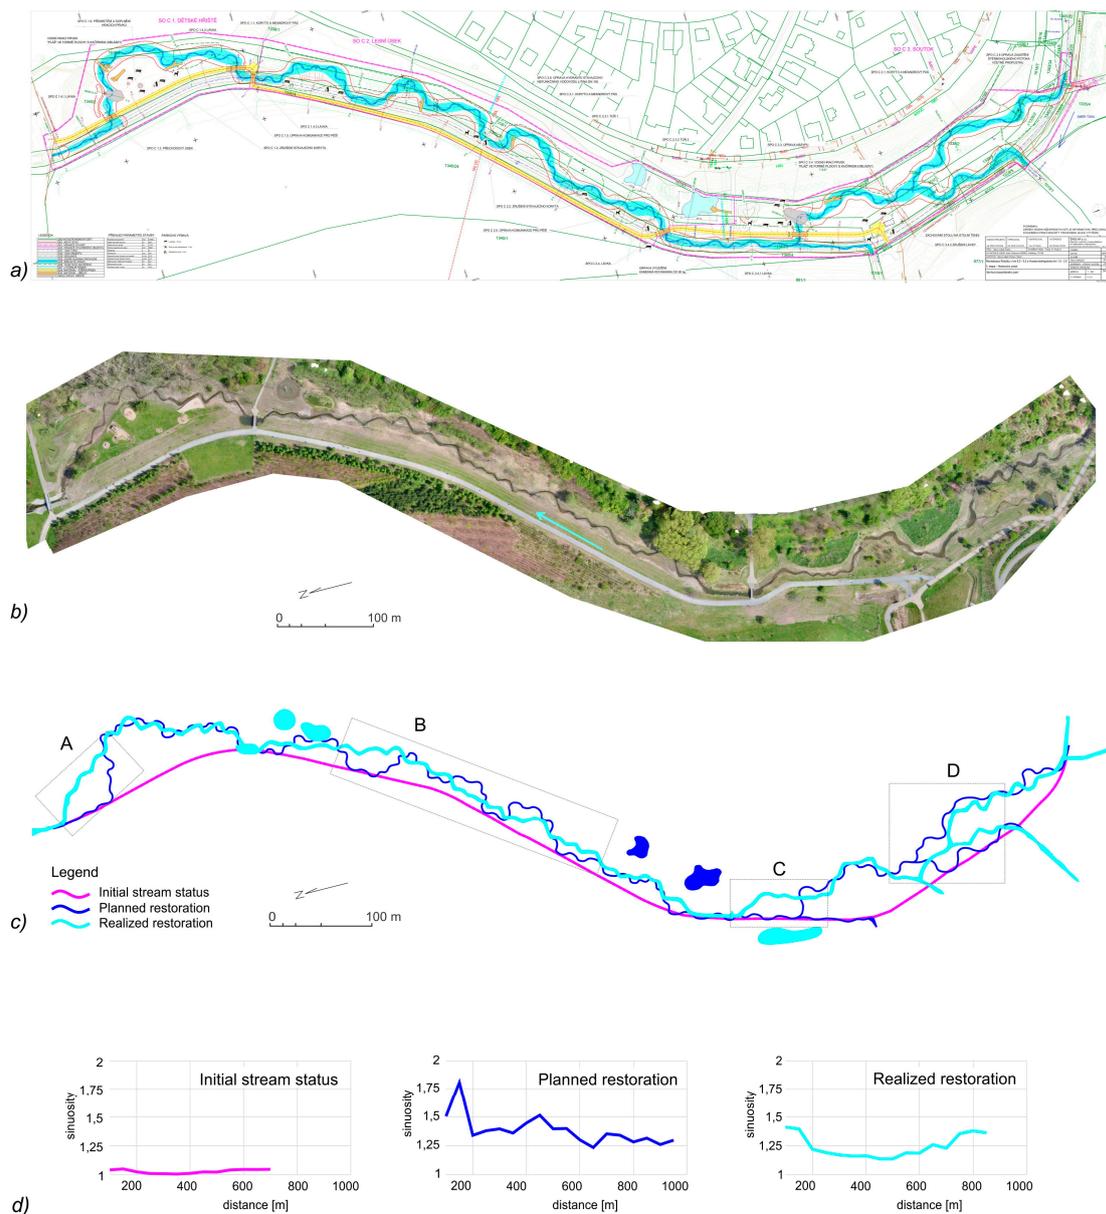
Figure 7. Fit of the resulting stream restoration to the plan. (a) Initial status and plan of the restoration, (b) newly shaped channel, six months after restoration, (c) identification of stream segments where the restoration has deviated from the plan, and (d) changes in stream length and sinuosity.

However, there were multiple and significant discrepancies identified between the planned and resulting status in the shape of the restored channel (Figure 7). From the geometric properties of the planned and resulting stream course, it is apparent that the resulting structure is less complex than planned (Table 1). A significantly lower number of meander bends than planned were built—4 instead of 121. The average amplitude of the then correspondingly increased from the planned 7.9 to 12.3 m. As a result, the built channel features also lower length and sinuosity than was planned.

The nature, extent, and location of the discrepancies are apparent from the GIS overlay of the planned and resulting status (Figure 7). First, the course of the whole newly built meandering belt substantially deviated from the approved plan in four stream segments, marked A, B, C, and D (Figure 7c). Second, there is apparent different size and amplitude of the newly-built meanders in the central part of the stream restoration. The scope of deviations from the plan is apparent from the different distribution of the stream sinuosity along the main stream segment (Figure 7d). Third, from the post-restoration status, there is apparent significant difference in location of the newly built ponds in the riparian zone. Some of the planned structures were not built at all, while others were constructed. Moreover, the newly built ponds have no surface hydrological connection with the stream.

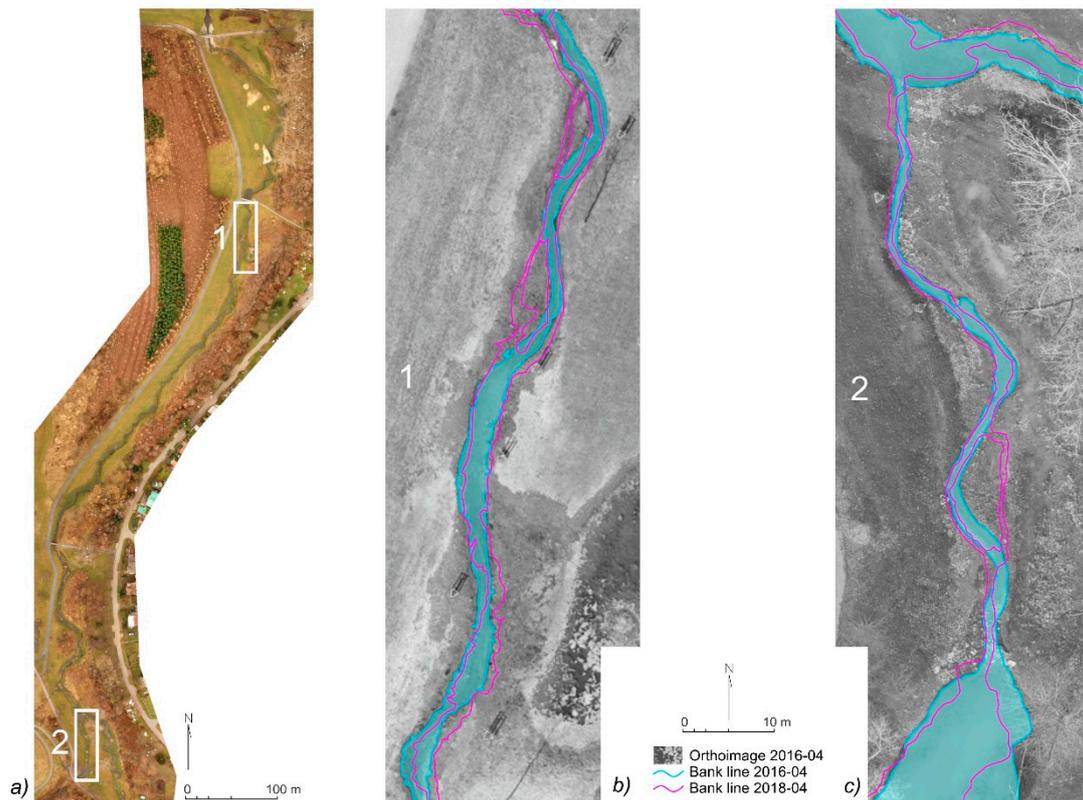
Figure 8. Evolution of the meandering system after restoration between April 2016 and April 2018. (a) Location of two segments where changes were detected. (b) Cutting of a meander in the stream segment 1, (c) channel changes in the segment 2.

The comparison of changes between spring 2016 and 2018 proved general stability of the channel with no traces of intense fluvial activity. There were two spots identified with traces of successive bank erosion and consecutive meander cutting (Figure 8). The overbank flow during the flood events initiated formation of the straight cut-off segments that are further evolving and naturally shortening the stream line. The stream development was facilitated by the absence of bank reinforcement by vegetation in the first year since restoration, when the newly created stream in the floodplain was formed by bare land.

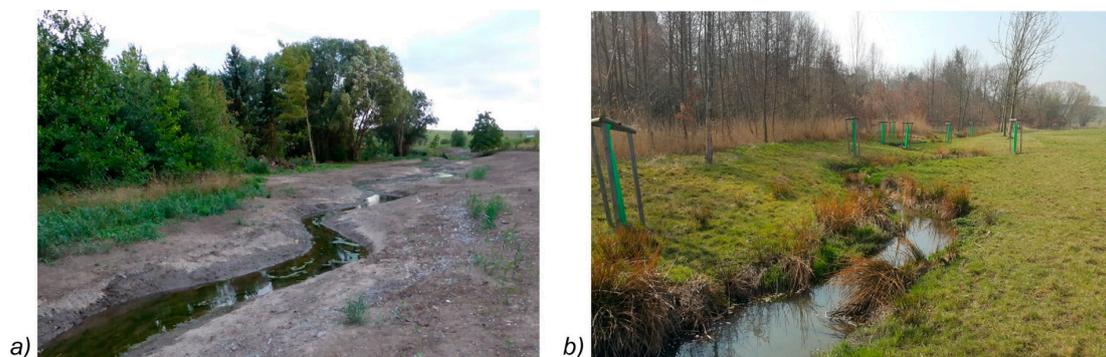
Figure 9. Vegetation succession in the riparian zone of the Hostavicky brook. (a) Bare surface of the newly built meandering belt in September 2015, (b) coherent grass cover in the same stream segment in April 2018. Photo by J. Langhammer.

The overall stability of the new channel was supported by coherent grassing of the restored riparian zone. The stream channel redesign was a part of the complex restoration of the floodplain, formerly covered by ruderal vegetation. The space for the newly formed meandering system was clear-cut from the succession vegetation and the riparian zone was completely remodeled and grassed. Since the completion of the construction works, grassing of the meandering belt and plantation of trees was started (Figure 9). The successful grassing of the riparian zone is a positive sign for the sustainability of the restoration as it helps to support the stability of the channel system and mitigate the potential bank erosion.

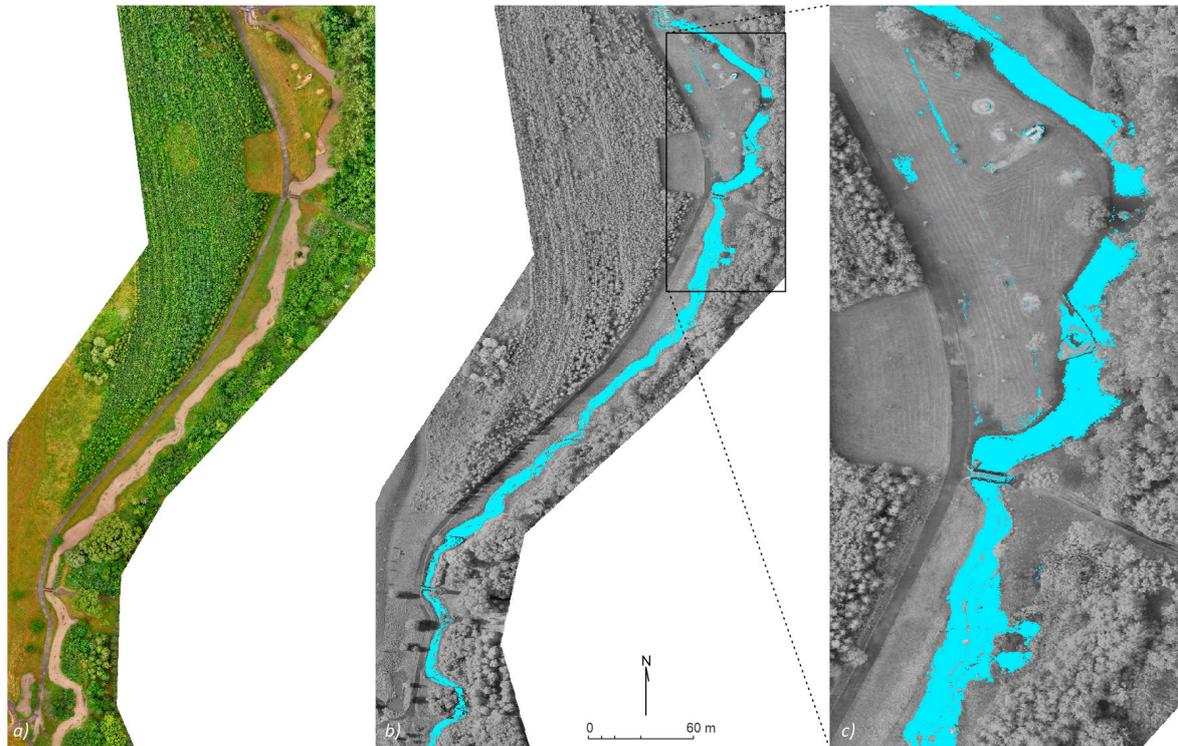
Figure 10. Detection of the extent of the flood spill during the crest of flood in 29 June 2017. (a) Orthoimage of the Hostavicky brook during the flood crest, (b) Classification of the water extent during the flood crest in the study area, (c) Detailed view to the classification results.

The potential of the newly restored channel to mitigate the flood events was tested by the flood in 29 June 2017, when a UAV imaging during the crest of the flood was taken to capture the extent of water spill in the newly shaped floodplain. The resulting orthoimage was used as a basis for the supervised classification of the water extent during the flood event (Figure 10).

From the classification results (Figure 10) it is apparent that the flood fully used the space of the meandering belt. From the detailed view to the flood spill extent (Figure 10b,c), there is also apparent overbank flow, temporarily connecting the stream with the newly built ponds. The water level exceeded the limits of the relatively shallow stream channel but was kept inside the inner space of the riparian zone and in the floodplain, there were not detected any spills outside the meandering belt. This indicates appropriate hydraulic properties of the stream, which is important in spite of the extent of deviations in stream restoration from the original design.

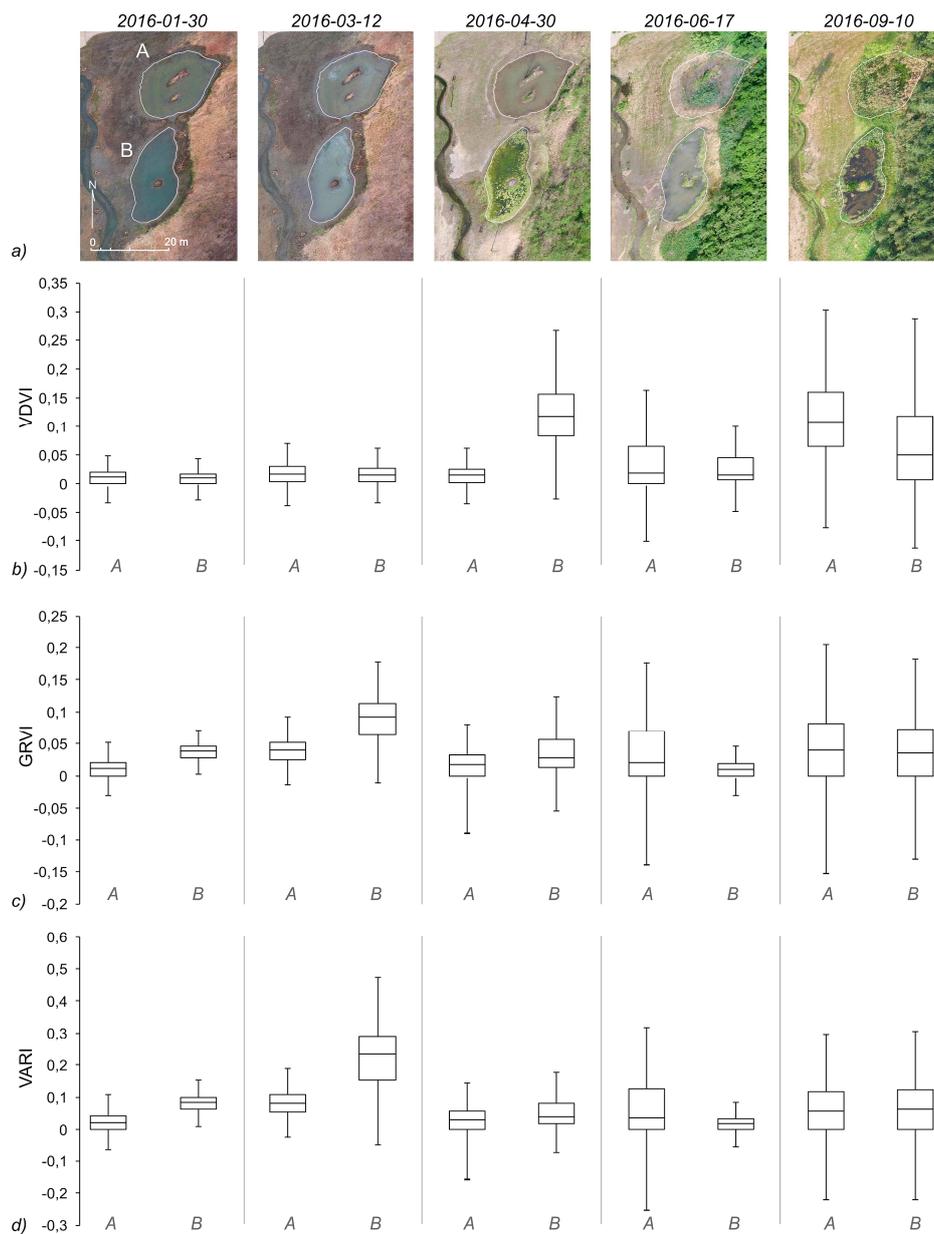
Figure 11. Vegetation overgrowth and intense eutrophication in the newly created ponds over the first vegetation season since the restoration. **(a)** RGB imagery, **(b)** visible-band difference vegetation index (VDVI), **(c)** green–red vegetation index (GRVI), **(d)** visible atmospheric-resistant index (VARI).

The progress of overgrowing and eutrophication is well apparent from the UAV imagery (Figure 11). In the spring season of 2016, pond B was first affected by heavy eutrophication, apparent in the imaging from late April. After the spring storm in the beginning of June 2016, both ponds were flooded and drained, which is reflected in the imagery from mid-June 2016. Over the summer season, the eutrophication in pond B restarted, at the same time pond A became overgrown by reed. The same pattern of the overgrowing and eutrophication in both ponds then appeared in both following years (Figure 12).

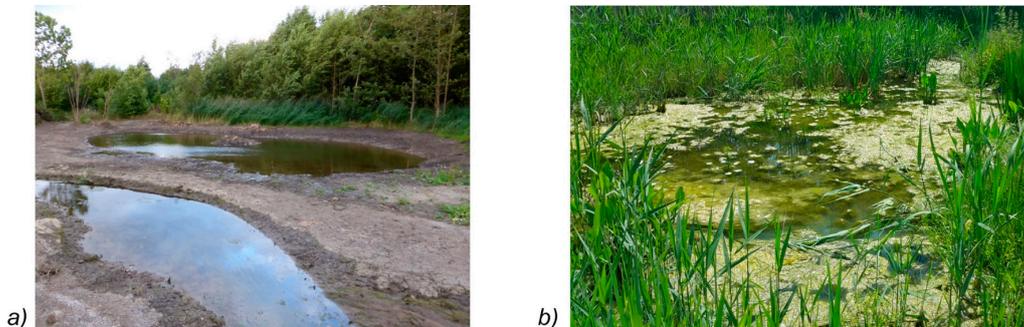
Figure 12. Eutrophication and vegetation overgrowing in the newly built ponds. (a) Pond B with apparent lack of hydrological connection to the stream during construction works in September 2015, (b) vegetation overgrowth and eutrophication in the pond B in April 2018. Photo by J. Langhammer.

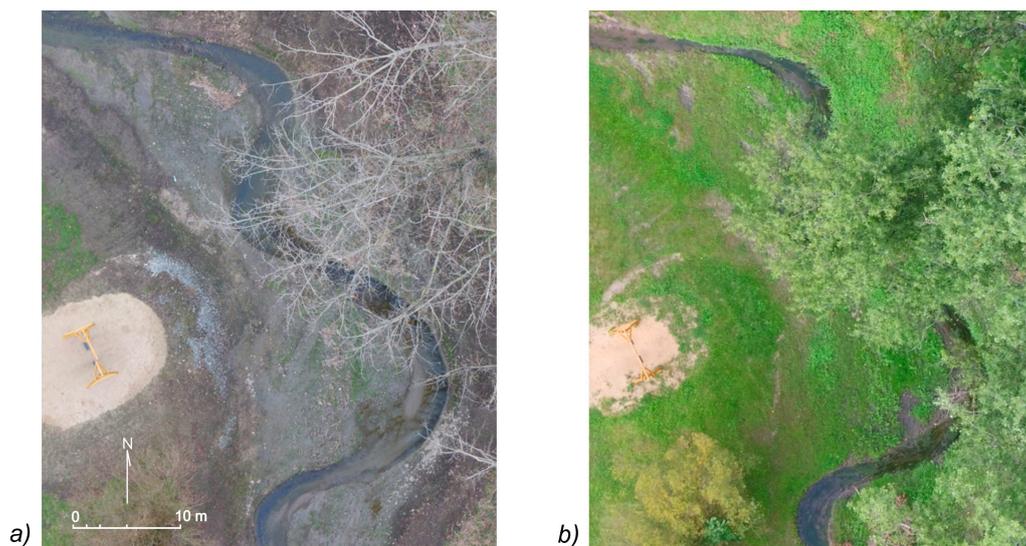
Figure 13. Stream, covered by riparian vegetation. (a) View of the stream through bare tree branches in March 2016, (b) a view partially obscured by the leaves in August 2016.

The reconstructions based on UAV imagery remain, however, limited by the optical nature of sensing. The optical sensor cannot record the points that are not directly visible, e.g., the areas obscured by the vegetation or in submerged zones [17,67]. In part, such effect can be minimized by the appropriate scheduling of the imaging campaigns to the periods of low water levels and off the vegetation season (Figure 13).
