Insights into Deformation and Mechanism of a Reactivated Landslide Occurrence from Multi-Source Data: A Case Study in Li County, China

Keywords: reactivated landslide; deformation; mechanism; integrated monitoring

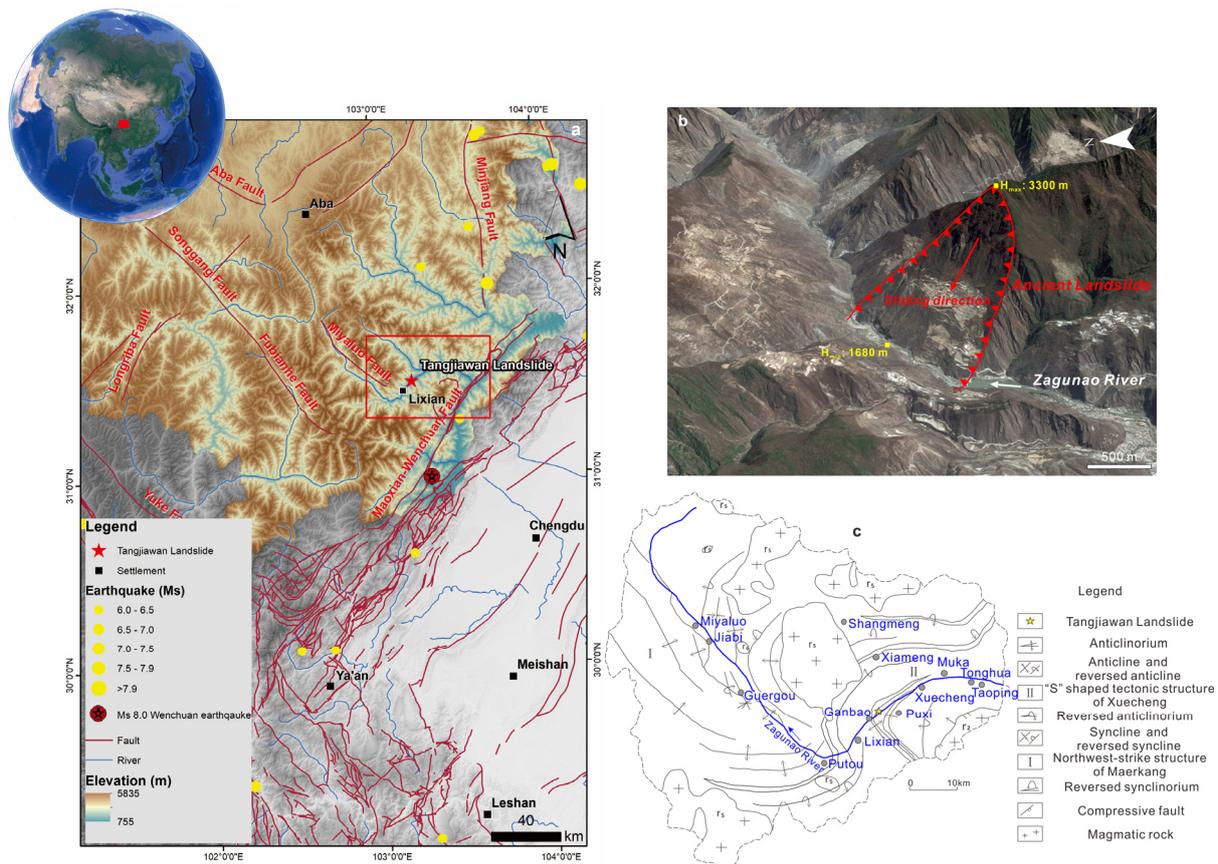
Figure 1. (a) Regional geological map of the study area. (b) Plan view of the ancient landslide. (c) Tectonic map of the study area.

The study area is situated on the southeastern margin of the Tibet Plateau, characterized by its lofty elevation and rugged terrain. The landscape is defined by deep canyons surrounded by high mountains (Figure 1a). The elevation range of the ancient landslide

area spans from 1600 m to 3300 m, with the peak of the slope positioned at an approximate elevation of 3300 m and the toe situated in the ravine bed of the Zagunao River at around 1680 m, resulting in a vertical variance of approximately 1620 m (Figure 1b).

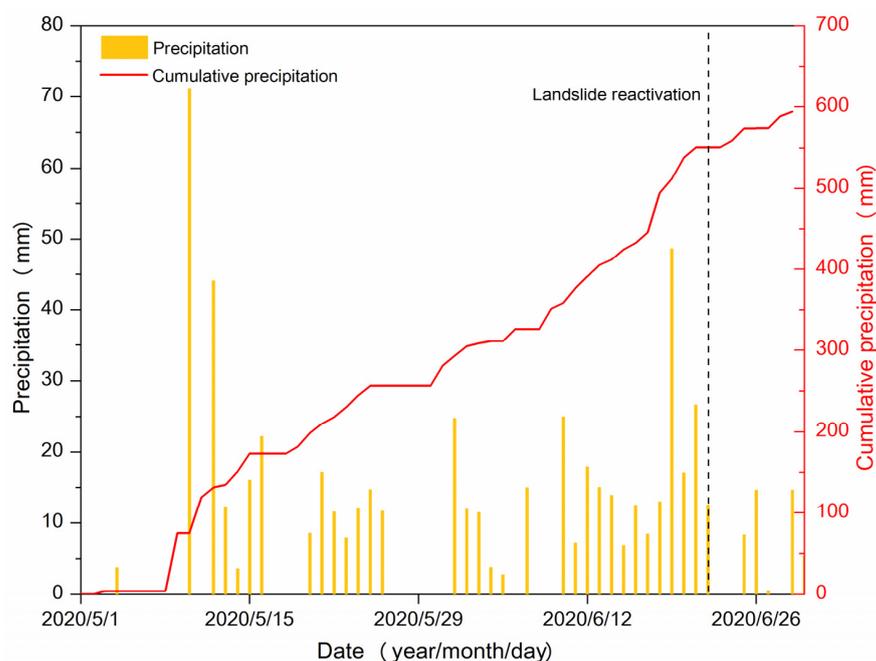
Figure 2. Daily and cumulative precipitation of May to June 2020 in the study area (Dash line means the occurrence of the landslide reactivation).

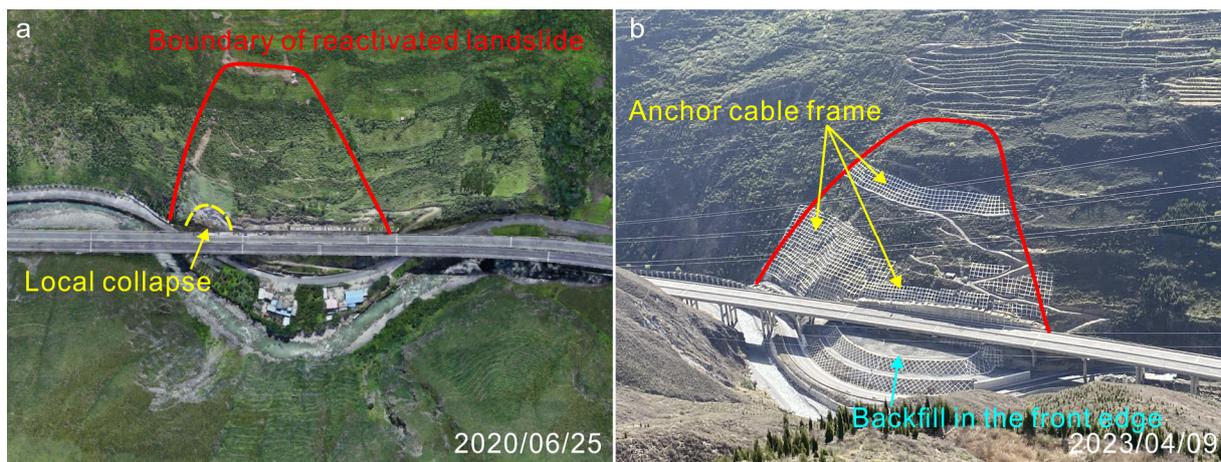
Figure 3. Geomorphologic characteristics of (a) pre-remediation and (b) post-remediation.

After the severe deformation and failure of the slope, emergency and permanent remedial works were performed, through a construction period of November 2020 to July 2022 (Figure 3), with the construction work conducted by Sichuan Highway Planning, Survey, Design and Research Institute Ltd. The InSAR technique was deployed to reveal the pre-reactivation landslide evolution; then, ground and UAV investigations were carried out to identify the landslide characteristics, and the in situ real-time monitoring system was conducted to achieve the outperformance of the remedial works (Figure 4).

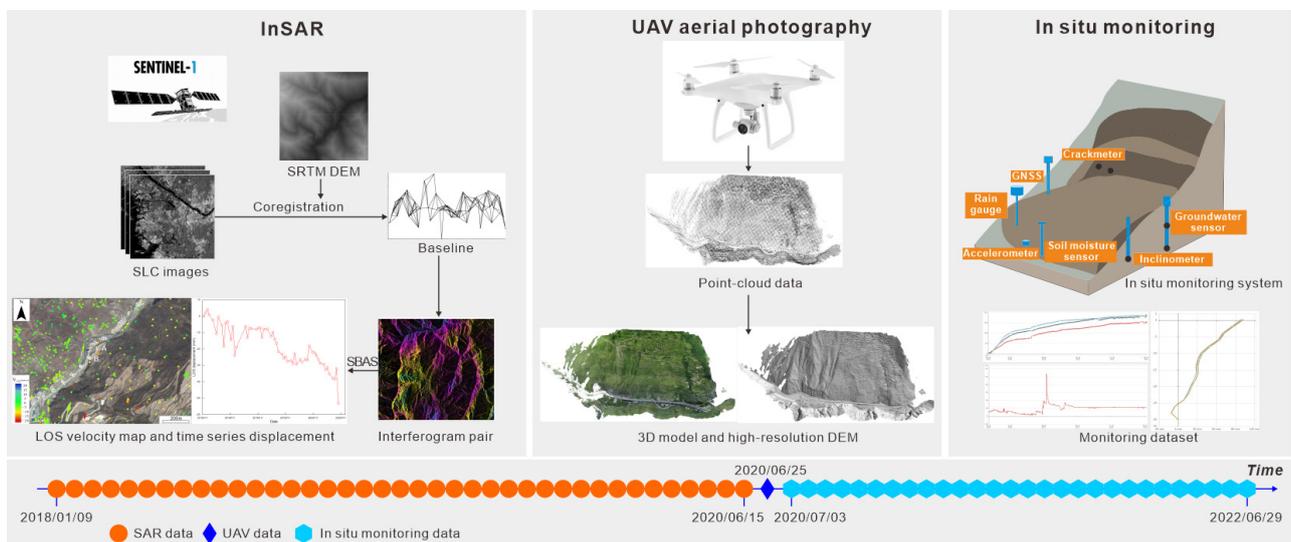
Figure 4. Integrated monitoring dataset and temporal coverage from different sources.

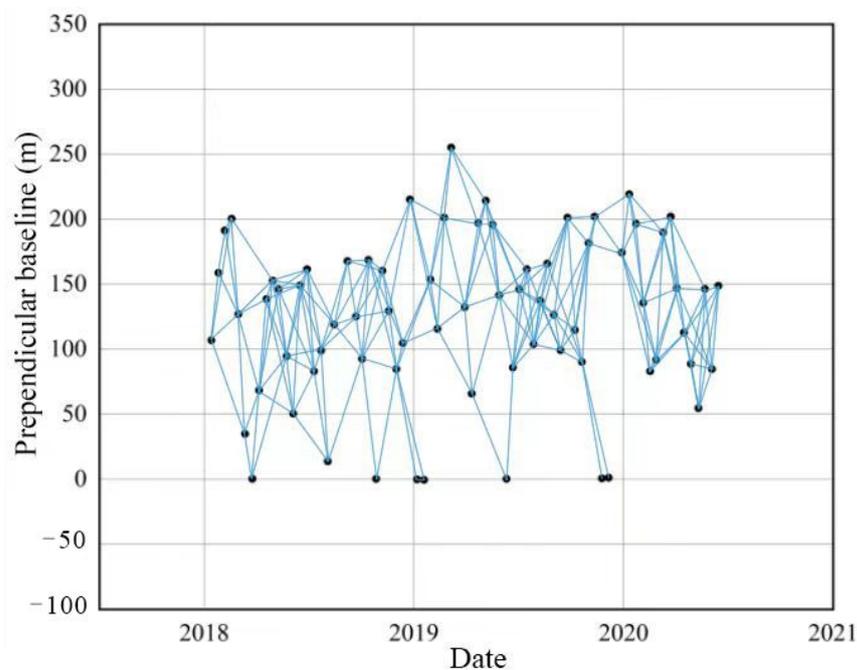
Figure 5. Temporal and perpendicular baselines of the InSAR processing.

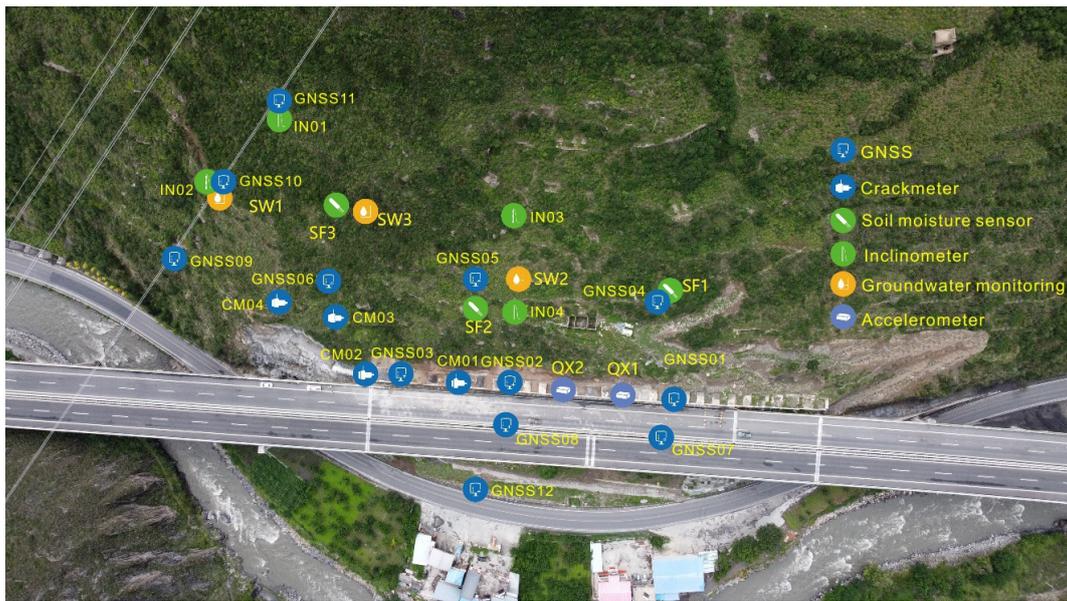
Figure 6. In situ real-time monitoring network and the locations of different instruments.

A monitor network of 12 permanent Differential Global Navigation Satellite System (GNSS) stations, 4 crack meters, 3 soil moisture sensors, 4 inclinometers, 3 groundwater monitoring stations and 2 accelerometers was deployed on the landslide in the aftermath of the June 2020 reactivation (Figure 6). The GNSS stations were set on the slope surface to obtain the ground surface displacement, and the displacements in the landslide area during the monitoring period were analyzed through the cumulative displacement and deformation velocity changes of each monitoring point. The cracks (including cracks on the infrastructures) were monitored by implementing crack meters to unravel the development tendency of cracks. The utilization of inclinometers was imperative to ascertaining the depth of the sliding surface and in monitoring the magnitude, velocity, and direction of landslide displacement. The soil moisture meters were set up to monitor the soil moisture content on the slope surface, and the groundwater monitoring gauges were installed to obtain the groundwater level of the study area. The accelerometers were installed on the anti-slide piles to measure the tilt of the structures. Moreover, near the boundary of the landslide, a rain gauge for monitoring precipitation was installed in an unobstructed and stable area. The deadline for all data statistics presented in this study is 29 June 2022.

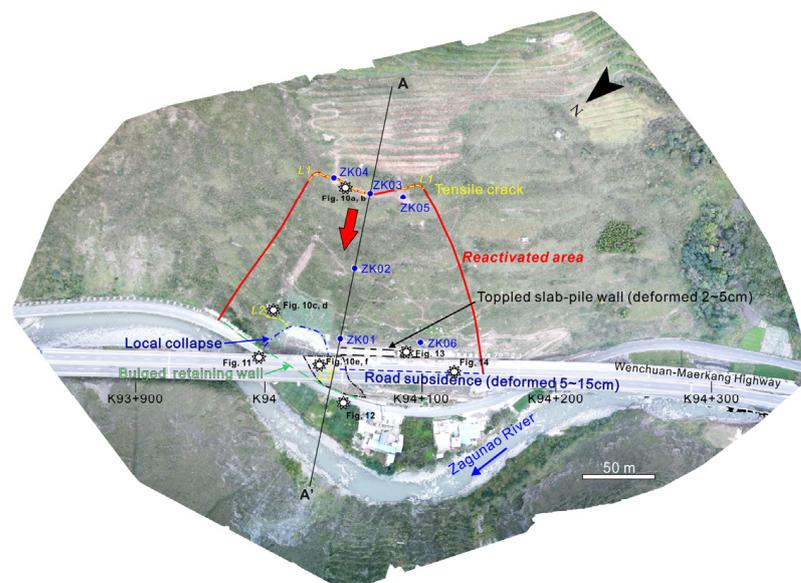
Figure 7. The geomorphological map of the reactivated landslide and the distribution of in situ investigation points. The base map is a UAV orthophoto from 25 June 2020.

Based on the field investigation, borehole drilling and UAV photogrammetry, reactivated area and depth were identified. The reactivated landslide shows a chair shape in the plane, spanning a length along the sliding direction of 100 m and reaching a maximum width of 100 m. The landslide covers an area of about $10 \times 10^3 \text{ m}^2$, with a summit altitude of the area of approximately 1855 m a.s.l and a minimum altitude near the foot of approximately 1685 m a.s.l. The toe of reactivated area falls into the K93 + 900~K94 + 200 section of the Wenchuan-Maerkang Highway. The gradient of front edge is about $20\sim 30^\circ$, while the middle and rear parts have a slope gradient of $30\sim 40^\circ$, and the main sliding direction is 300° (Figure 7). The determination of the thickness of the sliding mass is achieved through the process of borehole drilling, which is about 25.3~40.1 m, with an average thickness of 35.0 m; thus, the reactivated landslide has a volume of about $350 \times 10^3 \text{ m}^3$ (Figure 8).

The local collapse had occurred on 22 June 2020, which was located in the right-lower part of the reactivated landslide (Figure 7). This local collapse had a length along the sliding direction of 30 m, and a width of 20 m, covering an area of 600 m^2 . Based on the geometry measurement of the surrounding slope, the collapse had a thickness of about 2 m, corresponding to a shallow landslide (Figure 11). The volume of this area was approximately 1200 m^3 . The slide direction of this local collapse was approximately 30° , and several tensile cracks and fissures formed in its rear part.

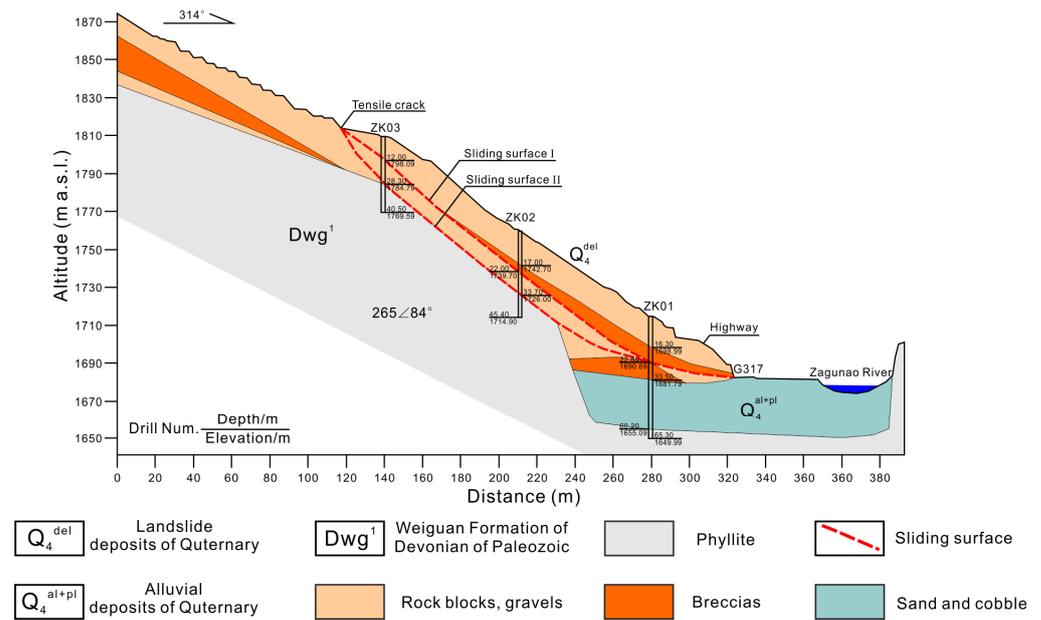
Figure 8. Longitudinal profile of the reactivated landslide (section A–A' in Figure 7).

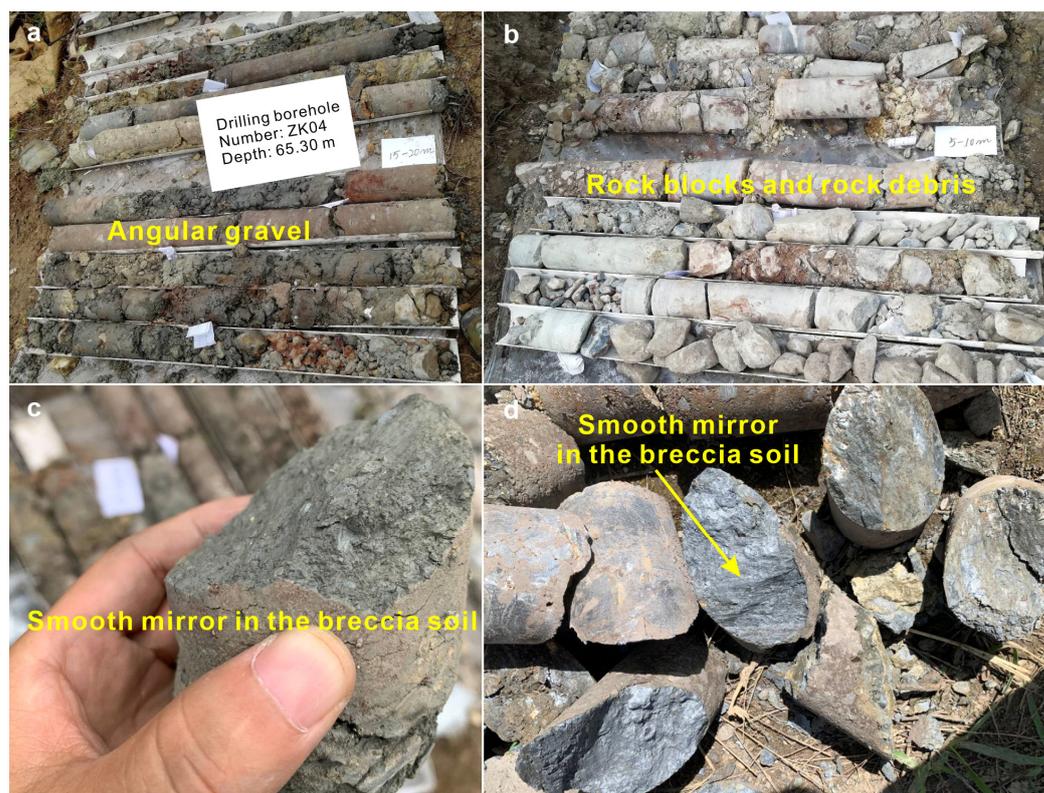
Based on the findings from borehole drilling, exploratory trench testing, and field out-crop investigations, it has been determined that the sliding mass primarily consists of rock blocks, gravels, and breccias (Figure 9). The rock blocks and gravels are characterized by loose structuring with a medium density and a grayish-brown color, and good permeability but a limited water retention capacity. Similarly, the breccias also present a loose structure, mainly medium density, with a gray-brown color, good permeability and water retention ability. The soil composition within the sliding masses is heterogeneous; while rock blocks and gravels have high porosity and strong permeability characteristics, breccias exhibit low porosity and poor permeability properties. Drillings indicate that the clay particles are concentrated in the breccias locally, where the smooth mirrors are also observed with a dip angle of 10~25° (Figure 9c,d).

Figure 9. Borehole drillings reveal the structure of the landslide. (a) Angular revealed by ZK04. (b) Rock blocks and debris from ZK03. (c,d) Breccia soil from ZK01 and ZK02, respectively.

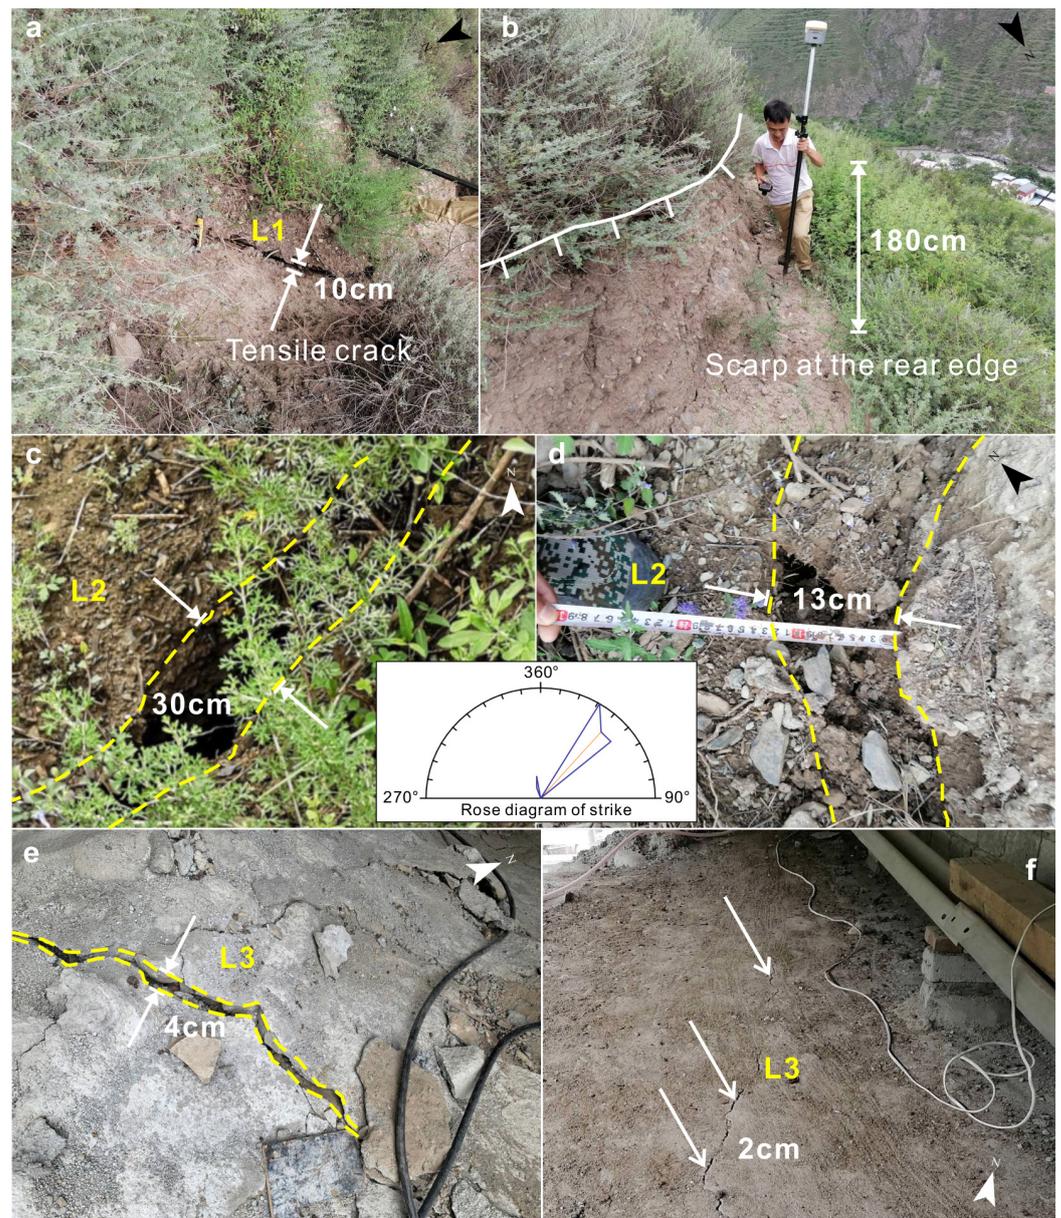
The ground surface tensile cracks involved three major cracks, mostly located along the boundary of the landslide (rose diagram of the crack strike in Figure 10). The crack L1 had developed at the rear edge, comprising several small cracks, with a length of approximately 100 m, a width of about 1~10 cm and a maximum drop of 180 cm. The strike of L1 was $210\sim 230^\circ$, and was nearly parallel to the road direction (Figure 10a,b). The crack L2 was located at the right part of the landslide, belonging to the extension of the rear boundary of the local collapse, with a length of about 30 m, a width of about 1~10 cm, a drop of approximately 20~100 cm, and a strike of $210\sim 230^\circ$ (Figure 10c,d). The crack L3 was near the front edge of the local collapse, mainly composed of cracks parallel and oblique to the road. The width of the crack was about 0.2~2 cm, the length was about 5~20 m, and the strikes were $210\sim 230^\circ$ and 350° , respectively Figure 10e,f).

The $210\sim 230^\circ$ orientation and progressive widening of these cracks, as well as the local collapse, are indicative of the overall shear strength reduction of the slope. The development of tensile cracks probably marked the pre- and entire failure creep deformation. Such occurrences afford a reasonable lead time, representing the temporal interval between the initial observations of precursors and the occurrence of a major failure event, with the aim of providing a timely early warning.

Figure 10. Cracks developed in the landslide area and their rose diagram of strike. (a,b) Tensile crack L1 at the crown of the reactivated landslide. (c,d) Tensile crack L2 observed in the vicinity of the local failure. (e,f) Tensile cracks at the ground surface at the slope toe.

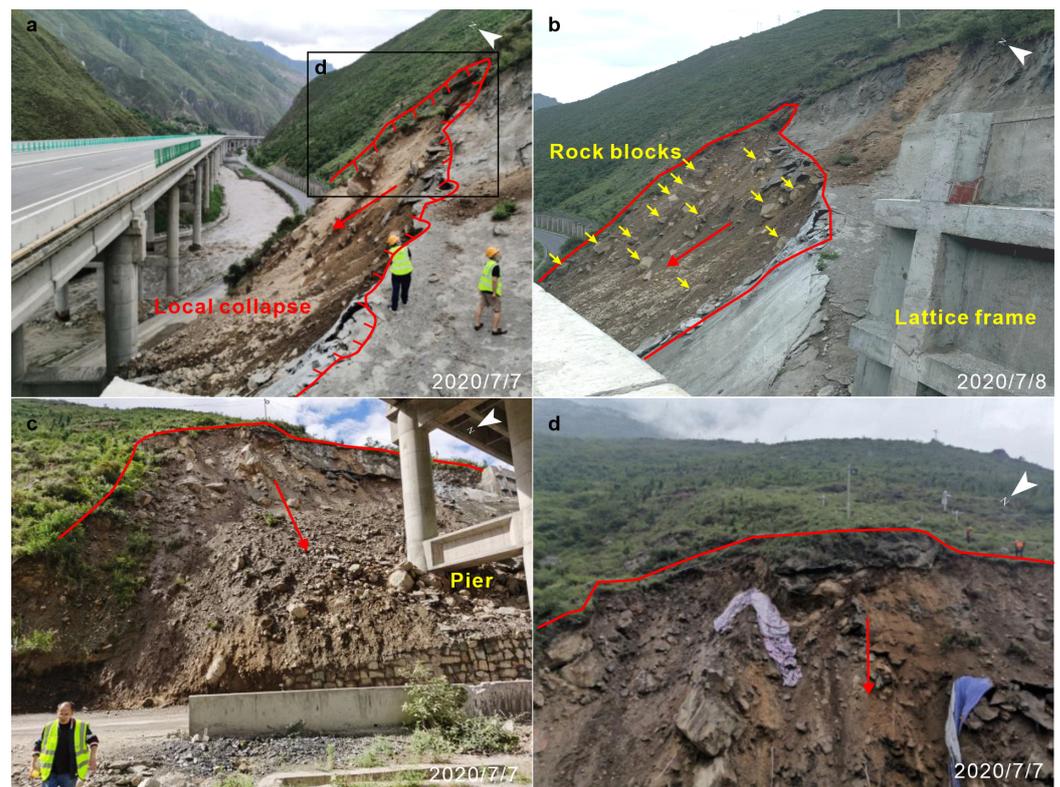
Figure 11. Local collapse occurred at the lower section of the slope. (a) The collapse reached the bridge. (b) Rock blocks distributed within the residual slope. (c) The failure of the slope damaged the pier of the bridge. (d) The rear edge of the local collapse.

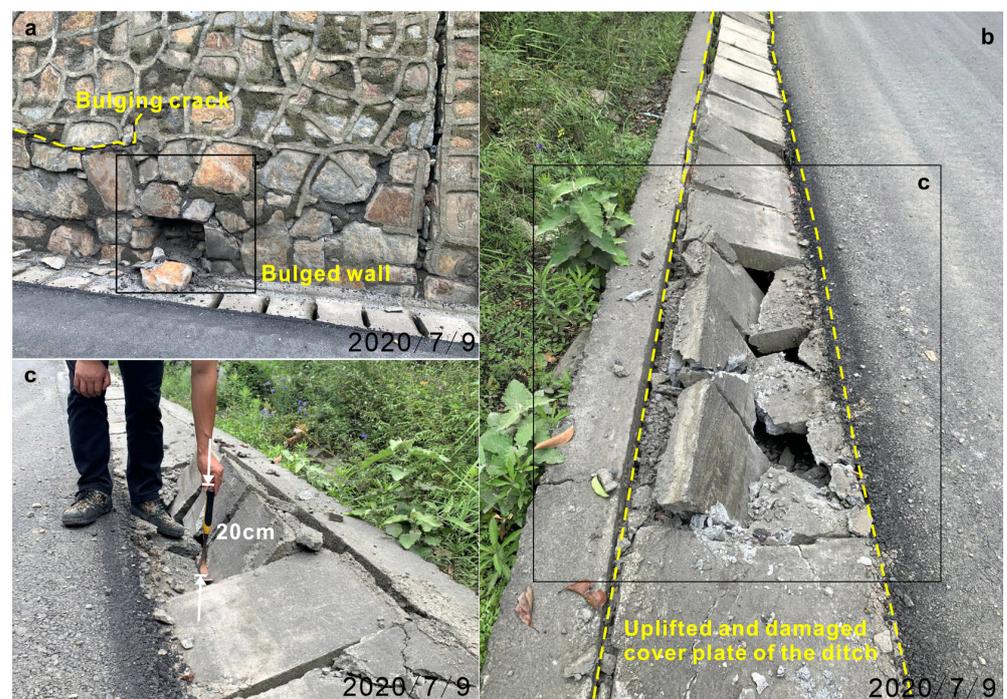
The deformation of infrastructure began from 2019 with slight signs of deformation on the road surface; due to the conducting of countermeasures, the deformation was not recorded. Since June 2020, the infrastructures within the landslide area were seriously damaged, which mainly included retaining walls, ditches, slab-pile walls and roads. National road G317 passes through the front edge in the form of excavation, with an excavated height of about 2~5 m, and a retaining wall with a slope ratio of about 1:0.3~1:0.5 was constructed around 2010 and has been used for nearly 10 years. On 22 June 2020, after heavy rainfall, the slope began to deform, and a bulging crack on the wall and a bulged deformation were observed (Figure 12a). Moreover, the boundary of left side of the road was a ditch with a concrete cover plate. The soil mass of this location was uplifted due to the extrusion, with a height of about 2–20 cm, and the cover plate was damaged (Figure 12b,c).

Figure 12. (a) Bulging deformation of the retaining wall. (b,c) Uplift deformation of the cover plate of the road ditch.

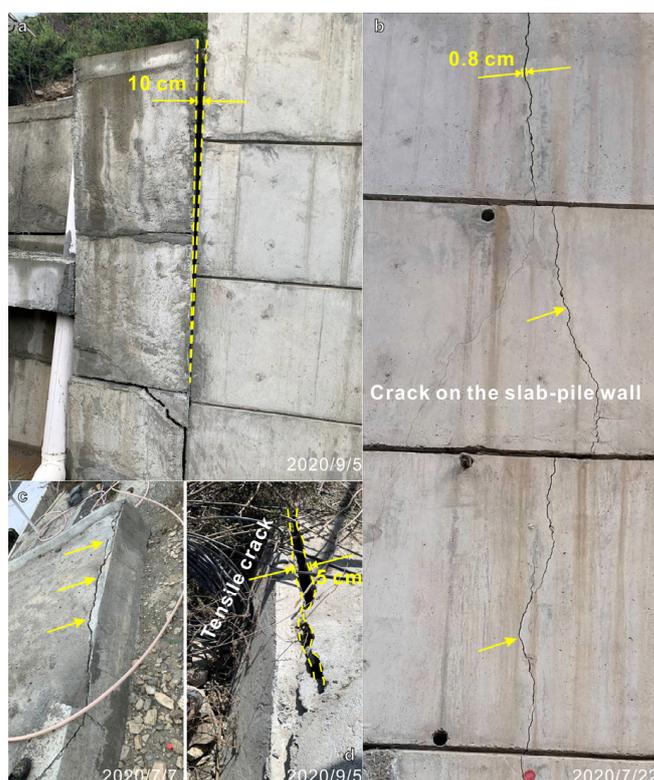
A 160 m long slab-pile wall was constructed at the front edge of slope. The investigation revealed that cracks appeared on both sides of the slab-pile wall. The tensile crack appeared at the junction of the pile and lattice frame, with a width of about 5~10 cm, showing severe damage (Figure 13a). About 11 vertical cracks were observed in front of the slab-pile wall, with widths ranging from 0.1 to 0.8 cm. It was noticed that the cracks began to gradually extend from 22 June 2020 (Figure 13b). The rear edge of the slab-pile wall was a ditch constructed using concrete, where the cracks began to develop from 22 June, with a width of 1~8 cm, and progressively extended (Figure 13c,d).

Figure 13. Crack deformations of the slab-pile wall in the front edge of slope. (a) The crack developed in the junction of pile and lattice frame. (b) Crack developed on the slab-pile wall. Crack observed on different dates: (c) 7 July and (d) 5 September 2020.

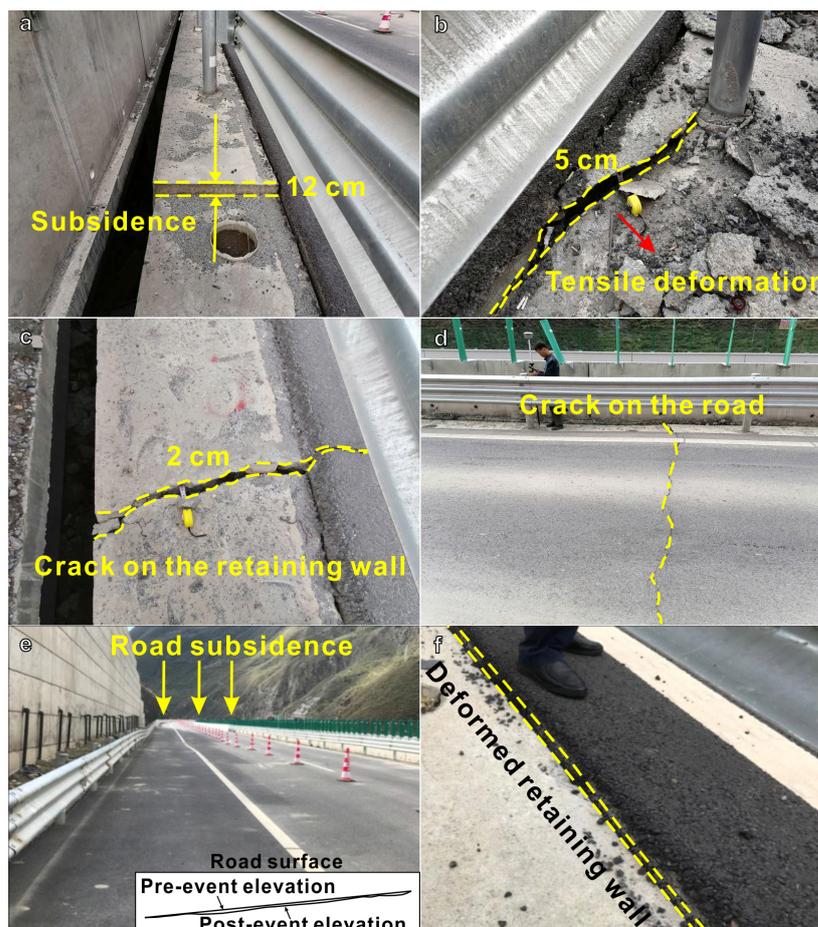
A concrete retaining wall was set on the right side of the subgrade. The subsidence and tensile deformation of the retaining wall began to appear after June 2020, with the maximum subsidence reaching 12 cm; in the entire retaining wall, some sections were cracked and damaged (Figure 14).

In late June 2019, the road ground surface of the left Wen-Ma highway exhibited local subsiding, and the subsidence height reached 2~13 cm. The subgrade of this section was grouting treatment. However, since June 2020, the subgrade continued to subside (Figure 14e), and several transverse cracks appeared, with the crack width ranging from 0.2 to 2 cm (Figure 14d).

Figure 14. Deformation signs of highway and retaining wall. (a) Subsidence of retaining wall. (b) Tensile crack in the inside of road. (c) Crack on the retaining wall. (d) Crack observed on the road. (e) Subsidence of road after the reactivation in 2020 while the profile showing the elevation change of the road surface. (f) Tensile crack developed in the junction of road and retaining wall.

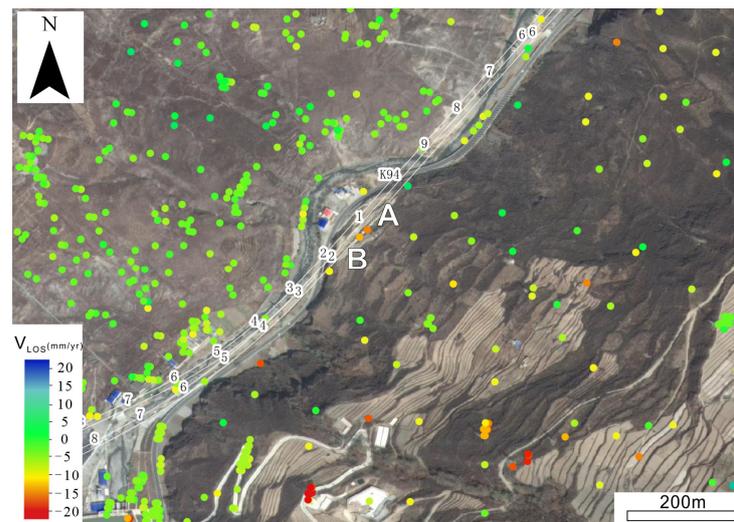
Figure 15 depicts the mean velocity of deformation in the LOS direction of the study area between 9 January 2018 and 15 June 2020, which is derived from the SBAS-InSAR technique. The monitored time stack has a mean LOS velocity of $-18.9\sim 6.5$ mm/yr. Two monitoring points of interest are obtained near the ground surface of the Wen-Ma highway, and the mean LOS velocity of point A was about -11.7 mm/year. The subsidence area was mainly distributed along K94 + 000~K94 + 200. The landslide area suffered uneven subsidence, with a mean LOS velocity of $-18\sim -5$ mm/year.

Figure 15. LOS Velocity of study area based on SBAS-InSAR (Points A and B are the selected monitoring points, while the numbers mean the mileage of the highway).

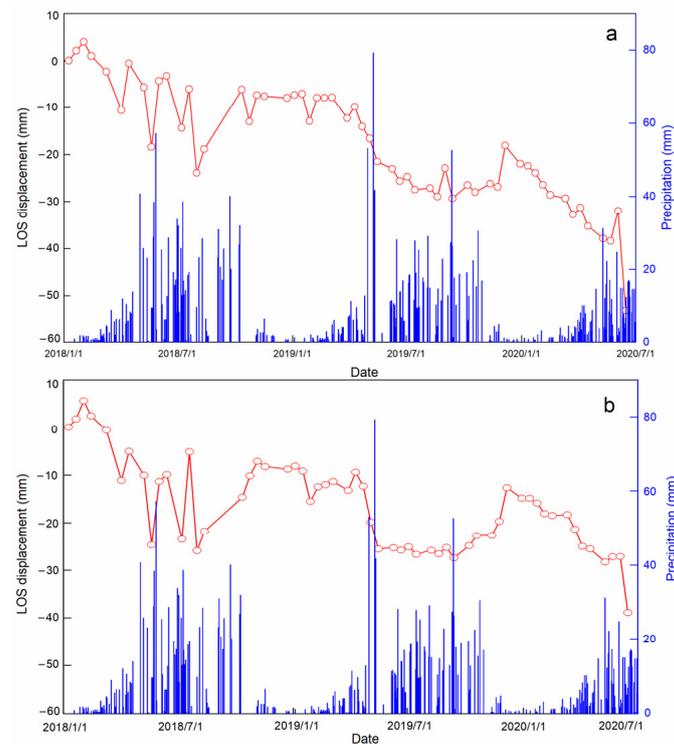
The cumulative displacement curve of InSAR-derived monitoring points in time series can be used to identify the evolution stage of the reactivated landslide. Cumulative displacement time tendency analysis of two monitoring points in three deformation regions was conducted. Figure 16 presents the time series LOS displacement of two PS monitoring points on the front edge of the slope. The ground surface represented by point A has shown a seasonal subsidence tendency since January 2018, but a large subsidence of about 21.2 mm occurred over 12 days from 3 June 2020 to 15 June 2020. The ground surface represented by point B also has a seasonal subsidence trend during the monitoring period, with a mean LOS velocity of about -5.9 mm/year and a total displacement of 50 mm from January 2018 to June 2020. The seasonal deformation indicates that the precipitation plays an important role on the slope stability.

Figure 16. LOS displacement versus time of point (a) A and (b) B.

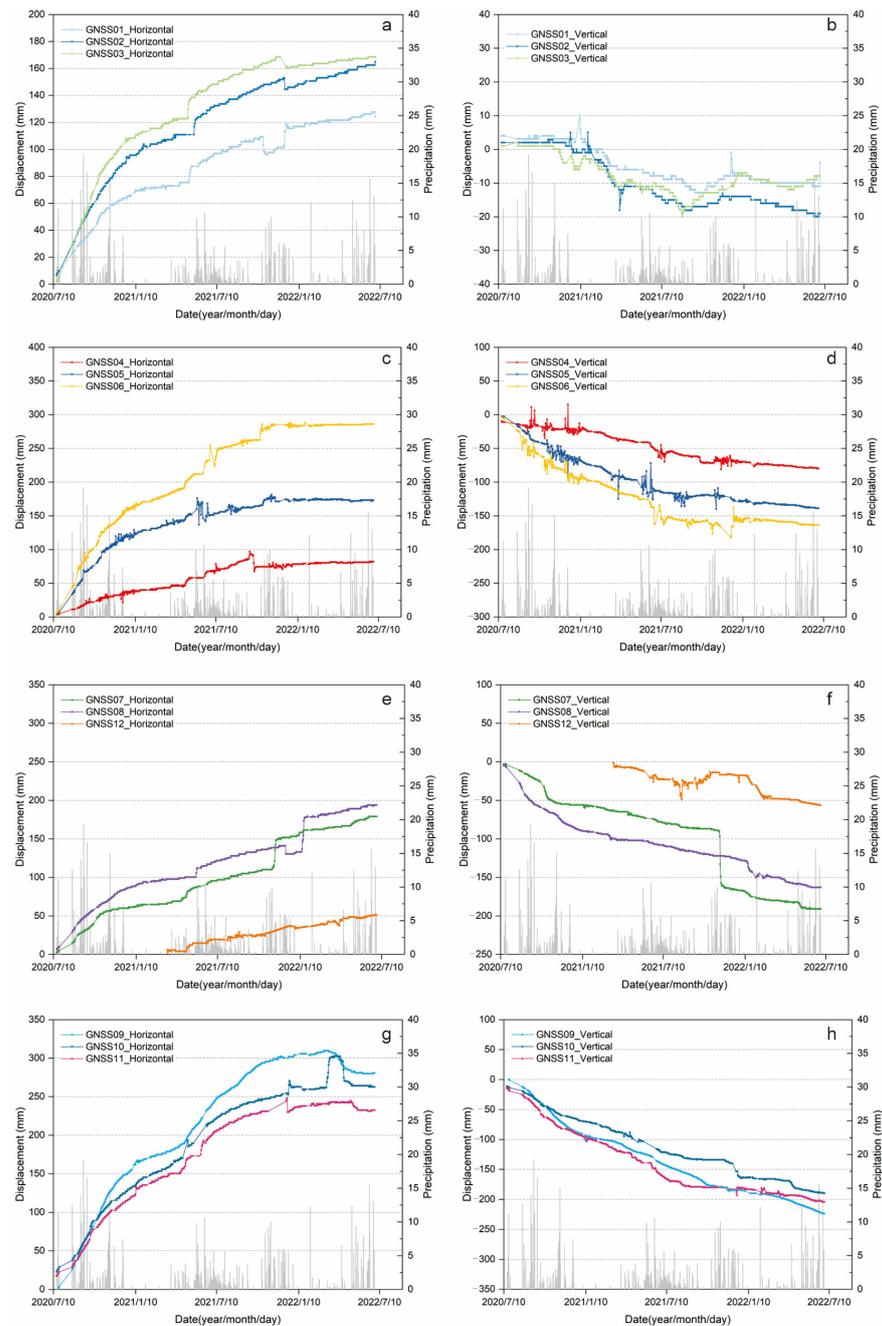
Figure 17 depicts the monitoring results of the surface deformation of the reactivated landslide obtained from the GNSS stations. Among the 12 GNSS stations, GNSS01-03 stations are installed on the original anti-slide piles at the toe of the slope. In terms of deformation varying with time, a period of rapid deformation was recorded in the three monitoring points from 17 July to 13 November 2020, with horizontal displacement increments of 56.4 mm, 77.3 mm and 92.6 mm for GNSS01-03, respectively. Such deformation characteristics are likely attributed to the unreinforced slope condition and heavy rainfall. Subsequently, the displacement evolution transforms into that of deformation induced by time-dependent slope strength reduction under rainfall and anthropogenic activities.

Figure 17. Displacement and precipitation versus time curves: (a) horizontal and (b) vertical displacement versus time monitored by GNSS01–03. (c) Horizontal and (d) vertical displacement versus time monitored by GNSS04–06. (e) Horizontal and (f) vertical displacement versus time monitored by GNSS07, 08 and 12. (g) Horizontal and (h) vertical displacement versus time monitored by GNSS09–11.

GNSS04–06 stations were installed on the lower part of the slope, which had a similar deformation response to GNSS01–03 after implementation until January 2021. A rapid deformation period can be observed at the onset of deformation monitoring, with horizontal displacements of 29.9 mm, 102.2 mm and 135.7 mm for GNSS04–06, respectively, but it disappeared after the countermeasures that were conducted on December 2020, and the deformation tended to be stable since December 2021.

For the ground surface of Wen-Ma Highway and the National Road G317 with GNSS07–08 and GNSS12 stations installed (GNSS12 installed on 20 March 2021), an increasing displacement over time is observed, which consists of initially rapid deformation followed by slow

increasing, due to the effective countermeasures. Notably, GNSS07 and GNSS08 present a sudden increase in both horizontal and vertical displacement in the period of 15 November 2021 to 18 January 2022, with displacement increments of 10~40 mm, indicating that the road surface deforms due to the cumulative precipitation of 95 mm in this period.

GNSS09-11 stations are installed at the right lateral boundary of the reactivated landslide, where the maximum displacement is recorded in the monitoring period, reaching 280.7 mm, 262.6 mm and 232.6 mm, respectively. Such deformation features corresponding to the countermeasures are conducted first at the sections in the vicinity of the Wenchuan-Maerkang Highway, followed by the right boundary; thus, these deformations become stable after November 2021.

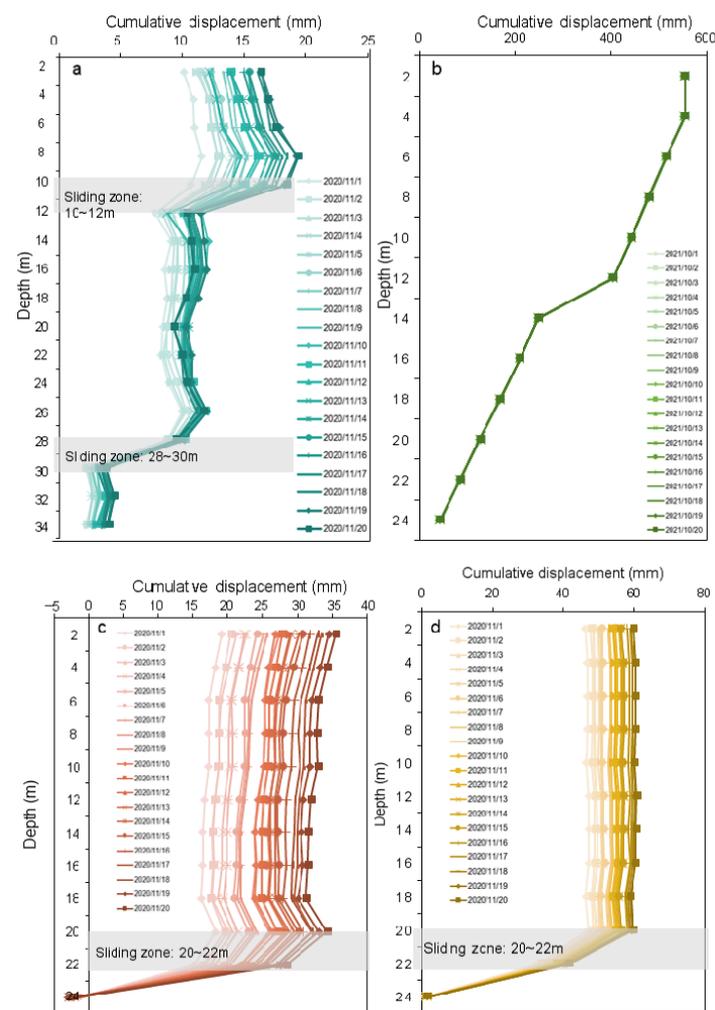
Borehole inclinometers are the most direct way to reveal the sliding zone and to understand the subsurface deformation of the landslide. Figure 18 depicts the deep displacement data measured by four inclinometers. It can be seen the cumulative displacements of inclinometers IN-1, IN-3 and IN-4 have been increasing during the selected monitoring period, suggesting that landslide deformation is still ongoing but at a low deformation rate. Due to the IN-2 being installed on 20 April 2021, the monitoring period of 1 October to 20 October 2021 was selected, when the deep displacement was constant, showing no increasing deformation in IN-2. In addition, Figure 18 illustrates that inclinometers IN-1, IN-3 and IN-4 show obvious shear displacement at different depths, that is, the depth of the sliding zone is 10~12 m and 28~30 m in borehole IN-1, 20~22 m in borehole IN-3, and 20~22 m in borehole IN-4.

Figure 18. (a–d) Cumulative displacement of inclinometers IN01-04.

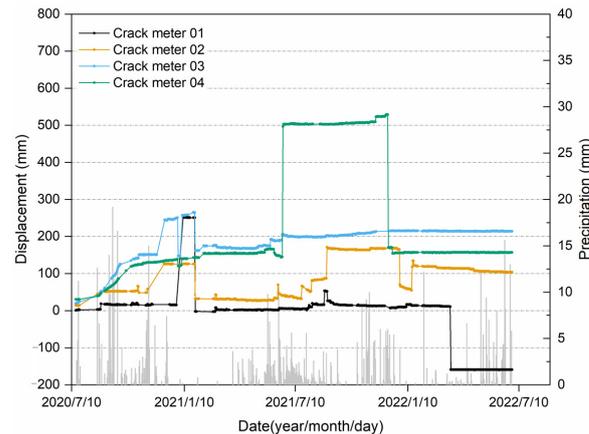
Crack meter 01 (CM01) and CM02 are installed on the anti-slide piles, and CM03 and CM04 are located at the rear edge of the local collapse. As shown in Figure 19, all cracks showed coherent opening rates at the early stage of the countermeasure constructing, reached displacements of 16.7 mm in crack meter 01, 51.9 mm in CM02, 111.2 mm in CM03, and 82.9 mm in CM04, which were overprinted by short-term accelerations triggered by heavy rainfall. Hereafter, the deformation rates showed a low level, except for several intense jump points, which may be influenced by the construction of the anchor cable frame. The ground cracks (CM03 and CM04) present a tendency for high rates and greater displacements compared to the infrastructure cracks (CM01 and CM02).

Figure 19. Displacement and precipitation versus time curves on cracks monitored by crack meters 01-04 (Grey bar is the precipitation).

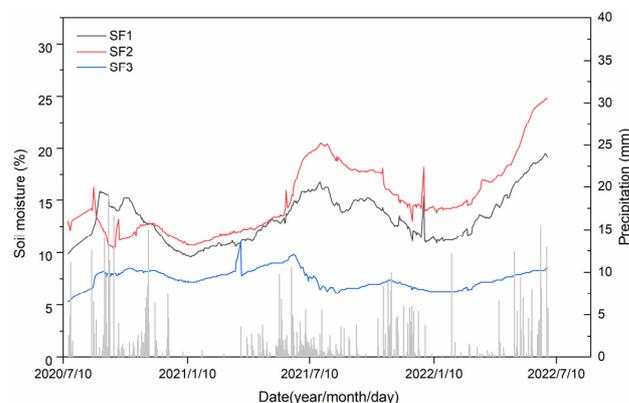
Figure 20 depicts the change in soil moisture within the landslide area. During the monitoring period, rainy seasons were accompanied by the marked increase in the soil moisture, with soil moisture peaking in the rainy season in 2022 for SF1 and SF2 at the left boundary and middle parts of the landslide, at 19.2% and 24.8% soil moisture content, respectively, as rainfall continued to occur with heavy precipitation in this period. SF3 at the right boundary of the landslide was characterized by stable soil moisture, changing from around 5 to 10%, and the variation mode was also related to the onset of the precipitation event. The deformation of the slope was related to the increase in soil moisture. Before the main countermeasures were conducted and completed in December 2021, the increase in soil moisture induced significant deformations of the slope; nevertheless, after the remediation, the slope tended to be stable, even though soil moisture increased.

Figure 20. Soil moisture versus time curves monitored by sensors SF1-3 in Figure 6 (Grey bar is the precipitation).

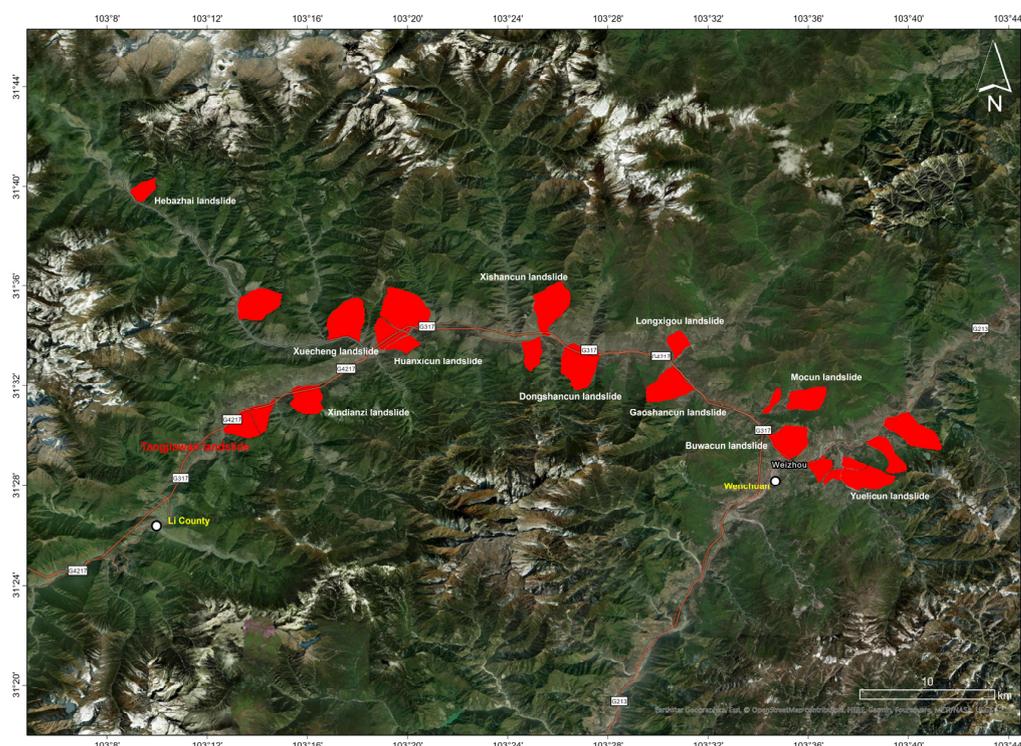
optical images, the SBAS-InSAR technique, and field investigations. As depicted in Figure 21, twenty-one ancient landslides are distributed along the highway, which pose a severe threat to the road and surrounding settlements. Efforts are concentrated on the remote measurement of ground surface deformations, in order to define the slope dynamics and landslide activities. Characterization of these ancient landslide deposits remains challenging because of their complex environments and the limitations of monitoring techniques. This paper utilizes an integrated monitor network, appropriately using the outcomes of satellite InSAR, UAV, and in situ monitoring instruments, such as GNSS. These monitoring data from different sources can help identify potentially active ancient landslide deposits preceding road construction and monitor real-time deformation during and after construction. Moreover, for an ancient landslide, which was stable during the construction stage but may be partially revived again due to triggering factors during the operation, the joint analysis could provide a comprehensive overview of the deformation of the landslide, and could evaluate the instability of the landslide in a timely manner, reducing the uncertainties of qualitative analysis.

Figure 21. Distribution of ancient landslides on the Wenchuan-Li County section of Wen-Ma Highway from a comprehensive investigation (Red polygons are the ancient landslide areas).
