Article

Bond Performance of Seamless Steel Pipe Grouting Sleeves under Large-Deformation Repeated Tension and Compression after High Temperature

Abstract: Grouting sleeves are widely used in the field of assembled construction. The present study aims to investigate the reliability of grouting sleeves under large-deformation repeated tension and compression after high temperature, considering the influences of steel bar diameter, the cooling method, and the protective layer. Through experimentation on 28 test pieces, we analyzed the bonding performance of the test pieces at different high temperatures. The results indicate that within the temperature range of 20–800 °C, the bond performance of the test pieces declines by no more than 9.8%. However, upon reaching a temperature of 1000 °C, the bond performance of the test pieces decreases by over 33.7%, with the compressive strength of the grout material reduced to only 27.50% of that kept at 20 °C. Employing larger-diameter steel bars is advantageous for maintaining the bond performance of the test pieces. Natural cooling shows relatively good bond performance, although its influence is not significant. Furthermore, the protective

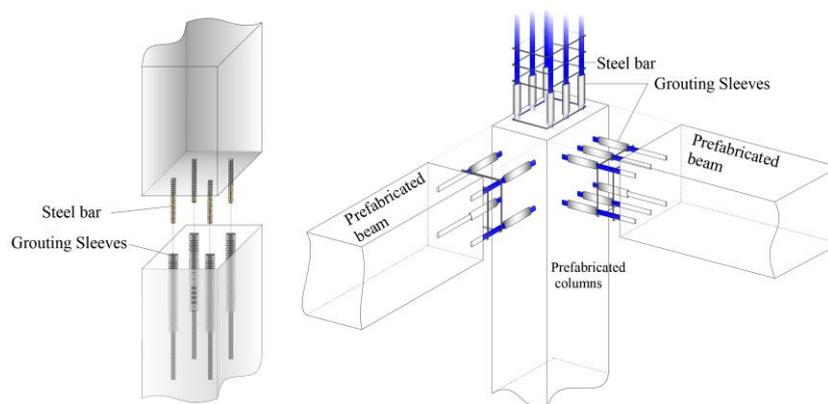
A grouting sleeve is a combination of connected steel bars (Figure 1) supporting grouting materials and a sleeve body, which was invented by Alfred A. Yee [1] in the 1960s and first used in the Ala Moana Hotel. Grouting sleeves are now widely used as connection parts in the field of prefabricated buildings due to their strong stability, easy installation and wide adaptability. Grouting sleeves promote the development of prefabricated buildings, and so have attracted many researchers' attention. Einea et al. [2] suggested that the anchorage length of the reinforcement could be reduced to seven times the diameter of the steel bars when the grouting materials possessed the required compressive strength. Ling et al. [3] and Hosseini et al. [4] studied the internal spiral restraint effect on the bonding stress–slip relationship of grouting sleeves. Alias et al. [5,6] studied the effects of the anchorage length of the reinforcement, the diameter of the sleeve and the internal structure of the grouting sleeve on the connection performance of grouting sleeves. Harajli et al. [7] studied the local bonding stress–slip relationship between steel bars and high-strength concrete under tensile loads. Haber et al. [8,9] studied the uniaxial tensile behavior of two kinds of commercial mechanical joints under different loading conditions, which

Figure 1. Application fields of grouting sleeves.

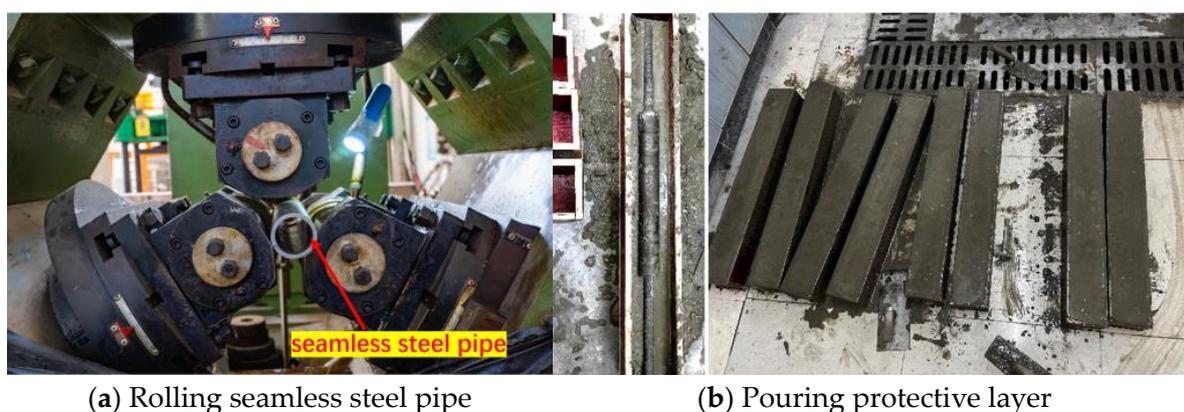
Twenty-eight seamless steel pipe grouting sleeve connectors were made. The sleeve body was made from Q345-type seamless steel pipe material (Figure 2a). As shown in Figure 3, the outer diameter of the sleeve D_d was 45 mm, the inner diameter D was 37 mm, the thickness t was 4 mm, the rib width a was 8.0 mm, the rib spacing b was 25 mm, and the rib depth c was 1.5 mm. L was the length of sleeve. The anchorage length of every test piece was taken as $7d$. The geometric parameters of test pieces with different diameters are shown in Table 1. Test piece sets were numbered according to the following criteria: “protective layer thickness—cooling method—connection steel bar diameter—heating temperature”. As shown in Figure 2b, C0 and C20 represent grouting layer thicknesses of 0 mm and 20 mm. N and W represent natural cooling and water cooling, respectively. d18, d20 and d22 represent diameters of the connecting steel bars of 18 mm, 20 mm and 22 mm. The grouping of the test pieces and the experimental procedures are shown in Table 2. Eighteen grouting material blocks with a volume of 40 mm × 40 mm × 160 mm were also prepared to further understand the effect of grouting materials’ compressive performance deterioration on the grouting sleeve’s mechanical properties after high temperature.

Figure 2. Test piece production.

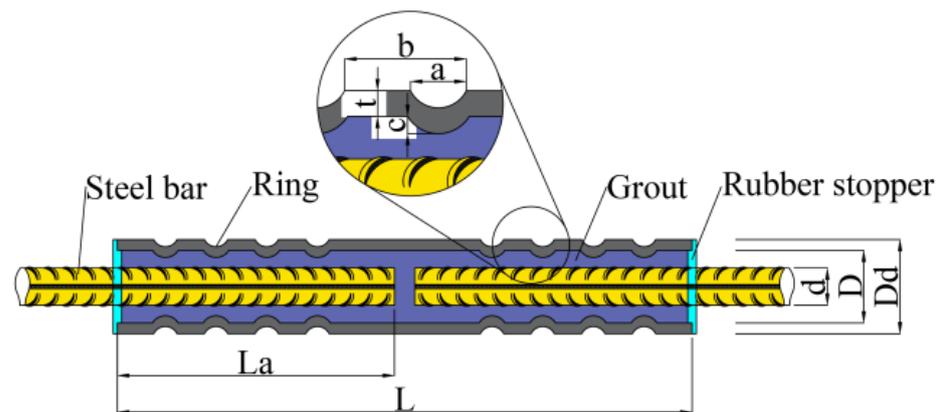
Figure 3. Seamless steel pipe grouting sleeves.

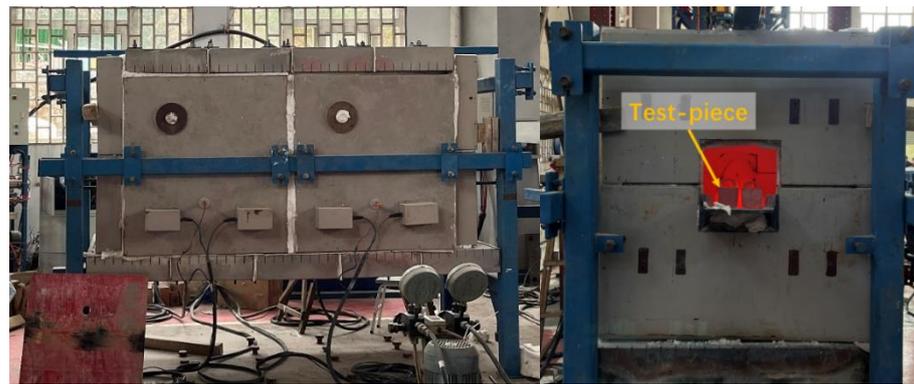
The heating equipment used in this experiment was a multi-functional experimental furnace, as shown in Figure 4, and the test pieces were heated according to the standard curve defined in ISO-834 [36,37]. The heating curve is shown in Figure 5.

Figure 4. High-temperature experimental furnace.

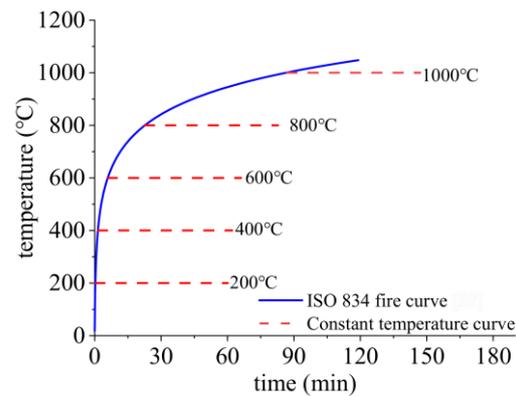
Figure 5. Rising and constant temperature curve [37].

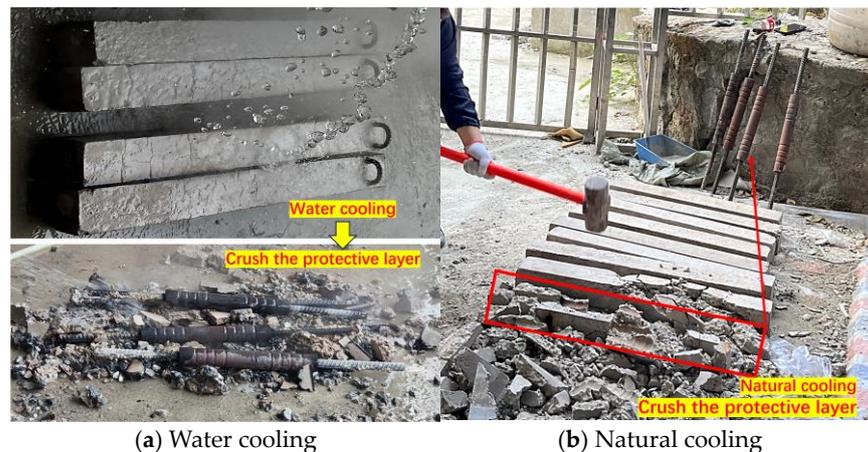
After the test pieces were heated to the preset temperature, the temperature was kept stable for 60 min, and then the heating was stopped. Then, the naturally cooled test pieces were placed directly into a 20 °C environment, while the water-cooled test pieces were cooled with running water for 20 min immediately after removal from the furnace. Then, the concrete protective layer was broken and we removed the test pieces, as shown in Figure 6.

Figure 6. Cooling method of test pieces after exposure to a high temperature.

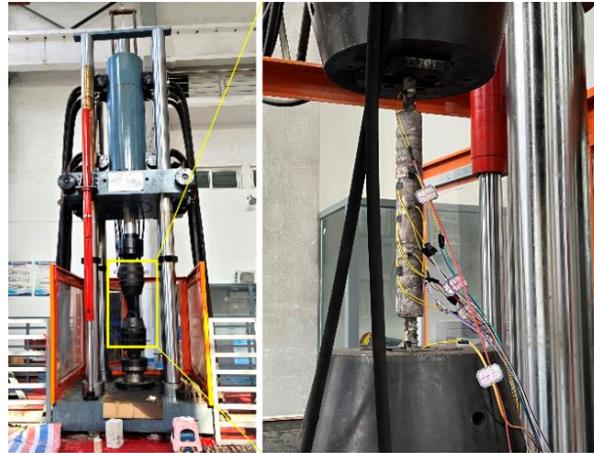
The loading test was carried out with a high-speed press testing machine (Figure 7) with a maximum static test force of 2000 kN, which can be loaded by means of force and displacement control. In this test, both the forward and the reverse loading were controlled

Figure 7. Test loading machine.

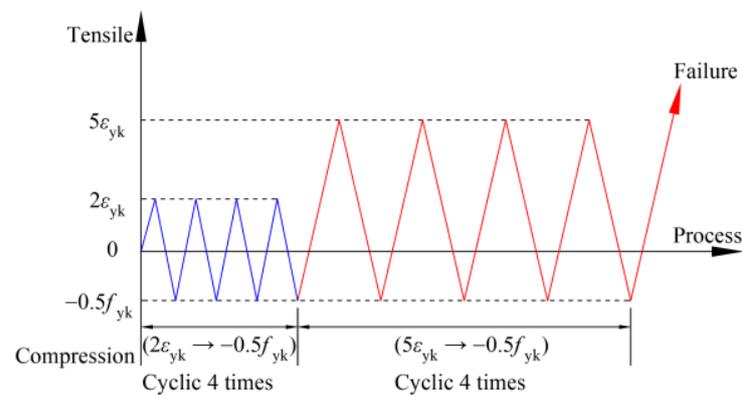
by the displacement, and the loading rate was 10 mm/min. The forward and reverse unloading was controlled by the force, and the unloading rate was 50 MPa/s. According to JGJ 107-2016 [14], the loading program is illustrated in Figure 8.

Figure 8. Loading procedure.

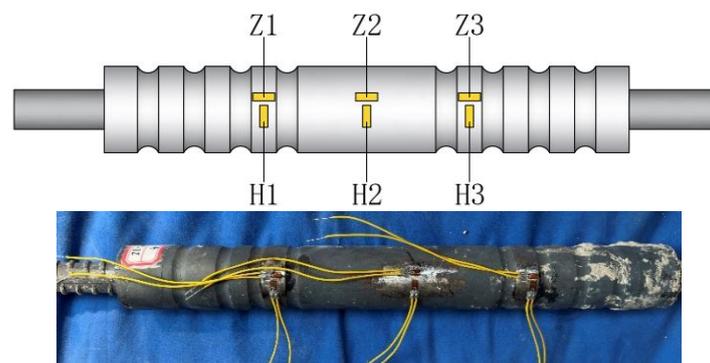
The load–displacement curve, ultimate load, and ultimate displacement of the test pieces were obtained as follows. Three axial strain gauges, Z1, Z2, and Z3, and three annular strain gauges, H1, H2, and H3, on the surface of the test pieces were used to measure the strain change trend of the sleeve surface. The locations of the axial and annular strain gauges are shown in Figure 9.

Figure 9. Strain gauges on the surface of the sleeve.

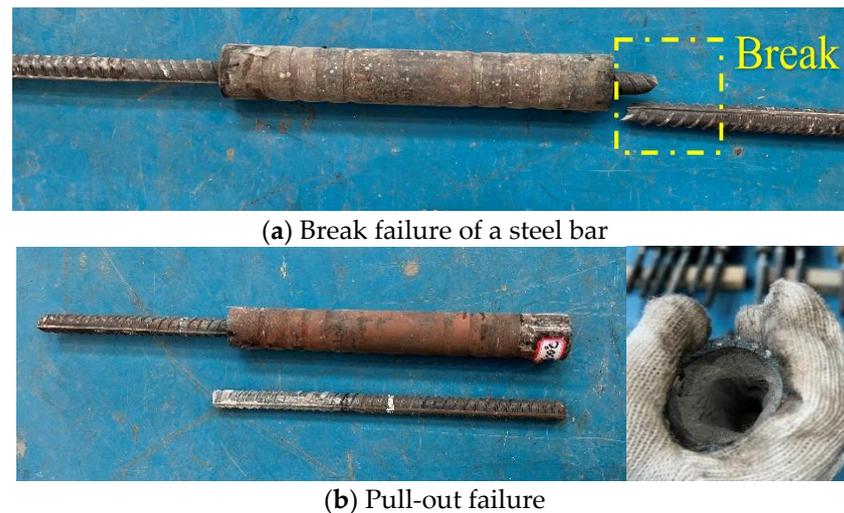
Two modes of failure appeared in the test pieces: (a) Break failure of the steel bar. As shown in Figure 10a, the bond strength of the grouting materials to the steel bar was greater than the ultimate tensile strength of the steel bar. (b) Pull-out failure. As shown in Figure 10b, the bond strength of the grouting materials to the steel bar was less than the ultimate tensile strength of the steel bar, and the steel bar pulled out of the grouting materials.

Figure 10. Test piece failure modes.

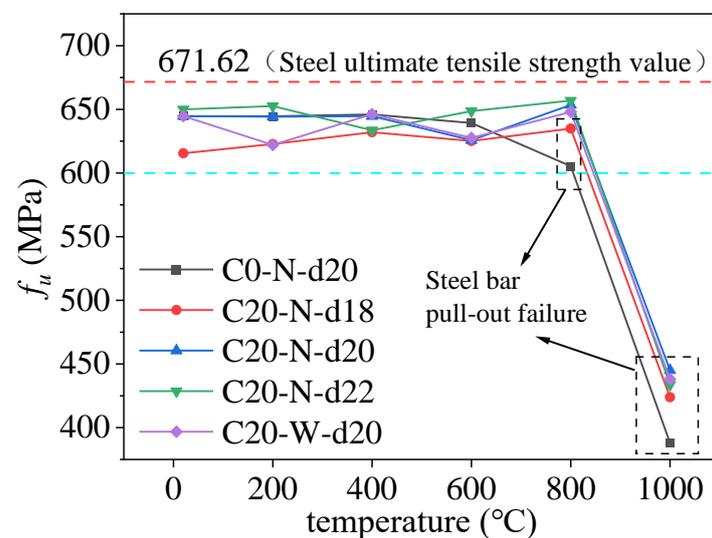
Figure 11 depicts the relationship between the ultimate tensile strength of the test piece and the temperature, compiled from the data in Table 3. After the temperature ranges from 20 to 600 °C, the group 2 test pieces show the lowest ultimate tensile strength at each temperature interval. The other four groups of test pieces did not show significant differences. After 800 °C, the test pieces belonging to group 1 and group 2 had a lower ultimate tensile strength compared to the other three groups due to steel bar pull-out failure. It is worth noting that, based on the observations at 20–800 °C, the ultimate tensile strength of all test pieces exceeded 600 MPa. At 1000 °C, all test pieces experienced steel bar pull-out failure, and compared to the 20 °C environment, the bonding performance decreased by 33.7~42.2%.

Figure 11. Relationship between the tensile strength and temperature.

It can be concluded that the test pieces with a diameter of 18 mm (group 2) showed poorer tensile performance after high temperature. There were no significant differences observed among test pieces subjected to different cooling methods at various temperatures. However, test pieces without protective layers showed inferior tensile performance compared to those with protective layers at temperatures above 800 °C.

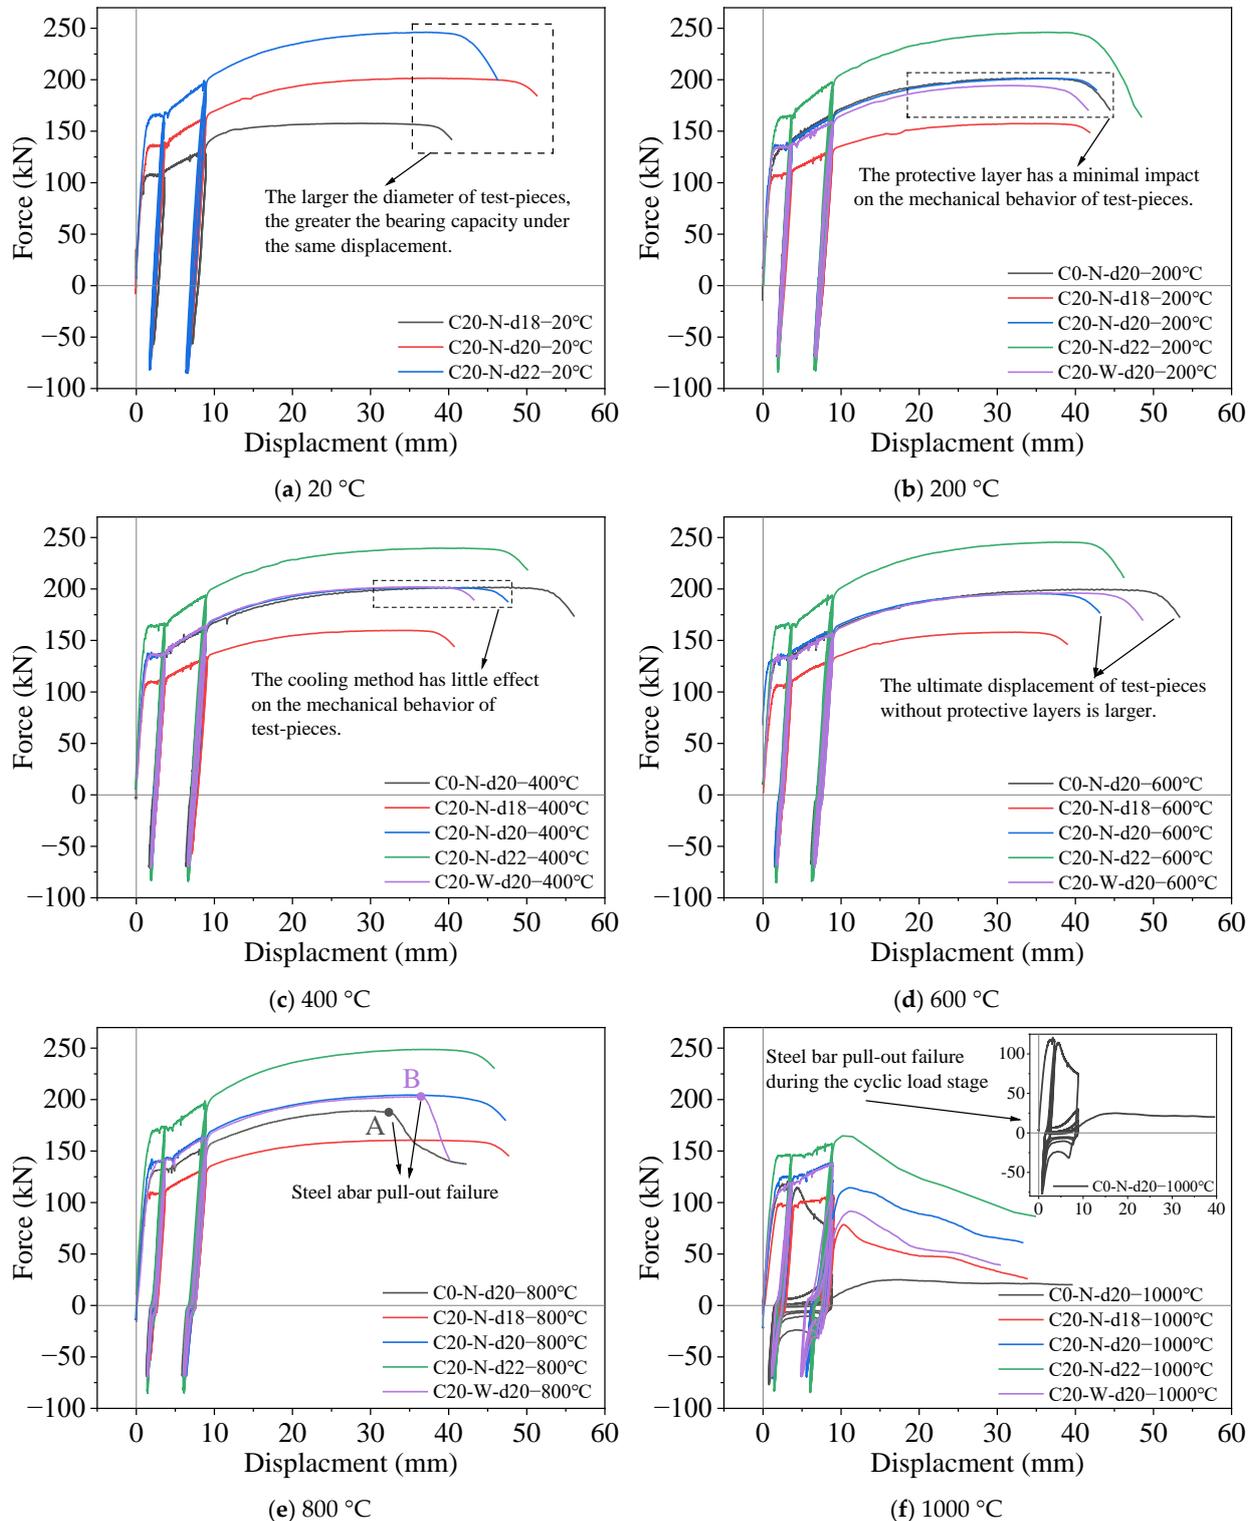
Figure 12 shows the load–displacement curves of the test pieces under different temperature conditions. In Figure 12a–f, it is visually evident that test pieces with larger diameters show a higher ultimate tensile strength under high temperatures. To provide a clear comparison of the effects of cooling methods and protective layers on the test pieces, only the group 1, group 3, and group 5 test pieces will be discussed.

Figure 12. Load–displacement curves of test pieces.

After 200 °C (Figure 12b), compared to those subjected to natural cooling (C20-N-d20–200 °C), the water-cooled test pieces (C20-W-d20–200 °C) showed larger displacements under the same tensile force and reached the load limit earlier. The curves of C20-N-d20–200 °C and C0-N-d20–200 °C overlap almost entirely, indicating that the protective layer has minimal influence on the mechanical behavior of the test pieces at 200 °C.

After 400 °C (Figure 12c), there is little difference in the ultimate tensile strength between test pieces subjected to different cooling methods. However, the water-cooled test pieces reached the load limit earlier and showed less deformation capacity. Comparing the curves of C20-N-d20–400 °C and C0-N-d20–400 °C, it is evident that test pieces without protective layers experience significantly larger displacements.

After 600 °C (Figure 12d), the displacement of C20-W-d20–600 °C during the ultimate tensile stage is 26.29% greater than that of C20-N-d20–600 °C. This indicates that at 600 °C, compared to natural cooling, test pieces cooled by water show more significant deformation under the same load. Test pieces without protective layers also experience larger displacements.

After 800 °C (Figure 12e), C0-N-d20–800 °C and C20-W-d20–800 °C experience a sudden decrease in tension at points A and B during the ultimate tensile stage, indicating a rupture of the bond between the grout material and the connecting steel bars under tension. This results in steel bar pull-out failure. Compared to C20-N-d20–800 °C, C0-N-d20–800 °C shows larger displacement under the same tension. The ultimate tensile strength of C20-N-d20–800 °C is 205.2 kN, which is 0.85% higher than that of C20-W-d20–800 °C and 7.95% higher than that of C0-N-d20–800 °C. This indicates that at this temperature, the bond performance of test pieces subjected to natural cooling is higher than that of test pieces subjected to water cooling, and test pieces with protective layers show better bond performance.

After the temperature reaches 1000 °C (Figure 12f), all test pieces undergo significant deformation during the cyclic loading stage, indicating that the bond strength between the grouting material and the connecting steel bars sharply decreases, leading to steel bar pull-out failure in the test piece. A comparison of test pieces with different diameters of the connecting steel bars reveals that the ultimate tensile force of C20-N-d22–1000 °C is 17.83% greater than that of C20-N-d20–1000 °C and 52.73% greater than that of C20-N-d18–1000 °C, indicating that test pieces with larger connecting steel bar diameters show better bonding strength. Test pieces subjected to natural cooling show a tensile strength during the tensile stage that is 24.9% higher than those subjected to water cooling. Due to the test piece not having a protective layer, C0-N-d20–1000 °C experiences nonlinear changes in its load–displacement curve during the cyclic loading stage. Moreover, as the number of cycles increases, damage accumulates in the grout under the compression of the connecting steel bar ribs, eventually leading to steel bar pull-out failure in this test piece.

It can be concluded that test pieces with larger steel bar diameters show better tensile performance at different high temperatures. Cooling methods have a minimal impact on the bond performance of test pieces at temperatures below 600 °C, but at 800–1000 °C, test pieces subjected to natural cooling show better bond performance. Test pieces with protective layers experience smaller ultimate displacements under large-strain cyclic loading, while those without protective layers show greater deformation.

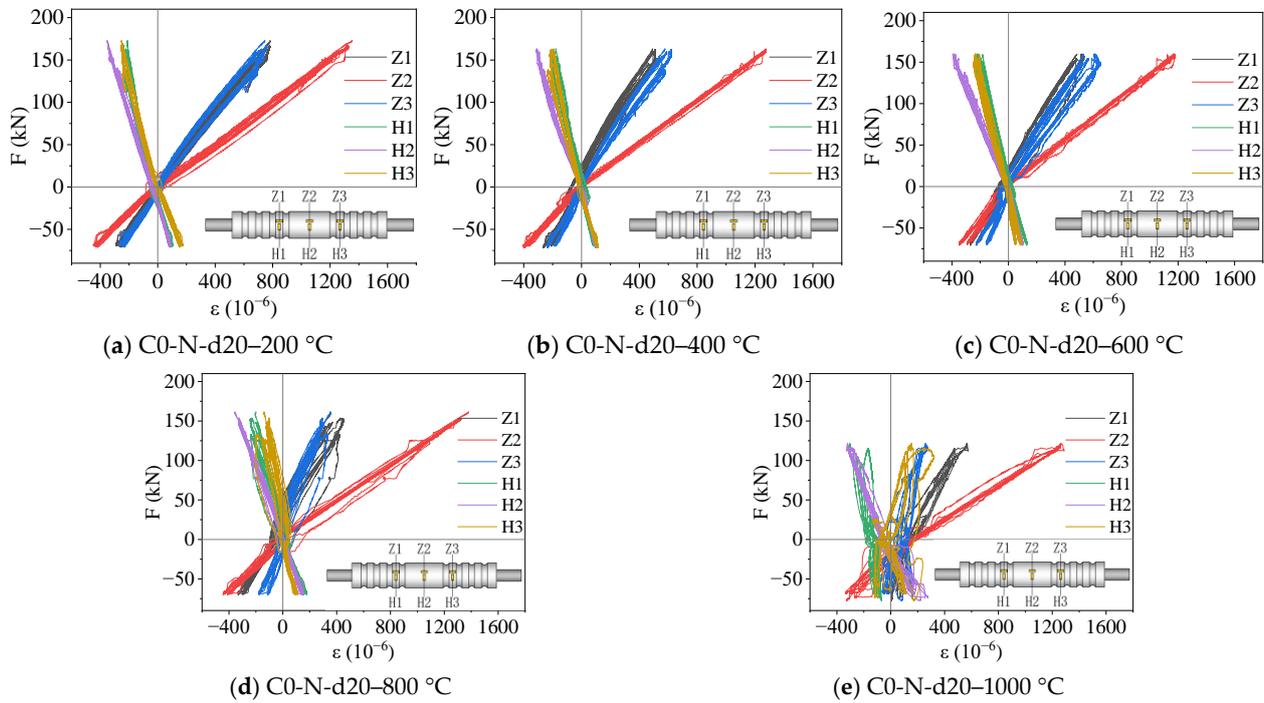
The performance of the load–strain curves of test pieces under different temperature conditions can be observed in Figures 13–17. When subjected to tension, the axial strains Z1, Z2, and Z3 on the outer wall of the sleeve are greater than 0, while the circumferential strains H1, H2, and H3 are less than 0, indicating that the sleeve is under axial tension and circumferential compression. The maximum tensile strain and maximum compressive strain for each test piece both occur at measurement points Z2 and H2. The maximum circumferential strain and axial strain measured during the experiment are -468.98×10^{-6} and 1298.23×10^{-6} , respectively. During the large-deformation repeated tension and

Figure 13. Load–strain curves of group 1 test pieces.

Comparing the strain variations of the test pieces at different temperatures, taking the first group of test pieces as an example, it is observed that as the temperature increases, the “overlap” of the curves gradually decreases. Moreover, the overlap at the central measurement points Z2 and H2 is higher than at other points, indicating significant deformation damage in the ribbed section. In Figure 13a–e, it is visually apparent that after high temperatures of 800 °C and 1000 °C, the load–strain curves of all test pieces do not overlap significantly, indicating significant damage to the test pieces’ elastic deformation performance.

Comparing test pieces with and without protective layers, belonging to group 1 (Figure 13) and group 3, test pieces with protective layers show better curve alignment at high temperatures compared to test pieces without protective layers, indicating that a protective layer provides better preservation of the test pieces’ elasticity under high-temperature conditions.

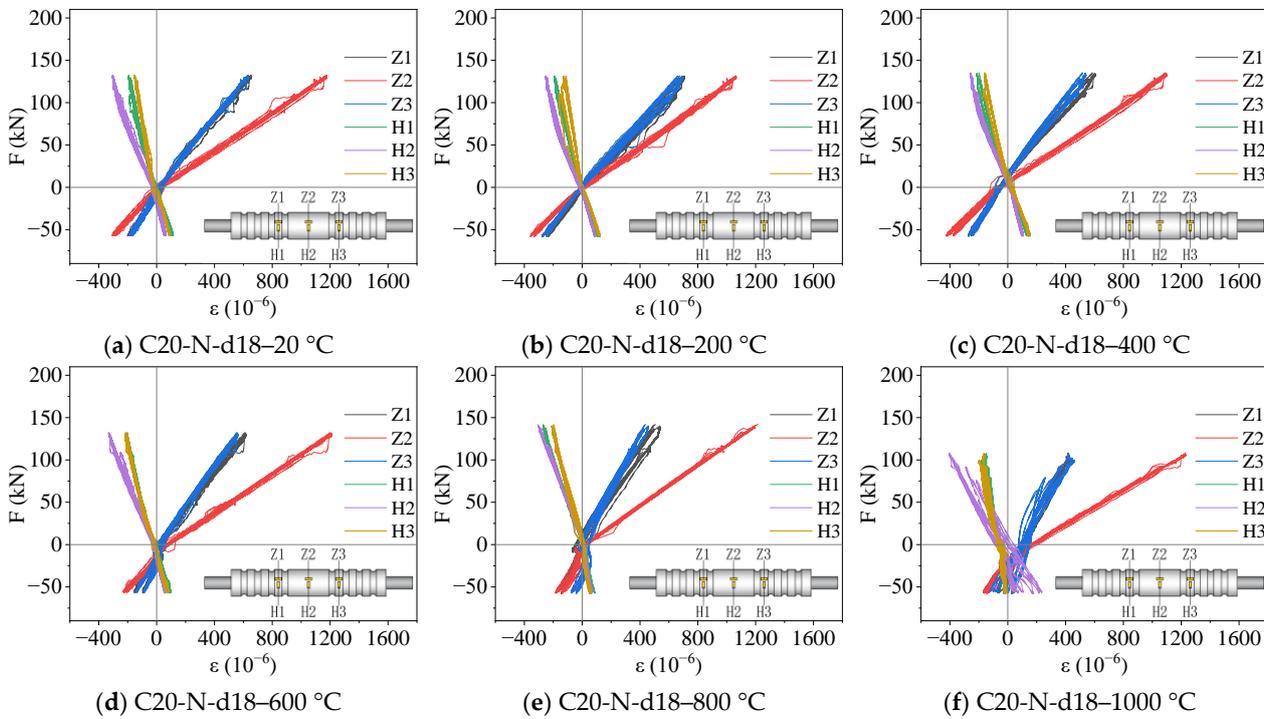
Figure 14. Load–strain curves of group 2 test pieces.

Comparing test pieces with different diameters, in group 2 (Figure 14), the paths of the Z1 and Z3 curves show a high degree of similarity. However, in the group 3 (Figure 15) and group 4 (Figure 16) test pieces groups, Z1 and Z3 show significant misalignment, indicating that the deformations of the test pieces with connecting steel bars belonging to group 2 are more uniform under high temperatures. In group 4 test pieces, as the temperature increases, the increment of strain values at measurement points Z1, Z3, H1, and H3 in the second cycle is greater than that in the first cycle, leading to an increase in residual strain. This suggests that in test pieces with larger steel bar diameters at high temperatures, the bond between the steel bars and the grout surface at the ribs is severely damaged.

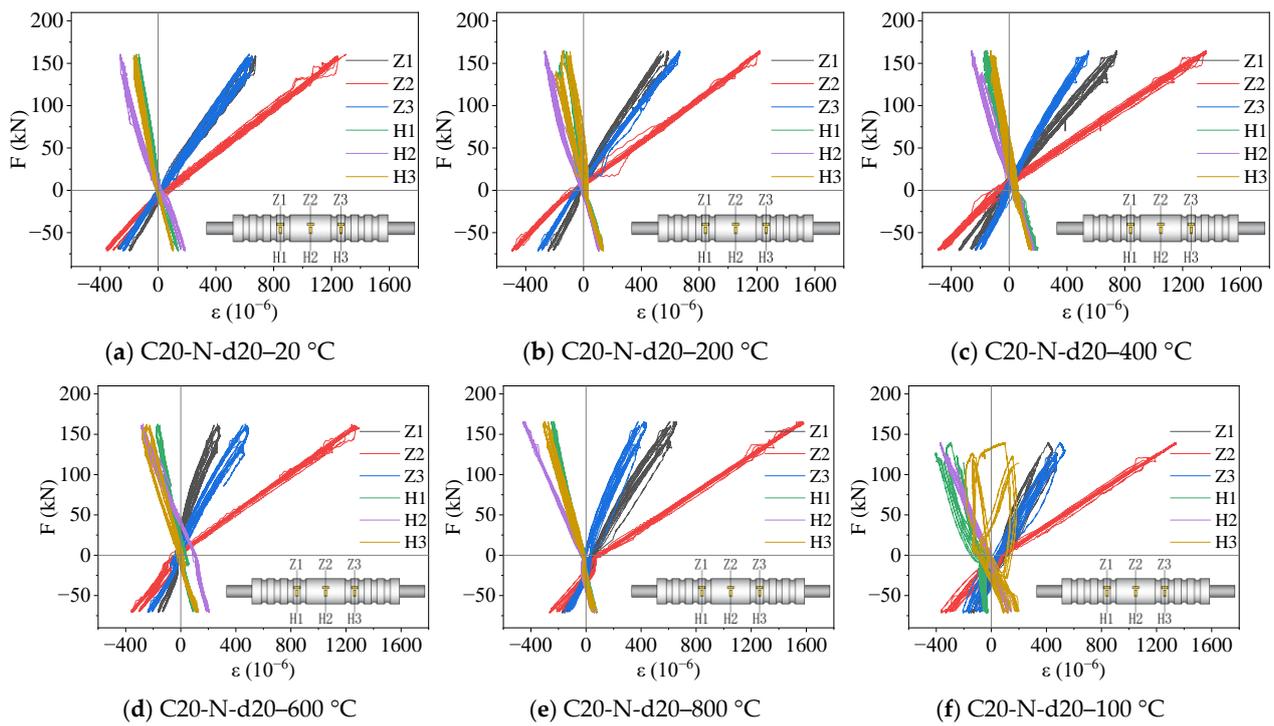
Figure 15. Load-strain curves of group 3 test pieces.

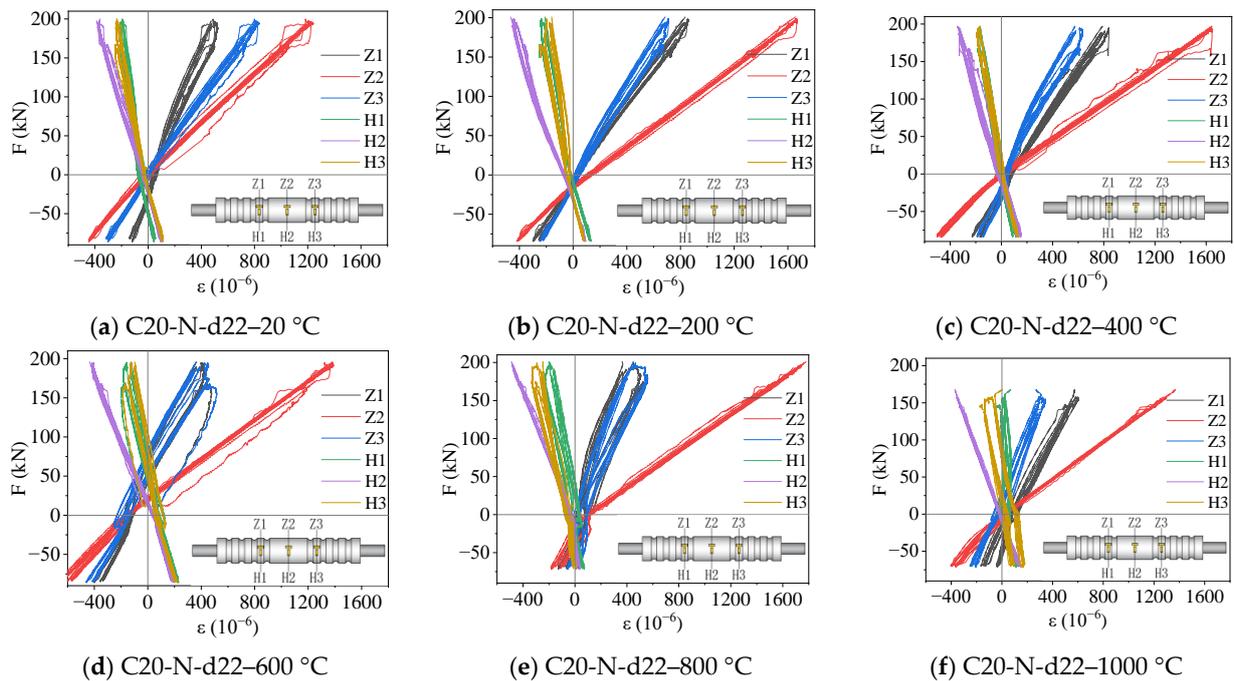
Figure 16. Load-strain curves of group 4 test pieces.

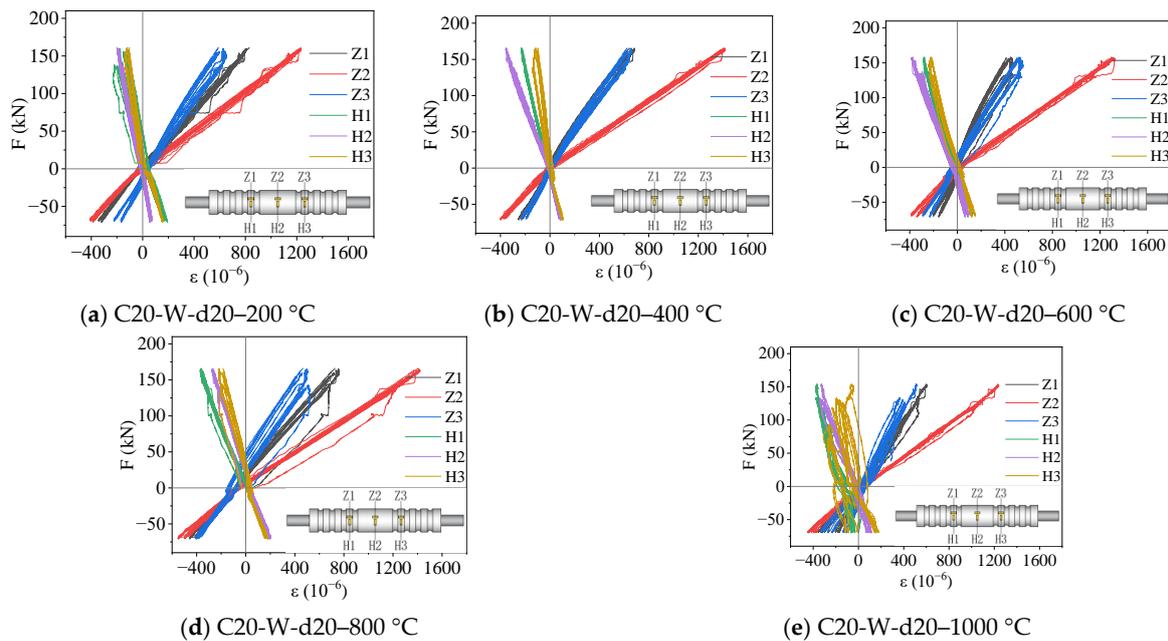
Figure 17. Load–strain curves of group 5 test pieces.

Comparing test pieces subjected to different cooling methods, belonging to group 3 and group 5 (Figure 17), after temperatures ranging from 20 to 600 °C, test pieces subjected to different cooling methods did not show significant differences. However, at temperatures of 800 °C and 1000 °C, the alignment of the Z1, Z2, and Z3 curves in the group 3 test pieces was better than that in the group 5 test pieces. This indicates that after experiencing temperatures higher than 800 °C, test pieces subjected to natural cooling demonstrate better elasticity under cyclic loading.

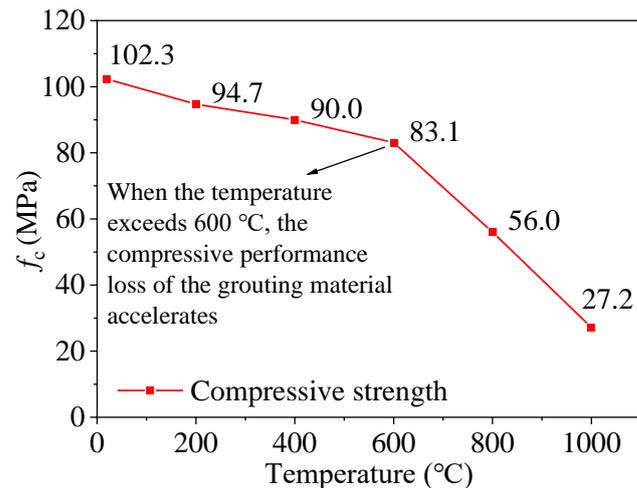
This article conducted compressive strength tests on 18 grouting material blocks. Figure 18 illustrates the relationship between the compressive strength of these grouting material blocks and temperature. After 600 °C, the compressive strength is 83.1 MPa, 15.98% lower than that at 20 °C. However, after the temperature reaches 600–1000 °C, the loss of compressive strength becomes larger. When the temperature reaches 1000 °C, the compressive strength of the grouting materials is only 27.50% of that at 20 °C, and the compressive performance is essentially lost.

Figure 18. Compressive strength of grouting material blocks at different temperatures.

After exposure to a temperature of 1000 °C (Figure 21f), C-S-H is essentially completely decomposed, and CaCO₃ begins to decompose under high-temperature conditions. Structural water undergoes extensive dehydration, resulting in a significant increase in internal pores. Large gaps and cracks appear between the aggregates, exacerbating the looseness of the grouting materials. Macroscopically, there is a sharp decline in mechanical performance. Comparing the SEM scanning results of the grouting materials after subjecting them to different temperatures, it can be seen that the deterioration degree of the grouting materials' microstructure changes significantly from 600 °C to 800 °C and then 1000 °C, which corresponds to the compressive strength curve of the grouting materials after different high temperatures (Figure 18).

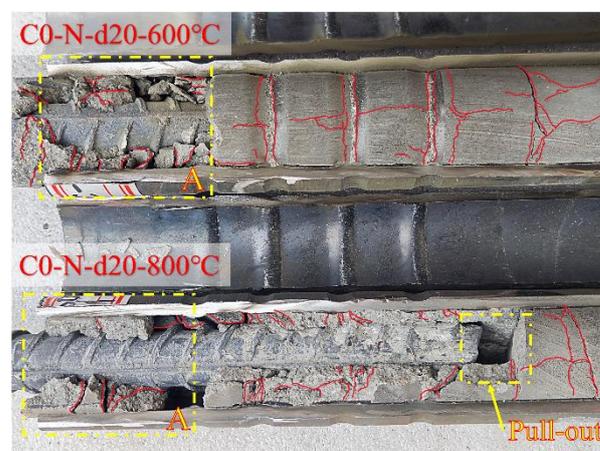
To further investigate the effect of temperature on the grouting materials of the sleeve, C0-N-d20–600 °C and C0-N-d20–800 °C test pieces were subjected to cut analysis (Figure 19). The observations reveal that grout cracks are mainly concentrated near the ribs, with significant lateral cracks in this area accompanied by a small amount of debris. This indicates that under cyclic loading, the ribs restrict the cyclic sliding of the grouting materials, leading to extrusion of the grout. At the end of the sleeve, as shown in region A of Figure 19, there are more cracks and greater fragmentation of the grouting materials. Additionally, due to the lack of rib constraints, the grouting materials are pulled out along with the steel bars.

Figure 19. Cutting of test pieces and crack distribution.

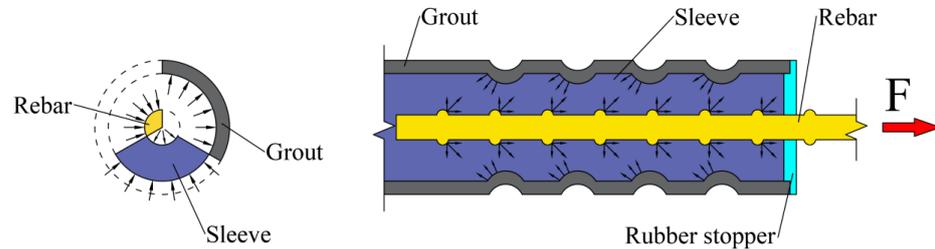
Figure 20 shows the local force model of the grouting materials in the grouting sleeve when it is under tension. The grouting materials are in a state of compression due to the constraints of the sleeve ring rib and the ribbed connecting steel bars during the cyclic load of the grouting sleeve.

Figure 20. Local force model of the grouting materials of the grouting sleeve under tension.

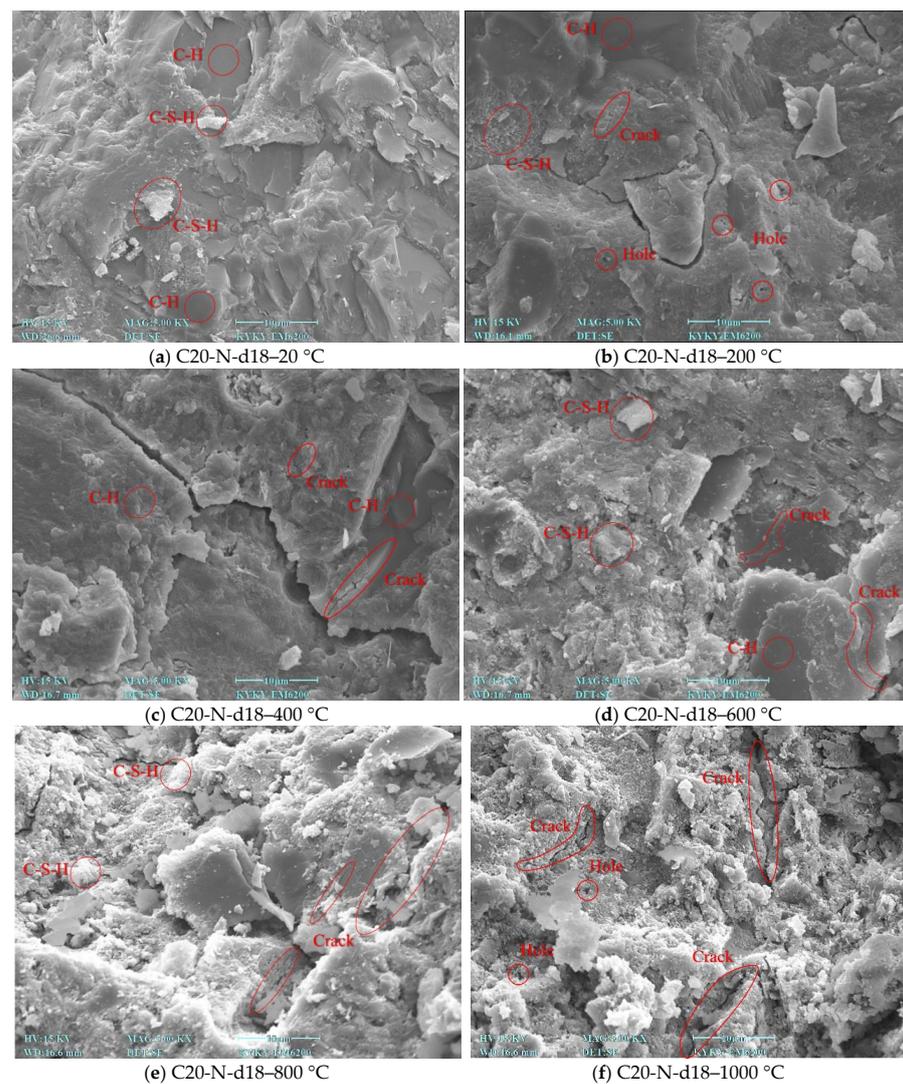
The test pieces belonging to group 2 were sampled, and the internal structure of the grouting materials was magnified by 5000 times with SEM. The results are shown in Figure 21. After 20 °C (Figure 21a), calcium hydroxide (C-H) and calcium silicate hydrate (C-S-H) show good adhesion to the aggregate surface, forming a continuous phase through the mutual bonding of hydration products, resulting in fewer voids.

Figure 21. SEM scanning results of the grouting materials belonging to group 2.

After 200 °C, the test pieces display the evaporation of capillary water and gel water. Microscopically, small pores can be observed (Figure 21b), but the overall structure remains largely unchanged compared to that at 20 °C ambient conditions. The grouting materials structure appears relatively dense, with good bonding of C-H crystals.

After 400 °C, as shown in Figure 21c, in addition to the evaporation of capillary water and gel water within the grouting materials, some crystalline hydrates begin to lose water molecules. The decomposition of C-H crystals becomes apparent, accompanied by the emergence of noticeable pores on the surface. Consequently, cracks further propagate, and the density of hydration products significantly decreases.

After reaching 600 °C (Figure 21d), further decomposition of C-H occurs, resulting in the appearance of unevenly sized crystalline particles and increased porosity. Cracks become more prominent, but there is no apparent complete penetration of cracks. The degradation of mechanical properties is relatively minor.

After the temperature reaches 800 °C (Figure 21e), C-S-H begins to decompose, with severe dehydration of structural water. Dispersed particles appear inside the grouting materials, and numerous interconnected microcracks emerge on the aggregate surface. Continuous or large pieces of hydrated cementitious gel are no longer present within the concrete. The overall structure of the grouting materials becomes loose and crumbly.

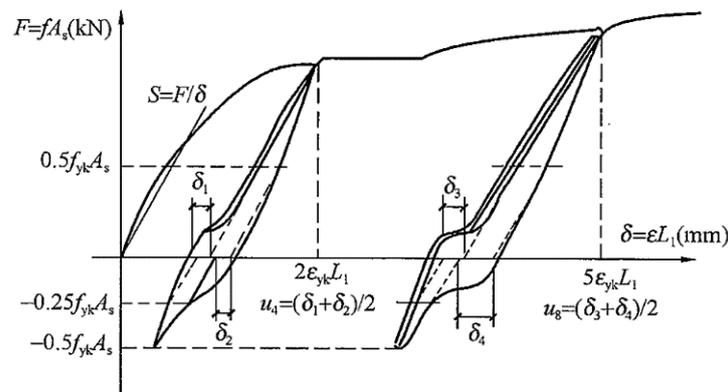
stipulate that $u_4 \leq 0.3$ mm and $u_8 \leq 0.6$ mm. The calculations of u_4 and u_8 are defined in Equations (1) and Equation (2) [14] and are shown in Figure 22.

Figure 22. Residual deformation calculation parameters.

$$u_4 = \frac{\delta_1 + \delta_2}{2} \quad (1)$$

$$u_8 = \frac{\delta_3 + \delta_4}{2} \quad (2)$$

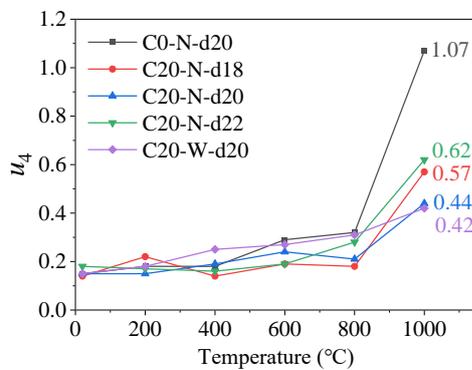
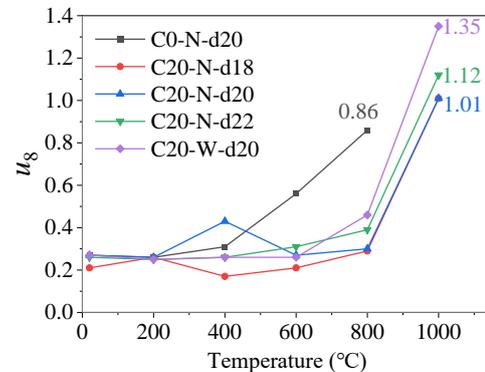
Figure 23 shows the variation trend of u_4 and u_8 of each test piece under large-strain cyclic loading. With the increase in temperature, the values of u_4 and u_8 have an overall upward trend, and as the temperature rises from 800 °C to 1000 °C, the slope of the curve increases sharply, indicating that large-deformation repeated tension and compression of the test piece occur. As shown in Figure 23a, between 400 °C and 1000 °C, both the value and the slope of group 1 are significantly larger than those of group 3. That reveals that the residual deformation u_4 of the test pieces without a protective layer is more obvious, so the protective layer can effectively reduce the mechanical loss of the grouting sleeve after exposure to a high temperature. In Figure 23b, the difference in the u_8 between group 3 and group 5 is 0.16 after 800 °C, but after 1000 °C, this value becomes 0.34, an increase of 112.50%. In other words, group 5 has a larger residual deformation at a higher temperature, which indicates that with the increase in the number of cycles, the grouting materials of the water-cooled test pieces are more seriously damaged after 1000 °C.

(a) Residual deformation after 4 cycles

(b) Residual deformation after 8 cycles

Figure 23. The residual deformation of test pieces under large-deformation repeated tension and compression.

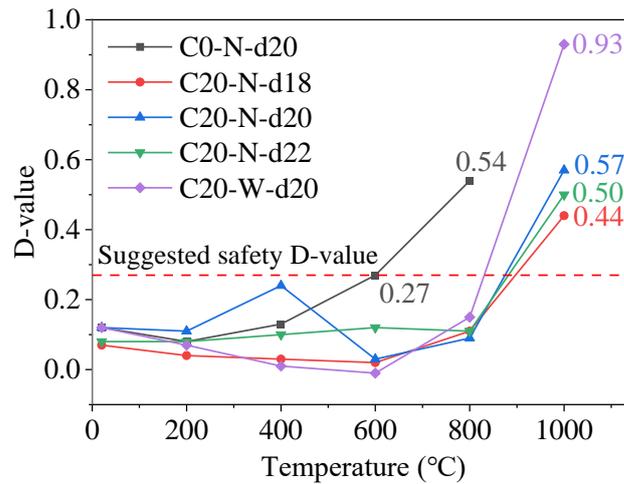
Figure 24 shows the difference between u_8 and u_4 (i.e., D-value), and also displays the second half of the residual deformation of the test pieces under large-strain cyclic loading. After the temperature is 800 °C, C0-N-d20–800 °C experiences steel bar pull-out failure, and its D-value is 0.54. When the temperature is 1000 °C, all the test pieces experience steel bars pull-out failure, and the D-value of C20-N-d18–1000 °C is the lowest, at 0.44. Based on the data above, to avoid steel bar pull-out failure, a safety D-value of 0.27 is recommended when fire and seismic design is performed for seamless steel pipe grouting sleeves.

Figure 24. The difference between the u_8 and u_4 of test pieces under large-deformation repeated tension and compression.

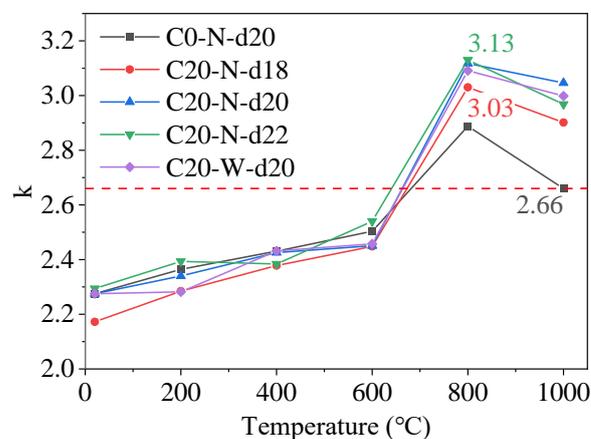
Figure 25 show the values of k for each test piece at different temperatures and their respective trends with temperature variation. In the range of 20–800 °C, the k value increases with increasing temperature. At 800 °C, the test pieces showing steel bar pull-out failure show a minimum k value of 3.03 (C20-N-d18–800 °C), while at 1000 °C, the minimum k value of 2.66 (C0-N-d20–1000 °C). Therefore, it is recommended in test piece design that the k value should not exceed 2.66.

Figure 25. Calculation results of test piece k values.
