# Exploration and Characterization of Dynamic Properties for Cultural Heritage Conservation: A Case Study for Historical Stone Masonry Buildings in Zanzibar

**Citation:** Ali, B.S.; Castro, J.J.; Omi, S.; Nazimi, K. Exploration and Characterization of Dynamic Properties for Cultural Heritage Conservation: A Case Study for Historical Stone Masonry Buildings in Zanzibar. *Buildings* **2024**, *14*, 981. <https://doi.org/10.3390/buildings14040981>

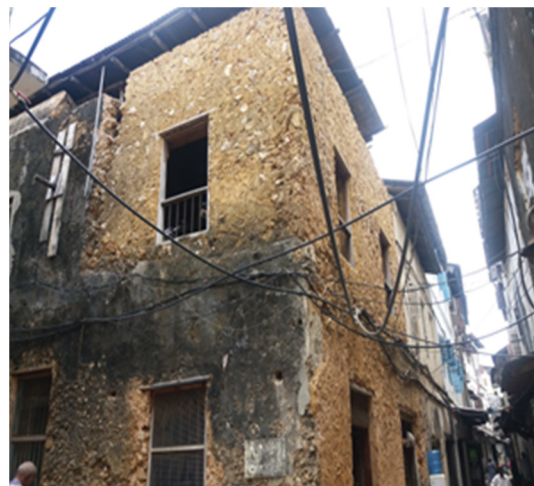
Figure 1. Example of a stone masonry wall.

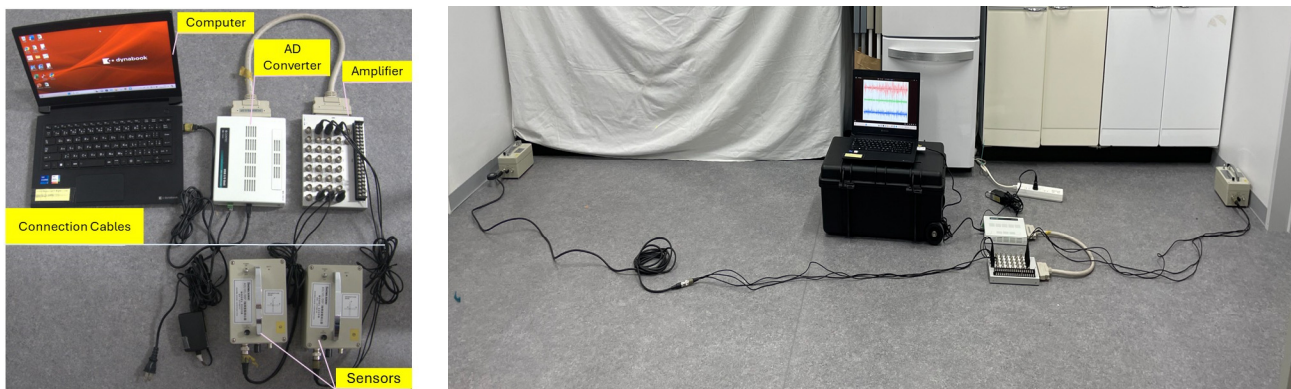
**Figure 5.** Pictorial illustration of AVT setup and deployment at various locations.

Two conductor cables connected the accelerometer to a computer workstation equipped with a data acquisition board for A/D and D/A conversion of the transducer signals, as well as for the storage of digital data. The periodic measurements were recorded at a 100 Hz sampling rate, with each recording lasting for 15 min at each point. Each observation point was taken multiple times to ensure data accuracy. Due to the limited number of sensors available, measurements were not taken simultaneously on each floor. The ambient response measurements and data acquisition took place on various days spanning from 18 December 2020 to 15 January 2020. Setting up the instruments typically requires approximately 30 min. The data collection was carried out continuously for a full day (10 h) for each of the buildings. The number of recorded points per floor varied depending on the complexity and accessibility of the structure. It was assumed that the buildings were subjected to excitations from wind, traffic, and human activities.
