Article

Evolution Law and Grouting Treatment of Water Inrush in Hydraulic Tunnel Approaching Water-Rich Fault: A Case Study

Citation: Gu, J.; Guo, J.; Chen, F.; Li, J. Evolution Law and Grouting Treatment of Water Inrush in Hydraulic Tunnel Approaching Water-Rich Fault: A Case Study. *Appl. Sci.* **2024**, *14*, 3407. <https://doi.org/10.3390/app14083407>

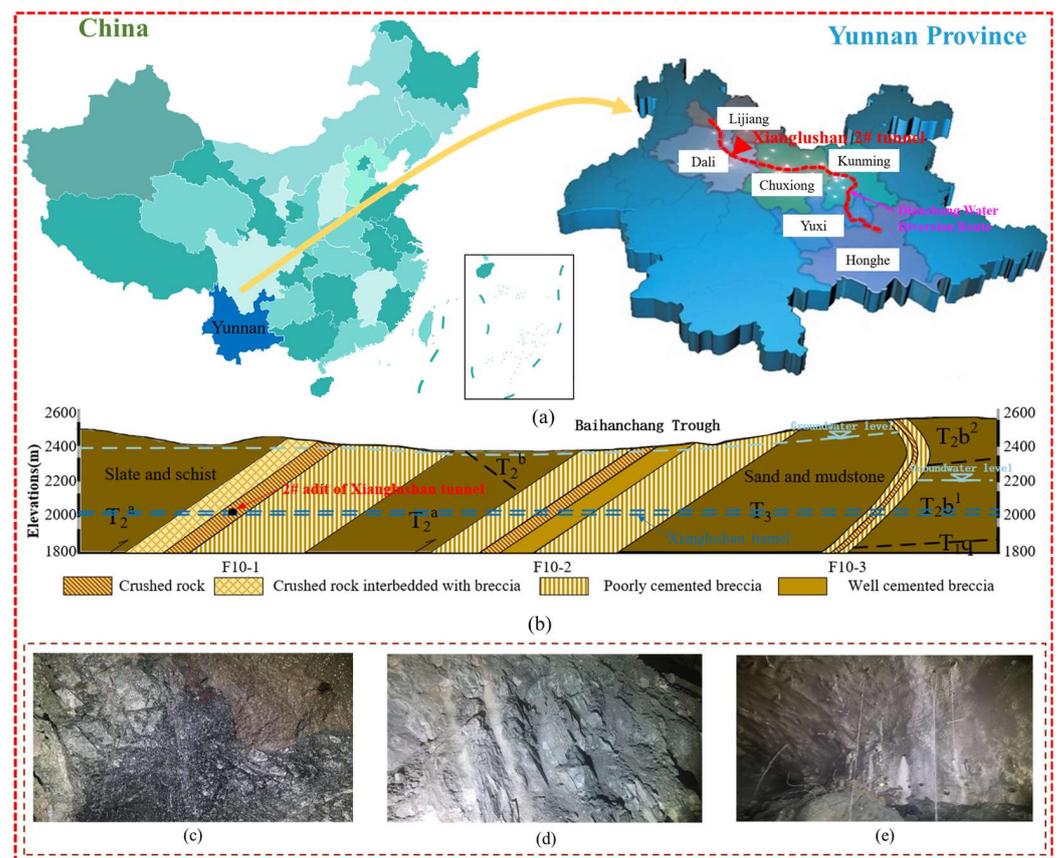
Figure 1. Overview of 2# adit of Xianglushan tunnel: (a) Location of 2# adit of Xianglushan tunnel; (b) Longitudinal geological profile of Xianglushan Tunnel; (c) Surrounding rock with fractured structure; (d) Misalignment situation; (e) Water leakage occurs in the tunnel.

The Xianglushan tunnel is located at the junction of the Hengduan Mountains and the central Yunnan Plateau, and it crosses the watershed of the Jinsha River and the Lancang River, with complex regional tectonic and geological conditions. The location of the Xianglushan tunnel is illustrated in Figure 1a. The total length of the tunnel is 62.60 km, with a depth of 600–900 m and a maximum depth of 1450 m, which is a typical super-long tunnel with a large depth. The rock masses of the Xianglushan tunnel revealed by the excavation are dark grey thinly bedded epidote schist and chlorite schist in the lower part of the Middle Triassic. The tectonic rocks are cataclasite, breccia, granulitic rock, powdery rock, and fault clay. The continued excavation would encounter the cataclasite zone, granulitic rock zone, powdery rock zone, and breccia zone, respectively. There is a risk of water inrush under high groundwater head after the excavation of the relatively poorly water-bearing strata (granulitic rock zone and powdery rock zone), as revealed in Figure 1c–e. The inappropriate treatment of water inrush may drain the groundwater system of the Baihanchang reservoir and even have a greater impact on the Baihanchang reservoir and the const.

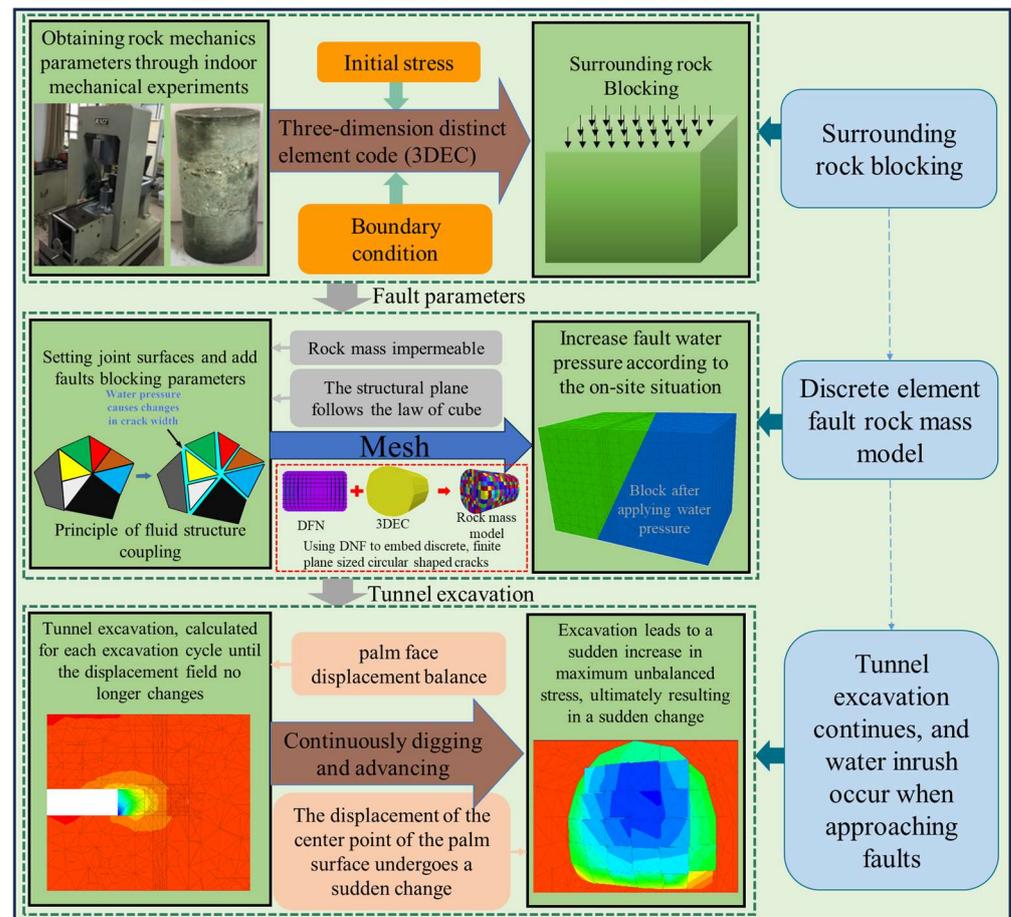
Figure 2. Numerical simulation calculation process of tunnel excavation approaching water-rich faults.

3DEC 5.20 software is a 3D discrete element programme focusing on discontinuous media, and it provides a powerful support for the in-depth study of deformation damage and movement of rock masses by employing an explicit solution method to compute the discontinuous motions of blocks. The M-C model is used for the calculation of surrounding rock blocks in the model. The joint constitutive model adopts the Mohr Coulomb slip model, which considers the shear failure and tensile failure of joints as well as the shear dilation of joints. The Mohr Coulomb joint slip model is applicable to the contact between rigid blocks and the contact between deformable blocks. The block can be further divided using DNF. Tetrahedral mesh is automatically generated in blocks, and each element mesh responds to a specified linear or nonlinear stress–strain relationship. The average length of the tetrahedral area after meshing was 2 m in this article. In this case, seepage in rock mass was regarded as a hydrodynamic coupling problem, which meant that changes in seepage pressure affected the mechanical deformation. At the same time, the mechanical deformation would in turn affect the seepage pressure. This interrelationship was accurately expressed in the hydrodynamic coupling formulation for discrete fracture networks, especially the effect of mechanical deformation on fracture permeability, which was mainly reflected by the change in fracture openness. The numerical simulation calculation process of tunnel excavation approaching water-rich faults is shown in Figure 2.

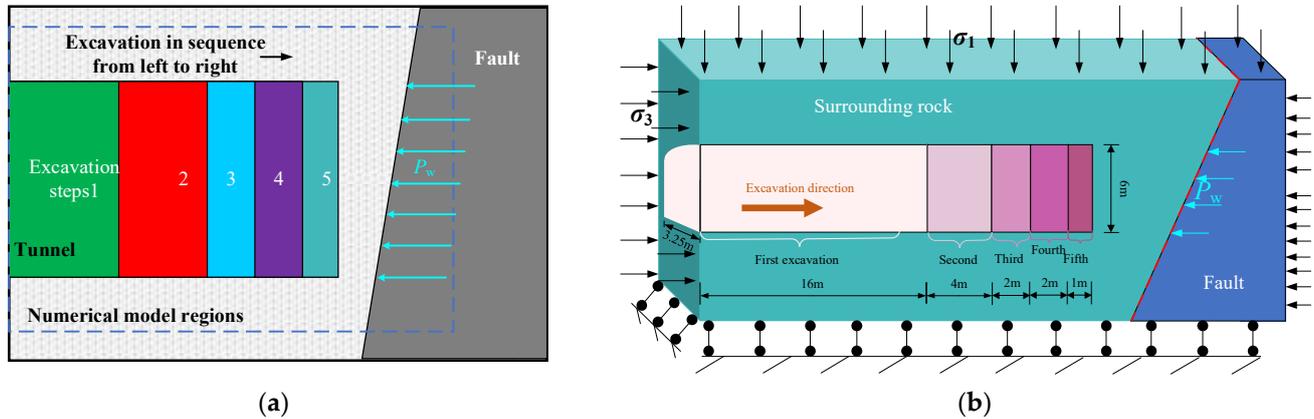
Figure 3. Tunnel fault system and its simplified numerical calculation model: (a) Tunnel–Fault System; (b) Simplified numerical calculation model.

The dip angle of the fault in the 2# adit of Xianglushan tunnel of the Central Yunnan Water Diversion Project is 70° . The length, width, and height of the numerical model were 60 m, 40 m, and 40 m, respectively. The tunnel adopted straight-wall and semi-circular-arch cross-sections, with a height of 6 m and a span of 6.5 m. The origin of the model was located at the center of the tunnel cross-section, and the coordinates of the x-axis of the left and right boundaries of the model were -20 m and 40 m, respectively. The fault zone was located at $x = 10$ m. The tunnel-fault system presented in Figure 3a was simplified and modeled in Figure 3b. After the model was established, the weight of the rock masses above the tunnel was converted into ground stresses according to the tunnel depth, which were then applied to the top boundary of the model. The bottom boundary of the model was fixed, and displacement constraints were applied to the left, right, front, and back boundaries. Constant water pressure was applied directly to the fault fracture zone. The tunnel was excavated from the left side (i.e., at $x = -20$ m) of the model. The numerical model of the tunnel crossing the water-rich fault zone is displayed in Figure 3.

reduced to 1 m at $x = 4$ m until the damage of the water-resistant rock mass at the tunnel face occurred, as displayed in Figure 3b. Eight monitoring points were set up at the tunnel face to monitor the displacement and water pressure after each excavation. The excavation simulation ended when the maximum unbalanced stress and the transverse displacement at the center of the face converged, and the model damage was identified by the sudden change in the displacement at the center of the face.

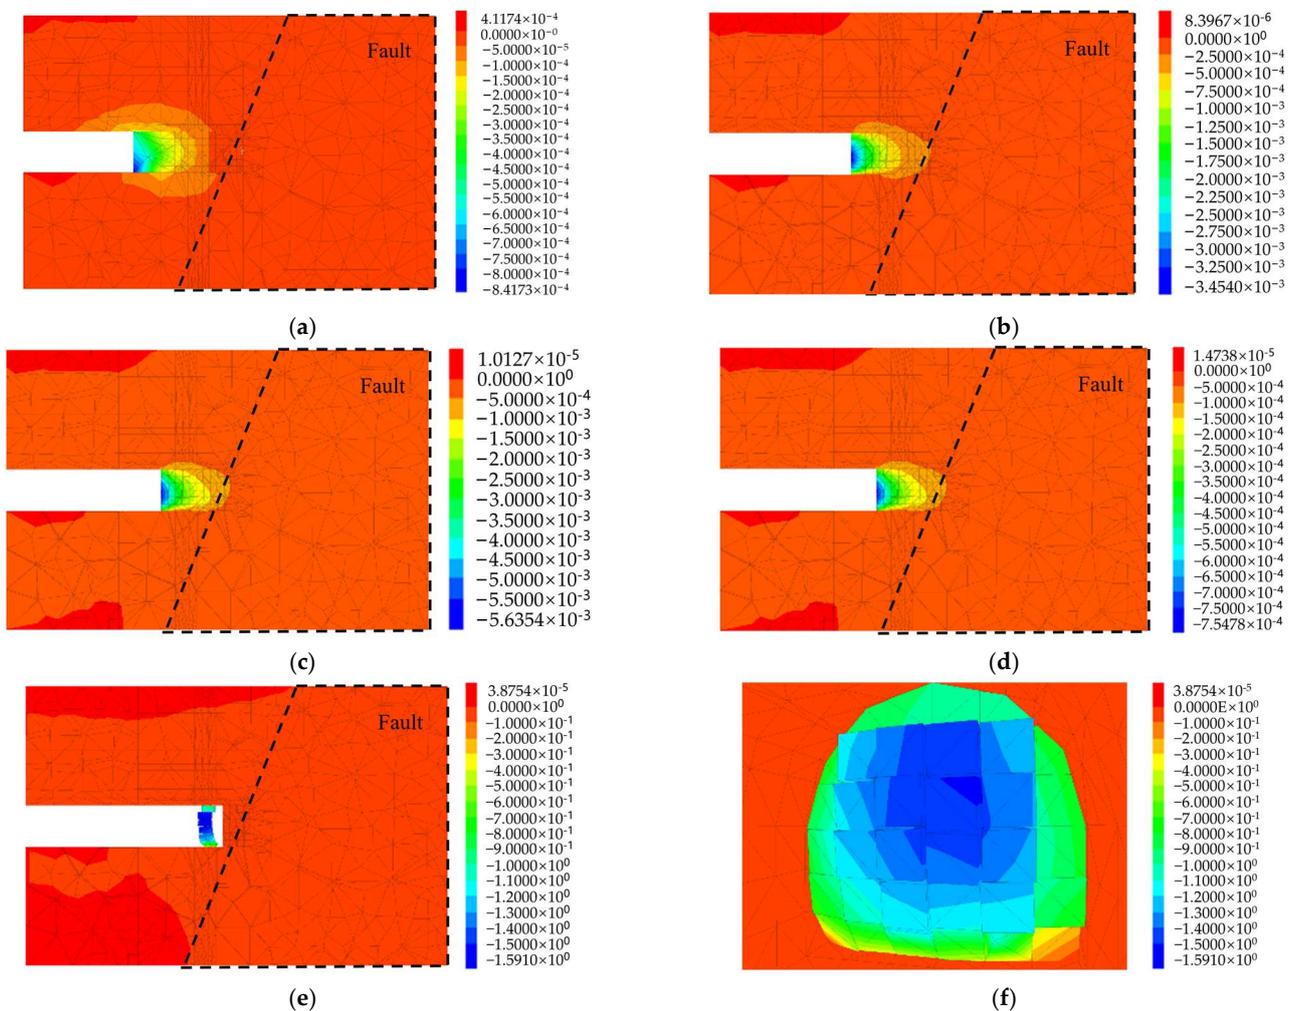
Figure 4. Evolution process of displacement field (unit: m): (a) First excavation ($h = 14$ m); (b) Second excavation ($h = 10$ m); (c) Third excavation ($h = 8$ m); (d) Fourth excavation ($h = 6$ m); (e) Fifth excavation ($h = 5$ m); (f) Local failure at $h = 5$ m.

A scenario with a tunnel depth of 400 m, a fault dip angle of 50°, and a water pressure of 2 MPa was selected for analysis. Figure 4 illustrates the process of tunnel face excavation crossing the water-rich fault fracture zone until the occurrence of water inrush damage, where the numbers in different colors indicate the displacements and h is the distance between the tunnel face and the fault. The displacement nephograms in Figure 4 indicated the displacement conditions when the model was in equilibrium after each excavation, and the displacement nephogram after the 5th excavation was the displacement condition when the face was obviously destabilized and damaged. Figure 4a–d confirmed that the maximum transverse extrusion displacements of the water-resistant rock mass at the face after the first, second, third, and fourth excavation steps were 0.84 mm, 3.45 mm, 5.63 mm, and 7.54 mm, respectively, which were increased by 2.61 mm, 2.18 mm, and 1.91 mm, respectively. This indicated that with the tunnel advancing towards the fault, the maximum transverse extrusion displacement of the water-resistant rock mass at the face increased

continuously under the joint influence of excavation disturbance and fault water pressure. Meanwhile, after the excavation was completed, the displacement of the lower part of the face on the axial longitudinal section of the tunnel was significantly larger than that of the upper part, indicating that the fault dip angle had a significant influence on the tunnel excavation. Figure 4d–f demonstrated that when the 4th excavation of the tunnel was advanced to $x = 4$ m, the water inrush damage did not occur yet. When the face was excavated to $x = 5$ m, the maximum transverse extrusion displacement reached 1.59 m. The water-resistant rock mass could not maintain stability, and its displacement changed abruptly. The fissures inside the rock mass were continuously generated and expanded to form a seepage channel. Finally, the water-resistant rock mass at the face collapsed and damaged under the joint action of excavation and fault water pressure, resulting in a water inrush disaster. Figure 4f revealed that there were obvious displacement changes in the blocks at the face, and it was expected that a large number of blocks would enter the tunnel if the calculation was continued. It was therefore concluded that under this scenario, the minimum safety thickness of the water-resistant rock mass at the face of the tunnel crossing the water-rich fault was about 5–6 m.

that after the completion of the fifth excavation step, the displacements at measuring points on the face (monitoring section of $x = 5$ m) suddenly increased, with obvious face instability and water inrush. It could be considered that the water-resistant rock mass at the face underwent destabilization damage, which was consistent with the interconnected damage of the water-resistant rock mass at the face after the completion of the fifth excavation step in Figure 4.

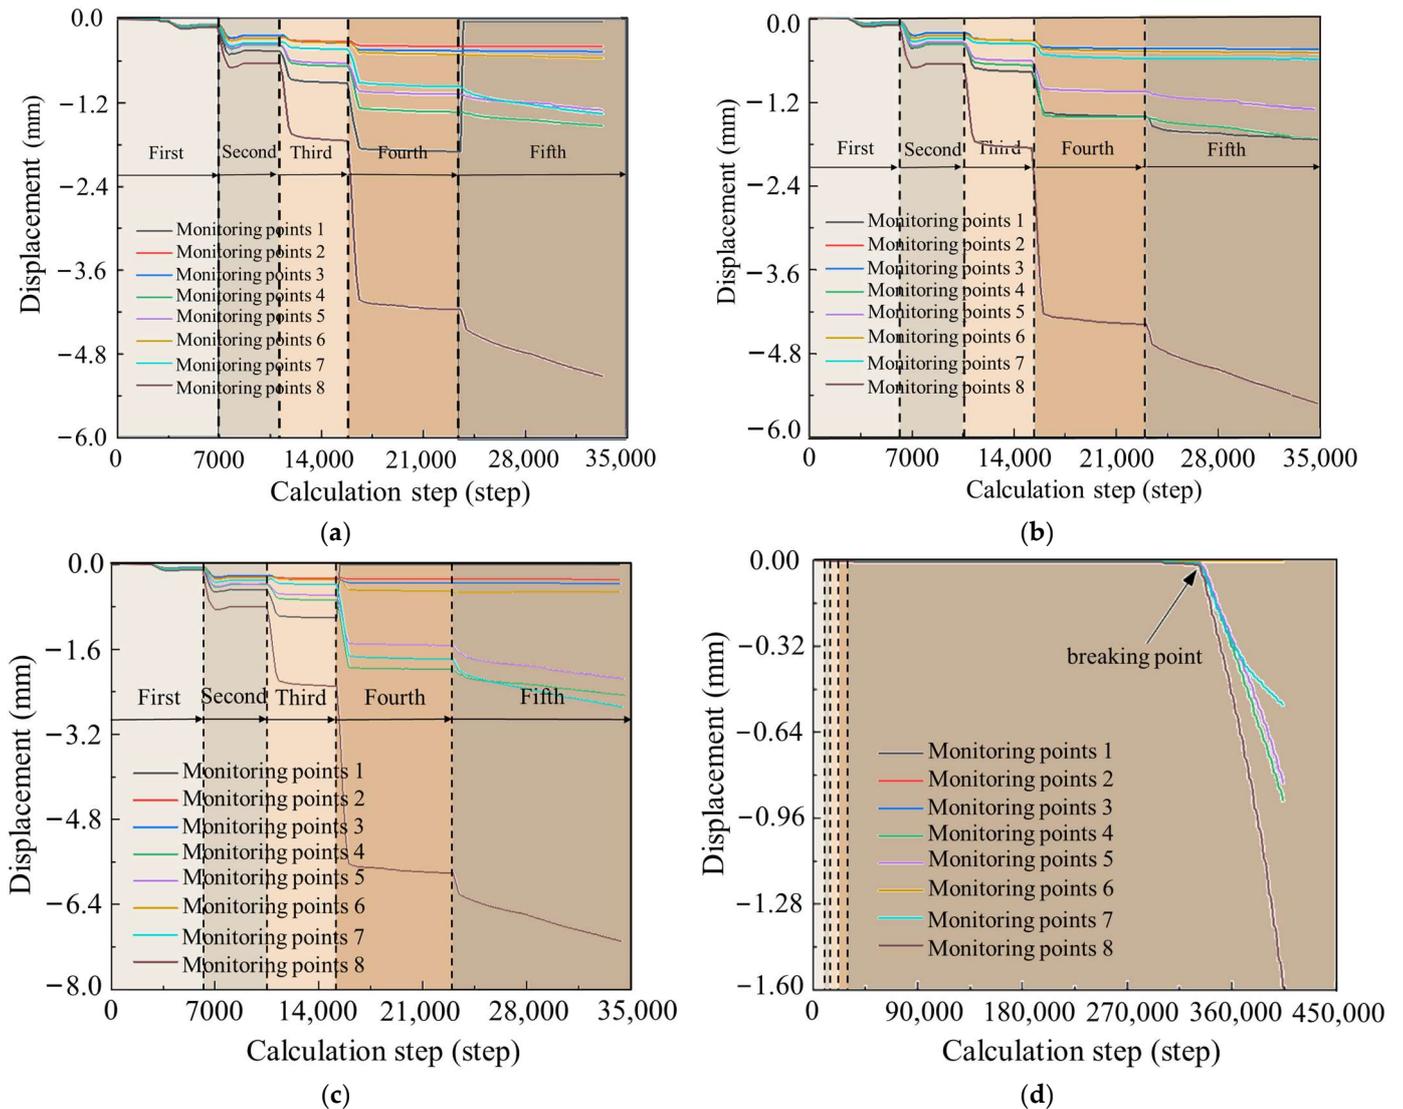
Figure 5. Monitoring point displacement curve: (a) $h = 3$ m; (b) $h = 4$ m; (c) $h = 5$ m (Before 35,000 steps); (d) $h = 5$ m.

each monitoring section. The change curves of displacements at monitoring points on each monitoring section are displayed in Figure 5. It should be noted that the number of calculations in the horizontal coordinates in Figure 5a–c is not the final number of calculations corresponding to the damage of the face. The 35,000 calculations were taken to demonstrate the staged development of the displacements at each measuring point with multiple excavations of the tunnel and the variability of the displacement changes at each measuring point, which can be reflected in Figure 5d.

Figure 5 revealed that as the excavation of the tunnel face advanced, different degrees of displacement response were observed at each monitoring point on different monitoring sections, and the change trends at all monitoring points were basically the same. The change trends of transverse displacement at the same monitoring position on different monitoring sections were identical. As the face gradually approached the water-rich fault, the displacement became larger with increasing growth magnitude. After the completion of the fourth excavation step, the closer the monitoring section was to the face, the greater the transverse displacement was at each monitoring point. On the same monitoring section, the displacement at monitoring point 8 (at the center of the face) was much larger than those at other monitoring points at the edge of the face. It was observed from Figure 5d

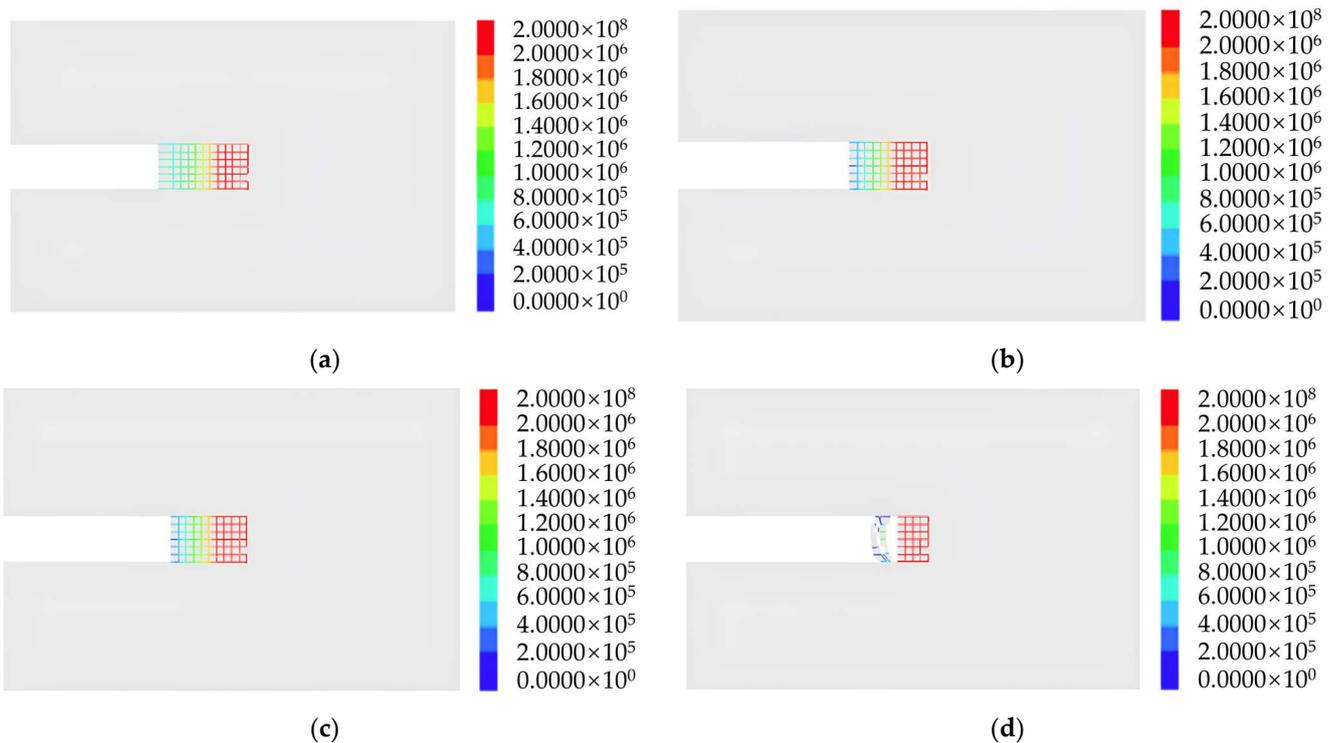
Figure 6. Evolution law of seepage field (unit: Pa): (a) Second excavation ($h = 10$ m); (b) Third excavation ($h = 8$ m); (c) Fourth excavation ($h = 6$ m); (d) Fifth excavation ($h = 5$ m).

During the excavation of the fault-crossing tunnel, the evolution of the seepage pressure field of the water-resistant rock mass at the face is displayed in Figure 6. Figure 6a demonstrated that after the completion of the second excavation step, the fault water entered the fissure connecting the water-resistant rock mass and the fault fracture zone, but the seepage effect of the face was not obvious at this time. It could be observed from Figure 6b,c that the seepage effect was increasingly obvious, and the closer the face to the fault, the faster the water pressure increased. Figure 6d confirmed that after the completion of the fifth excavation step, the water-resistant rock mass at the face was destabilized and damaged under the seepage. For each excavation of the tunnel, eight monitoring points were set up on the excavation surface to monitor the change in water pressure. Since the displacement response at the center of the face was more pronounced than that at the edges during the excavation, the change in water pressure at the center of the face was analyzed. The change curves of water pressured at measuring points (6,0,0), (7,0,0), and (8,0,0) are displayed in Figure 7.

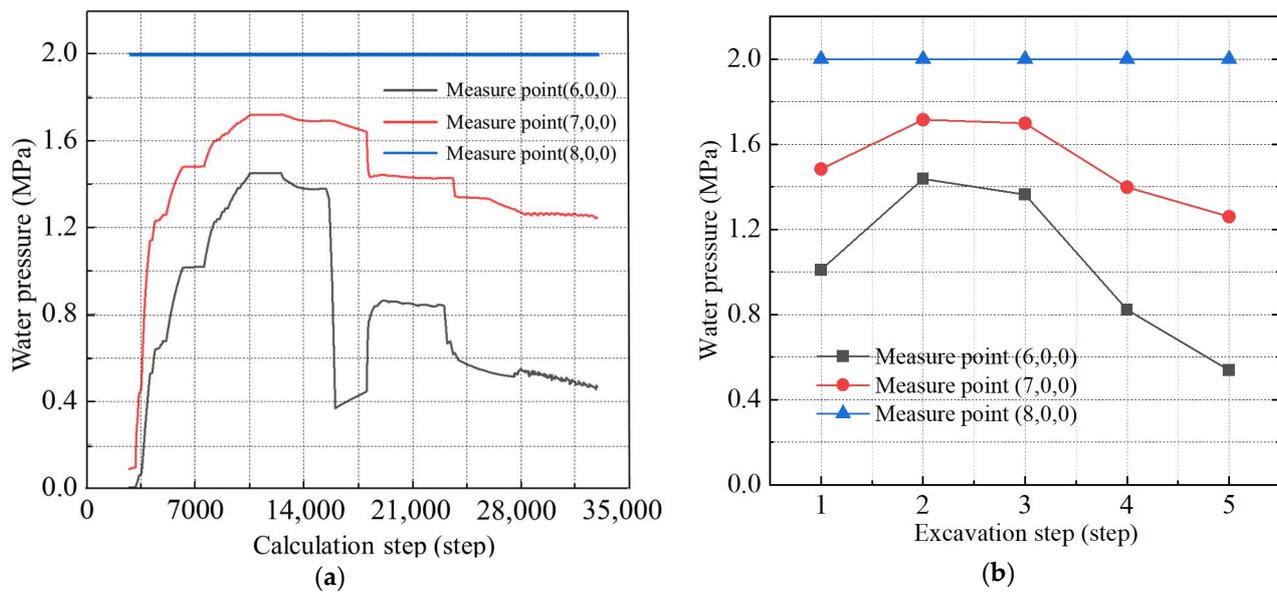
Figure 7. Water pressure change curve: (a) Water pressure variation curve with calculation step; (b) Water pressure variation curve with excavation step.

Figure 7 showed that the water pressure of the fault at measuring point (8,0,0) was constant at 2 MPa. With the continuous excavation of the tunnel, the water pressures at measuring points (6,0,0) and (7,0,0) followed the same trend before the damage of the water-resistant rock mass. As the face gradually approached the fault, the water in the fault continuously entered the fissure, resulting in the rising water pressure. When the water-resistant rock mass at the face of the tunnel was damaged, the fissure was connected to the face, which led to the water flowing out from the face and the sudden decrease in fissure water pressure. The water-resistant rock mass underwent a large deformation under the joint action of disturbance stress and water pressure, and the blocks in the model were squeezed or separated from each other, resulting in a sharp change in the fissure width.

The variation in water pressure at each measuring point indicated that water in the fault flowed into the fissure at the early stage of tunnel excavation, and water pressure in the fissures increased continuously. Once the excavation face intersected the pre-established fissures, the water in the fissures flowed out from the face under the influence of the excavation disturbance, and the water pressure decreased. Then, the water pressure continued to rise under the recharge of fault water. When water inrush damage of the water-resistant rock mass occurred, the water pressure at each measuring point near the damage area increased sharply.

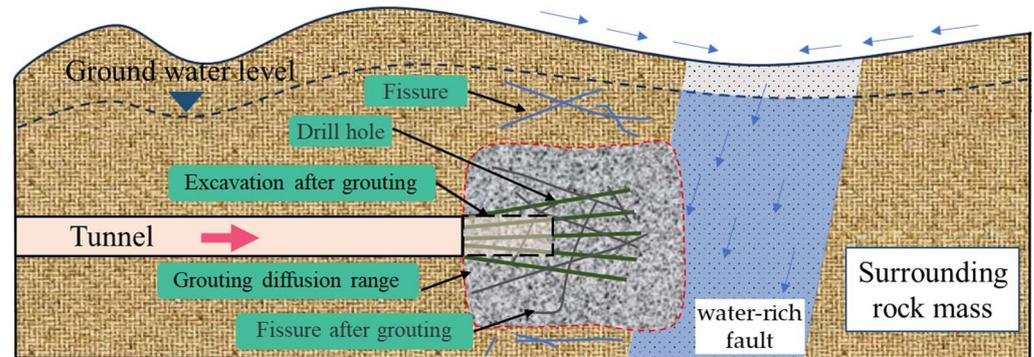
Figure 8. Mechanism of grouting reinforcement.

stability, and seepage resistance. The slurry can effectively fill the cracks in the surrounding rock, thereby blocking the underground water seepage channel. Therefore, rock mass grouting is effective in preventing the water inrush disasters of the tunnel adjacent to the water-rich fault. The mechanism of grouting reinforcement is illustrated in Figure 8.

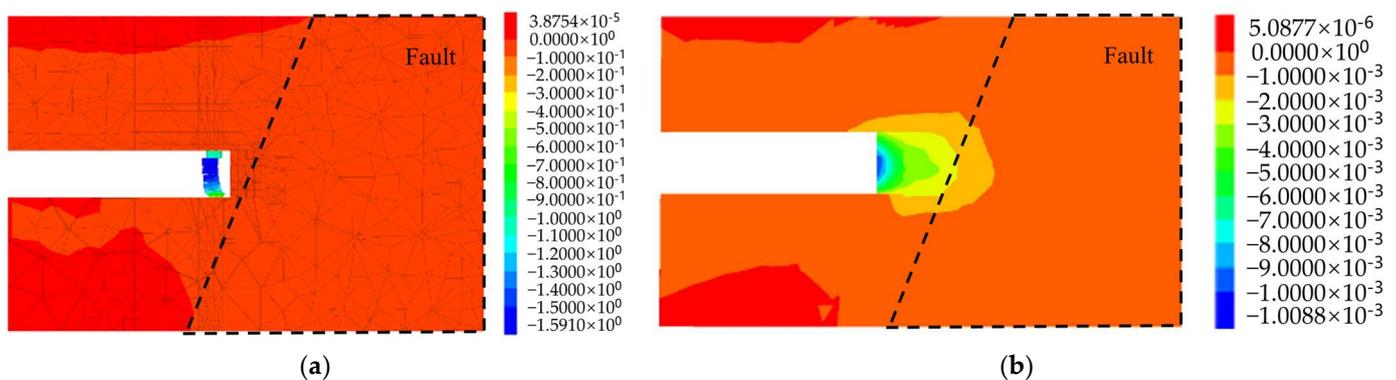
Figure 9. Displacement field for excavation to step 5 before and after grouting (unit: m): (a) Displacement field for excavation to step 5 before grouting ($h = 5$ m); (b) Displacement field for excavation to step 5 after grouting ($h = 5$ m).

To ensure the feasibility and reliability of the grouting scheme, numerical simulation experiments of the excavation of the tunnel adjacent to the fault after grouting reinforcement were performed. After the completion of the fifth excavation step of the face ($x = 5$ m), the displacements before and after grouting are displayed in Figure 9. When the fifth excavation step of the face with grouting was completed ($x = 5$ m), the maximum displacement after grouting was only 10.09 mm, as indicated in Figure 9b. In this case, no water inrush damage occurred. In contrast, when the fifth excavation step of the face without grouting was completed ($x = 5$ m), water inrush damage occurred, as presented in Figure 9a. The results confirmed that the grouting reinforcement was effective and the prevention and control measure was feasible.

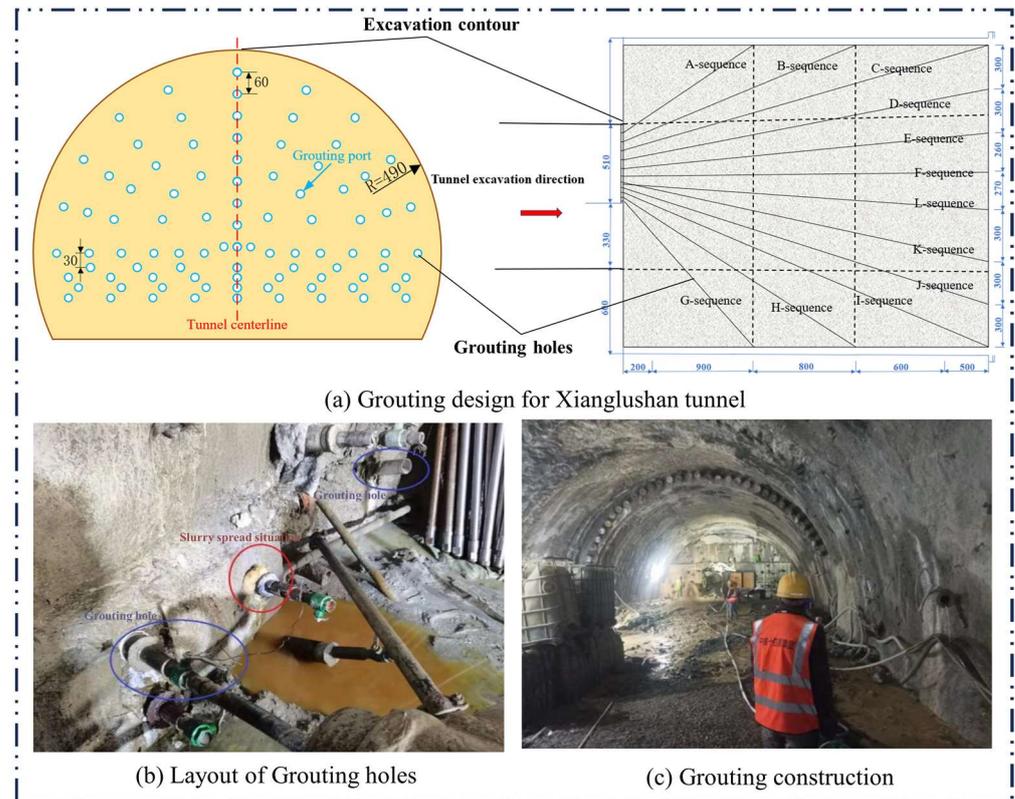
Figure 10. Grouting hole arrangement and grouting site.

The middle bench of the 2# adit of Xianglushan tunnel was first excavated and supported at the face, and a C20 grouting wall with a thickness of 2.0 m was applied to the face. The range of the grouting reinforcement circle was 6 m outside the excavation profile, and the length of cyclic grouting was 30 m. The length of cyclic excavation was 25 m, and a 5 m long grouting rock disc was retained in each cycle. The layout of grouting holes is illustrated in Figure 9a. The grouting holes were arranged in the excavation direction from the face with a form of umbrella radiation. The radius of slurry diffusion was 2 m, and the distance between the bottom of the holes was not more than 3 m. The sequence of drilling and grouting followed the principle of “from the outside to the inside, from the bottom to

the top, and jumping the holes at intervals” to achieve contour-controlled grouting and compacted reinforcement. The drilled and finished hole conditions suggested that the forward-type or backward-type segmental grouting method could be utilized. Grouting slurry was cement slurry with a water–cement mass ratio (W/C ratio) of 0.5–1:1. The design grouting pressure (final pressure value) was 4.5–6 MPa or the hydrostatic pressure at the grouting place plus 2 MPa. The grouting site and the diffusion of grouting holes are presented in Figure 10b,c.

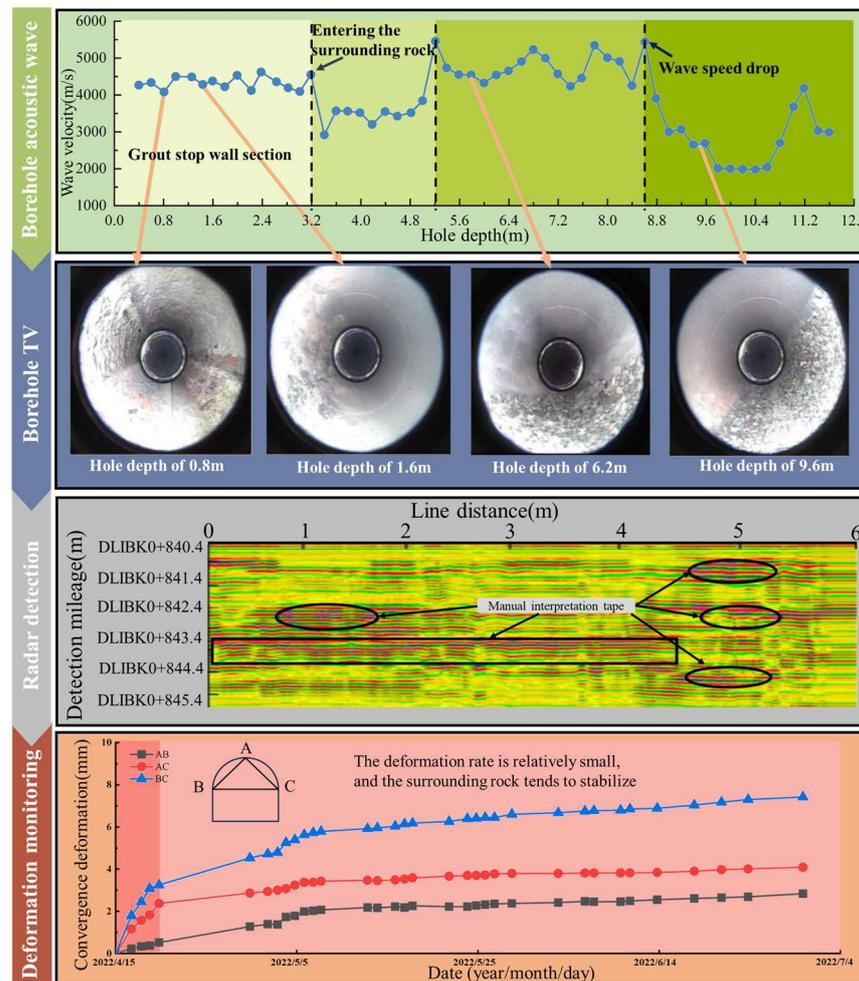
Figure 11. Results of borehole acoustic, borehole TV, geo-radar detection, convergence monitoring.

As depicted in Figure 11, the average values of wave velocity after grouting reinforcement were larger, which identified an excellent grouting effect. Meanwhile, the borehole TV was used for videotaping rock masses in the inspection holes to visually assess the integrity of the strata, the cementation of the grouting reinforced rock bodies, and the location of the water inrush. The results of the borehole TV showed that the integrity of grouting reinforced rock bodies improved significantly and that the rock mass had the self-stabilization ability. No collapsed holes were observed, and the grouting reinforcement effect of the rock mass was remarkable. Portable geological radar was employed to detect the grouted rock mass and to identify the weak areas of grouting. The elliptical circled area was the water-bearing zone. The rectangular area was the artificial interpretation zone, whose signals were abnormal, and the information of this area was ignored for interpretation. The reflected wave groups in the radar images before grouting were few and horizontally distributed, while those after grouting were more energetic and exhib-

ited a chaotic pattern with no regularity in the vertical and horizontal directions. This phenomenon demonstrated the change in the structure of the soil layer after grouting, which led to the destruction of the original soil layer after the slurry penetrated the soil layer. Horizontally and vertically distributed grouting areas or the staggered distribution of ungrouted areas formed a reflective surface between grouted and ungrouted areas. Due to the unevenness of this distribution, the above phenomenon reflected by radar images demonstrated the reinforcement effectiveness of the grouting. A convergence monitoring deformation analysis was carried out on section DLIBK0+840 of the tunnel. Since the upper bench was under excavation when the monitoring was conducted, the convergence monitoring points were arranged in the upper bench. Monitoring points A, B, and C were placed in the vault, left abutment, and right abutment, respectively. The convergence deformation of tunnel rock mass after grouting was controlled within 8.00 mm, which could ensure the safe construction of the tunnel.

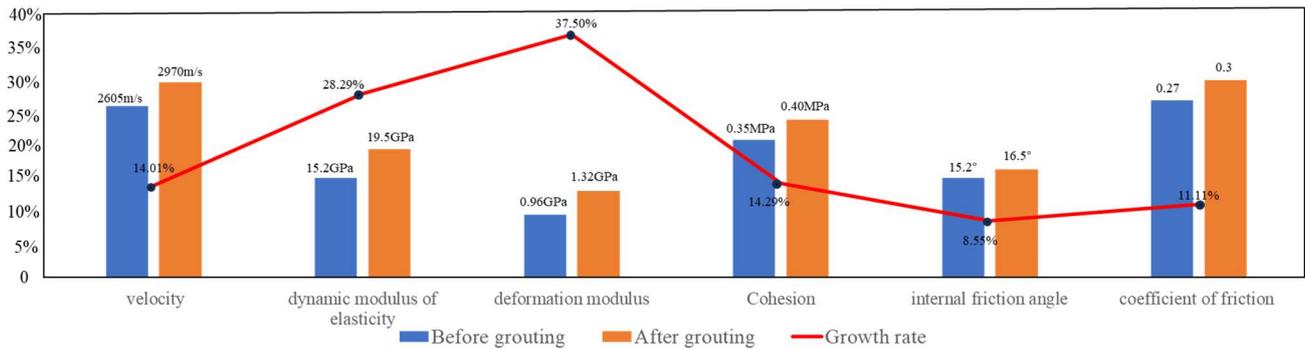
Figure 12. Comparison of mechanical parameters of surrounding rock in the grouting section before and after grouting.

According to the laboratory mechanical test results of the core samples from the inspection holes, the comparison of the mechanical properties of the rock mass before and after the grouting of the 2# adit of Xianglushan tunnel was presented in Figure 12. The deformation modulus of the rock mass after grouting was increased by 37–53%. The rock mass possessed better elastic deformation capacity to external loads, which slowed down the deformation process of the rock mass. The shear strength parameters (cohesion c and friction coefficient $\tan\phi$) were increased by 10–14%, which enhanced the overall adhesion and improved the shear and sliding resistance of the rock mass.

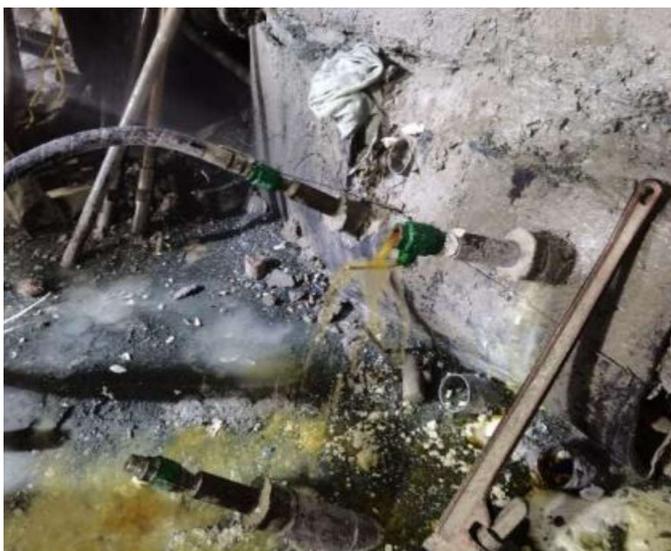
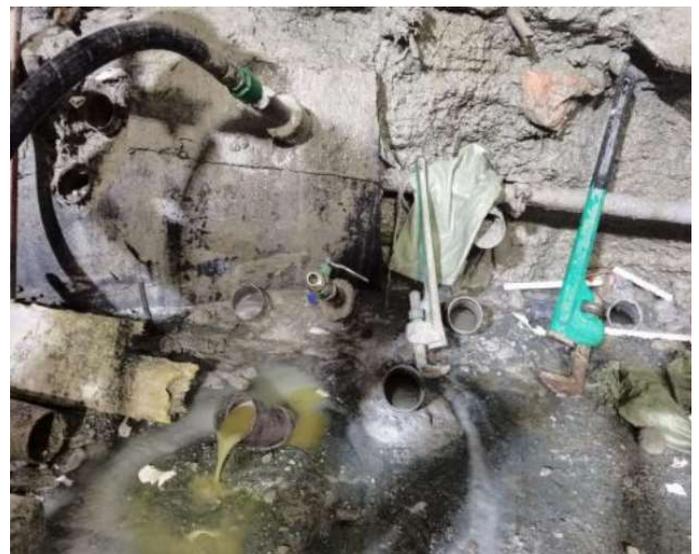
Figure 13. Water gushing situation of inspection hole: (a) Inspection hole of CGJ10-32; (b) Inspection hole of CGJ11-32.

The water discharge situation of inspection hole and coring result are shown in the Figure 13. The slurry was well filled, with good densification, no obvious fractures were found, and the slurry had a high coagulation strength with the rubble mass. After grouting, the construction unit conducted a water pressure test on the inspection hole, and the depth of the inspection hole is generally slightly less than 10m, located within the range of the grouting reinforcement circle. The decreasing permeability of inspection holes is shown in Table 3. The average permeability of the inspection holes after grouting was 3.32 Lu, compared with the average permeability of 4.39 Lu before grouting, the permeability was reduced by 24%, which indicated that the rock mass was reinforced to some extent after grouting. The inspection hole on the right side of the tunnel face changed from flowing water to dripping water after grouting, and there was no water gushing in the later stage. Multiple boreholes are drilled in the lower left corner of the tunnel face, and the water gushing significantly decreases or stops after the diffusion of slurry.
