Article

Impact of Vetiver Plantation on Unsaturated Soil Behavior and Stability of Highway Slope

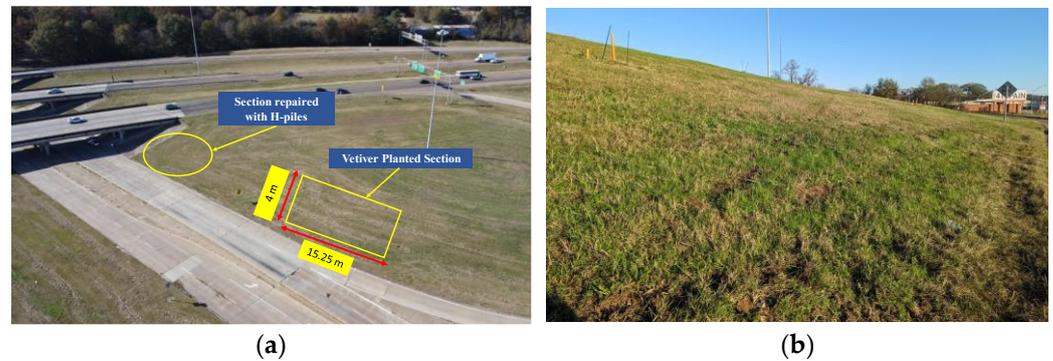
Figure 3. (a) Location of the study site; (b) Vetiver grass planted on the slope.

The slope near Terry Road along Interstate I-20 Interchange in Jackson, Mississippi, was selected for the study. The slope soil type is Yazoo clay, characterized as a highly expansive soil with a weathered upper zone overlaying unweathered clays. Weathered Yazoo clay typically exhibits a plasticity index exceeding 50%, attributed to a liquid limit ranging from 70% to 100% and a plastic limit of 20% to 30%. Previous observations [5] indicated signs of slope movement at 1.5 m depth. A section of the slope near the existing bridge experienced a shallow rainfall-induced landslide, which was repaired using H-piles. A study conducted on the impact of rainfall on the slope's shear strength found that the slope soil exhibited an increased void ratio with an increase in the number of wet-dry cycles. Stability analysis conducted on the representative slope observed a reduced factor of safety due to rainfall events [2]. The slope has a height of 4.572 m and a slope ratio ranging from 3.5H:1V to 4H:1V. The movement of the section without the H-pile was monitored using an inclinometer for one year starting from January 2019. The inclinometer data indicated a movement of up to 1.6 inches at the slope surface for the year 2019 [5]. For reinforcement, a 15.25 m wide section of the slope was chosen, and the 'Sunshine' Vetiver grass genotype (*Chrysopogon zizanioides* or *Vetiveria zizanioides*) was planted at a spacing of 0.6–0.9 around an area of 65 m² (Figure 3). The plantation was done at the section where there were no H-piles installed. Due to the tropical character of the grass, planting was conducted to guarantee adequate precipitation, which promotes grass growth. The plantation was done in a staggered way. As the Vetiver root is fibrous enough to spread inside the slope

soil, the spacing of 30.48 cm (1 ft) was taken considering the ease of the manual plantation process. It is suggested to plant the Vetiver at the beginning of the rainy season to have sufficient irrigation [43]. Considering this, the plantation was conducted in July 2020 when there was a lot of rainfall in Mississippi. The grass was allowed to grow naturally, and no modifications were made to the surrounding vegetation during the planting process.

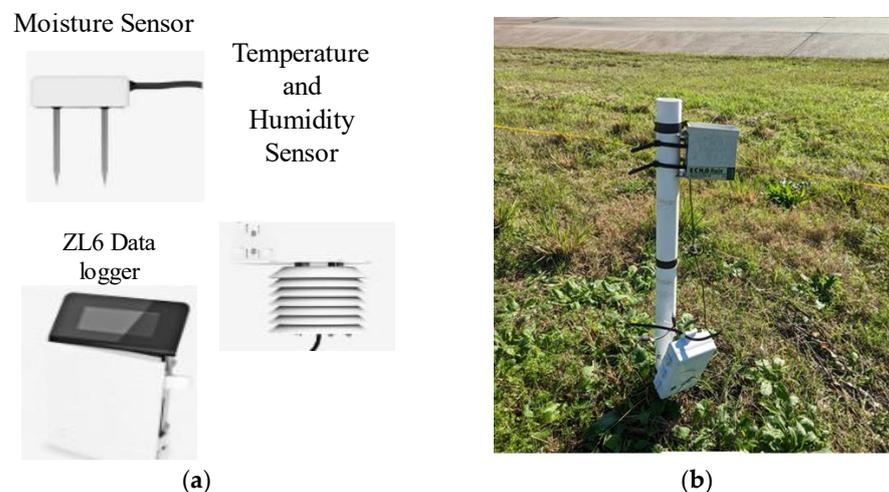
Figure 4. (a) Different sensors installed at the site; (b) rain gauge to track precipitation of the area.

A micro weather station was set up on the study slope to monitor field weather conditions. This installation included the integration of various industrial-grade sensors, such as the GS-1 moisture sensors to measure moisture sensors, the ECRN-50 tipping-bucket rain gauge to track the precipitation, the RT-1 to measure air temperature, and the EM50 data logger (Figure 4). Variations in moisture contents were observed in the planted section up to the depth of Vetiver growth of 300 cm using sensors, with calibrated sensors positioned at depths of 15.24 cm (6 inches) and 45.72 cm (18 inches). The depths were considered to track the slope soil water content, which may induce shallow slope failure. A 3.5 mm stereo audio extension cable is utilized to link each sensor with the data recorders to continuously capture and record in situ measurements. Following the completion of the installation process, the data recorders were programmed to gather information from the soil temperature, rain gauge, moisture sensor, water potential probe, and air temperature sensors hourly. Changes in moisture content and pore water pressure were monitored using these sensors and water probes within the planted section, with sensors placed at depths of 15.24 cm and 45.72 cm. All the sensors were linked to automatic data loggers programmed to collect data at hourly intervals. The data collected from the moisture sensor installed at 45.72 cm were utilized for this study.

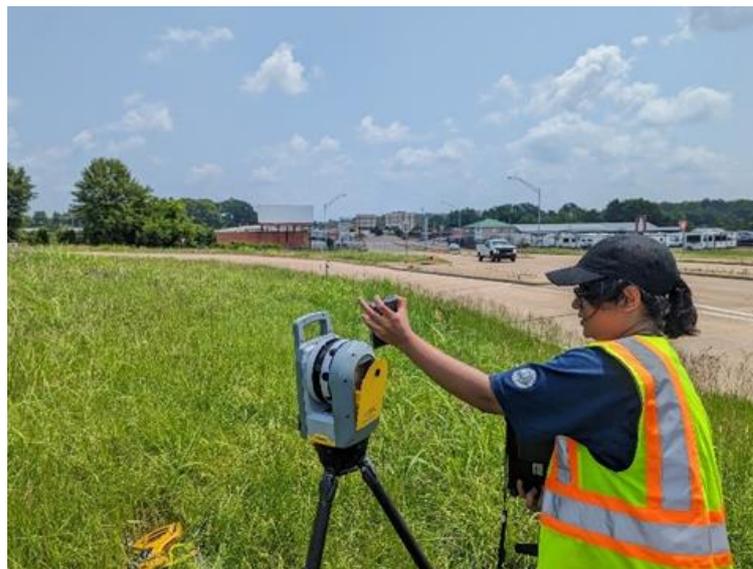
Figure 5. LiDAR survey conducted on the site.

The attractiveness of LiDAR instruments comes from their high spatial and temporal resolution of measurements, the capability to observe the atmosphere under ambient conditions, and the potential to cover the height range from ground level to over 100 km altitude [44]. Conducting recurring LiDAR point cloud surveys at a consistent location over time aids in monitoring subtle changes within geotechnical assets and mapping potential risks [45]. This current study applied 3D laser scanning with the terrestrial LiDAR equipment Trimble X7. Dense point cloud data were captured from the slope, and topographical surfaces were generated using the dense point cloud data, followed by the extraction of bare ground. Temporally spaced surface profiles for both the failed and undamaged sections of the slopes were created for comparative analysis (Figure 5).

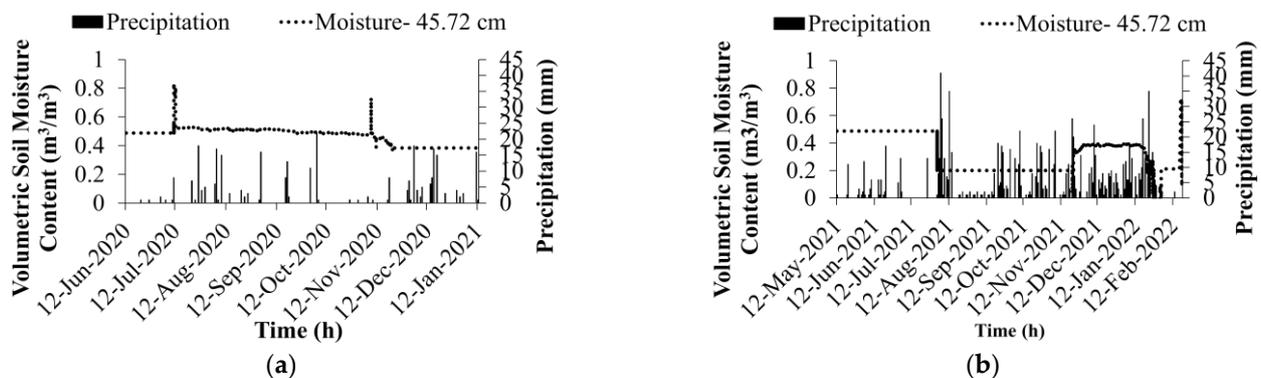
Figure 6. Moisture content variations in the slope soil with precipitation. (a) June 2020 to January 2021; (b) May 2021 to February 2022.

As part of the process of carrying out the analysis, the information about the moisture content of the slope for the years 2020–21 and 2021–22 was meticulously analyzed. The moisture content of the slope soil was initially higher (about $0.5 \text{ m}^3/\text{m}^3$) (Figure 6a), which may indicate that there is a perched water zone at shallower depth. The moisture content started to decrease in August of 2021, which was more than a year after the plantation was formed.

In 2020, which was the year that the plantation was carried out, the initial high volumetric moisture content can imply that Vetiver roots were not sufficiently grown to absorb water initially. As the roots started growing in the latter part of the year after August 2021, the water content stayed mostly constant throughout this period. As Vetiver roots can grow to full length up to 3 m after a one-year period, the results imply that the root uptake of the reduced water content reduces the volumetric water content of the soil. The deep root and long leaves of Vetiver allowed a better evaporation rate. There were several events of extreme precipitation during the study period. However, the lower hydraulic conductivity of expansive soil resulted in a delay in the peak in moisture content.

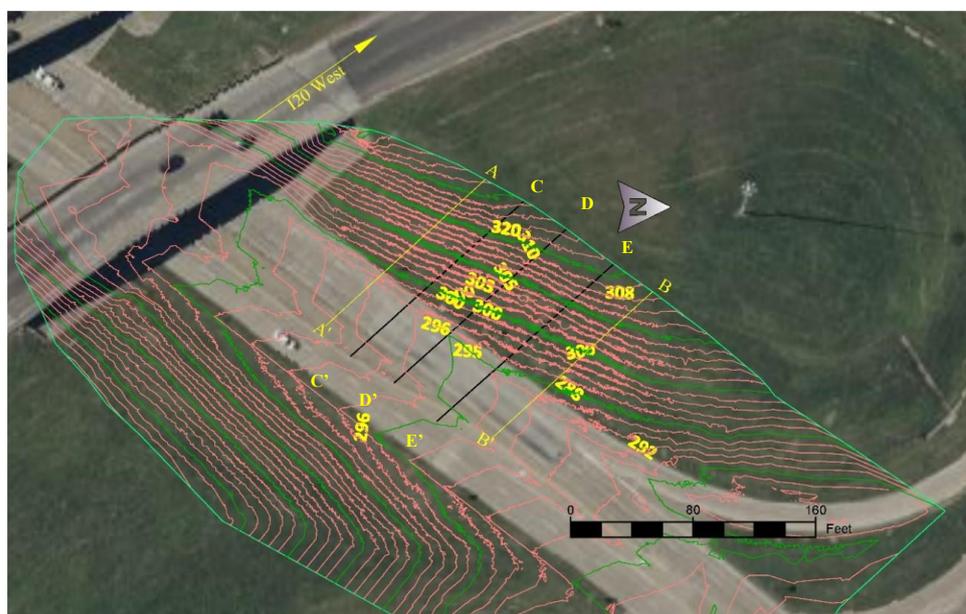
Figure 7. LiDAR surface topography.

In this study, the Trimble X7 terrestrial LiDAR equipment was utilized to carry out 3D laser scanning. Dense point cloud data were collected for the site and with the collected data, topographical surfaces were constructed. The LiDAR scanner was set up at five different stations on the slope for surveying and point cloud data were gathered while the scanner was in operation. In addition, ten spherical targets were placed around the slope at a height of four feet above the ground to facilitate the registration of the point cloud data that were collected from each station. To compare the temporally spaced point clouds and identify any changes that may have taken place, the point clouds were georeferenced and stacked, respectively. The slope surface profiles for each season were retrieved from the same locations on both point clouds to compare the changes that occurred in the slope during each season.

After field data collection, surface data from each season were superimposed, and alignments were established along the slope. Following this, surface profiles were created by utilizing the alignments along the Vetiver sections C-C', D-D', and E-E' (Figure 7). This process involved superimposing the surfaces to compare the changes over different seasons, and the alignments along the specific sections allowed for the generation of detailed surface profiles in relation to the Vetiver planting areas.

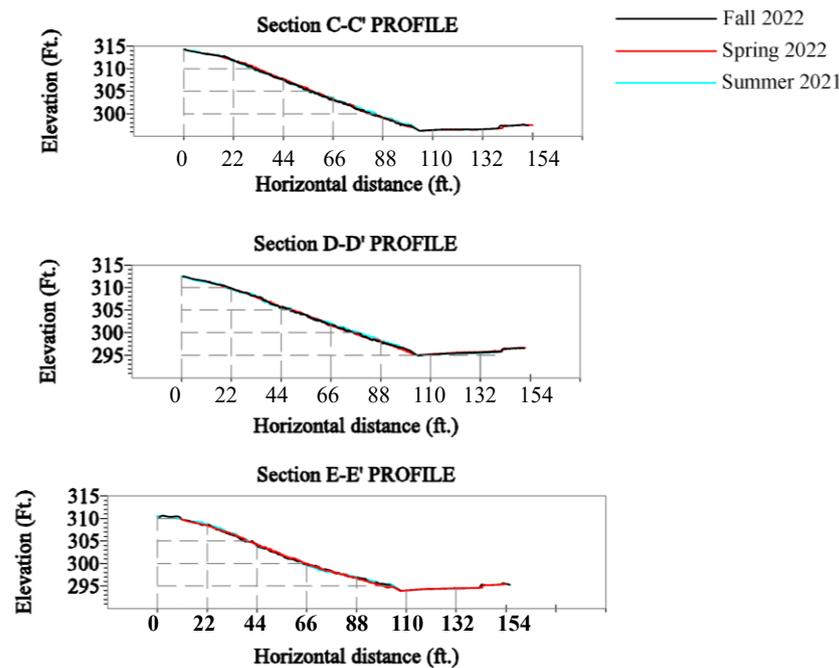
Figure 8. LiDAR surface profiles for (a) section C-C', (b) section D-D', and (c) section E-E'.

Three sectional profiles were created for summer 2021, Spring 2022, and Fall 2022 (Figure 8).

After the analysis, the profiles obtained for summer 2021, Spring 2022, and Fall 2022 from the cloud point data were superimposed. There were no significant changes in the slope section with seasonal changes. The profiles from the three sections indicate that there was no slope movement after the plantation of the Vetiver. The Vetiver root helped to lower the moisture content of the slope soil, which increased the shear strength eventually. The increased shear strength prevented any substantial movement along the slope soil.

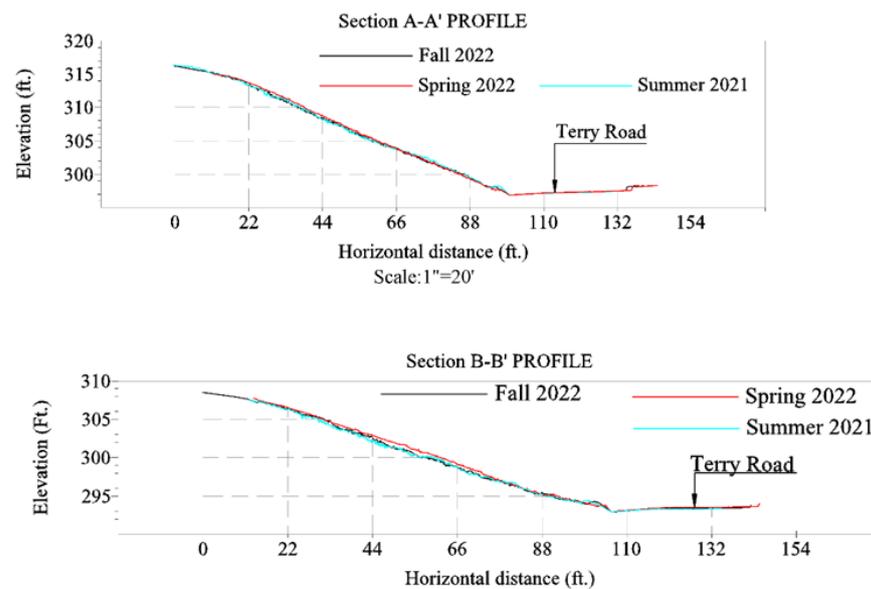
Figure 9. LiDAR surface profiles for the (up) repaired section A-A', and (down) control section B-B.

The constant moisture content along the slope soil in 2020 shows the existence of a perched water zone within the slope. The decrease in water content proves the improvement of soil quality after the Vetiver grass grew deeper into the soil. This illustrates the performance of Vetiver in providing slope stability. This was further evaluated through the LiDAR data analysis and surface profile generated from the point clouds. There was no significant change in the soil sectional profile in summer 2021, spring 2022, and fall 2022. It indicates that there was no significant slope movement during this period. The previous repair to the slope where no vetiver exists is still working as intended (Figure 9).
