Article

Thermal Transmission through Existing Building Enclosures: Destructive Monitoring in Intermediate Layers versus Non-Destructive Monitoring with Sensors on Surfaces

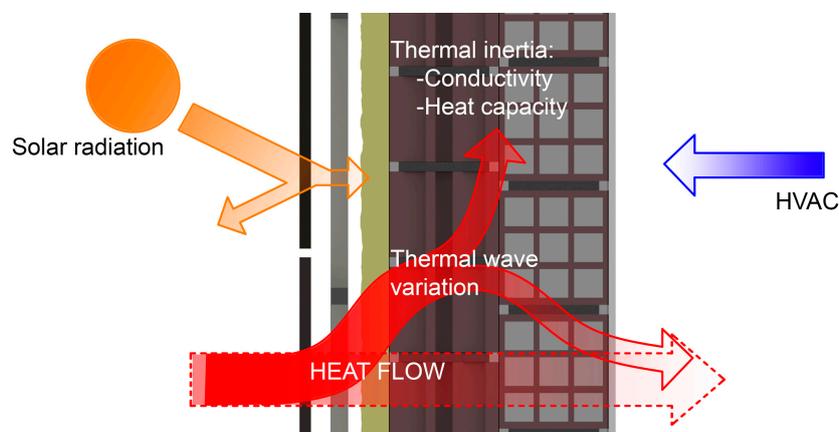
Figure 1. The dynamic process of heat transmission through enclosures.

However, this law is valid only for ideal situations. Walls have limited dimensions and present discontinuities due to metalwork, woodwork, and glazing. Thermal bridges also exist due to construction requirements, etc. [12,13]. Furthermore, different layers are often made up of various types of materials with different physical parameters regarding thermal resistance values [14]. In addition, outdoor air conditions differ according to solar radiation, wind speed, water vapour pressure, etc. Solar radiation frequently affects outer surfaces, provoking substantial increases in temperature [15]. Additionally, if we look at the indoor environment, different thermal loads and conditioning systems alter the physical parameters of relative humidity, indoor air temperature, and wall surface temperatures. To finish, Fourier's linear process is altered by variations in the thermal inertia of enclosure materials over time. These variations are due to the thermal gap between indoor and outdoor air temperature, solar radiation affecting the exterior surface, or indoor air conditioning systems, that all change according to different moments in time. Heat flow can thus be defined as a dynamic and complex process [16] (Figure 1).

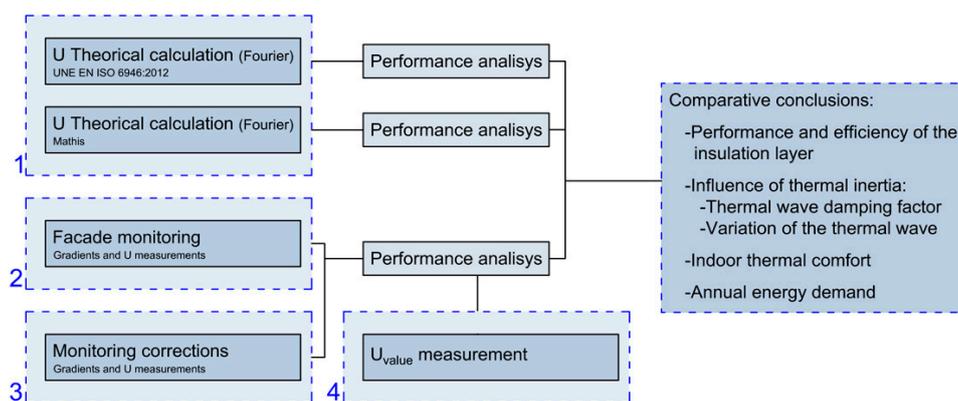
Figure 2. Design of the research methodology process.

The research methodology is shown in Figure 2. The first step consisted in examining the thermal behaviour of the enclosure in a steady state according to Fourier's law, applying theoretical values of λ thermal conductivities according to the UNE EN ISO 6946:2012 standard. Secondly, the same analysis was performed based on thermal conductivity measurements values using Mathis TCi equipment. Thirdly, the monitoring data were analysed, as well as the monitoring data corrected by the mathematical model, once the enclosure had been pierced and repaired. These results were analysed comparatively, mainly through graphs, detecting temperature variations in the daily cycle due to the materials' thermal inertia and solar radiation. Finally, measurements of U -values were made both for the original enclosure and for the repaired enclosure.

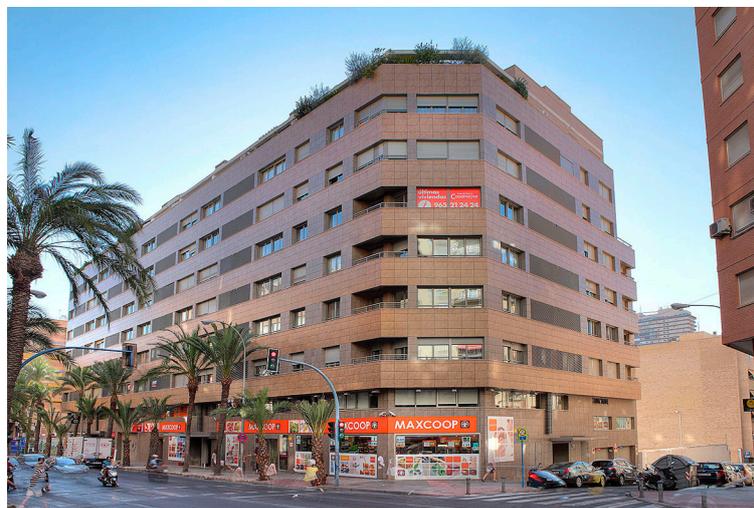
Figure 3. Building façade. North façade and west façade.

The building under study was located in the urban area of Alicante city (Figure 3). This corner building has a façade giving onto Benito Pérez Galdós Avenue and another giving onto Catedrático Ferre Vidiella Street. The building houses 69 flats with two, three or four bedrooms, garages and storage rooms. It has eight different types of homes (flats A–F, penthouse types N–P). It is a corner building between party walls, with a ground floor, six more floors and a loft. There are five vertical communication nuclei: four of them with direct access to Benito Pérez Galdós Avenue and the fifth with direct access to Catedrático Ferre Vidiella Street.

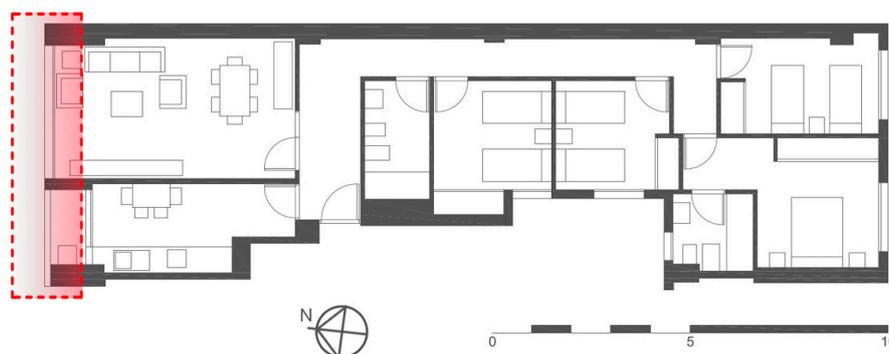
Figure 4. General floor view of type C flat.

The housing under study corresponded to the building's type C flat. It is located on the third floor, with north and south facades. It consists of two bathrooms, four bedrooms (two bedrooms giving onto the interior patio of the building measuring $4\text{ m}^2 \times 4\text{ m}^2$ and two bedrooms giving onto the block's interior courtyard), a living room and kitchen oriented towards the north façade giving onto Benito Pérez Galdós Avenue (Figure 4). None of the flat boundaries give onto the party walls so all of the flat's partitions are bordered by other flats in the same building.

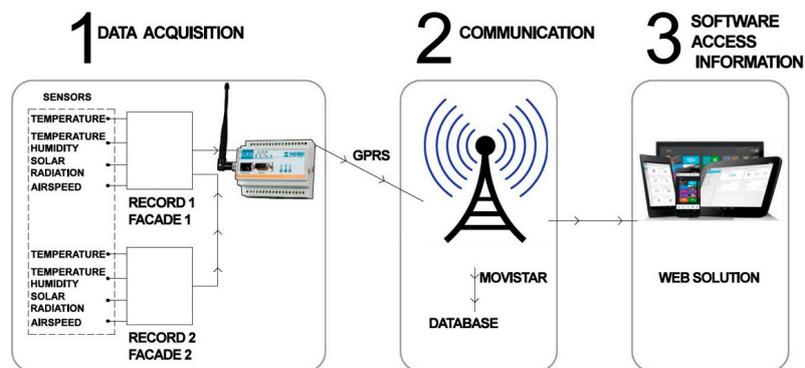
Figure 5. Connection flow chart.

The monitoring system consists of the probes described above, placed at the strategic points of the building's two enclosures, determined according to the physical composition of the glazing and front slabs. Data collected by the sensors are sent to a data logger (analyser), which transmits a signal via GPRS to a database. This information is accessible from a web platform (Figure 5).

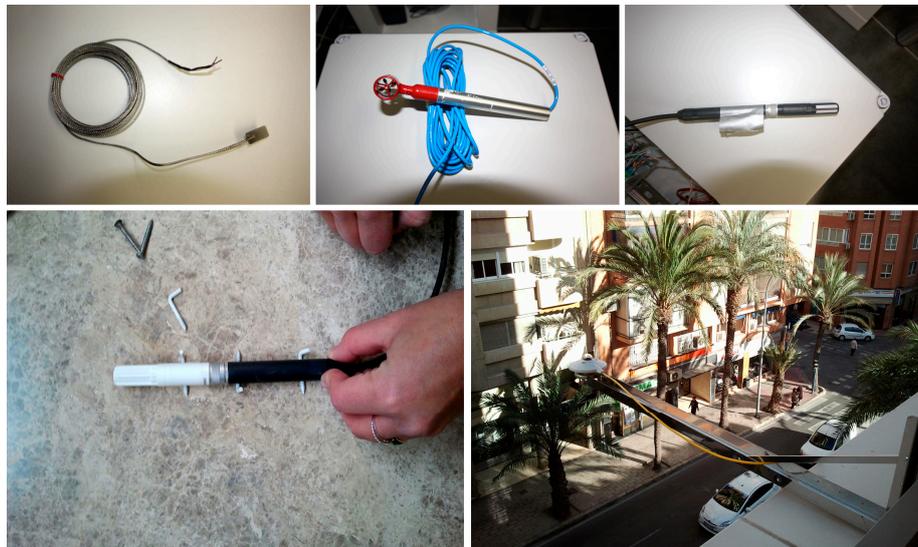
Figure 7. Sensors for surface temperature, anemometer and environment temperature; and pyranometer.

Environmental variables are individually monitored for each enclosure construction solution (Figure 7). Records were made of:

- GPRS RTU, one RS232/385 port, two pulse inputs, 14 digital inputs, six Open Collector Digital Outputs, six 0–10 V Analog Inputs'. Modbus master.
- Standard Hygroclip2-HC2-S Temperature and Relative Humidity Probe. Temperature ranges from $-50\text{ }^{\circ}\text{C}$ to $+100\text{ }^{\circ}\text{C}$ ($-40\text{ }^{\circ}\text{C}$ to $+60\text{ }^{\circ}\text{C}$, 0–1 V outputs); Relative Humidity 0% to 100%. Accuracy $\pm 0.8\%$ RH, $\pm 0.1\text{ }^{\circ}\text{C}$.

- Standard Hygroclip2-HC2-S3 Temperature/Relative Humidity probe for meteorology applications. Temperature ranges from $-50\text{ }^{\circ}\text{C}$ to $+85\text{ }^{\circ}\text{C}$; Relative Humidity 0% to 100%. Accuracy $\pm 1\%$ RH, $\pm 0.3\text{ }^{\circ}\text{C}$.

- KIPP Model CMP3 pyranometer ISO second class. Spectral range 310–2800 nm (50% points), response time $< 18\text{ s}$ (95%), non-linearity $< 2.5\%$ ($0\text{--}1000\text{ W/m}^2$), directional error $< 20\text{ W/m}^2$ (80° at 1000 W/m^2), sensitivity $7\text{--}20\text{ CV/W/m}^2$ (variation $< 5\%$ from $-10\text{ }^{\circ}\text{C}$ to $+40\text{ }^{\circ}\text{C}$), operating temperature $-40\text{ }^{\circ}\text{C}$ to $+80\text{ }^{\circ}\text{C}$. Thermopile detector.

- MiniAir64 Mini, probe anemometer, air velocity range 0.5–40 m/s, accuracy $\pm 0.5\%$ of full scale, 1.5% of reading, power supply 9–24 vDC, O/P 4–20 mA. Temperature $-65\text{ }^{\circ}\text{C}$ to $150\text{ }^{\circ}\text{C}$.

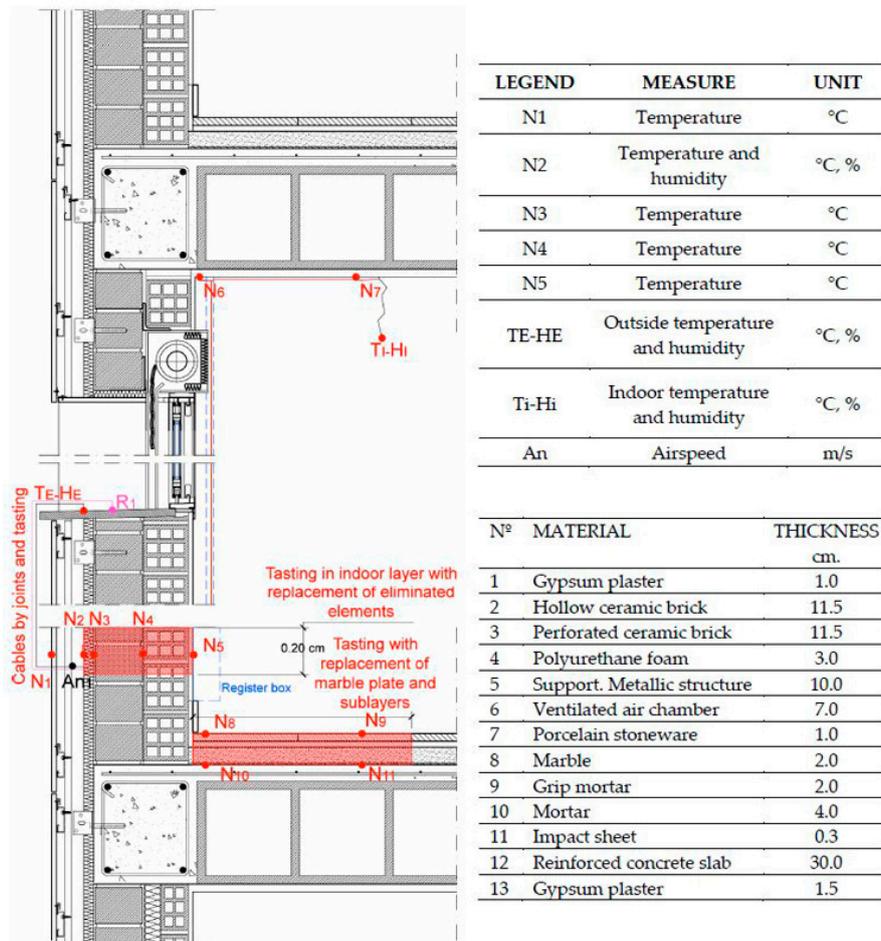
Figure 8. Chart of sensor locations.

As indicated, the sensors were introduced several years after the completion of the building. After opening the enclosure, the sensors were fixed to the surfaces according to the location plan shown in Figure 8. Sensors for surface temperatures were arranged in an ordered way for the different layers at similar position coordinates (Figures 9 and 10).

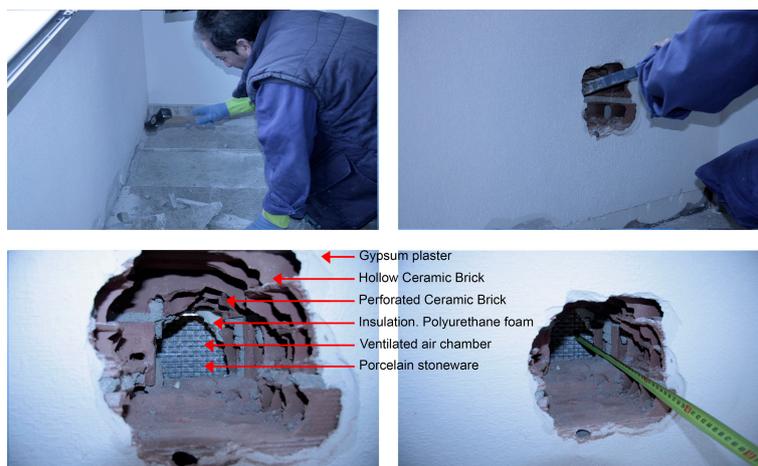
Figure 9. Destruction process of the enclosure to introduce the sensors.

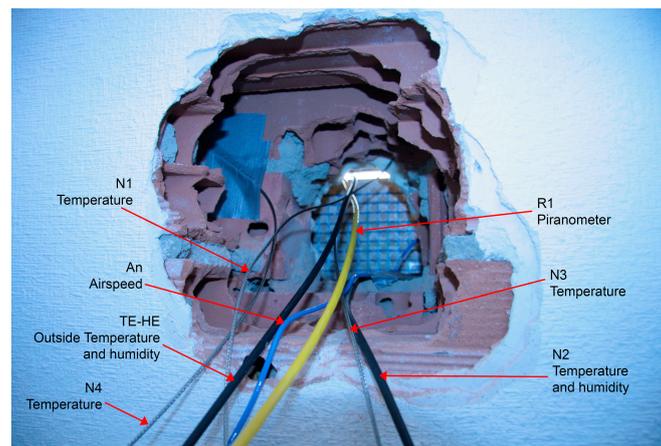
Figure 10. Location of sensors in the enclosure layers.

The damage to the enclosure was repaired once the sensors were placed with connecting cables to the analyser. The various layers of plaster, hollow brick, perforated brick, polyurethane, etc., were sealed so as to ensure maximum continuity with the original materials (Figure 11). Nevertheless, for reasons of formats, shapes of the cracks, new binder materials, etc., certain discontinuities occurred in the materials, which led to differences in thermal conductivity, heat capacity, specific heat and effusivity.

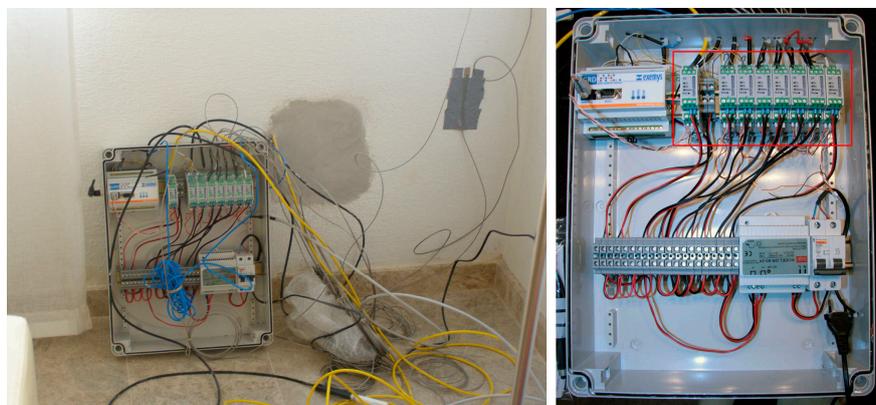
Figure 11. Data Logger, Data Reception and GPRS Communication.

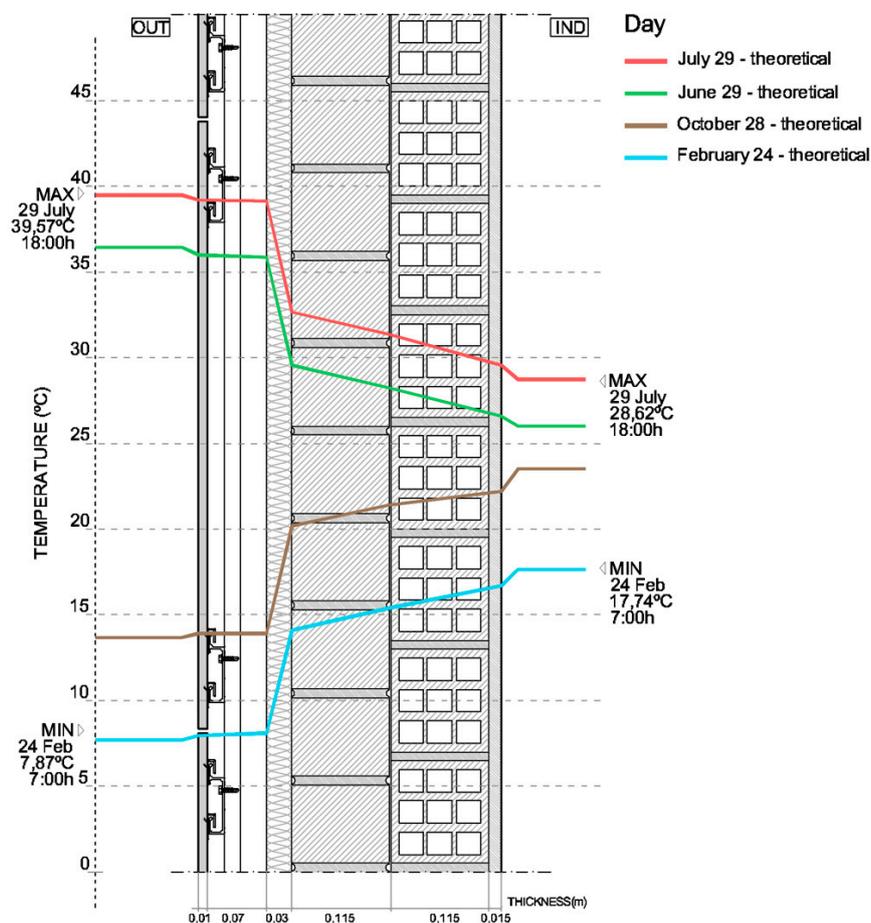
Figure 12. Dynamic temperature graphs of the enclosure measured according to Fourier's law, for λ values of the Mathis TCi unit and thickness of the project layers, on the less favourable days in each season.

To simulate this behaviour in static conditions, unaffected by other energy sources such as solar radiation, the indoor air conditioning system, materials' effusivity or thermal inertia [24], we applied the maximum temperature of outdoor summer air (39.57 °C), and the minimum outdoor winter temperature (7.87 °C) that had been collected by the monitoring sensors, and an indoor air temperature of 28.62 °C in summer and 17.74 °C in winter without switching on the conditioning system. Temperature gradients for the most unfavourable days of each season results are shown in Figure 12. To do this in accordance with Spanish CTE regulations [25,26], we took into account a surface thermal resistance of $1/h_i$ of 0.13 m² °C/W, a surface thermal resistance of $1/h_o$ of 0.04 m² °C/W and a thermal resistance R_c of the ventilated façade cavity of 0.176 m² °C/W, considered to be a poorly ventilated cavity. The reason for this choice of value was that ventilation hole surfaces represented less than 20 cm² per vertical section linear meter. Furthermore, the lower part was sealed and thus closed to the passage of air. These conditions reduced the efficiency of heat dissipation in summer and the insulation layer also had a drying effect in the rainy season.

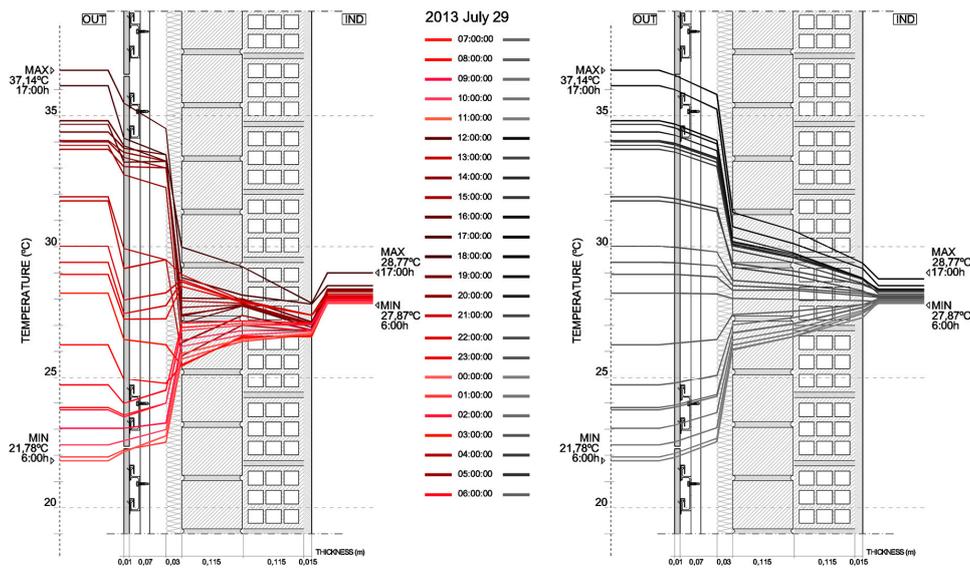
Figure 13. Dynamic temperature graphs showing each hour on 29 July 2013. (Left) Data obtained by monitoring; (Right) gradients in steady state according to Fourier.

We proceeded to study the evolution of the temperature gradients during the cycle of a full day on the four days indicated above. The results are shown in Figures 13 and 14. When comparing with the graphs based on Fourier's ideal regime, it is possible to detect, thanks to the real monitoring data, the effects on thermal behaviour produced by: the physical properties of real—not ideal—enclosures; the effect of solar radiation on the porcelain stoneware façade; the materials' thermal inertia or effusivity; and the air conditioning systems used [27]. To this end, Figure 12 shows a comparison between graphs obtained based on Fourier for these maximum thermal gaps and graphs obtained from monitoring data.

22 cm of hollow and perforated ceramic brick can also be observed in Figures 13 and 14. They cushion the thermal wave due to the produced ΔT of indoor–outdoor air.

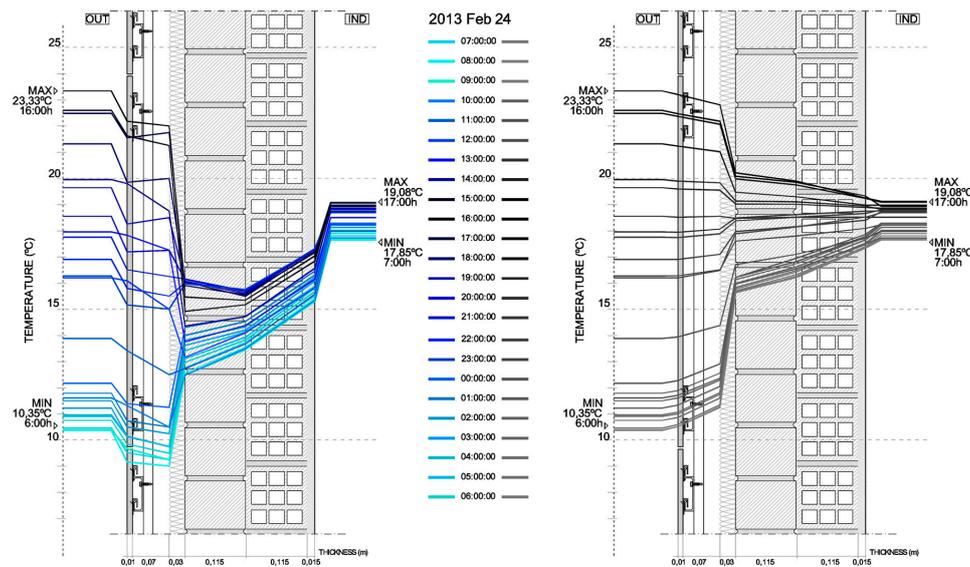
Figure 14. Dynamic temperature graphs by hours for 24 February 2013. (Left) Data obtained by monitoring; (Right) gradients in steady state according to Fourier.

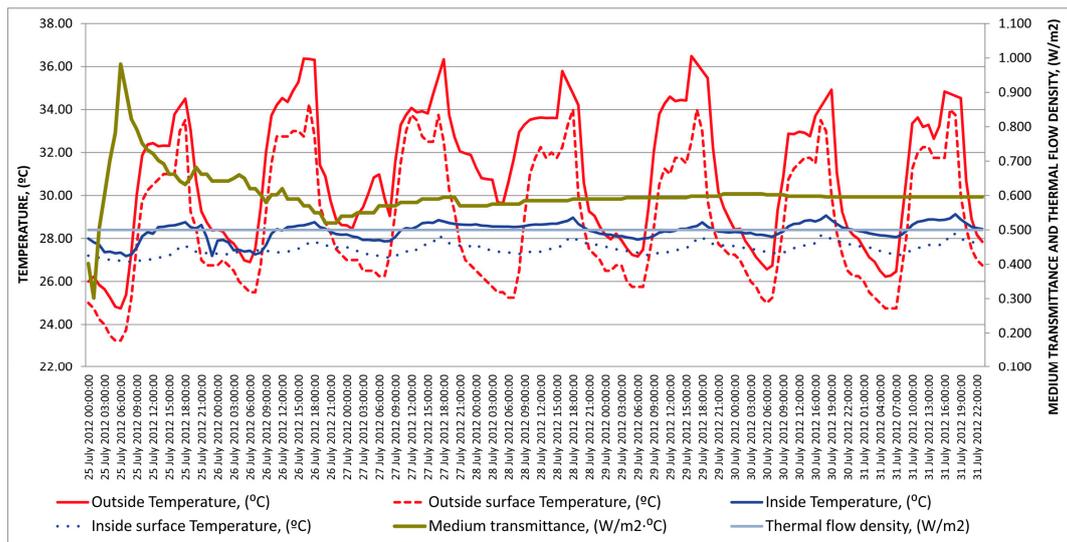
Scheme 1. Graph of metric study of thermal flow showing the temperature and flow data from which the U -value was calculated.

Subsequently a metric study of thermal flow in the opaque enclosure was also carried out in order to obtain the real measurement of *U*-value [28,29]. It was measured in the two façade units (living room at a height of 1.70 m and adjoining kitchen, C1 monitoring), and also in the centre of the repaired hole (monitoring C2). For this, the ISO 9869-1:2014 standard was followed [30]. The equipment consisted of a thermal flow plate and a transducer that generates an electrical signal proportional to the total heat rate applied to the surface of the sensor.

Data were analysed using the thermal transmittance calculation module, which is part of the AMR WinControl software developed by Ahlborn for ALMEMO measuring equipment. The method used was the "average method" [31]. The results are shown in Scheme 1 and Table 6. The C1 and C2 monitoring values were higher by 10.4% and 25%, respectively, compared to the theoretical values.

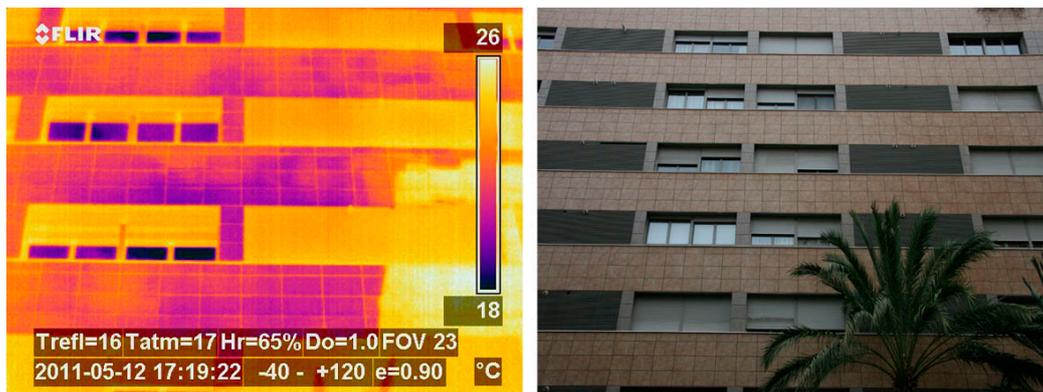
Figure 15. Thermographic picture of the northwest façade. Taken on 12 May 2013 at 3:55 p.m.

The heat flow analysis was completed using thermographic images, taken with ThermoCam P25 thermographic camera from Flir. We proceeded to detect thermal bridges and evaluated the behaviour of the outer enclosure in its ventilated chamber [32,33]. Quantifying thermal bridges was not, however, the aim of this research [34] (Figure 15).

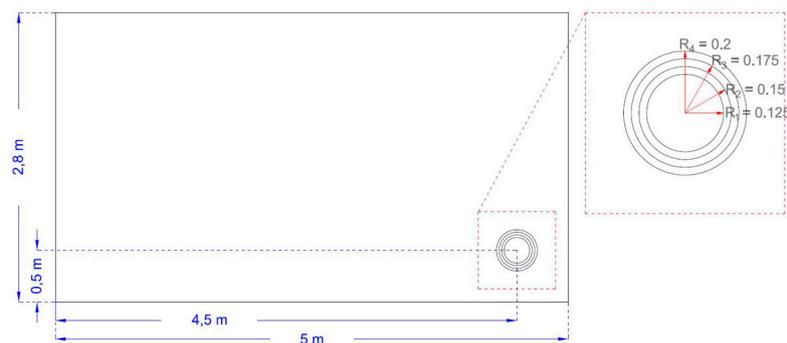
**Figure 16.** Image that shows the dimensions of the complete wall and a graphic representation of the hole synthesized in a circle of known radius.

The broken surface of each of the layers had an irregular shape that was given a simplified circle shape of a similar size and a known radius (Figure 16). The inner layers were larger than the outer ones, leading to:

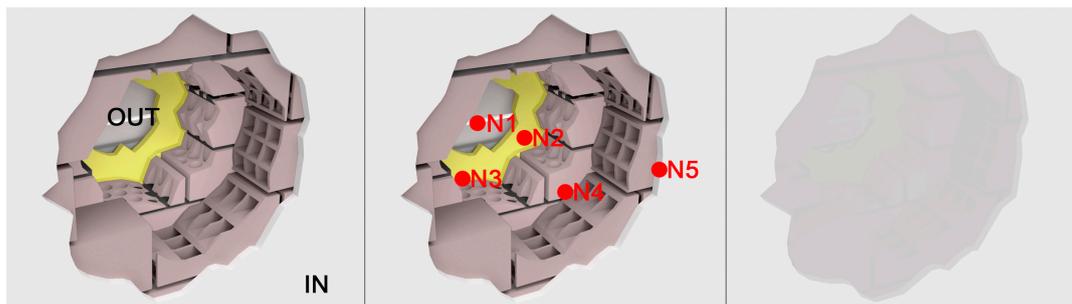
Figure 17. Picture of hole in the wall and subsequent repair using a different material.

By introducing the sensors after the building was constructed, it was necessary to repair the hole that had been drilled to make the measurements (Figure 17). Therefore, the punctual thermal conductivity λ in a wall layer, within an area where there had been no repairs, was affected by the theoretical conductivity λ_1 of the material used in its execution, depending on the distance between the location of the sensor and the location of the area built with new materials (the greater the distance, the lesser the impact). That is, to correct the produced deviation, we had to quantify the thermal conductivity value λ for each of the layers according to the extent to which the area was affected by the sensor that had been introduced. This way, by finding the deviation ratio (global effect), it becomes possible to deduce the temperature in cases where no damage was caused by introducing the sensors.

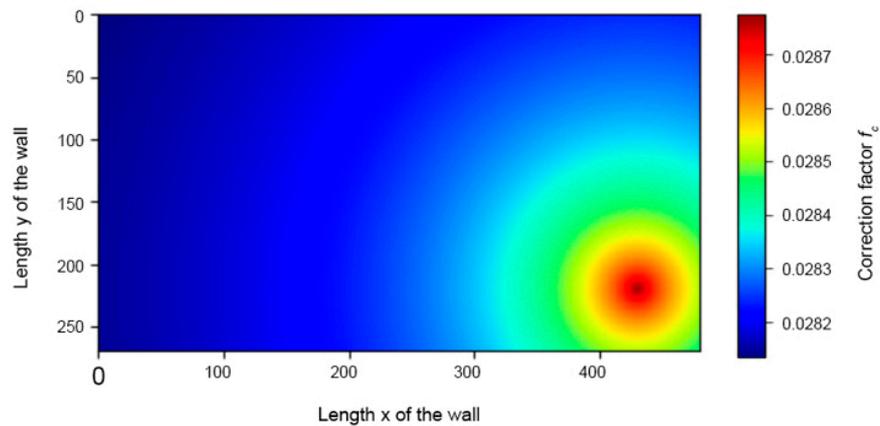
Figure 18. Picture showing the size of the complete wall and cavity made in each of the layers interpreted as a circle for simplification.

Taking these data into account, it is possible to visualize the results obtained after modifying the thermal conductivity λ of each of the points in the plane. Figure 18 shows the application of this algorithm to the interior wall of the home's living room where the sensors were located. Table 8 shows the correction factor value for each of the sensors inserted in the inner layers of the enclosure.

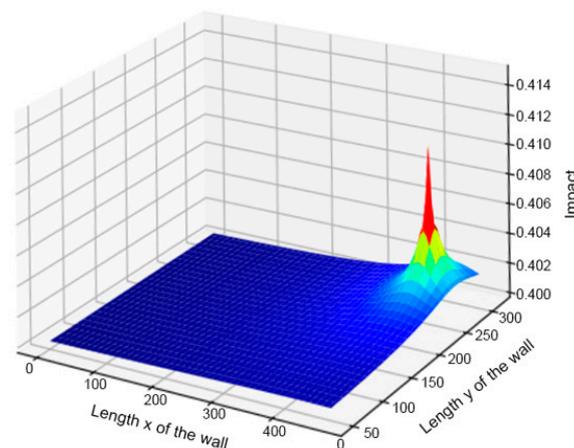
Figure 19. Flow diagram showing the impact of the change of materials used in an area of each of the points of the wall.

The three-dimensional diagram (Figure 19) shows an increase in the heat flow inside the hole due to the increase in the materials' thermal conductivity λ . The correction factor f_c was applied to the system receiving the sensors' surface temperature data. Data already corrected were thus visualized and entered in the database, so that the actual behaviour of the enclosure could be processed later. The actual temperature gradients experienced by the building in dynamic regime were thus obtained [37]. Scheme 2 shows the corrected temperature data for 29 July 2013, from sensors N2 and N3. The temperature gradients obtained before and after the application of the correction factor f_c are shown in Figure 20, on days presenting the greatest thermal gap for each season in 2013: 24 February, 29 June, 29 July and 28 October.

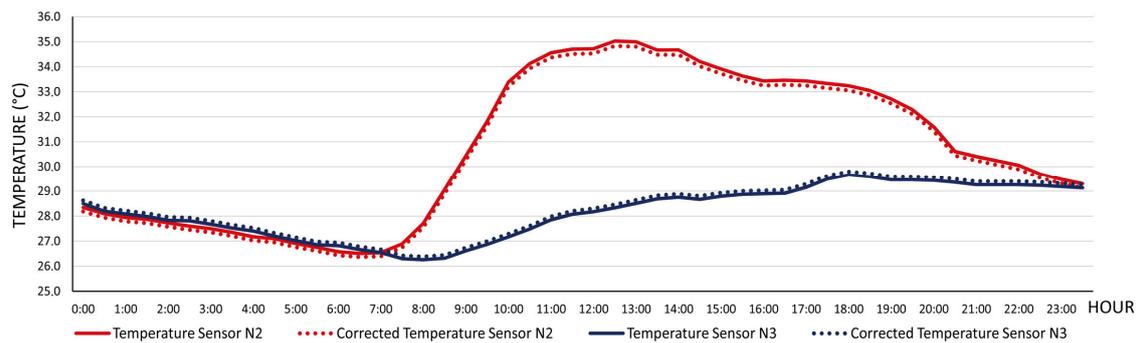
Scheme 2. Temperature values recorded by sensors N2 and N3 on 10 August 2013. Temperature values corrected with f_c .

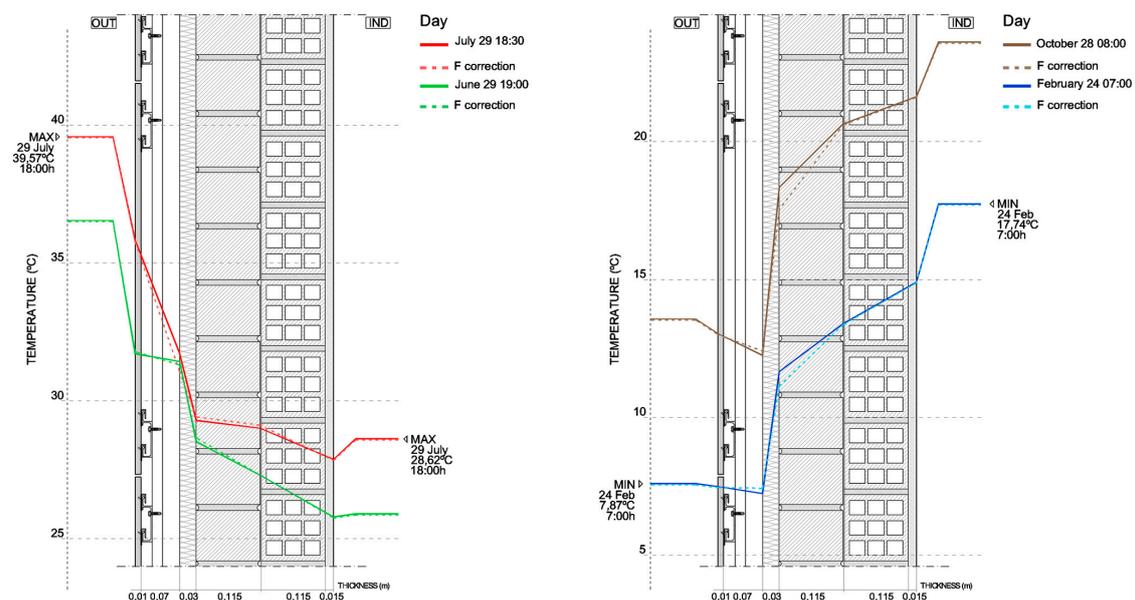
Figure 20. Comparison of temperature gradients before and after applying the f_c .

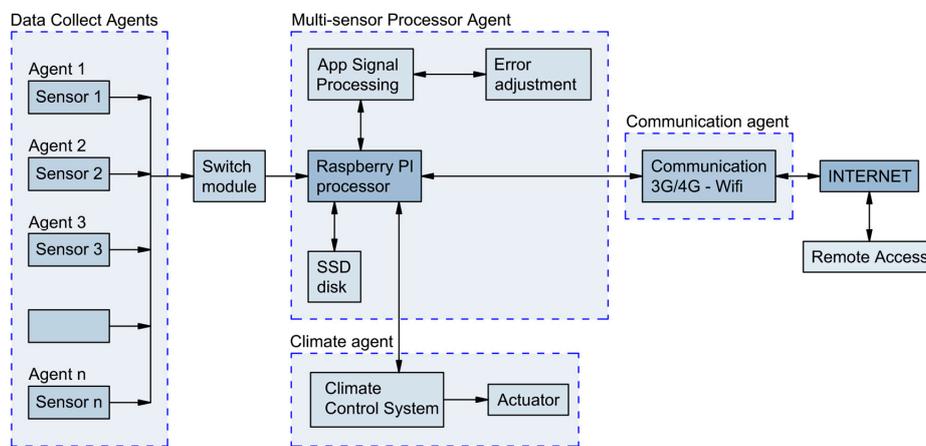
Figure 21. Outline of the architecture of the Multi-sensor Processing System.

The architecture designed to process the temperature data corrected by factor f_c , obtained from the multiple sensors described, allowed us to improve the initial proposal by using Multi-agent System (MAS) techniques. These techniques incorporate a set of agents that distribute the required components' different tasks so that sensor data are processed on site (Figure 21). The MAS is a field of research that covers a wide range of applications in smart buildings, construction, building sensing and control, or maintenance [38–40]. A modern approach to architectural construction considers that MAS components are connected to a building's architectural design. From this perspective, a multidisciplinary approach is essential in constructive design [41], where models for Building Information complemented with MAS turn into powerful systems for holistic building design [42].

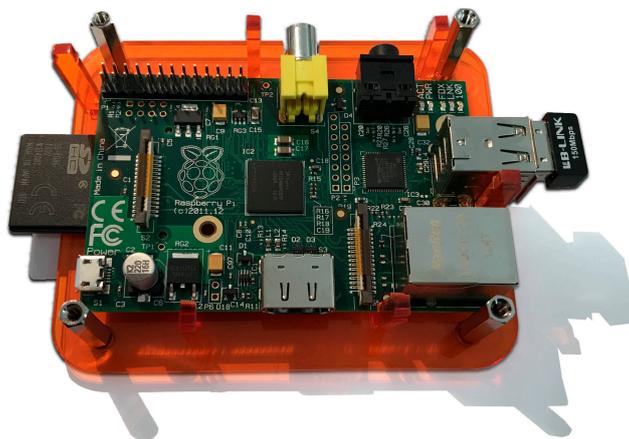
Figure 22. Raspberry Pi processor connected to the SSD subsystem.

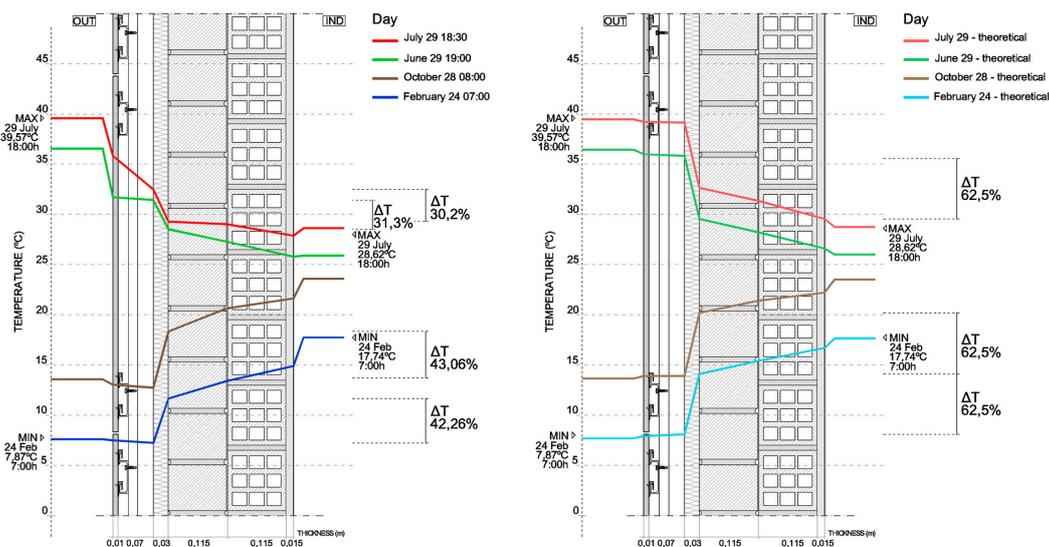
Figure 24. Comparison of temperature gradients in the insulation layer, and percentage of thermal gap $T_i - T_o$ (Left) according to monitoring; (Right) according to the Fourier stationary regime.
